Brookhaven Graphite Research Reactor (BGRR) Decommissioning Project

CHARACTERIZATION REPORT FOR BUILDING 701
ABOVE GROUND SURFACES, SYSTEMS, AND
STRUCTURES

May 2003

BROOKHAVEN NATIONAL LABORATORY
BROOKHAVEN SCIENCE ASSOCIATES

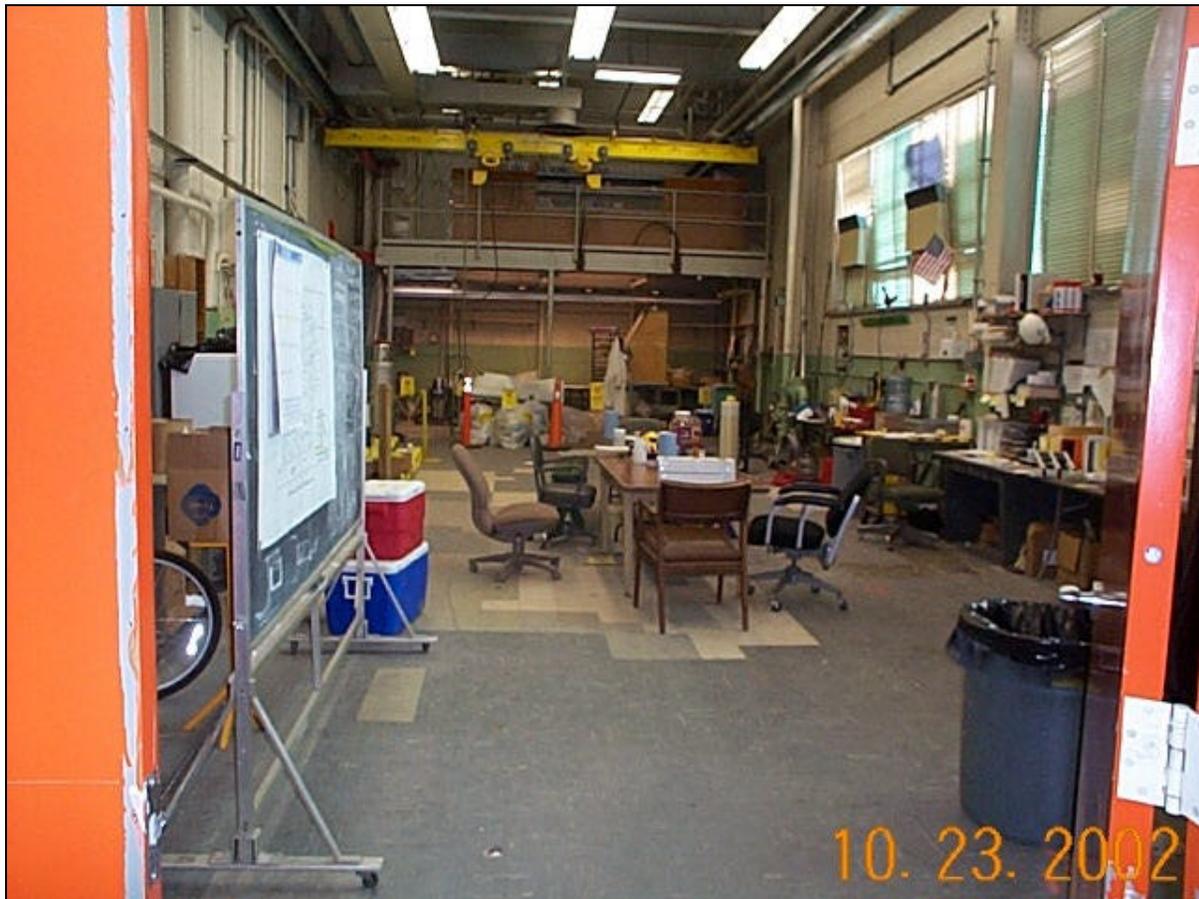
Figure A-1 Machine Shop

Based on historical and current data and information, this area is Class 1 for radiological surveys.

Recommend additional sampling for asbestos during remediation activities.

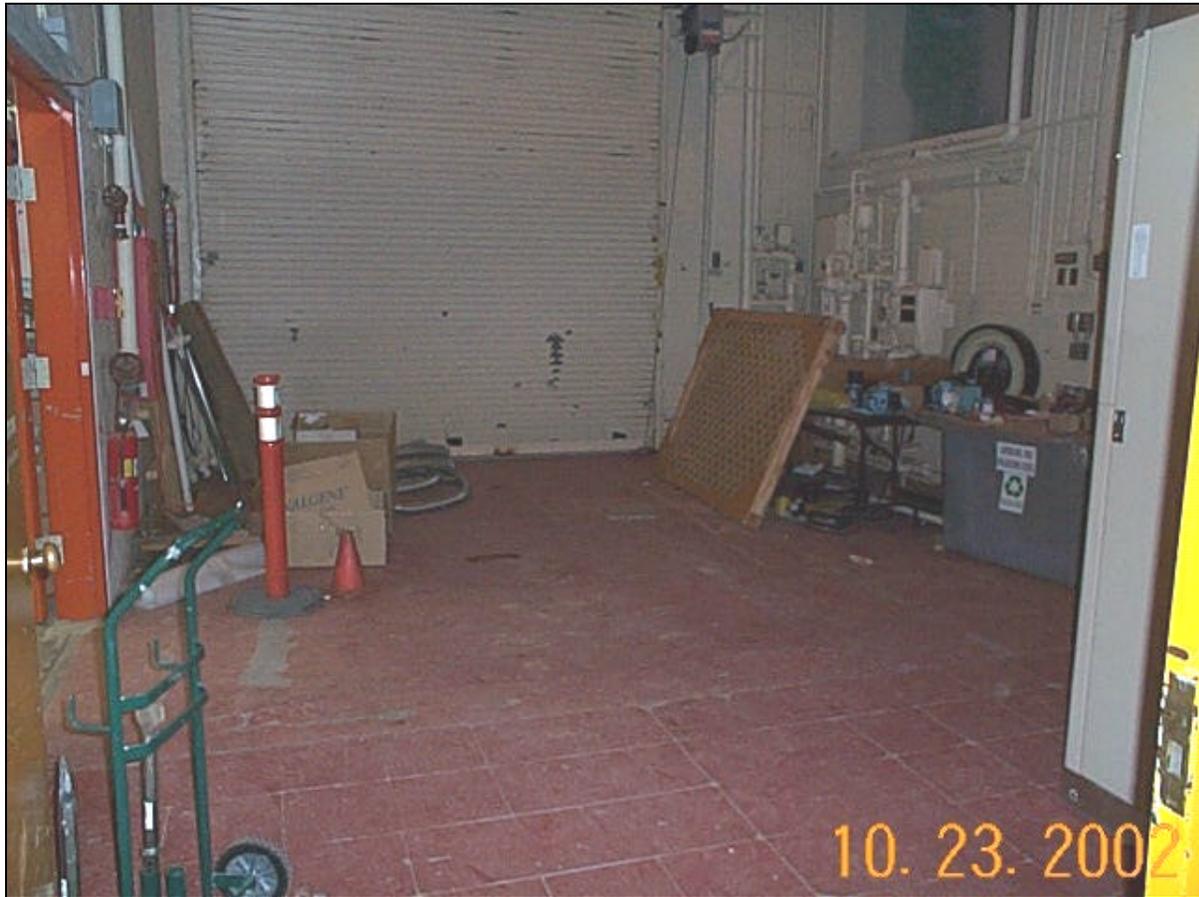
Figure A-2 Receiving Room

Based on historical and current data and information, this area is Class 2 for radiological surveys.

Recommend additional sampling for asbestos and lead during remediation activities.

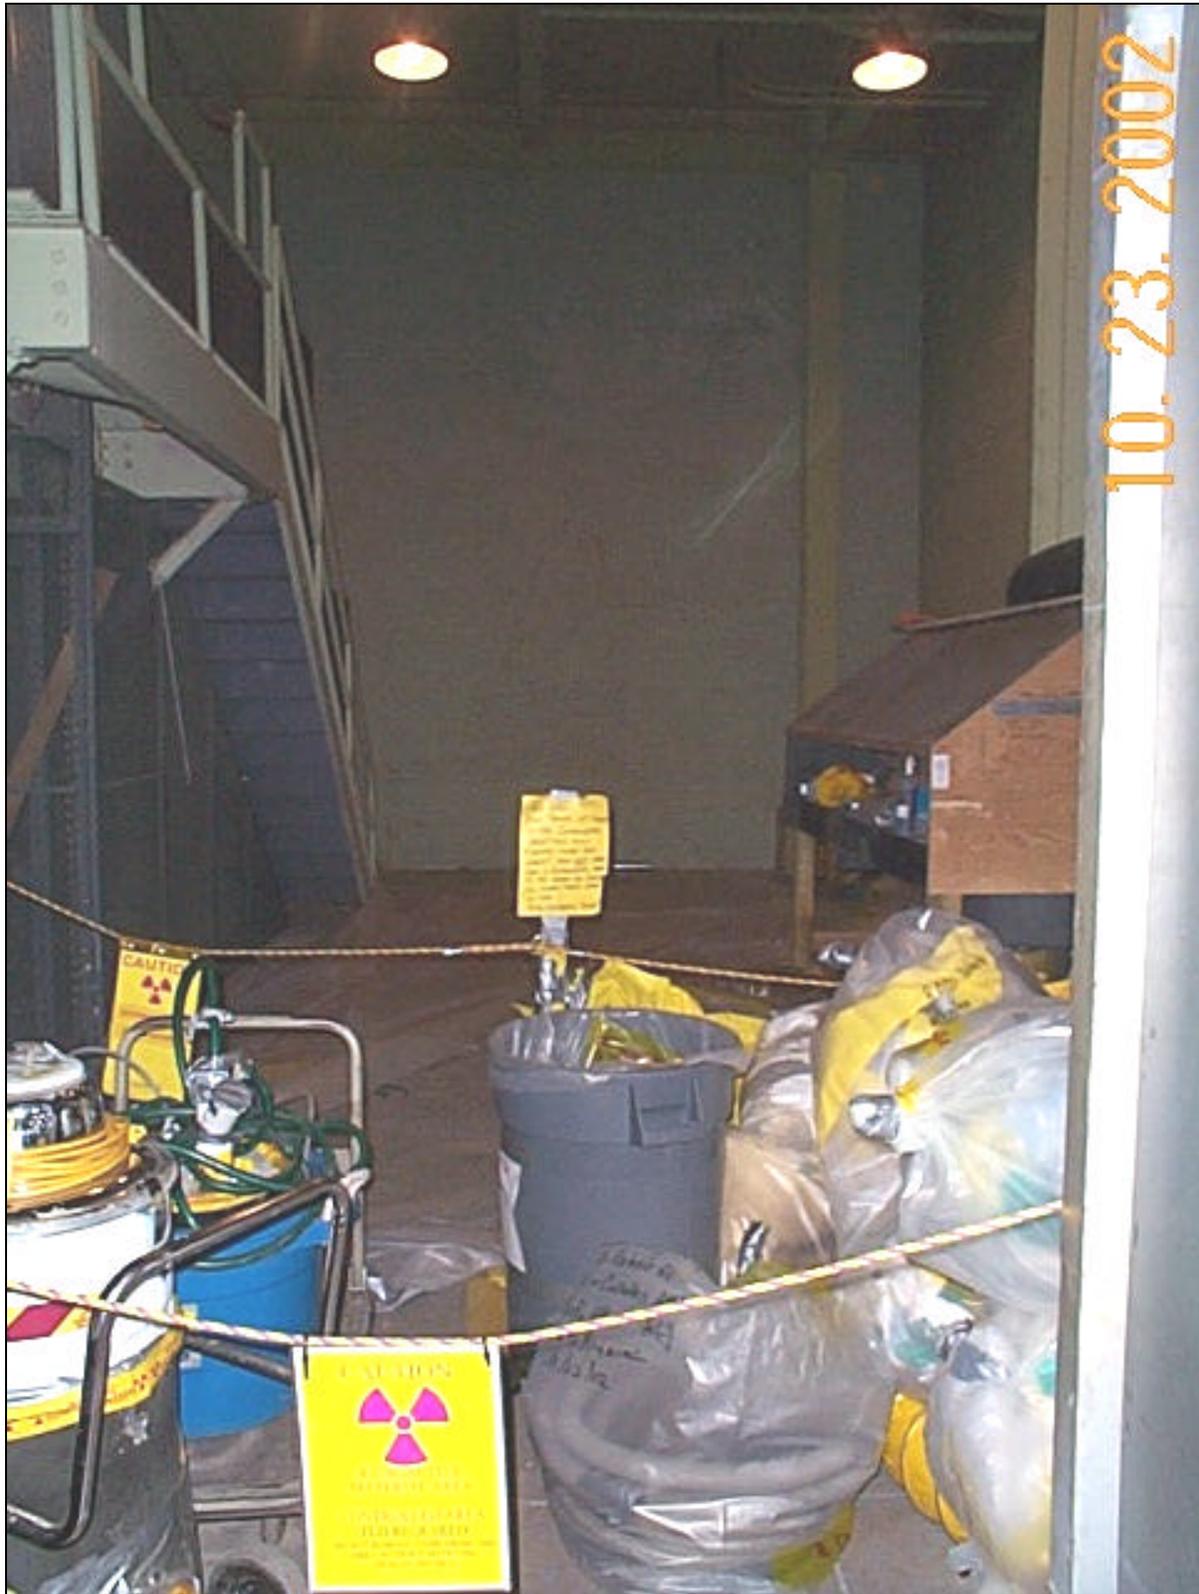
Figure A-3 Fuel Vault

Based on historical and current data and information, this area is Class 1 for radiological surveys.

Recommend additional sampling for asbestos and lead during remediation activities.

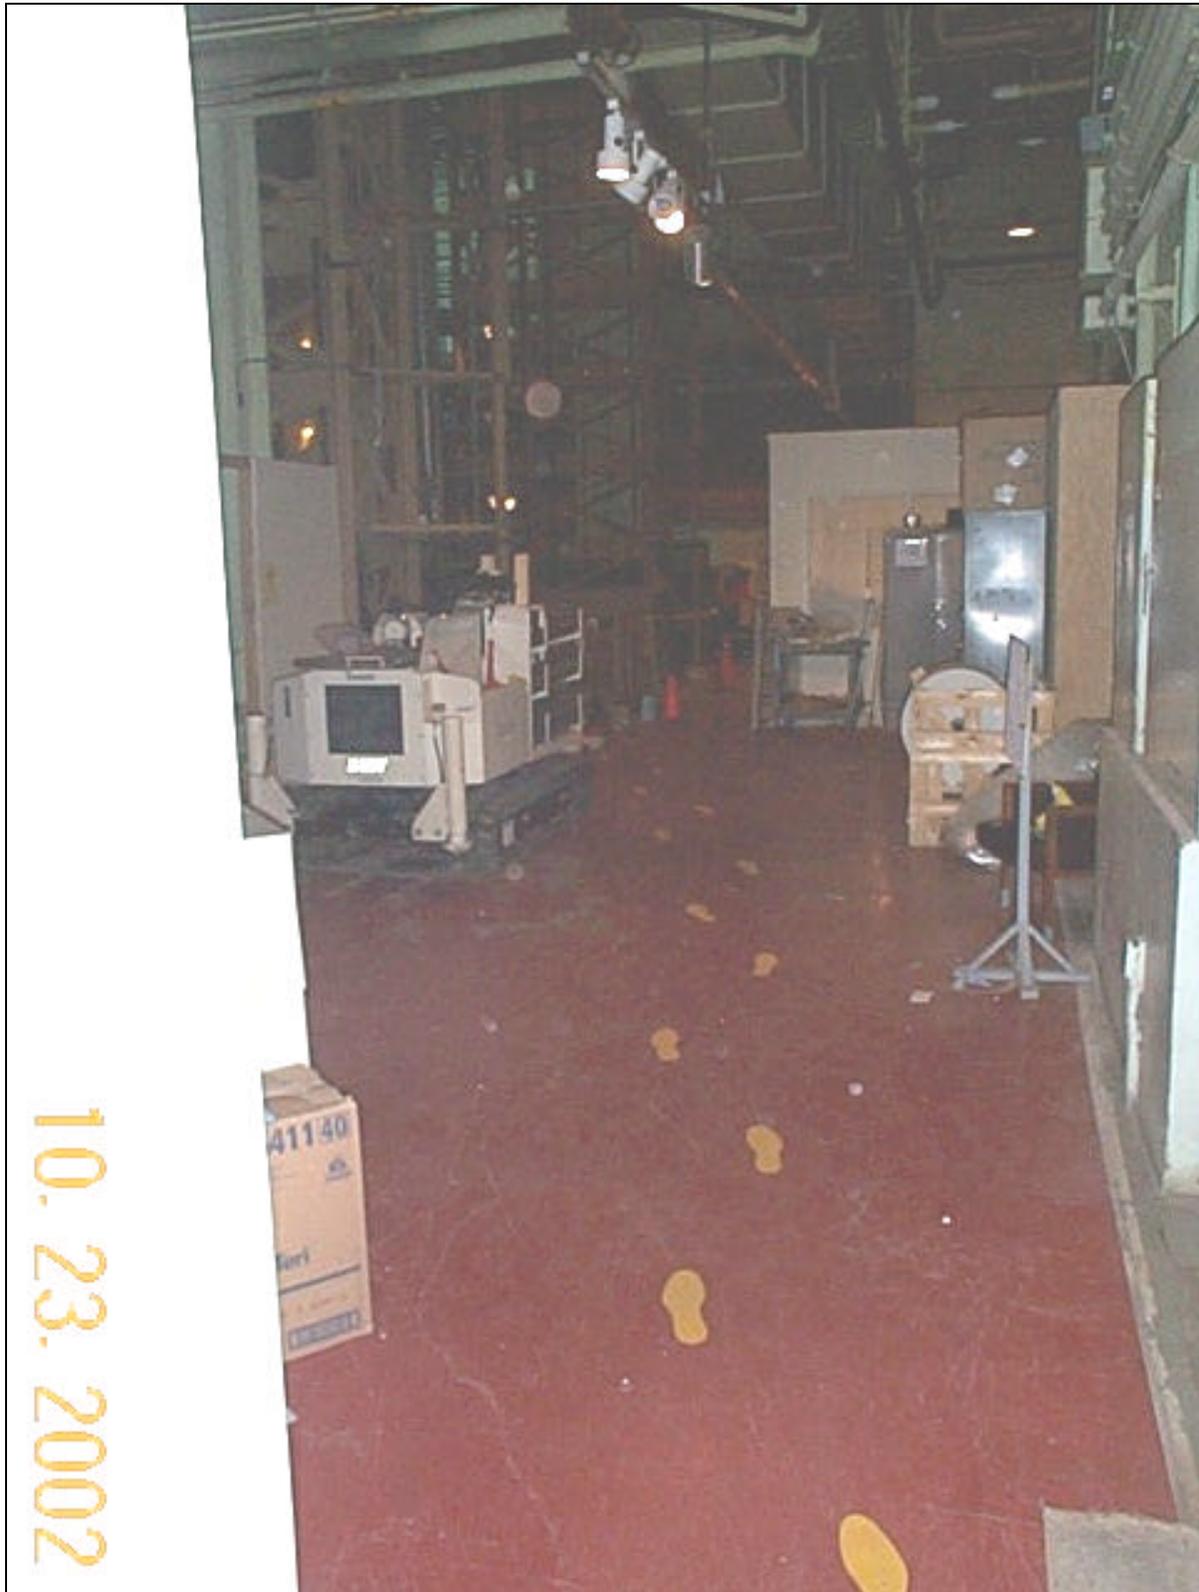
Figure A-4 Reactor Building South General Area

Based on historical and current data and information, this area is Class 1 for radiological surveys.

Recommend additional sampling for asbestos during remediation activities.

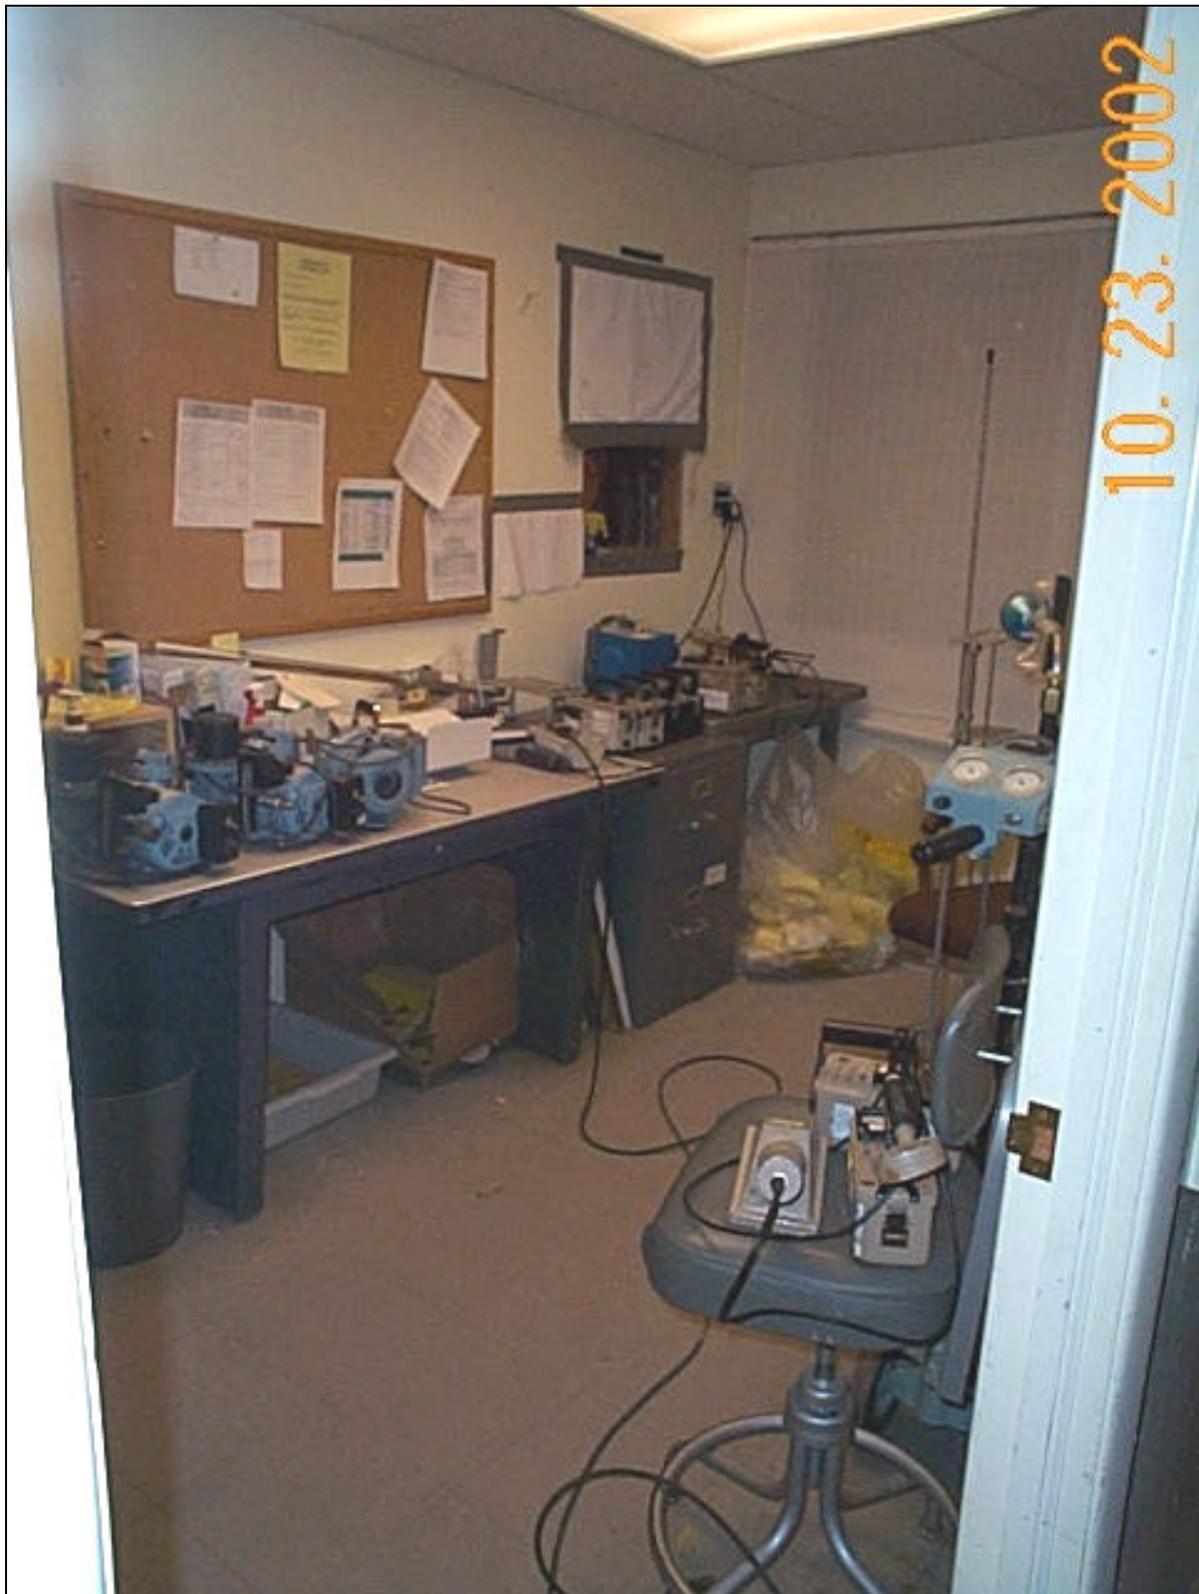
Figure A-5 HP Office

Based on historical and current data and information, this area is Class 1 for radiological surveys.

Recommend additional sampling for asbestos during remediation activities.

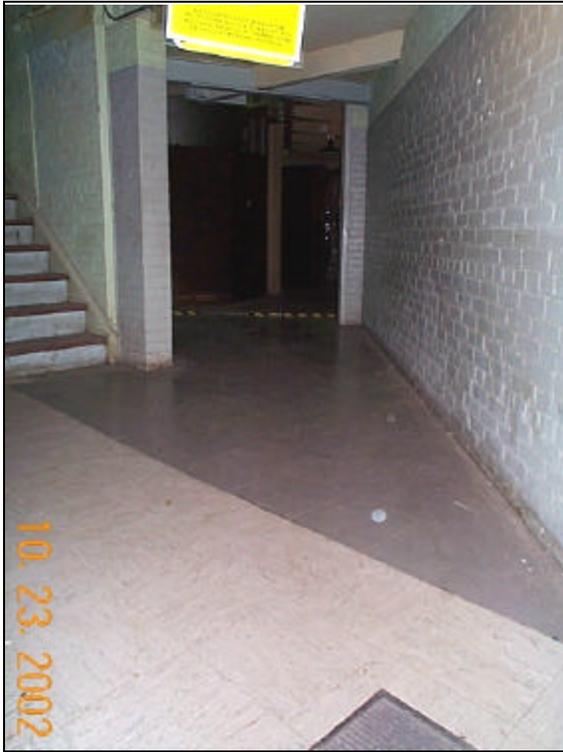
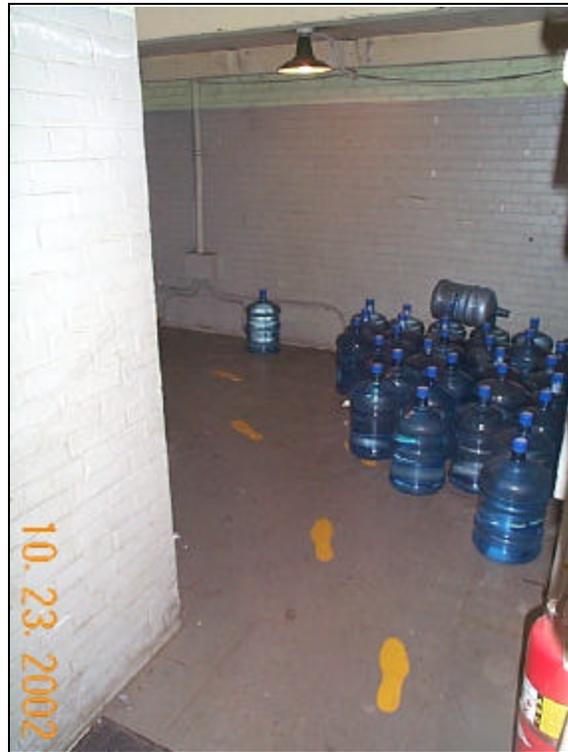
Figure A-6 Main 701 Entrance Area

Based on historical and current data and information, this area is Class 2 for radiological surveys.

Recommend additional sampling for asbestos during remediation activities.

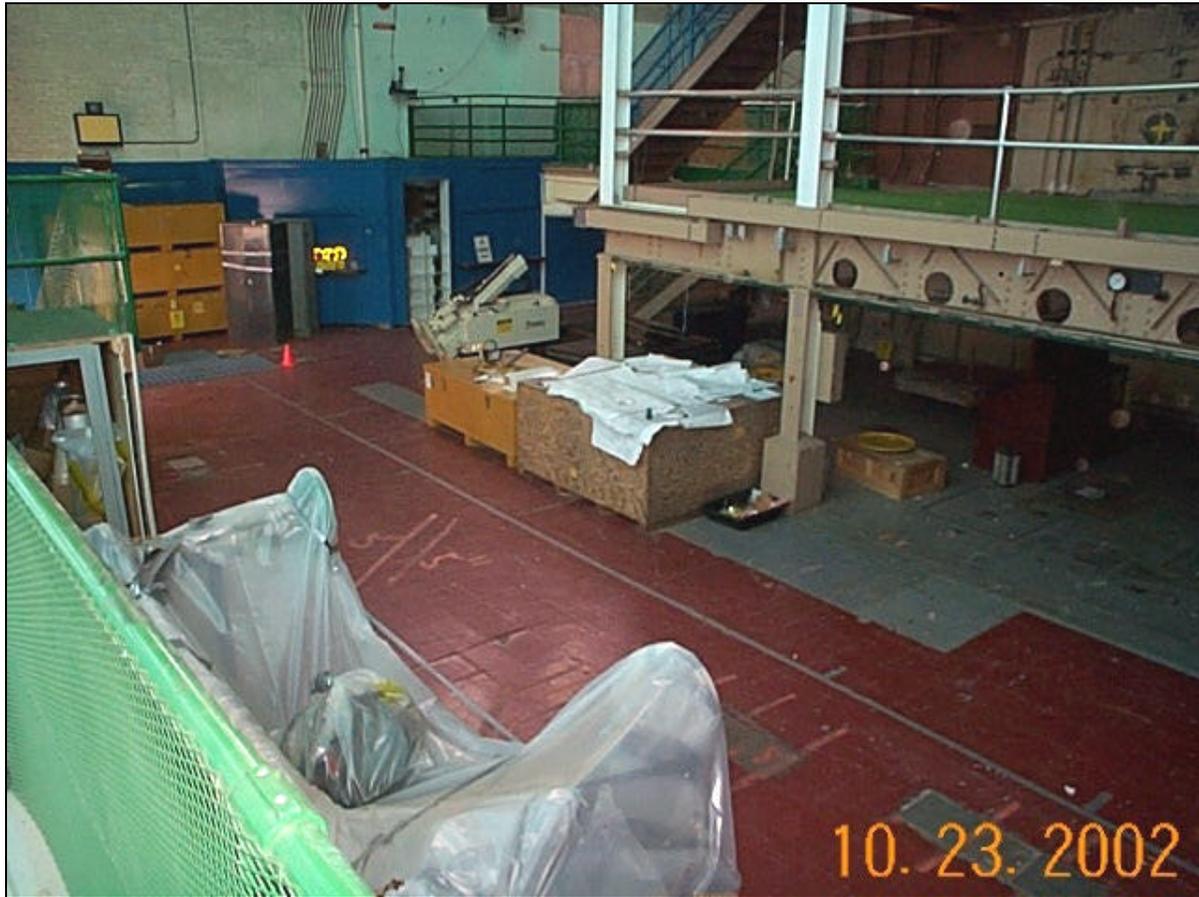
Figure A-8 Reactor Building West, General Area

Based on historical and current data and information, this area is Class 1 for radiological surveys.

Recommend additional sampling for asbestos during remediation activities.

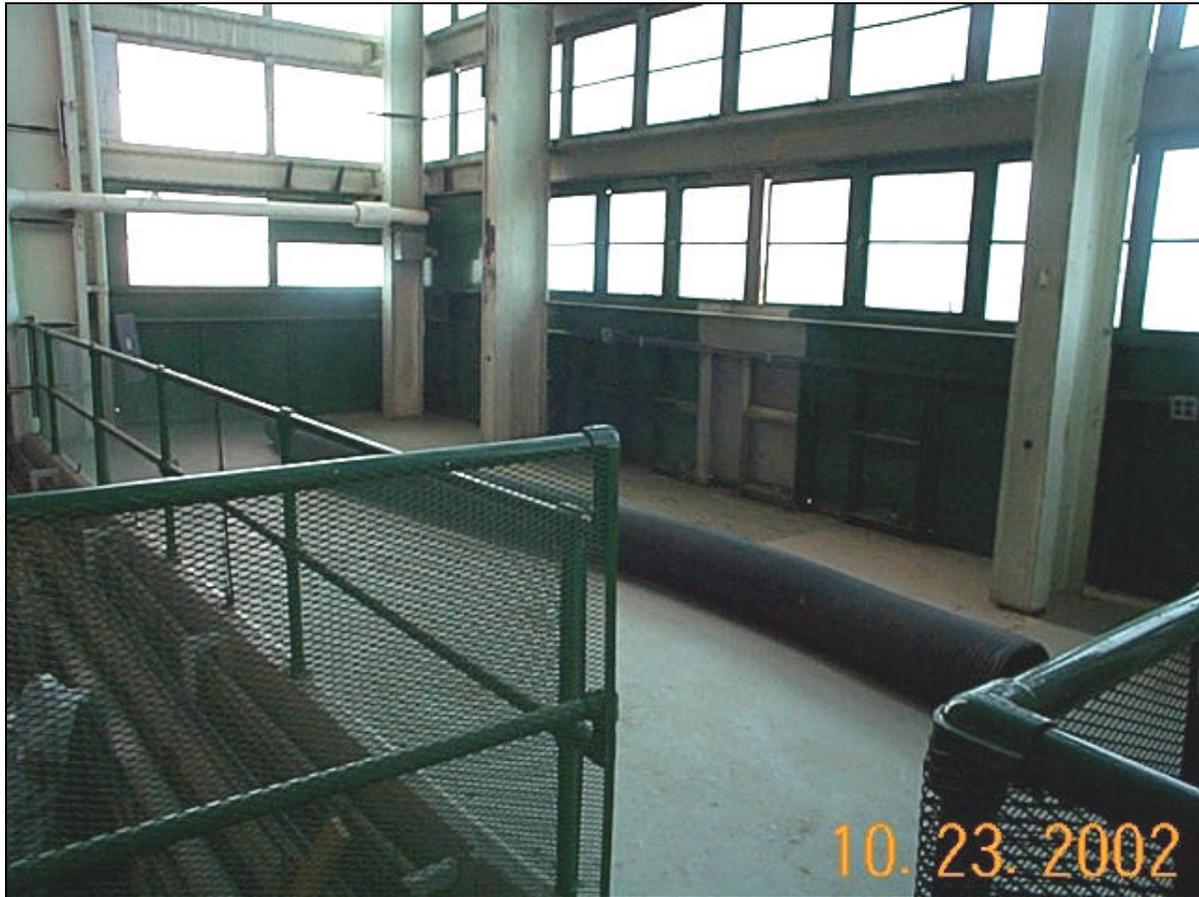
Figure A-9 West Air Intake Chamber (top surfaces)

Based on historical and current data and information, this area is Class 2 for radiological surveys.

Recommend additional sampling for asbestos during remediation activities.

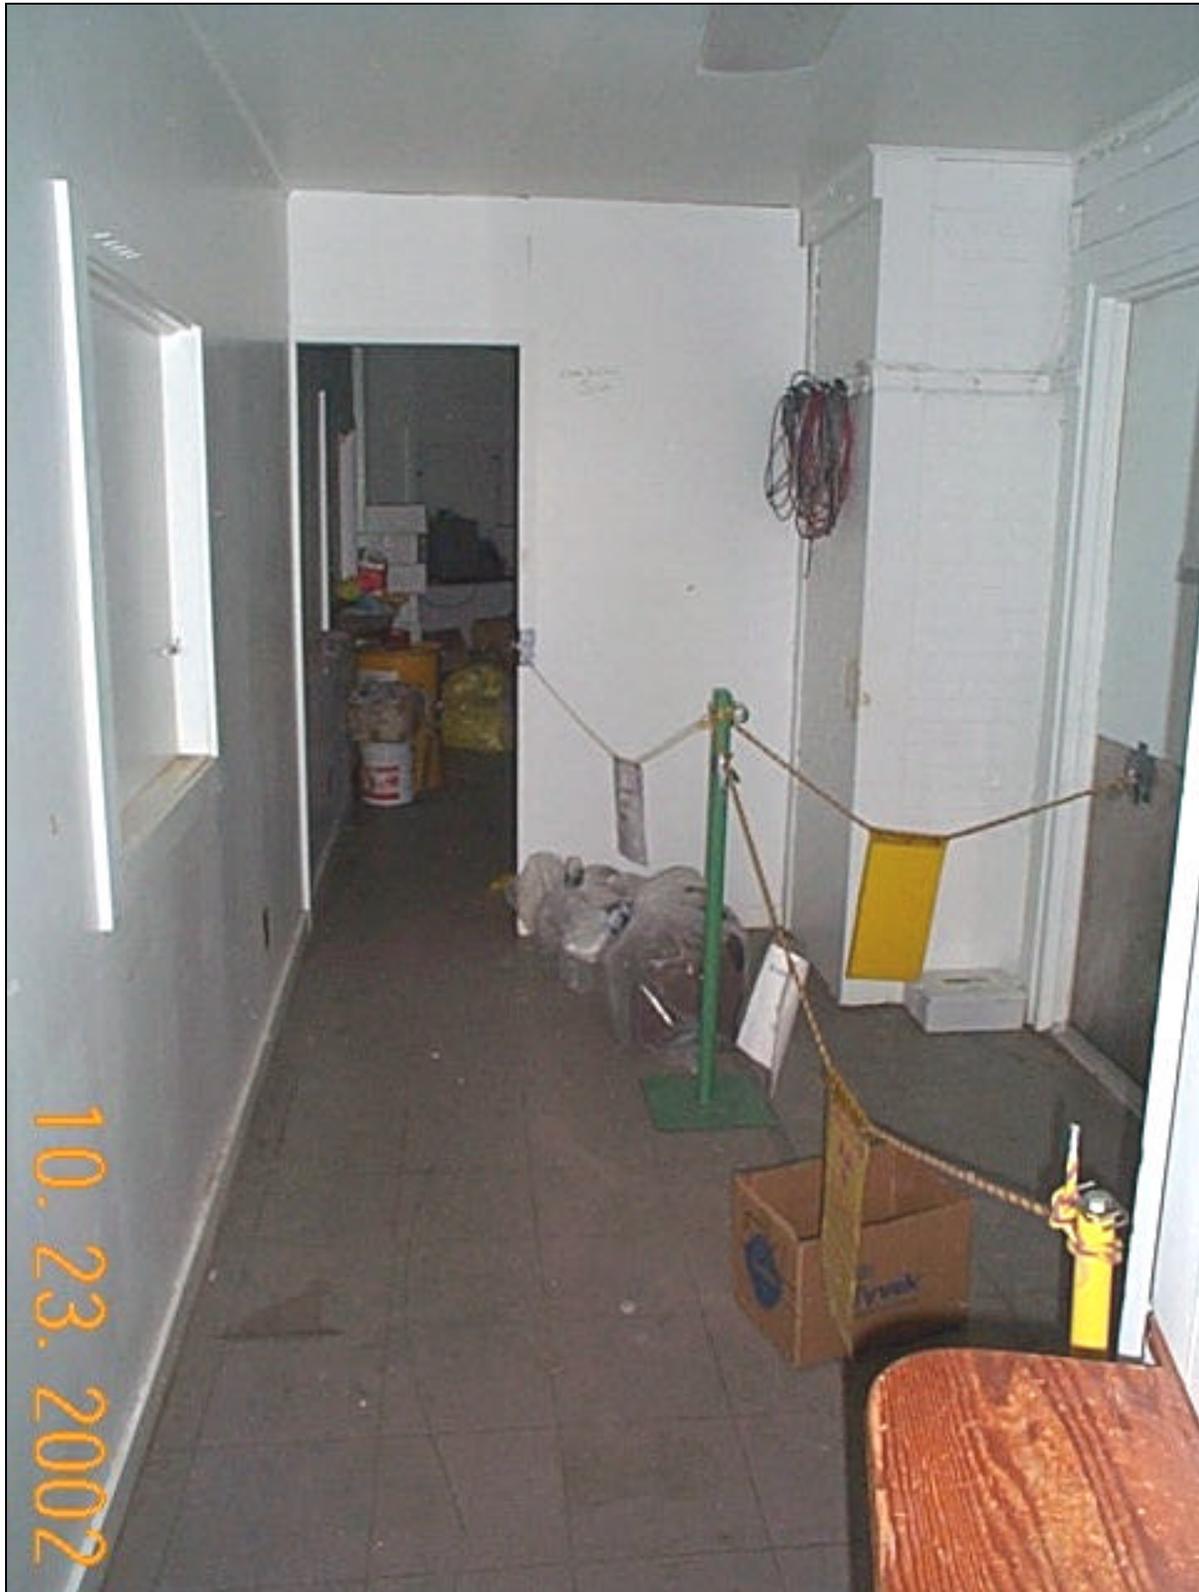
Figure A-10 North Supply Room

Based on historical and current data and information, this area is Class 1 for radiological surveys.

Recommend additional sampling for asbestos during remediation activities.

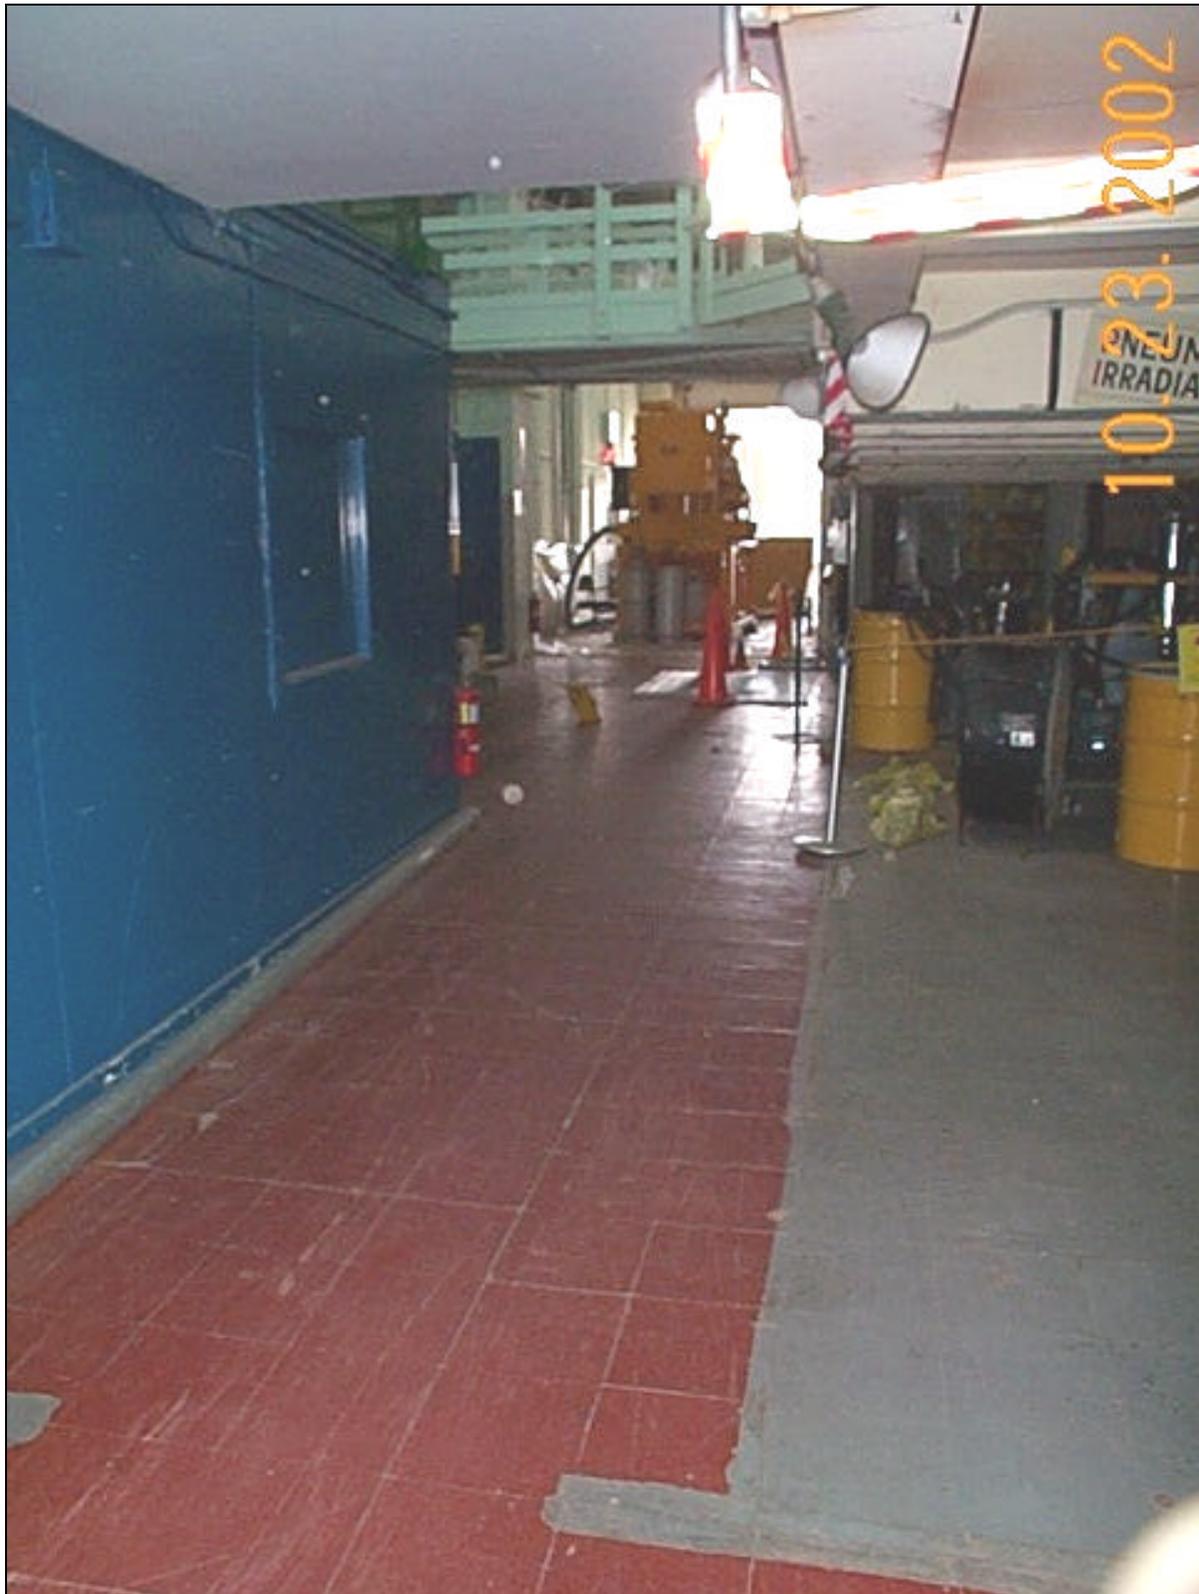
Figure A-11 Reactor Building North, General Area

Based on historical and current data and information, this area is Class 1 for radiological surveys.

Recommend additional sampling for asbestos during remediation activities.

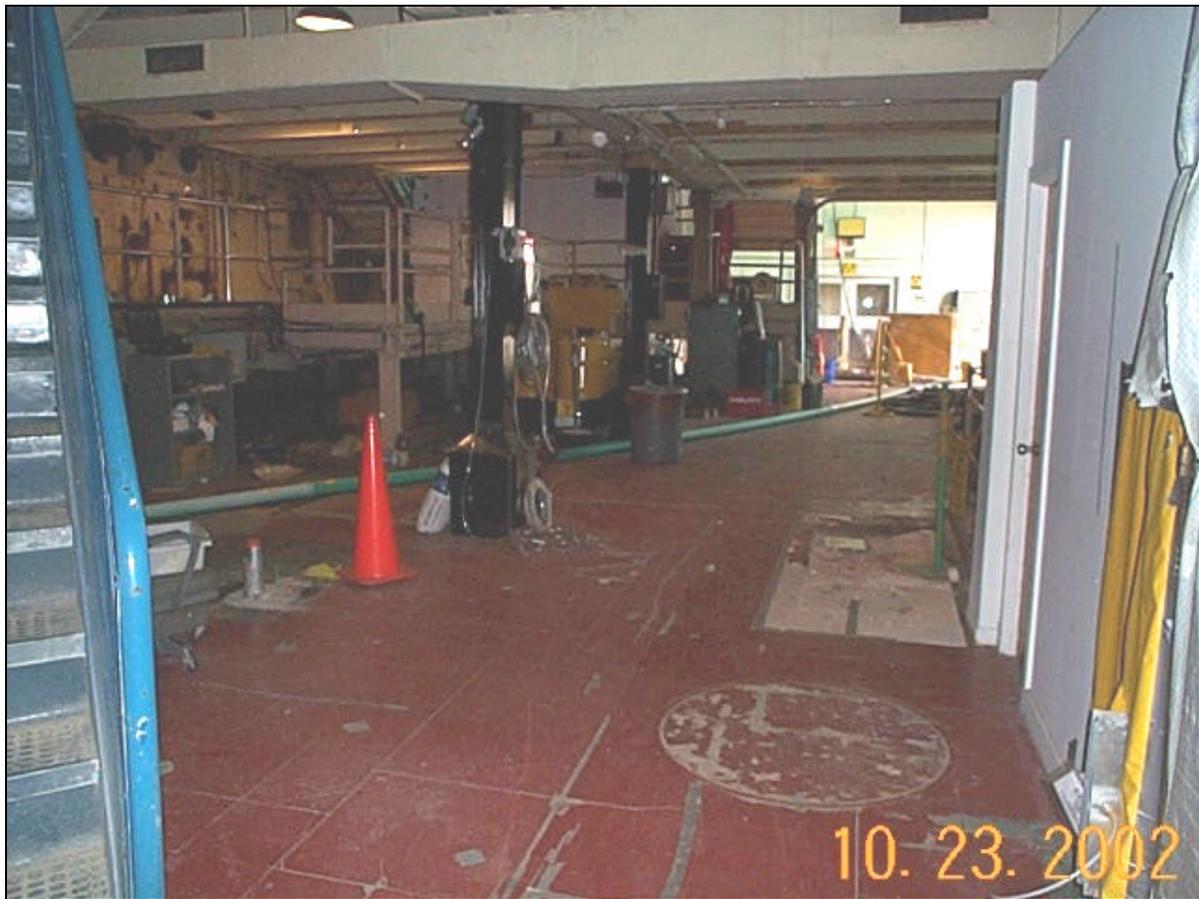
Figure A-12 Reactor Building East, General Area

Based on historical and current data and information, this area is Class 1 for radiological surveys.

Recommend additional sampling for asbestos during remediation activities.

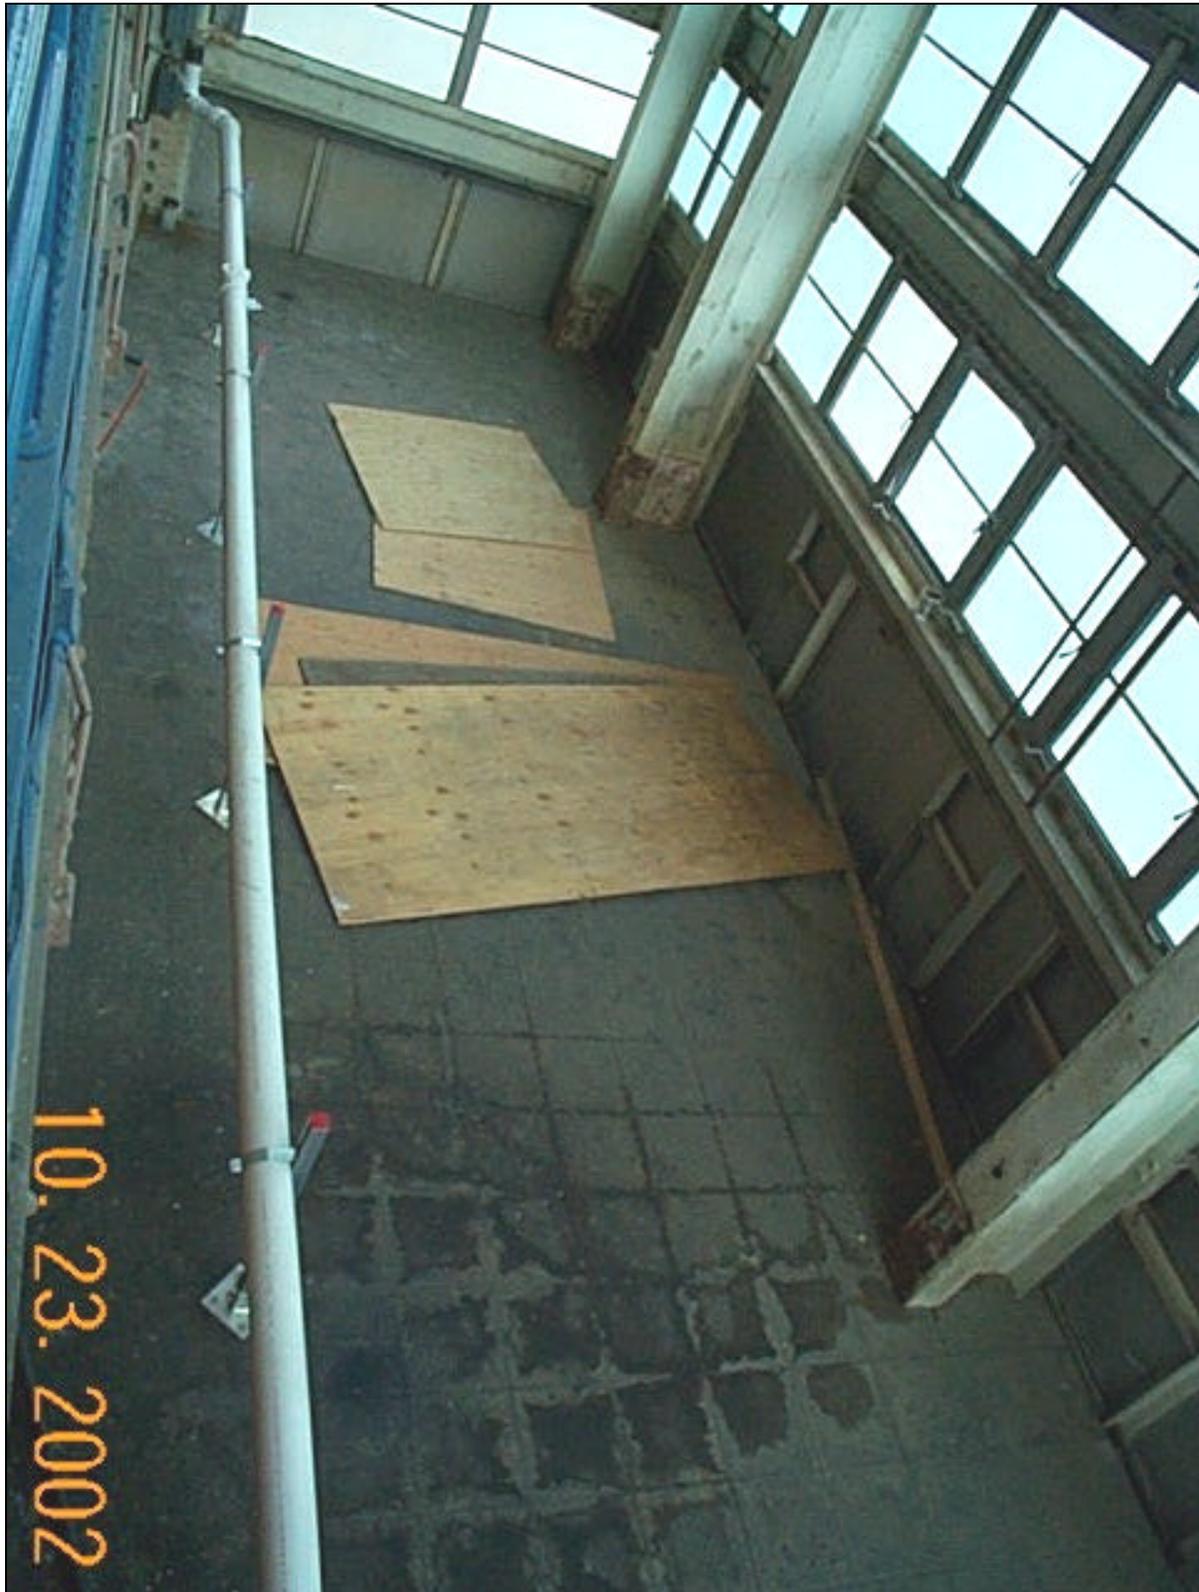
Figure A-13 East Air Intake Chamber (top surfaces)

Based on historical and current data and information, this area is Class 2 for radiological surveys.

Recommend additional sampling for asbestos during remediation activities.

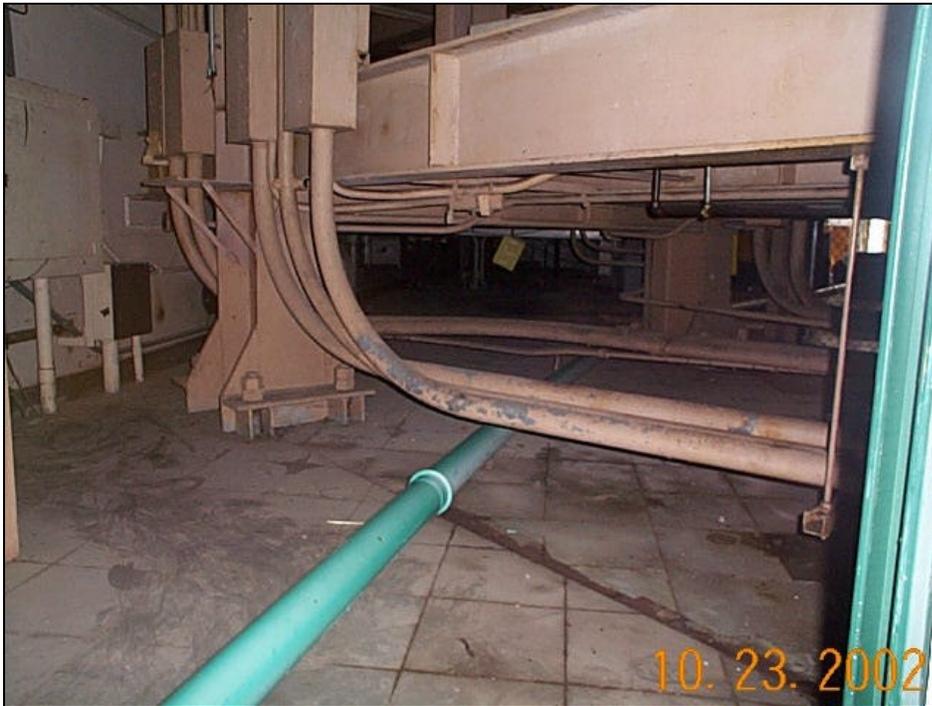
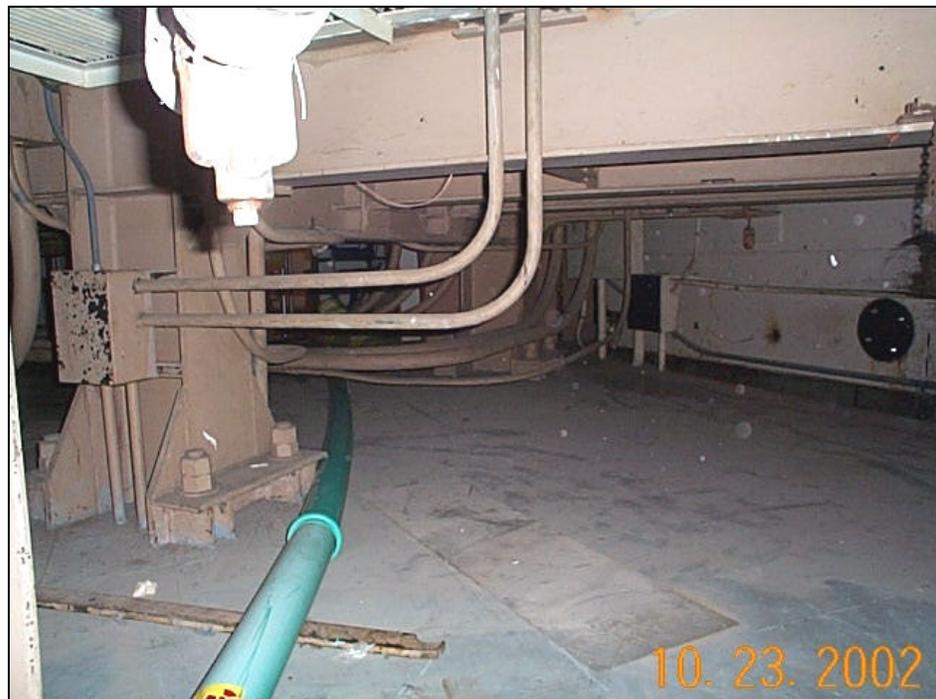
Based on historical and current data and information, this area is Class 1 for radiological surveys.

Recommend additional sampling for asbestos during remediation activities.

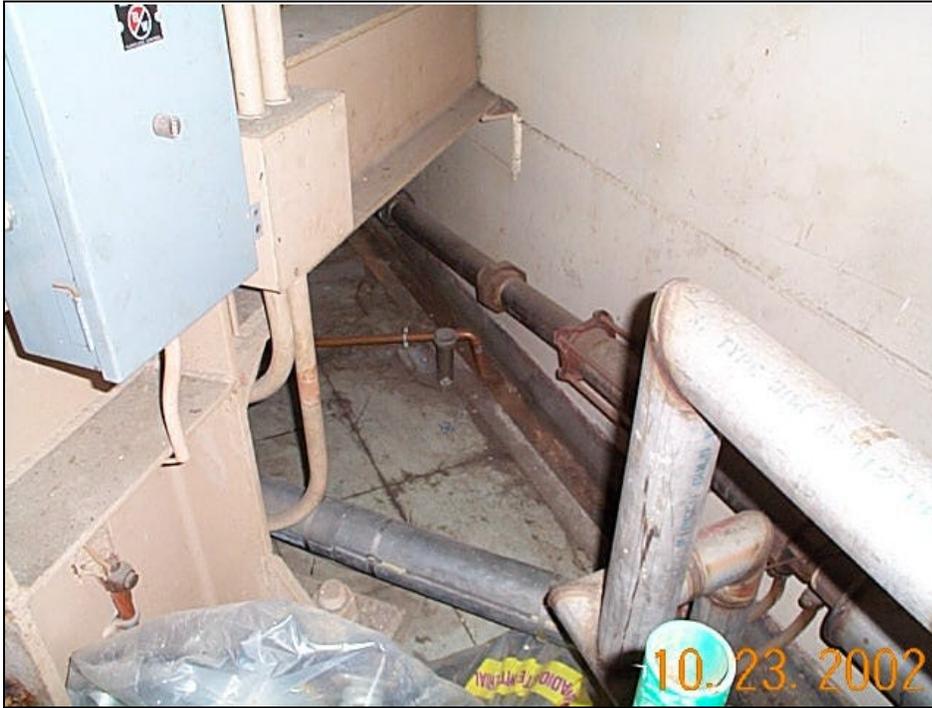
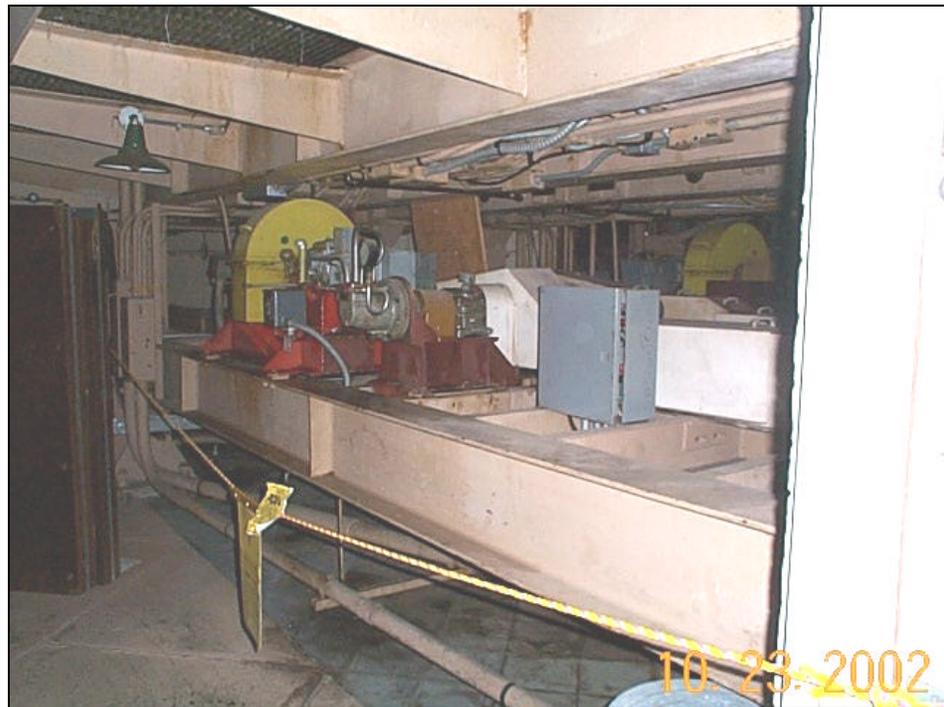
Based on historical and current data and information, this area is Class 1 for radiological surveys.

Recommend additional sampling for asbestos during remediation activities.

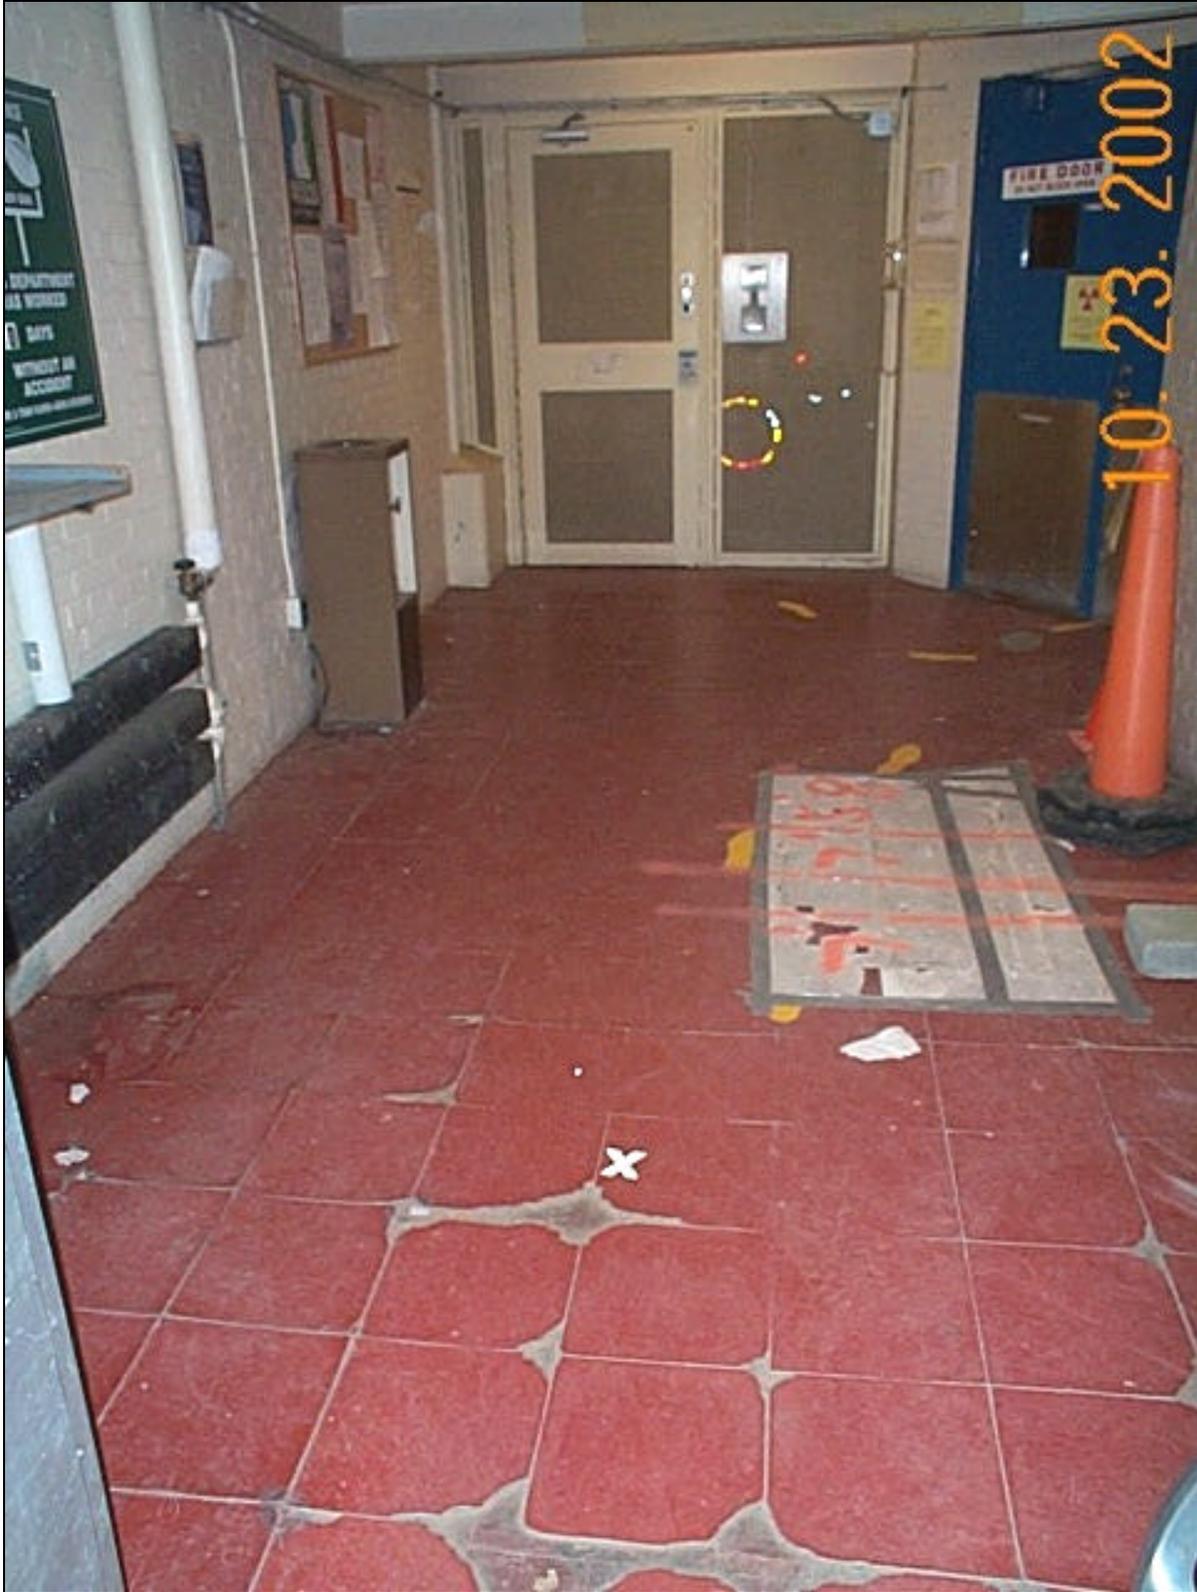
Figure A-18 East 701 Entryway and Main Stairwell

Based on historical and current data and information, this area is Class 1 for radiological surveys.

Recommend additional sampling for asbestos and lead during remediation activities.
