Brookhaven Graphite Research Reactor (BGRR) Decommissioning Project

CHARACTERIZATION REPORT FOR BUILDING 701
ABOVE GROUND SURFACES, SYSTEMS, AND
STRUCTURES

May 2003

BROOKHAVEN NATIONAL LABORATORY
BROOKHAVEN SCIENCE ASSOCIATES

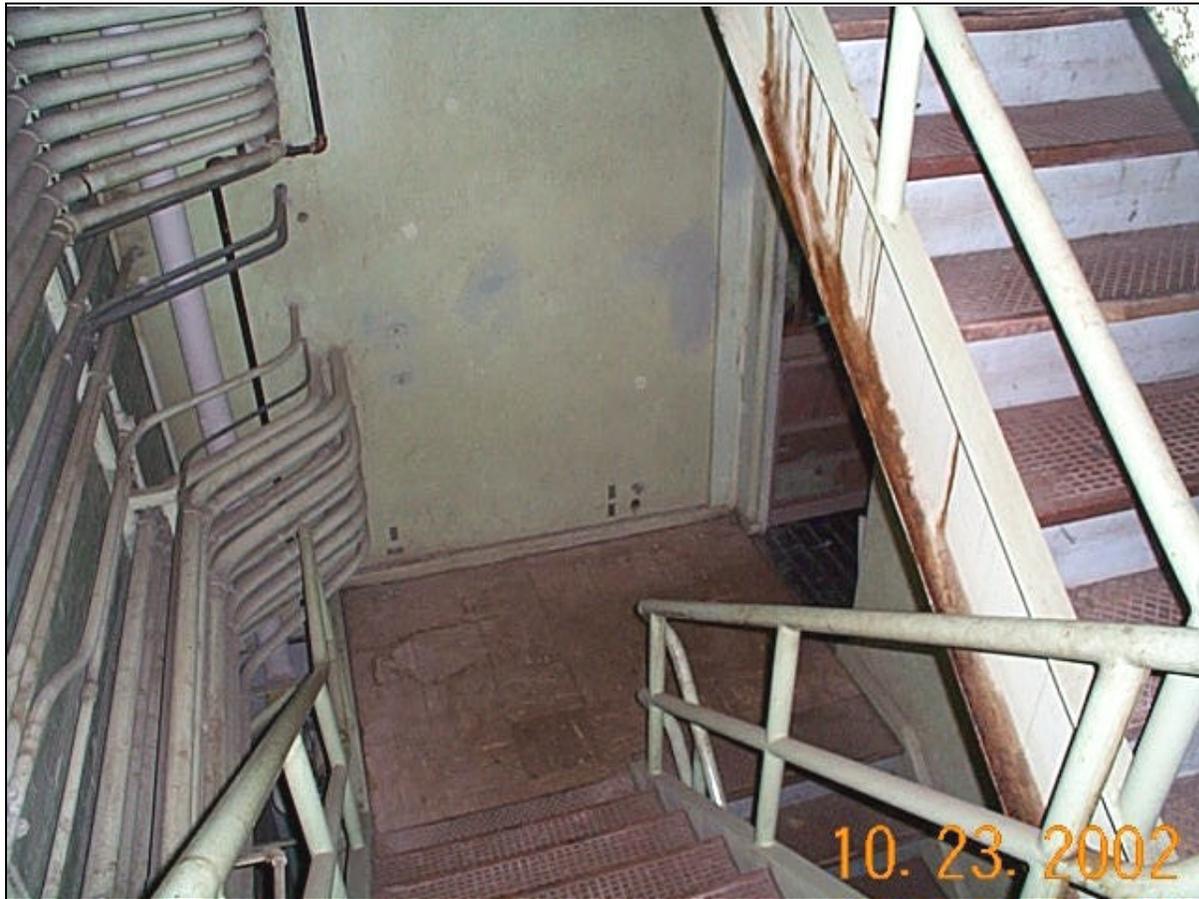
Figure A-19 Control Room Stairwell & Walkway

Based on historical and current data and information, this area is Class 1 for radiological surveys.

Recommend additional sampling for asbestos and lead during remediation activities.

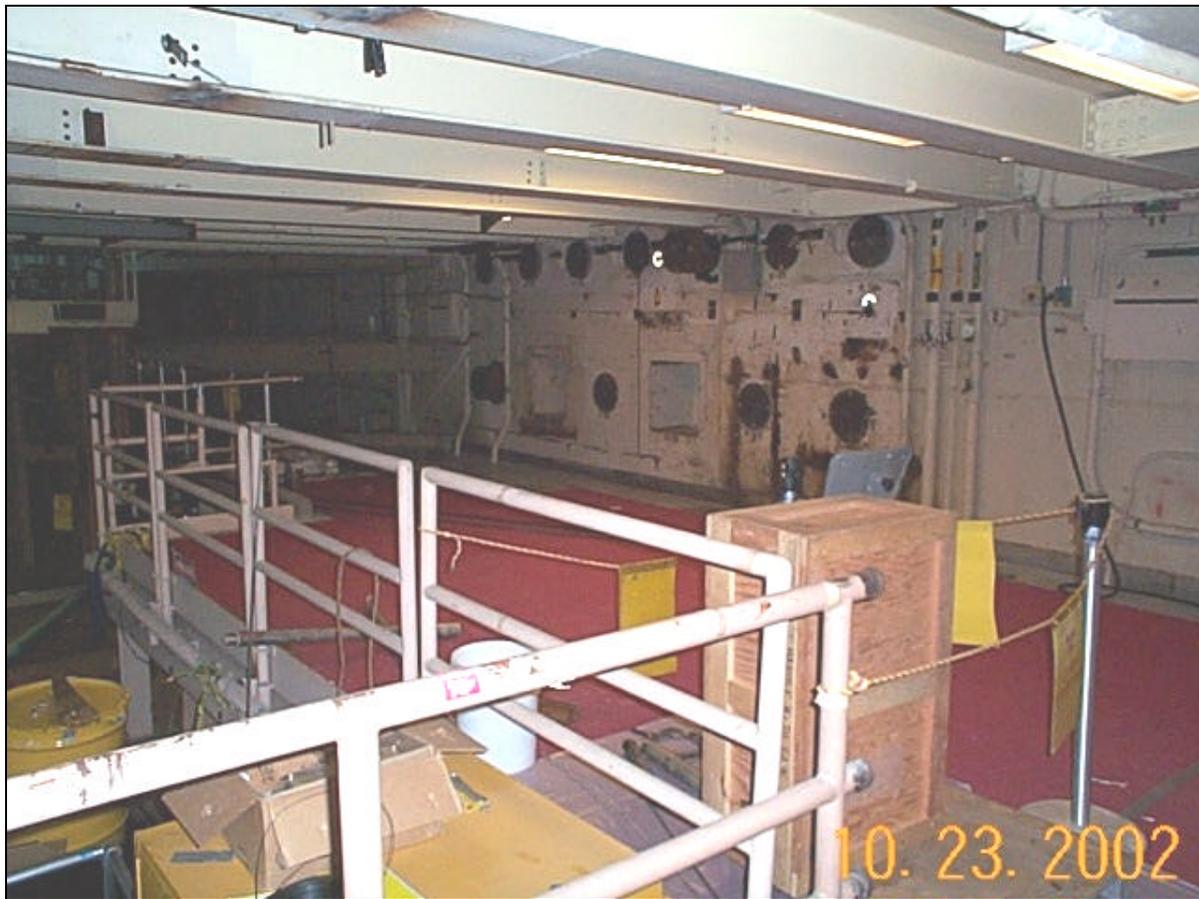
Figure A-20 East Pile Face 114' Balcony

Based on historical and current data and information, this area is Class 1 for radiological surveys.

Recommend additional sampling for asbestos and lead during remediation activities.

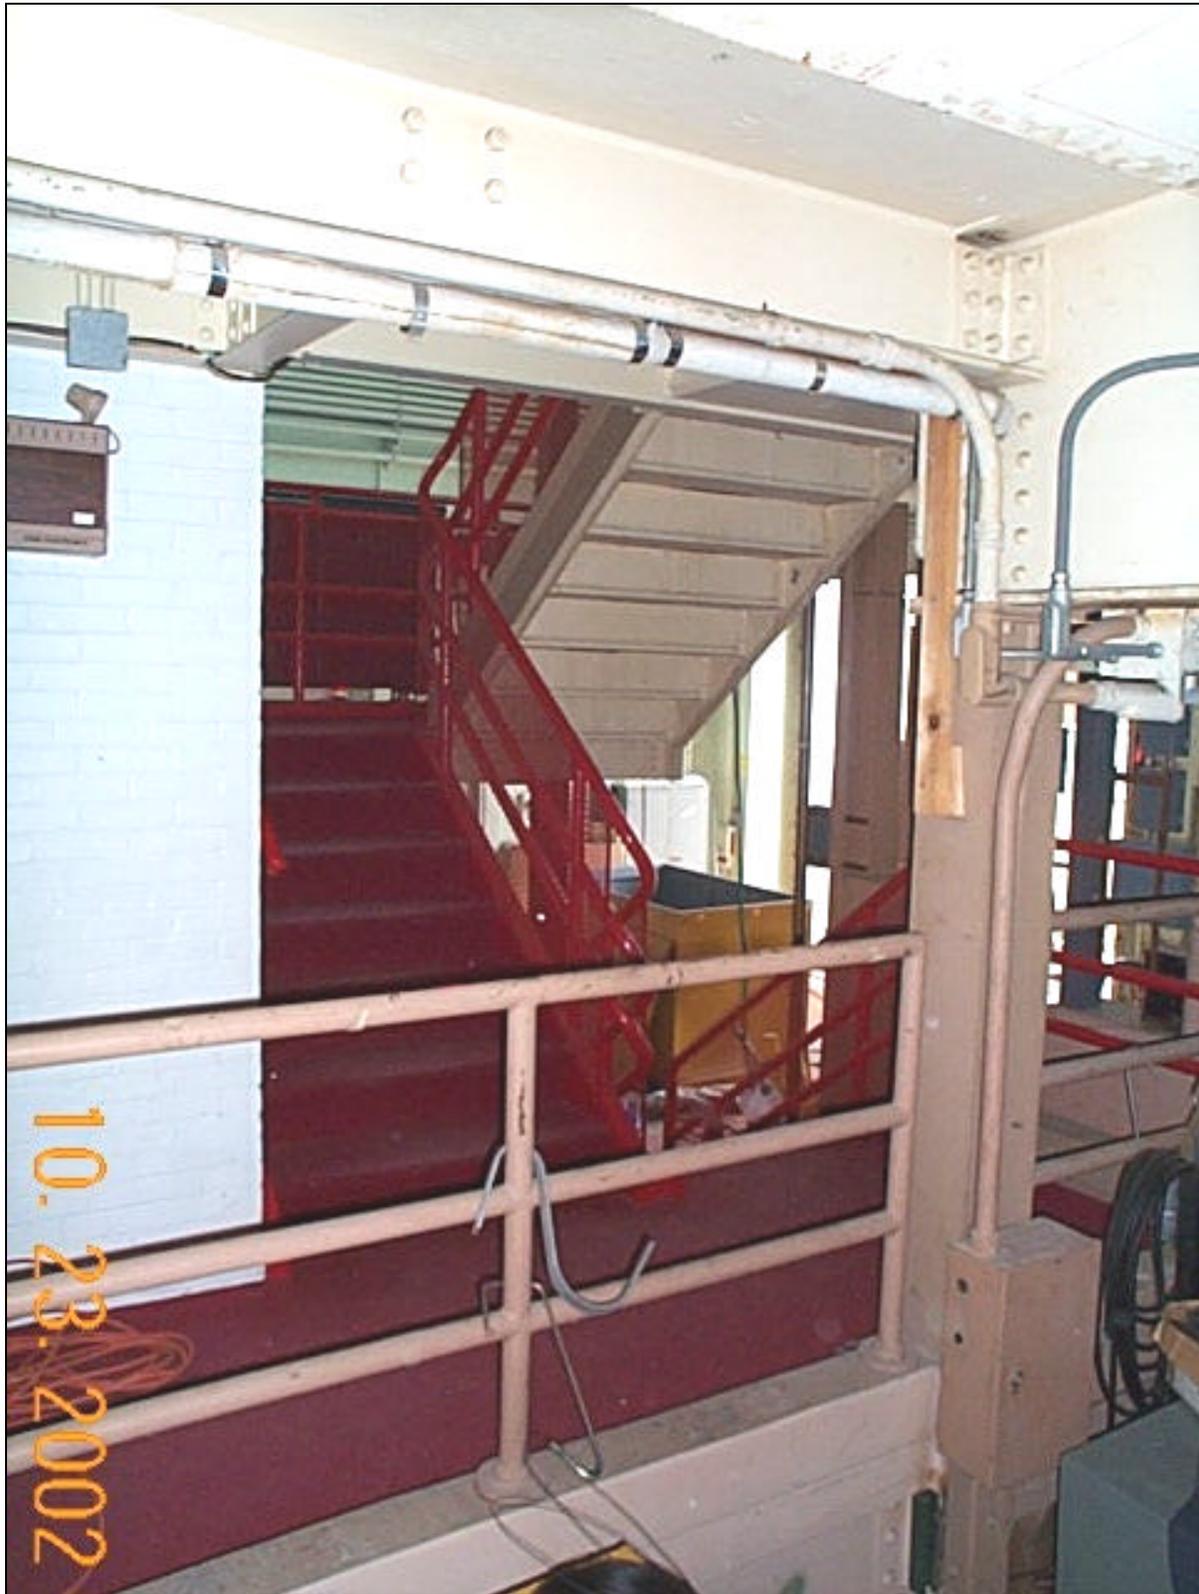
Figure A-21 Pile Balcony Stairwell

Based on historical and current data and information, this area is Class 1 for radiological surveys.

Recommend additional sampling for lead during remediation activities.

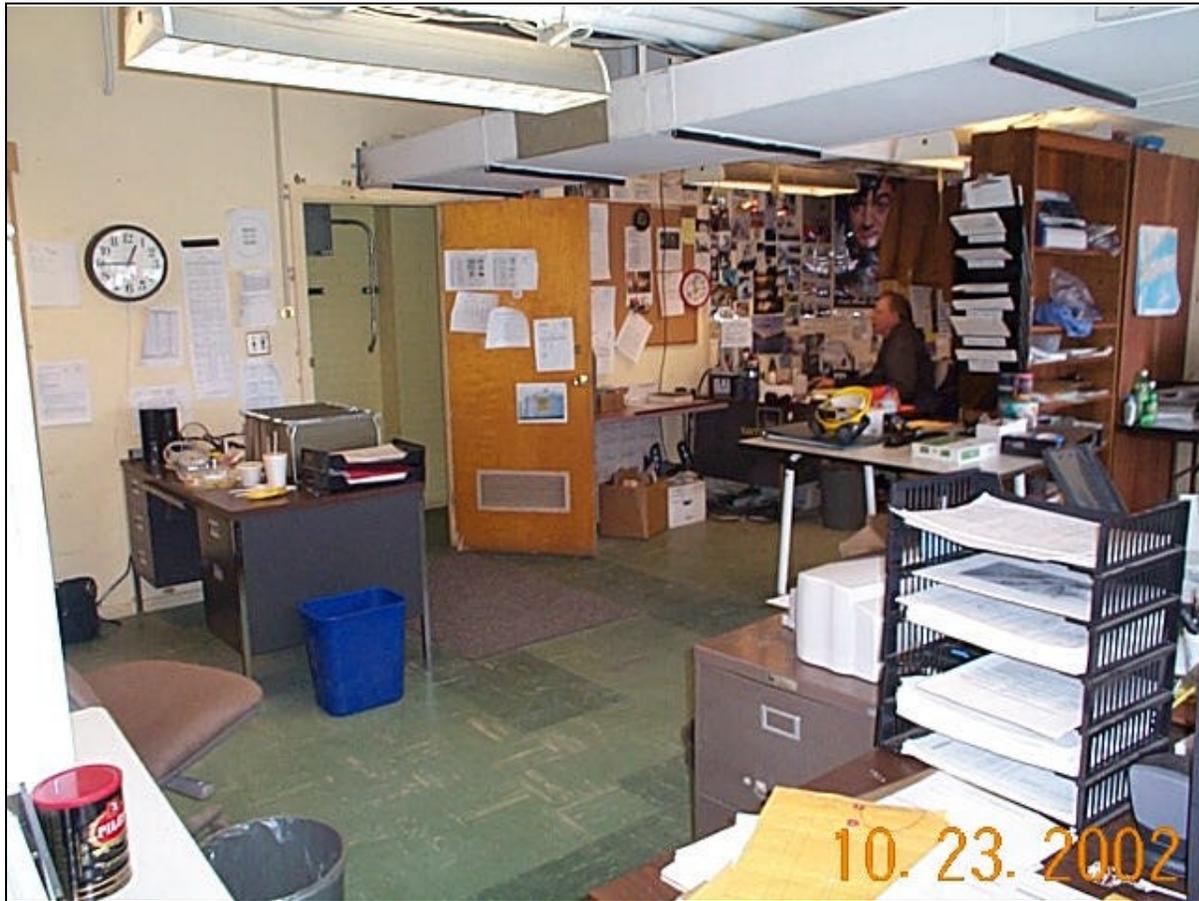
Figure B-1 Office 103

Based on historical and current data and information, this area is Class 1 for radiological surveys.

Recommend additional sampling for asbestos during remediation activities.

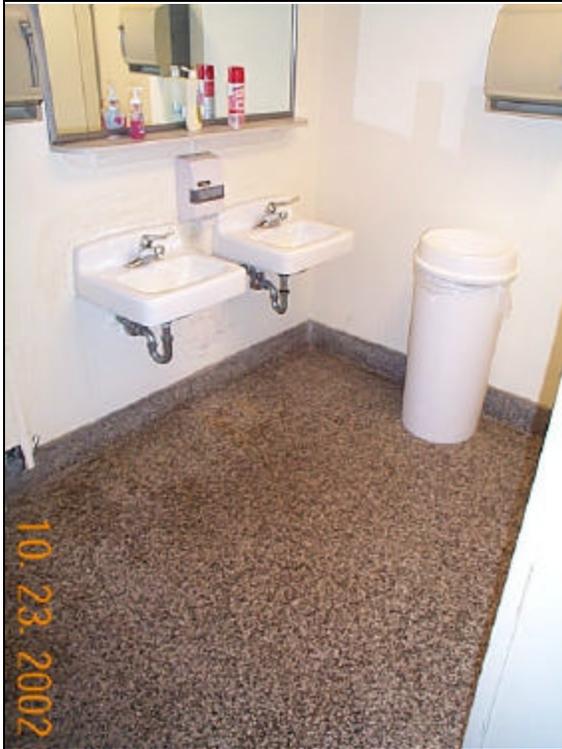
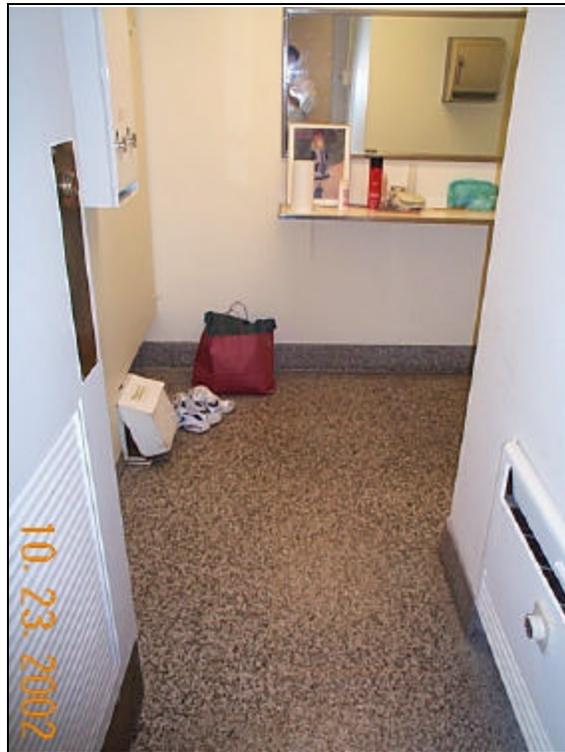
Based on historical and current data and information, this area is Class 1 for radiological surveys.

Recommend additional sampling for asbestos during remediation activities.

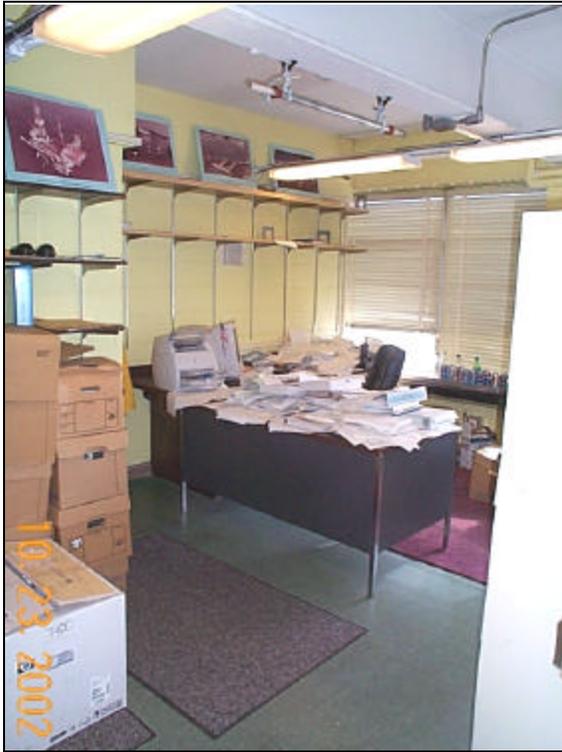
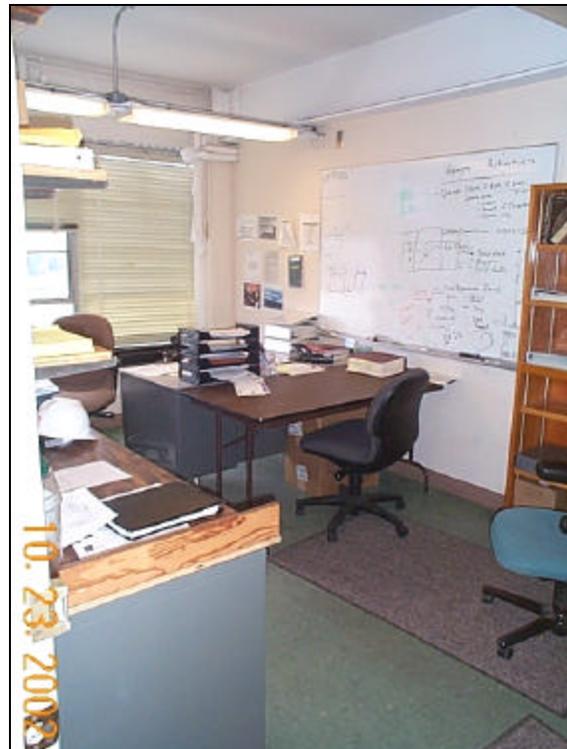
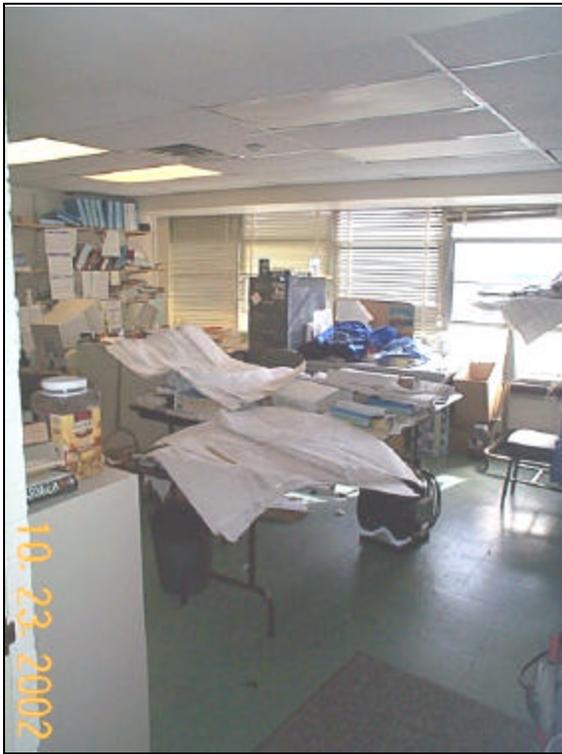
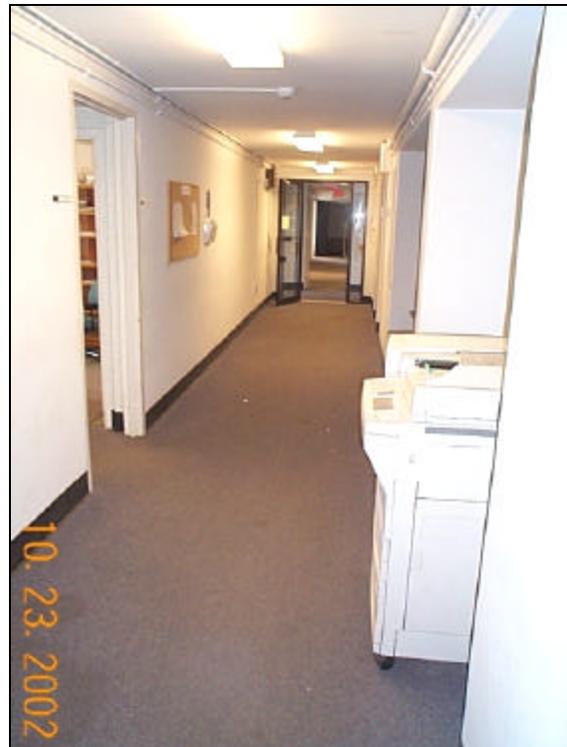
Based on historical and current data and information, this area is Class 1 for radiological surveys.

Recommend additional sampling for asbestos during remediation activities.

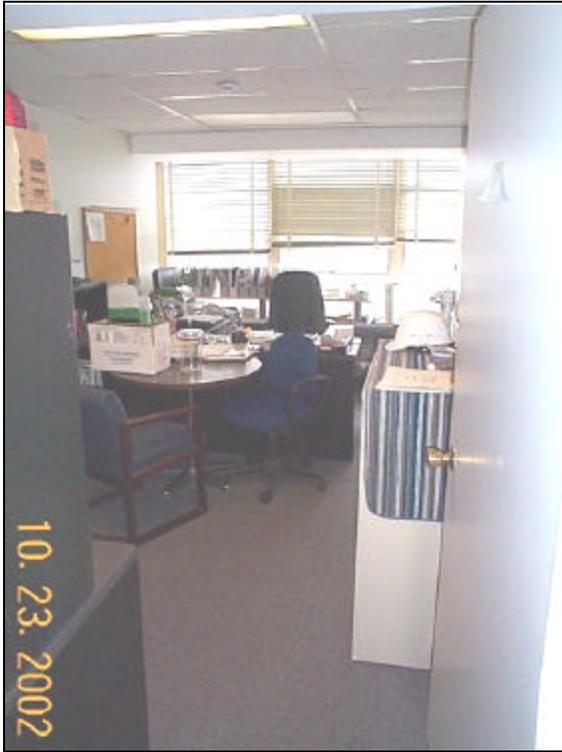
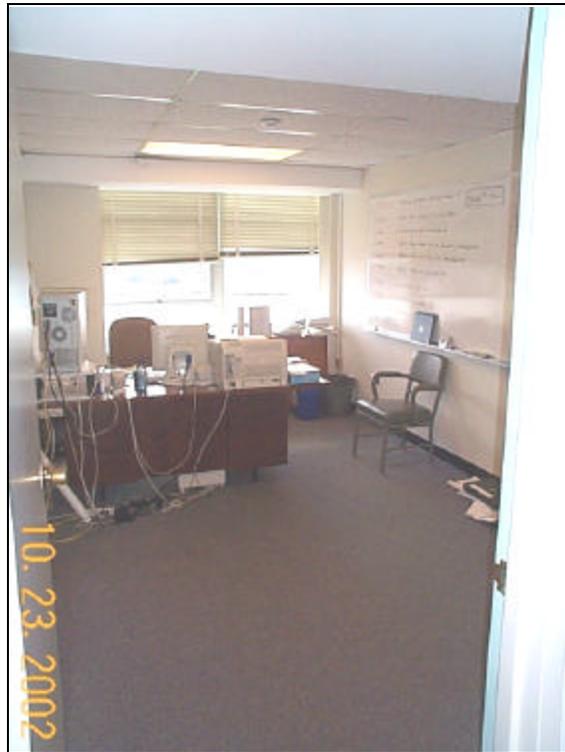
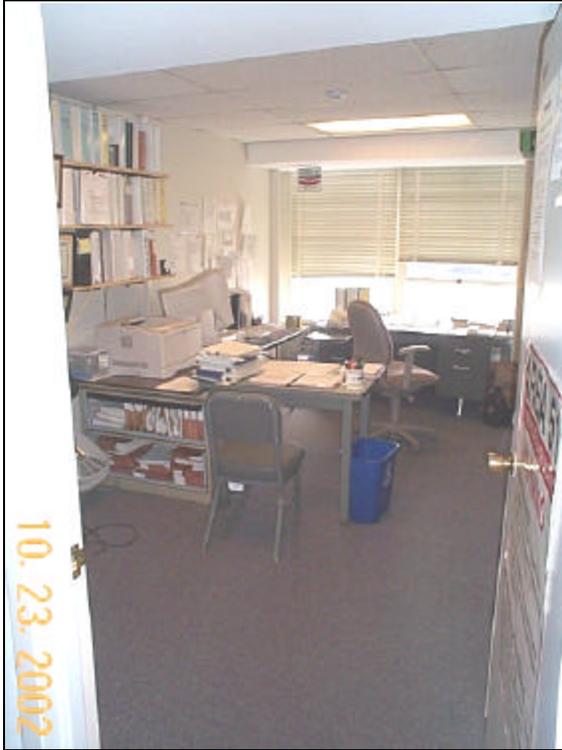
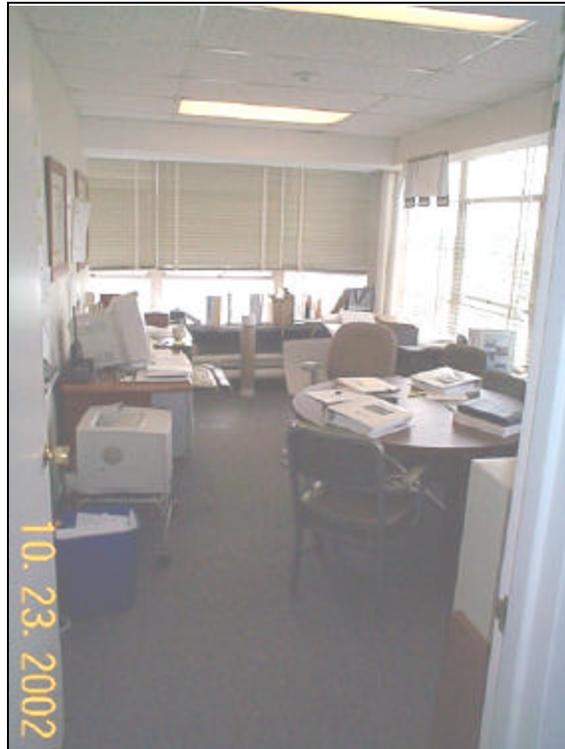
Based on historical and current data and information, this area is Class 2 for radiological surveys.

Recommend additional sampling for asbestos during remediation activities.

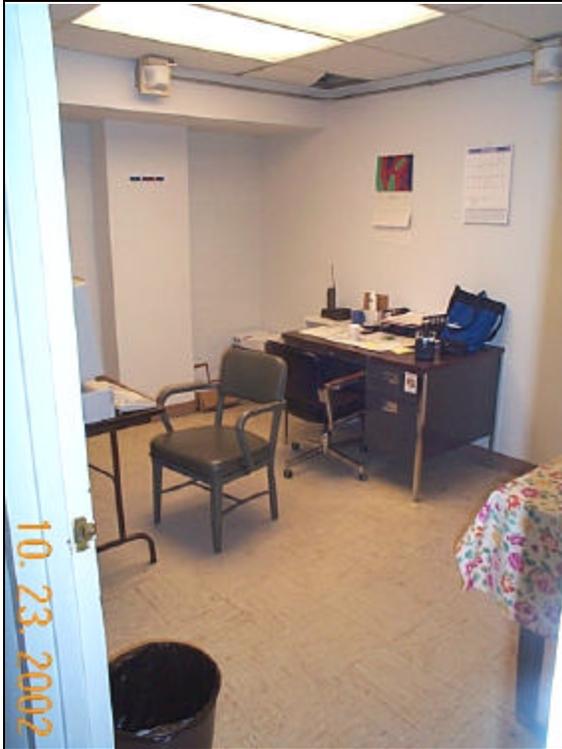
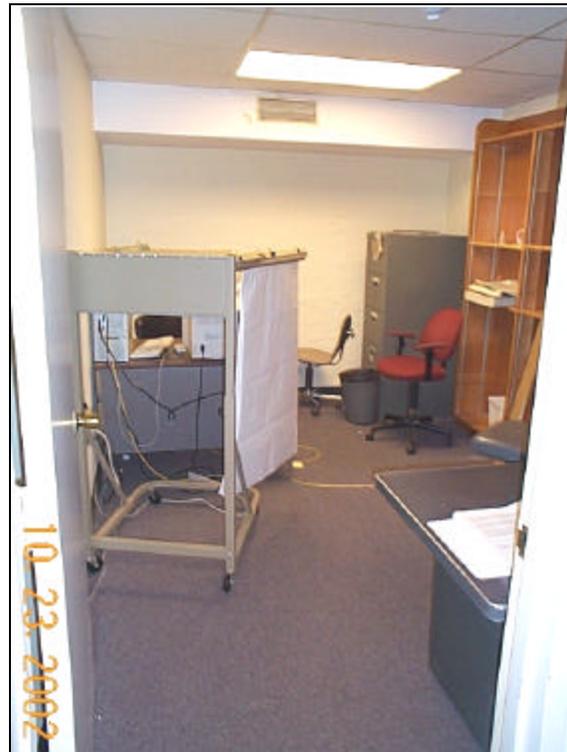
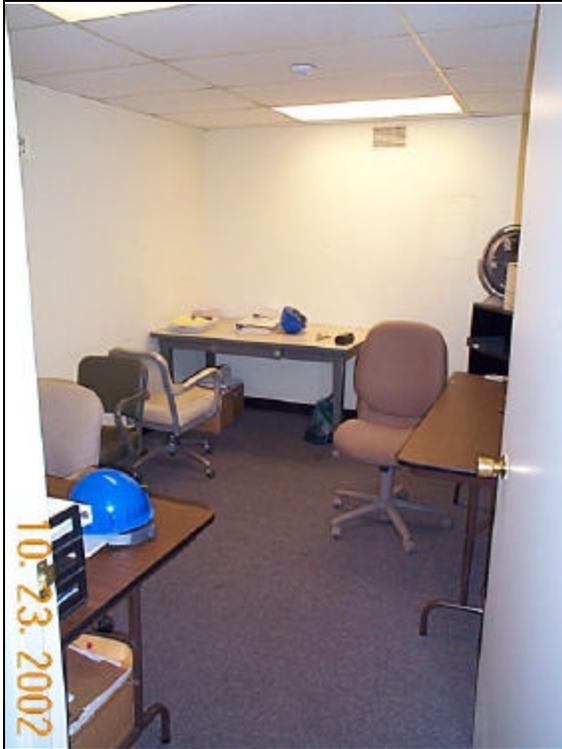
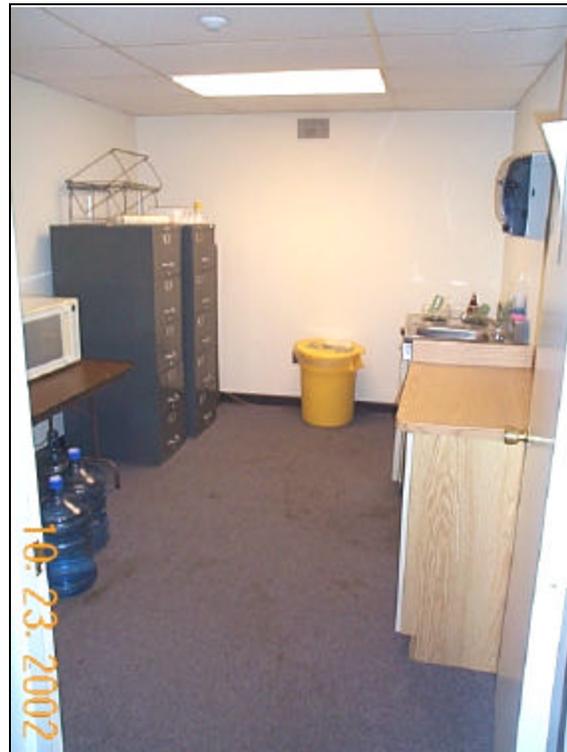
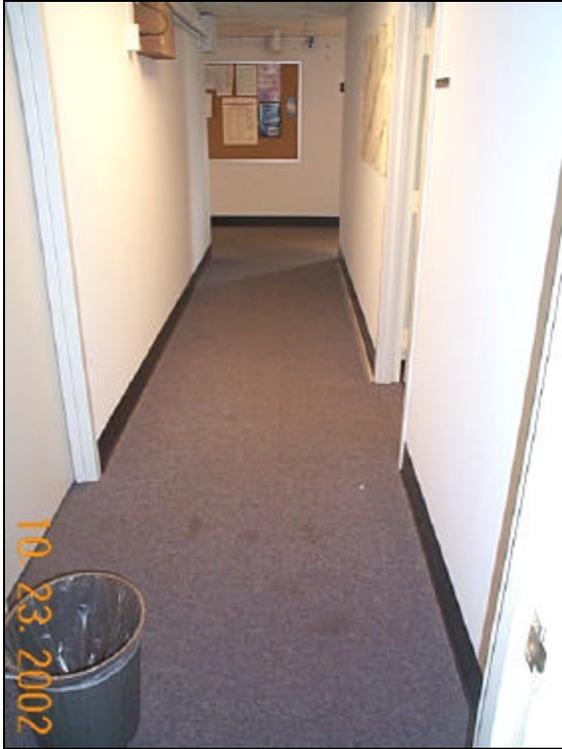
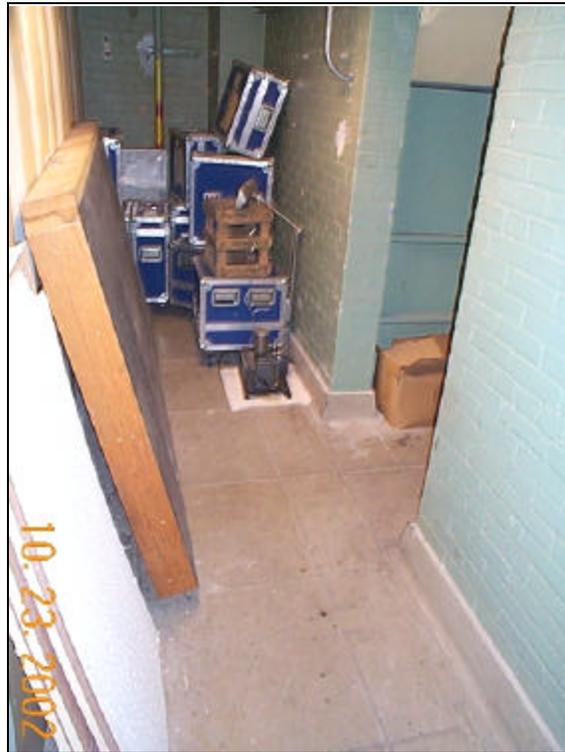
Based on historical and current data and information, this area is Class 2 for radiological surveys.

Recommend additional sampling for asbestos during remediation activities.

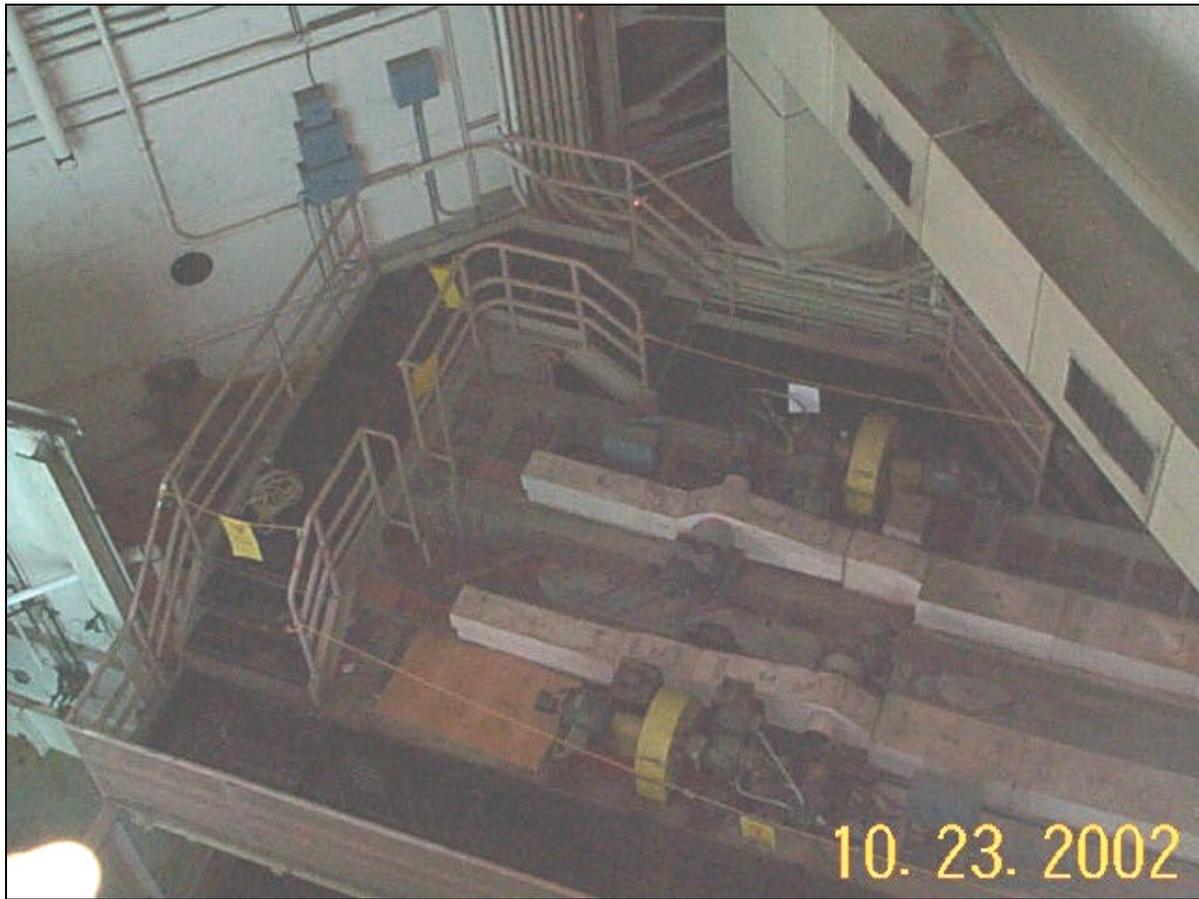
Figure C-1 West CRDM Access Balconies (from crane stairwell)

Based on historical and current data and information, this area is Class 1 for radiological surveys.

Recommend additional sampling for lead during remediation activities.

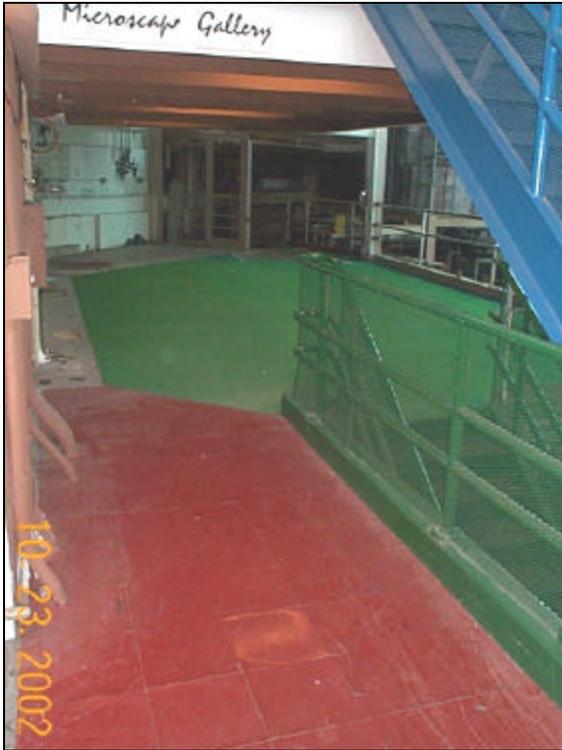
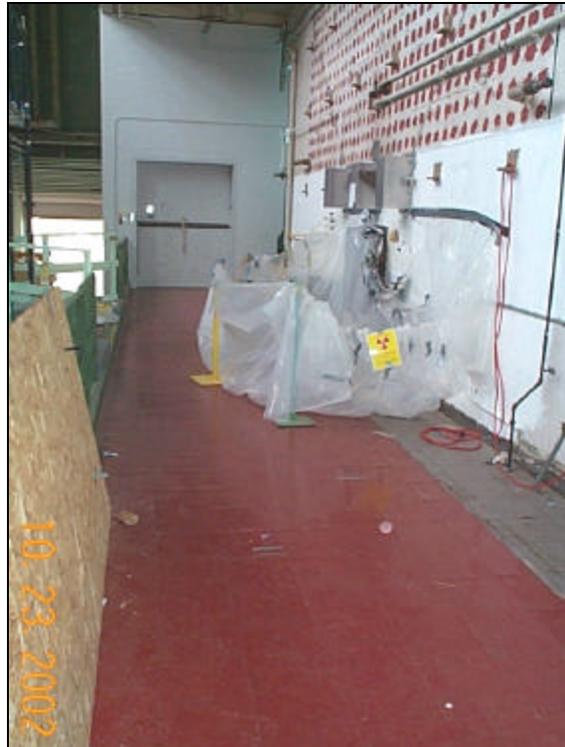
Figure C-2 Northwest 118' Pile Face Balconies

Based on historical and current data and information, this area is Class 1 for radiological surveys.

Recommend additional sampling for asbestos and lead during remediation activities.

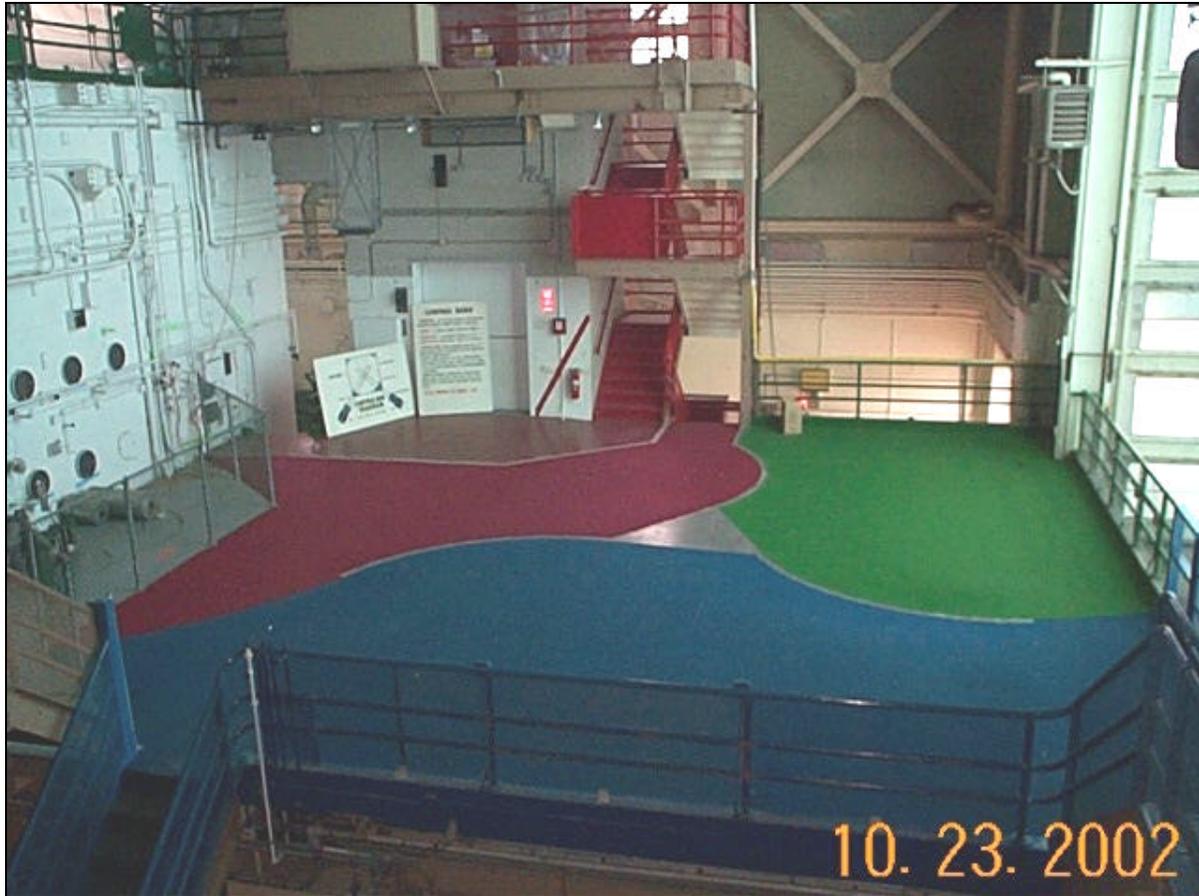
Figure C-4 East Pile Face 123' Balcony

Based on historical and current data and information, this area is Class 1 for radiological surveys.

Recommend additional sampling for asbestos and lead during remediation activities.

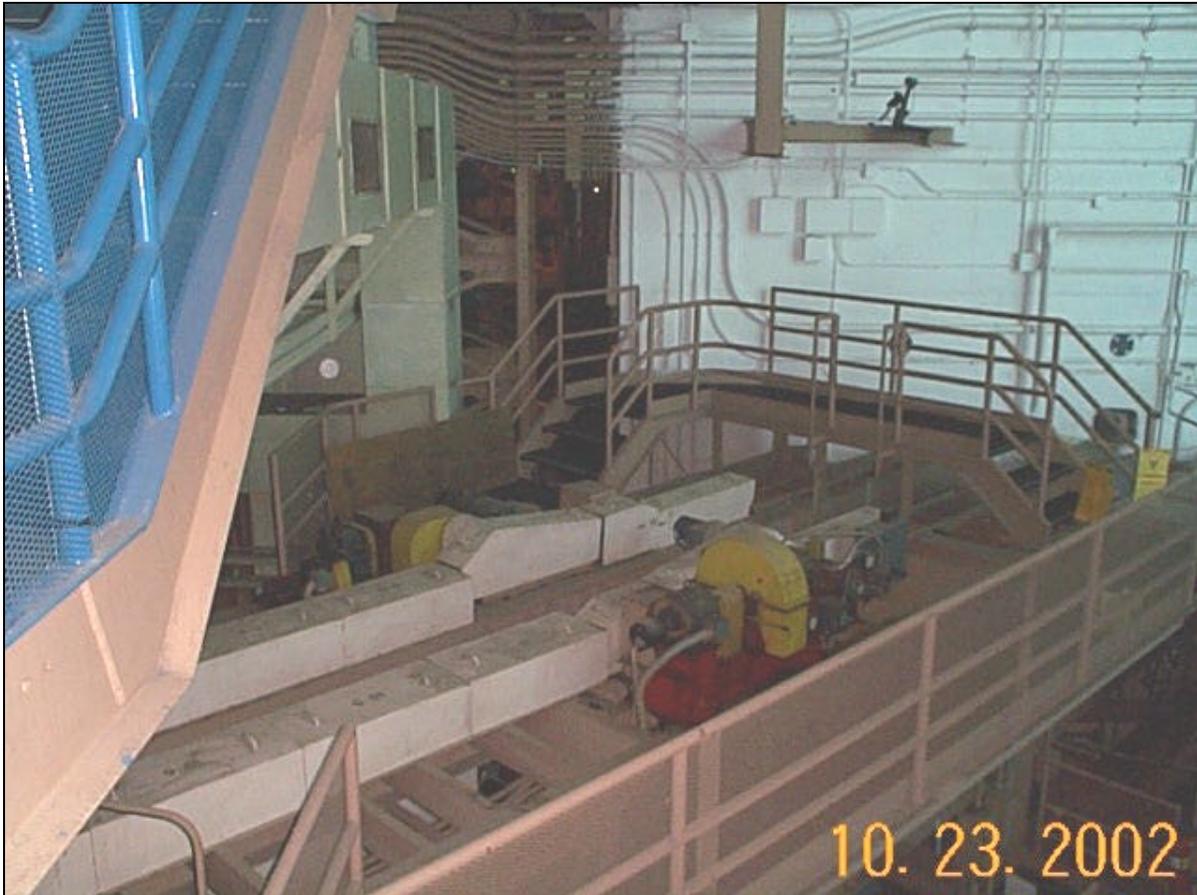
Figure C-5 East CRDM Access Balconies

Based on historical and current data and information, this area is Class 1 for radiological surveys.

Recommend additional sampling for lead during remediation activities.

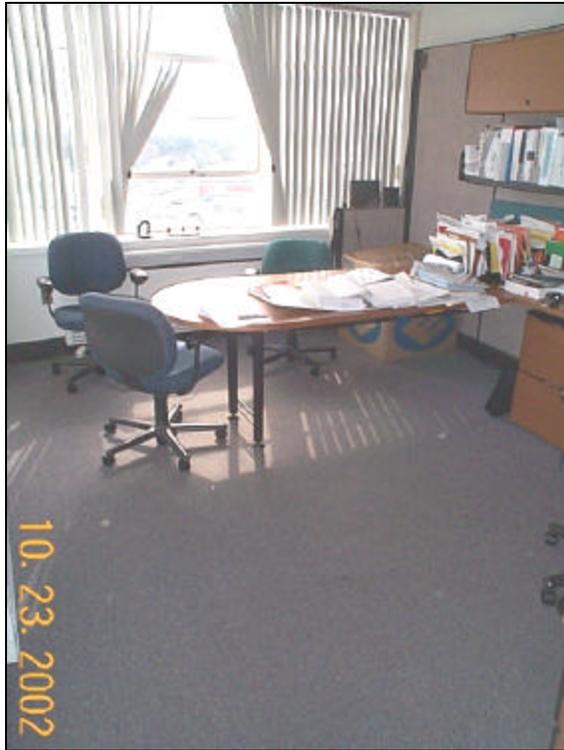
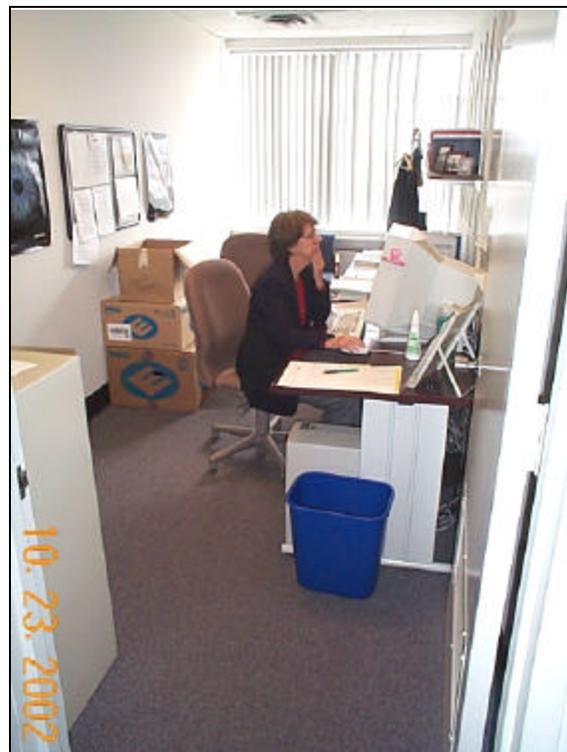
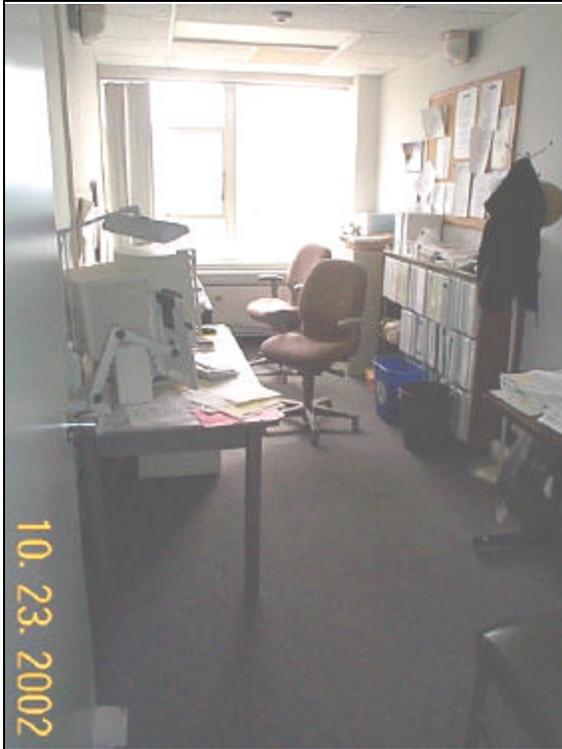
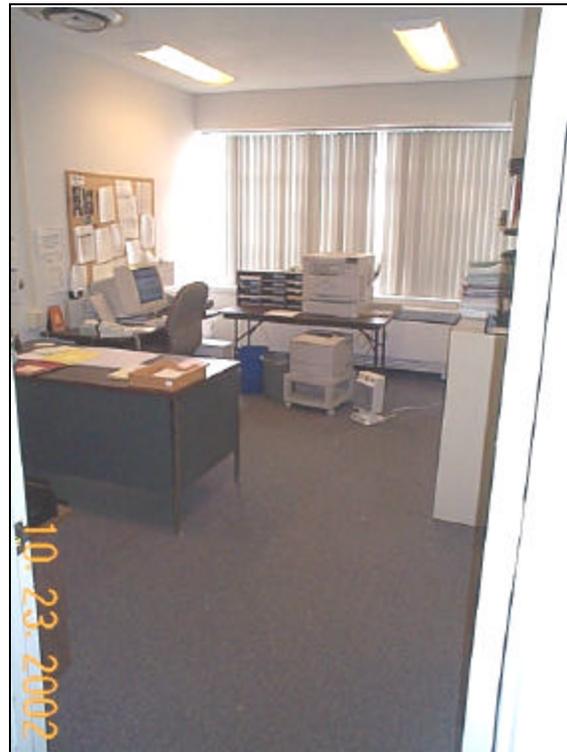
Based on historical and current data and information, this area is Class 2 for radiological surveys.

Recommend additional sampling for asbestos during remediation activities.

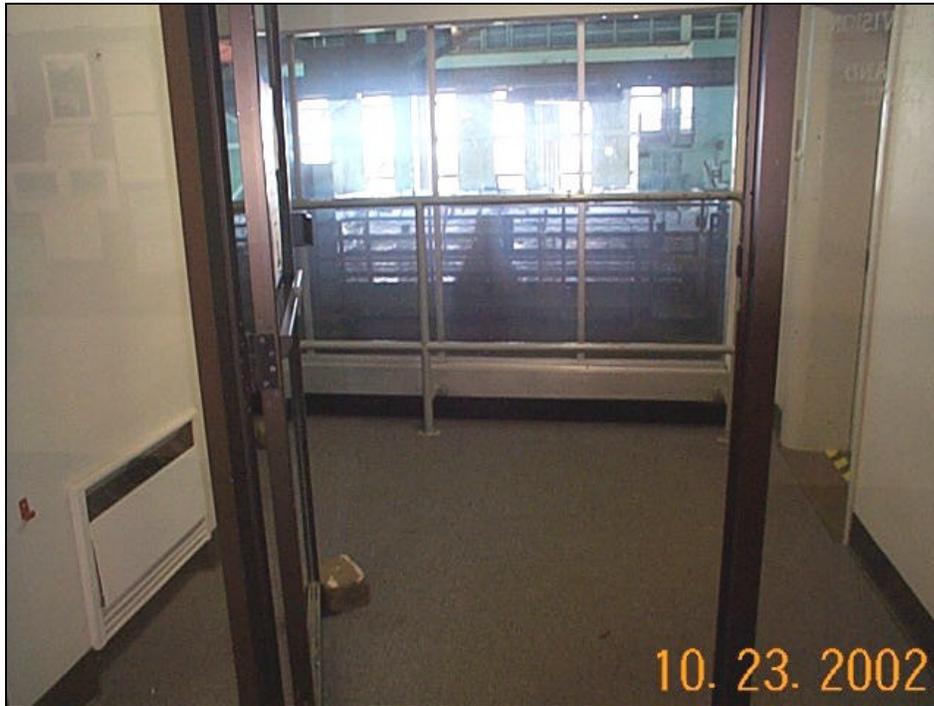
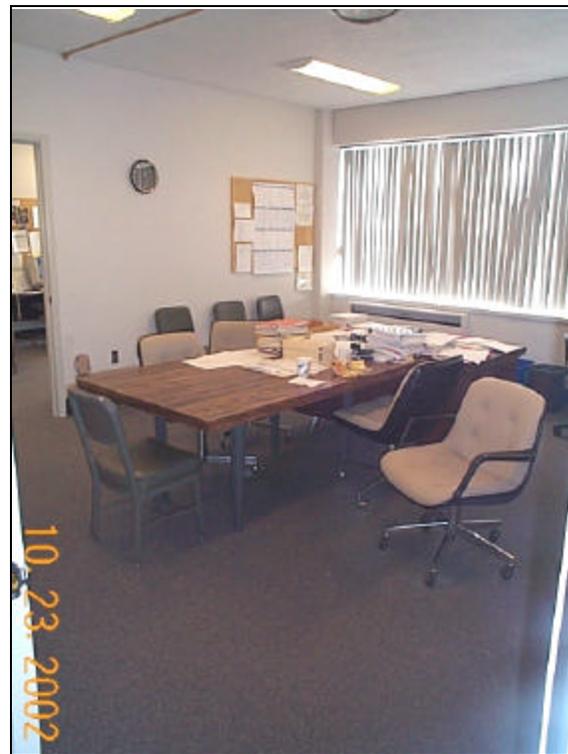
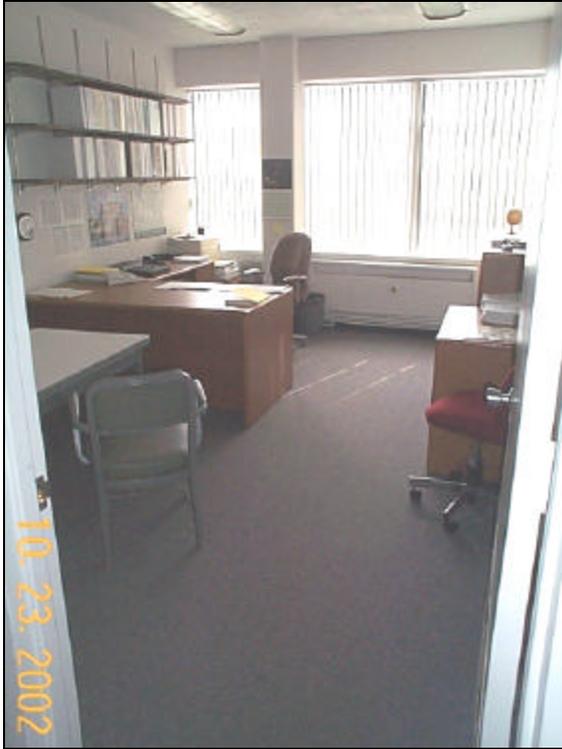
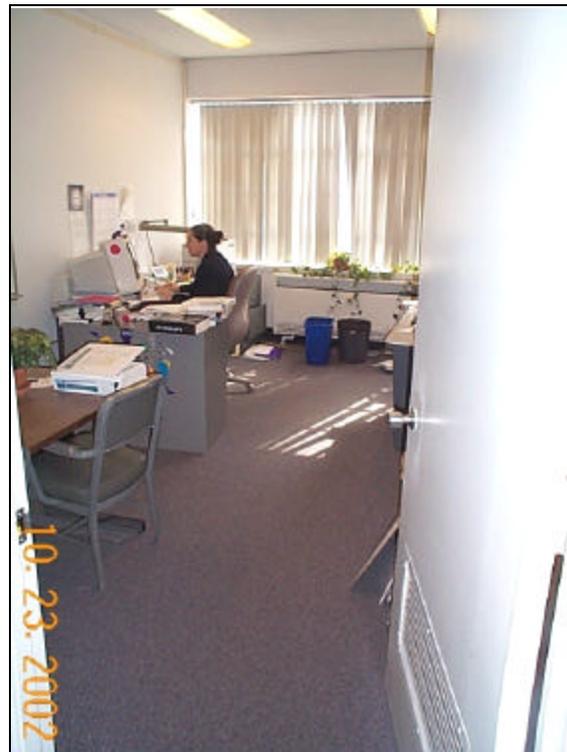
Based on historical and current data and information, this area is Class 2 for radiological surveys.

Recommend additional sampling for asbestos during remediation activities.
