Brookhaven Graphite Research Reactor (BGRR) Decommissioning Project

CHARACTERIZATION REPORT FOR BUILDING 701
ABOVE GROUND SURFACES, SYSTEMS, AND
STRUCTURES

May 2003

BROOKHAVEN NATIONAL LABORATORY
BROOKHAVEN SCIENCE ASSOCIATES

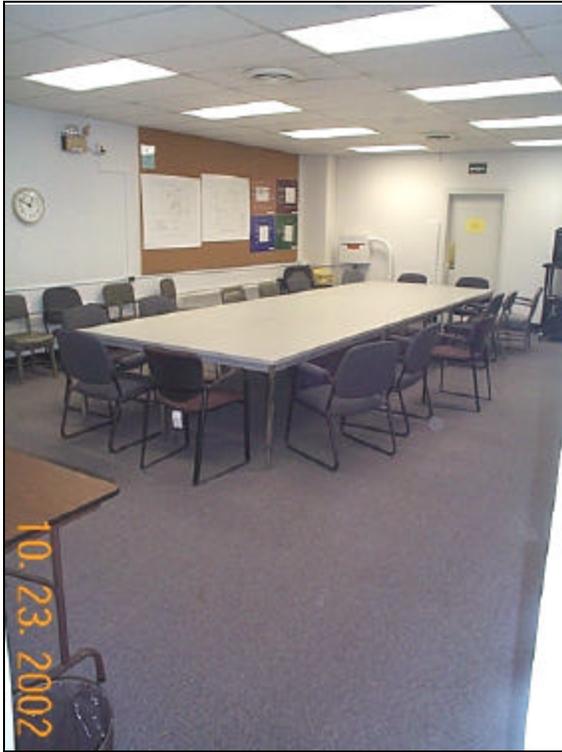
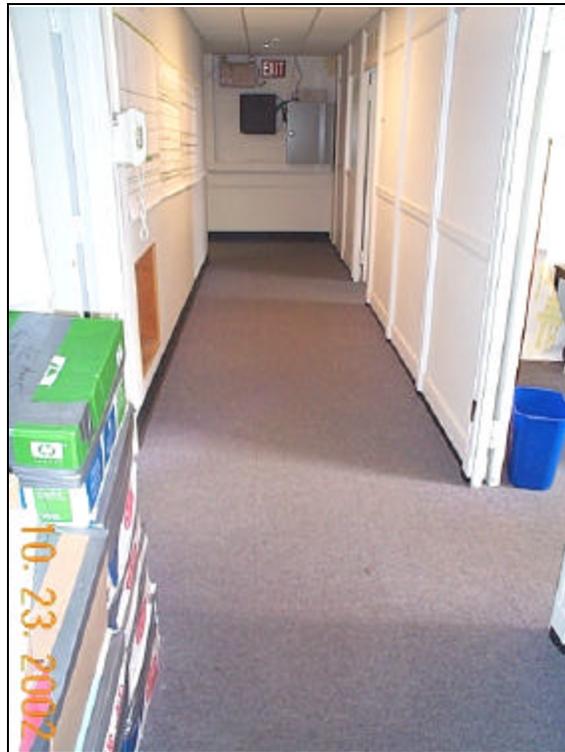
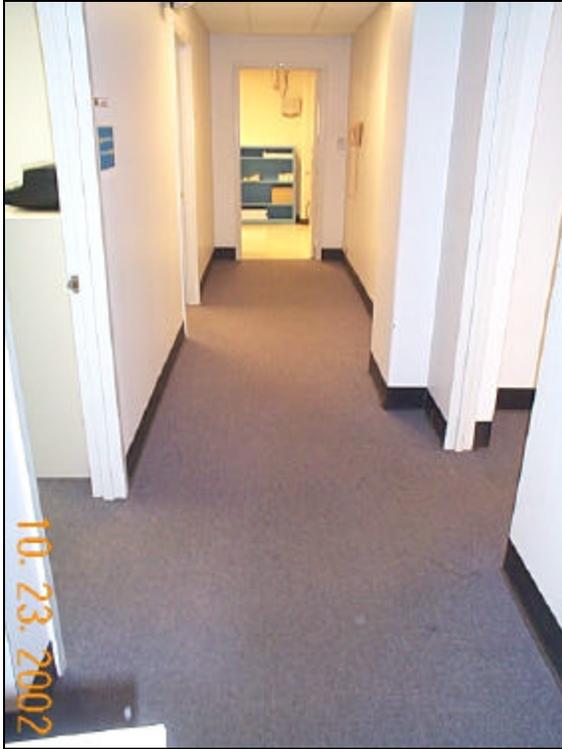
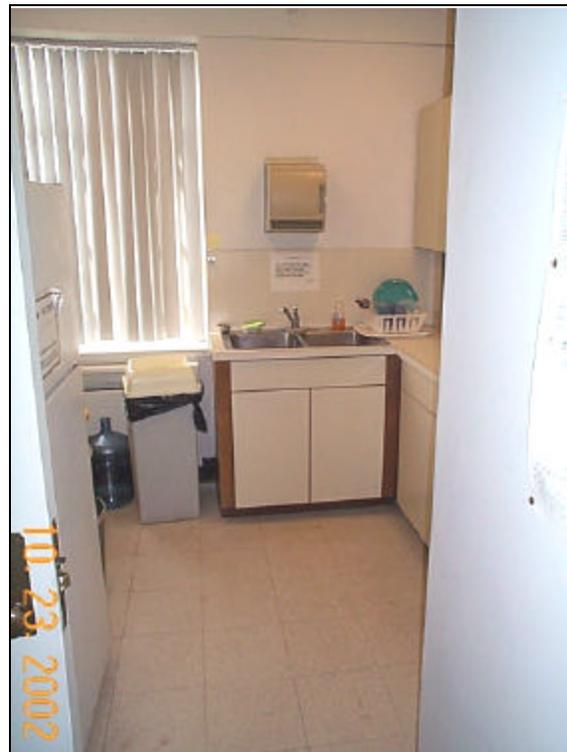
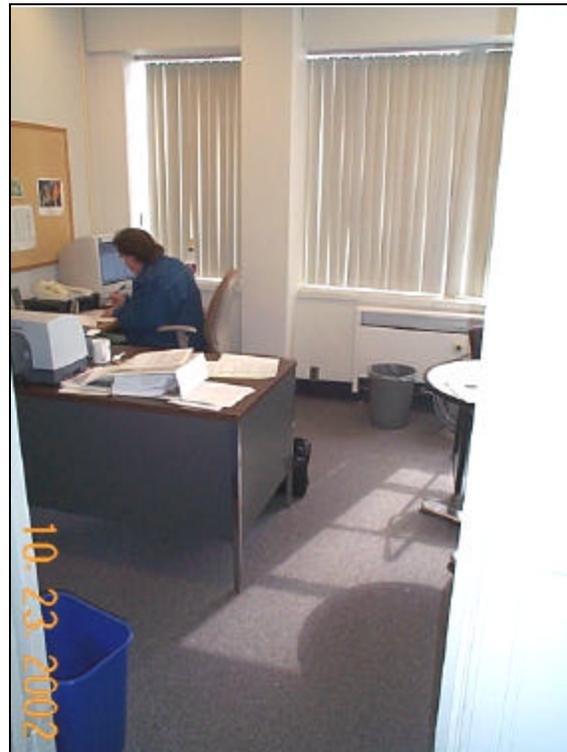
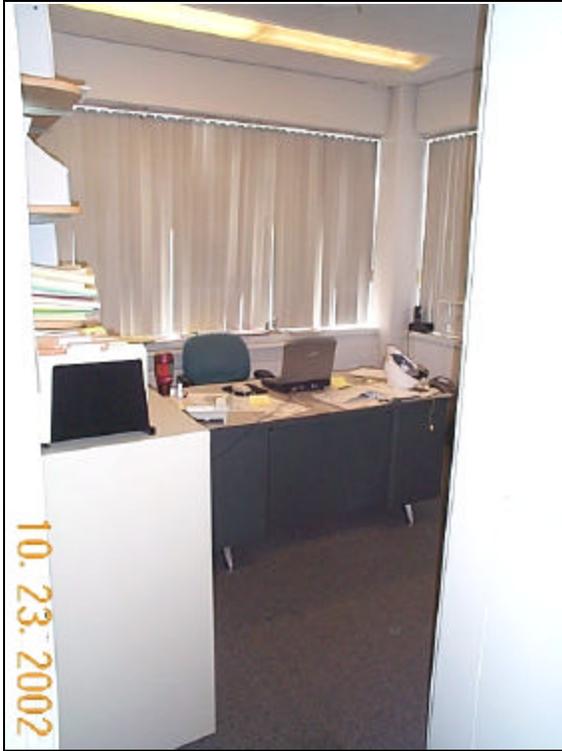
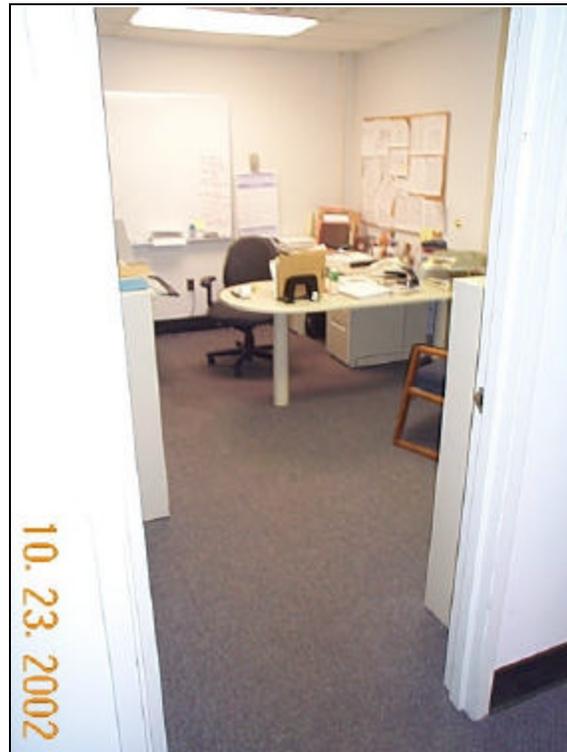
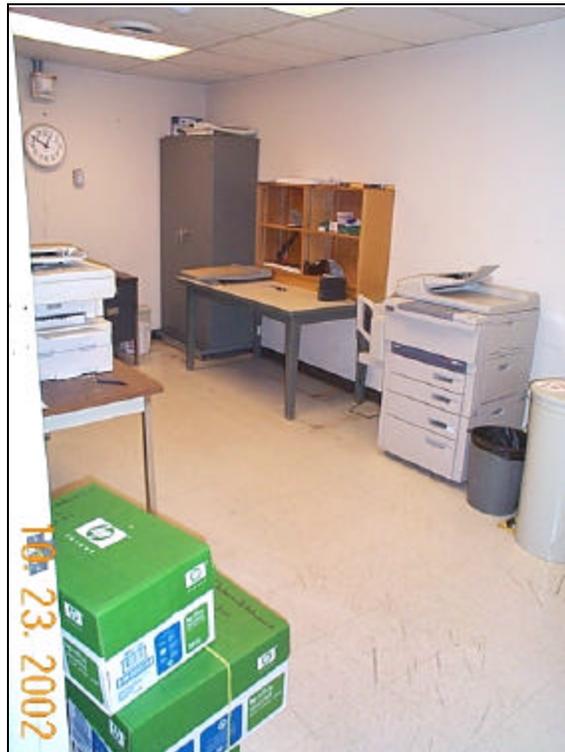
Based on historical and current data and information, this area is Class 2 for radiological surveys.

Recommend additional sampling for asbestos during remediation activities.

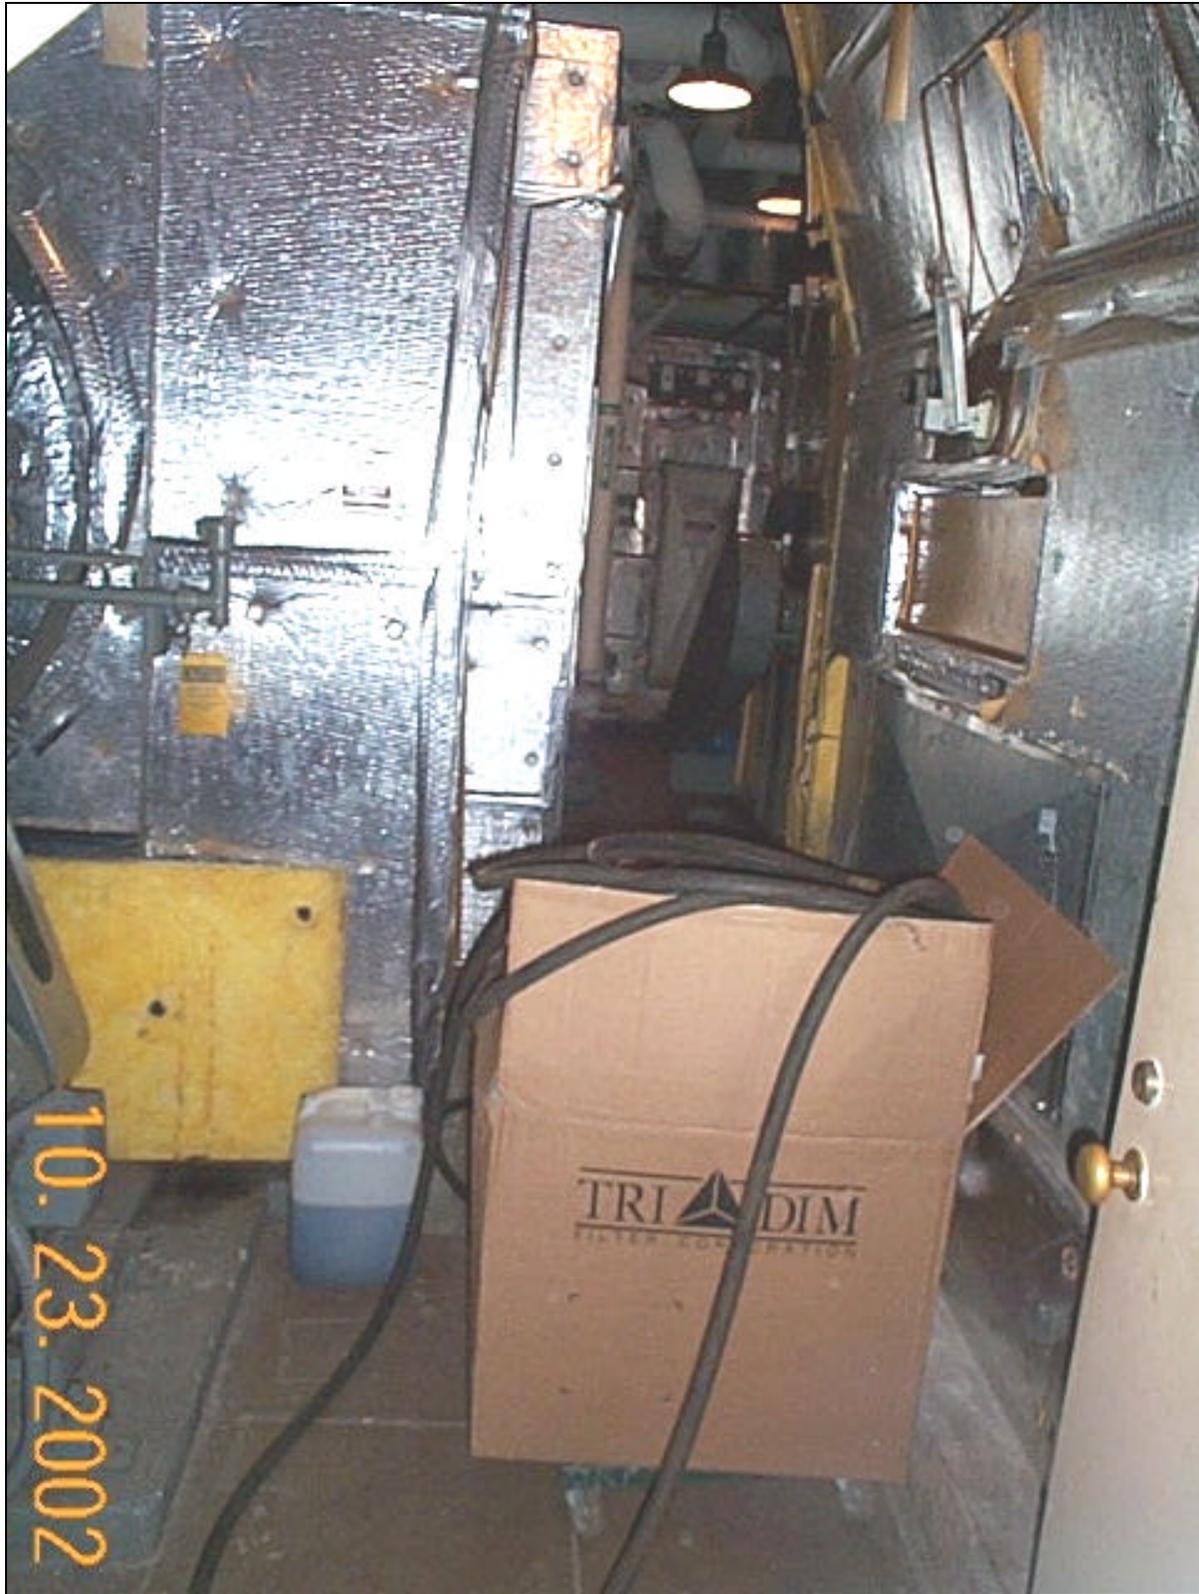
Figure E-1 Mechanical Equipment Room

Based on historical and current data and information, this area is Class 1 for radiological surveys.

Recommend additional sampling for asbestos and lead during remediation activities.

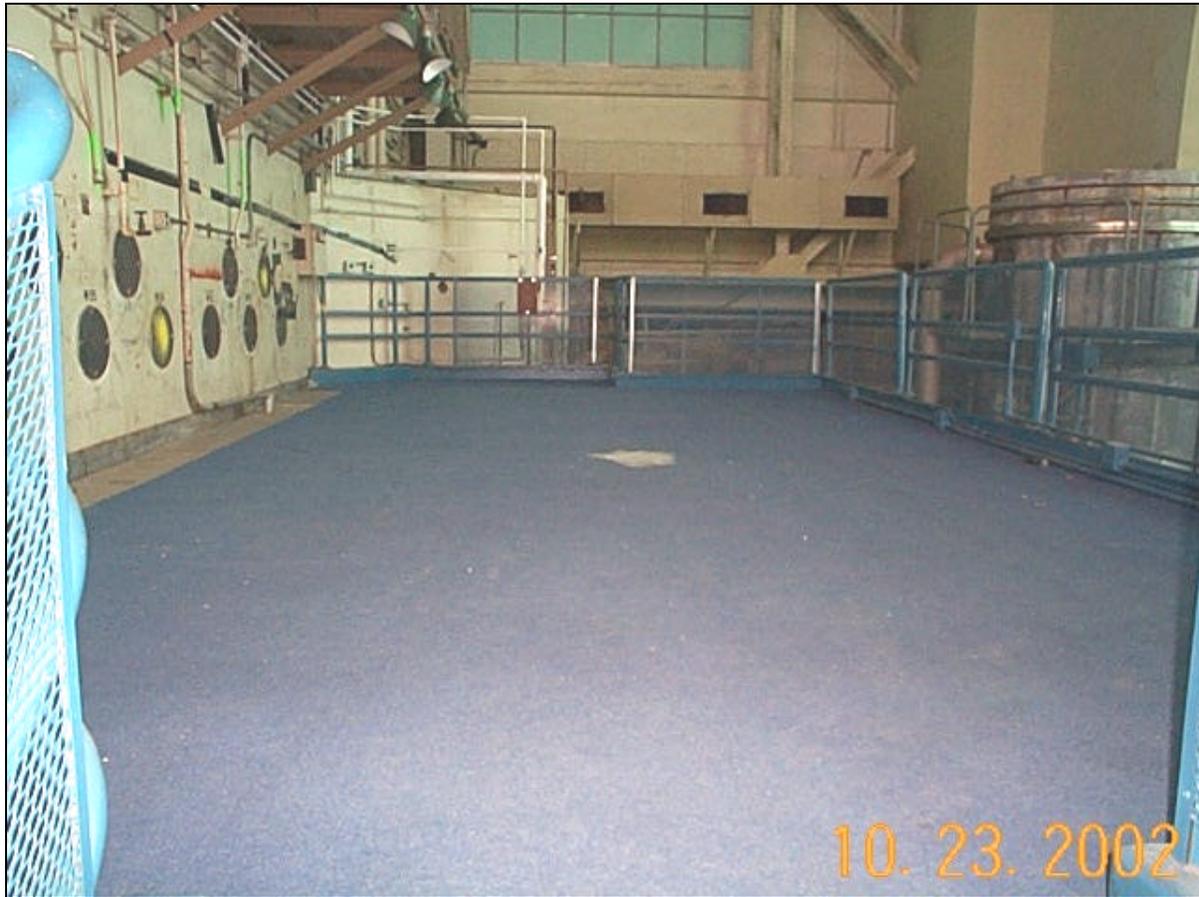
Figure E-2 West 127' Pile Face Balcony

Based on historical and current data and information, this area is Class 1 for radiological surveys.

Recommend additional sampling for asbestos and lead during remediation activities.
