Brookhaven Graphite Research Reactor Decommissioning Project

DRAFT CANAL AND WATER TREATMENT HOUSES, EQUIPMENT, AND ASSOCIATED SOILS COMPLETION REPORT

April 15, 2002

BGRR-048, Rev. C
April 15, 2002

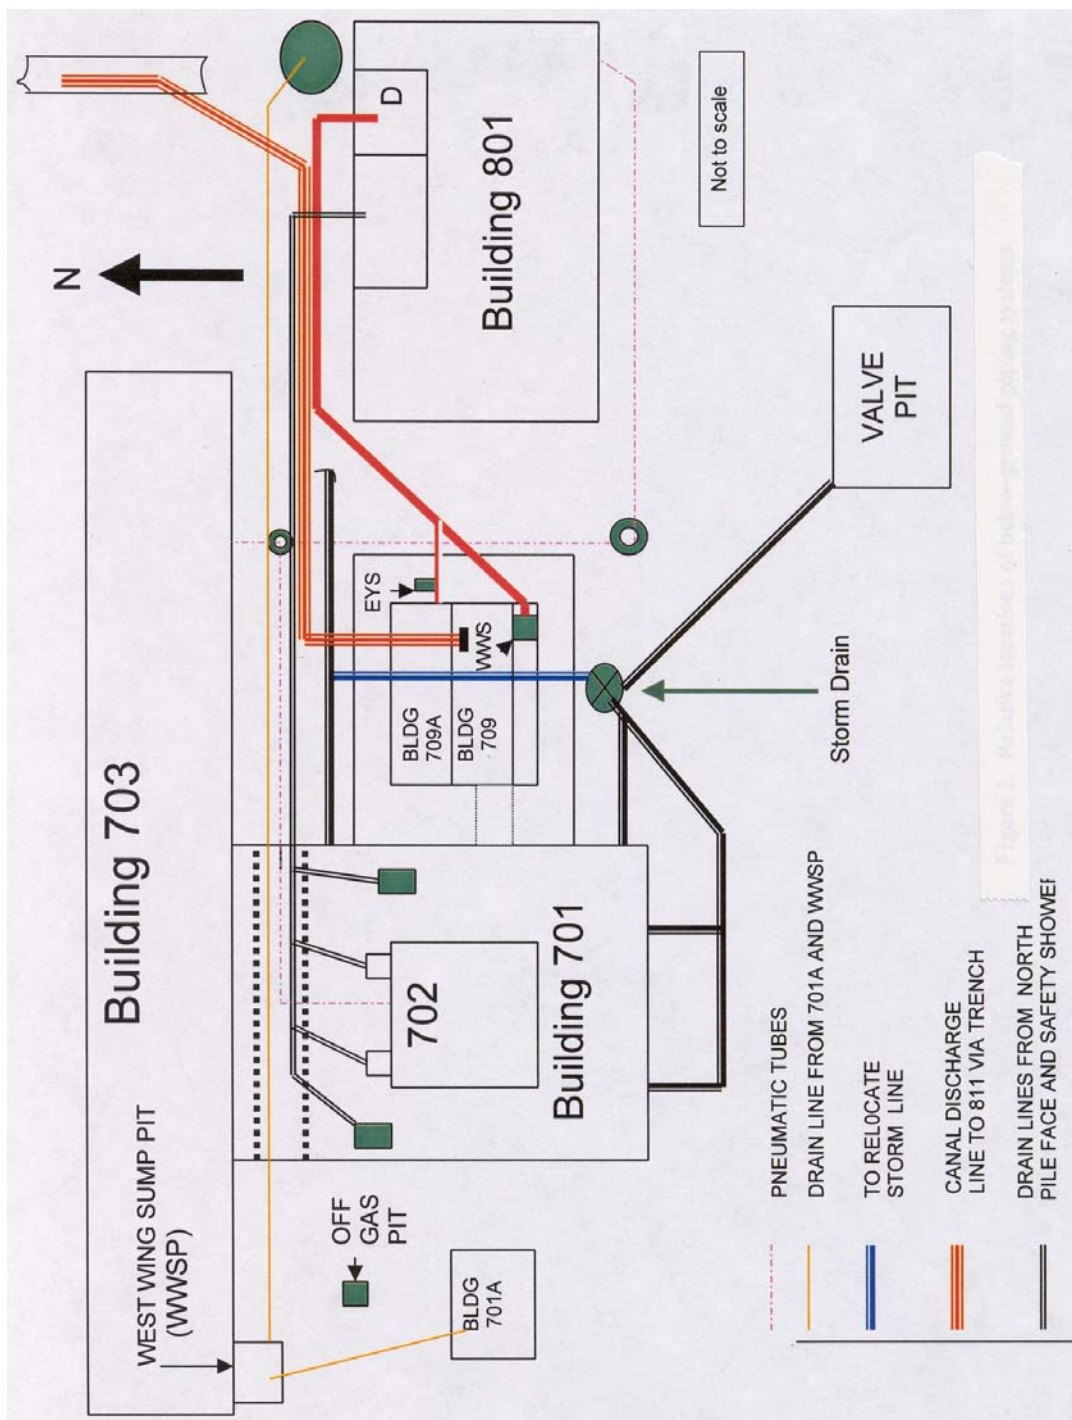
Figure 6. Sketch of the Below-grade Piping Systems Associated with the Canal Soils

- The contaminated exterior walls were coated with a fixative.
- The existing excavation was backfilled.
- A 10-foot-wide sheet rubber lining was installed beneath the surface pitching away from the Canal. This will prevent rainwater percolating through the soil, previously covered by blacktop, from moving deeper into the ground.
- The area was then graded for installation of a larger "weather-rated" tent.

- The "weather-rated" tent that was installed extends 5 feet beyond and over the existing tent. (This precludes the expense of surveying and removing the existing tent, and will prevent contaminating the new one. Hence, work within the Canal will be possible under present controls.)
- A monitoring well south of the construction joint between Building 701 and the Canal, damaged while excavating soil south of the Canal, was repaired.
- A soil survey was undertaken to reduce the size of the radiologically controlled area.
- The core-bore holes, made in the East Wall, and the S-2 and S-3 sumps excavations were plugged and sealed.

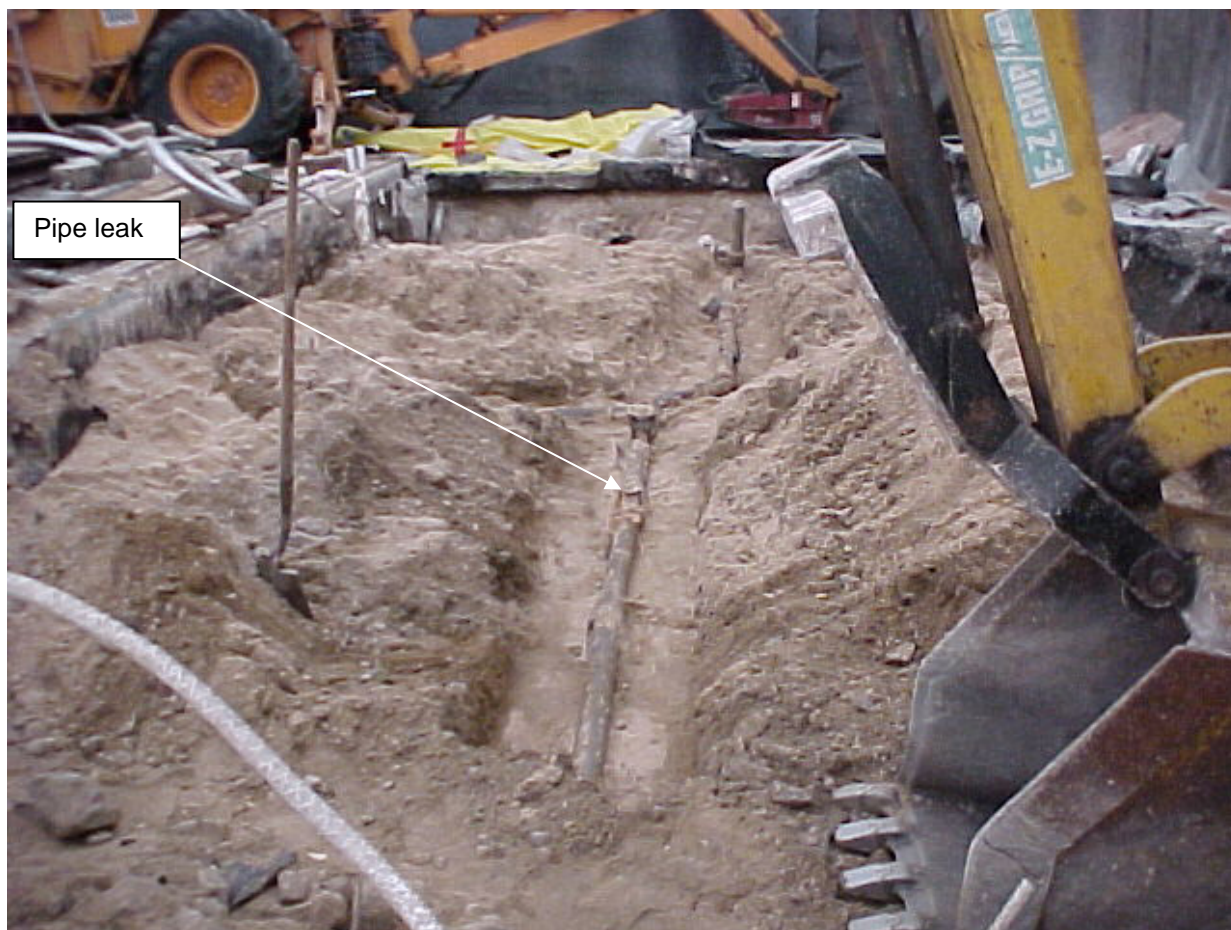
The Water Treatment House's floor drain system looking west, towards Building 701. Just west of the first drain, the pipe leaked water contaminated with Cs-137 and Sr-90 to the soil.

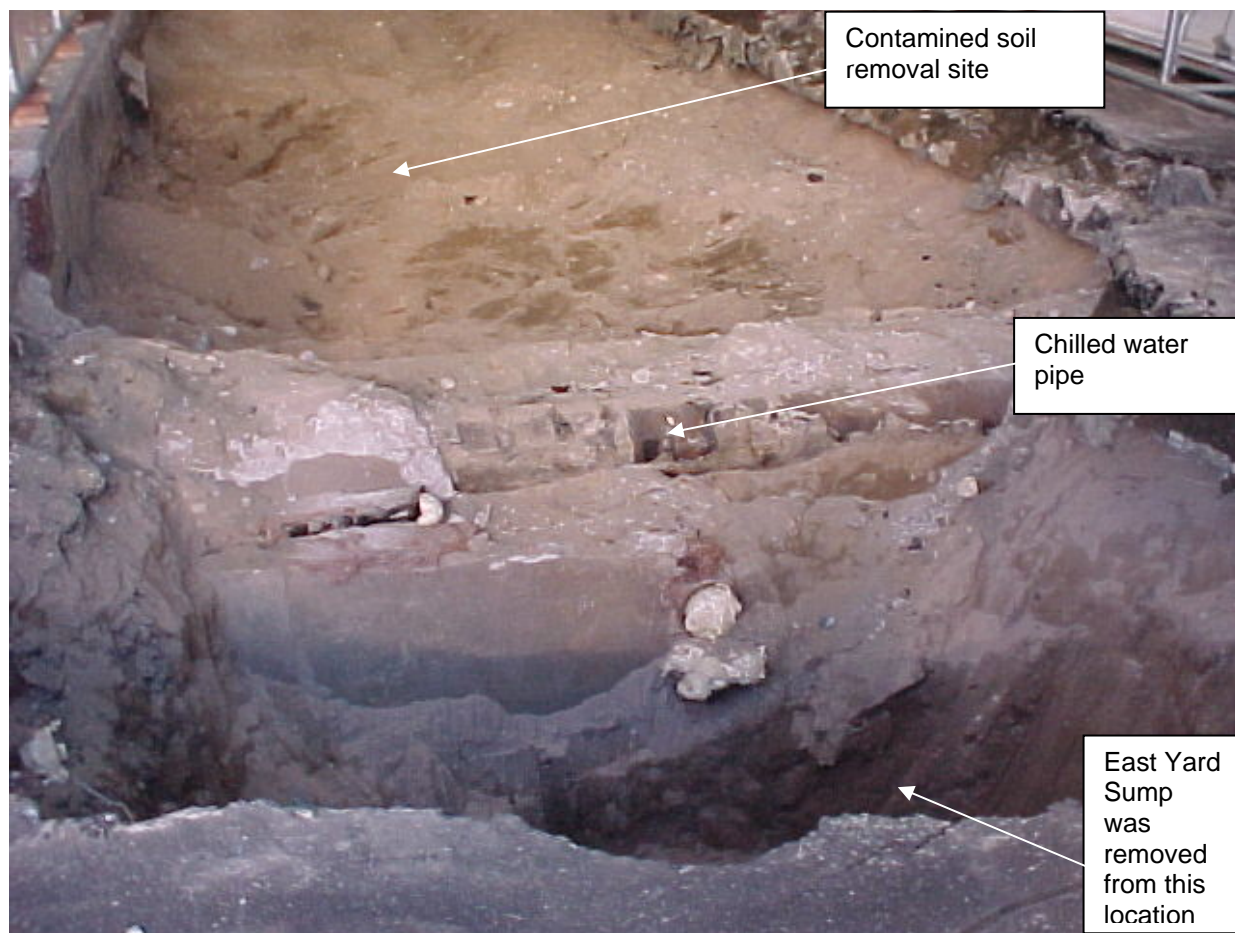
The Water Treatment House's foundation area looking west toward Building 701. The contaminated soil below the floor drains was carted away for disposal. The two large pipes are abandoned chill-water pipes that were removed. The East Yard Sump was removed from the hole at the bottom of the picture, to the east of the chilled-water piping.

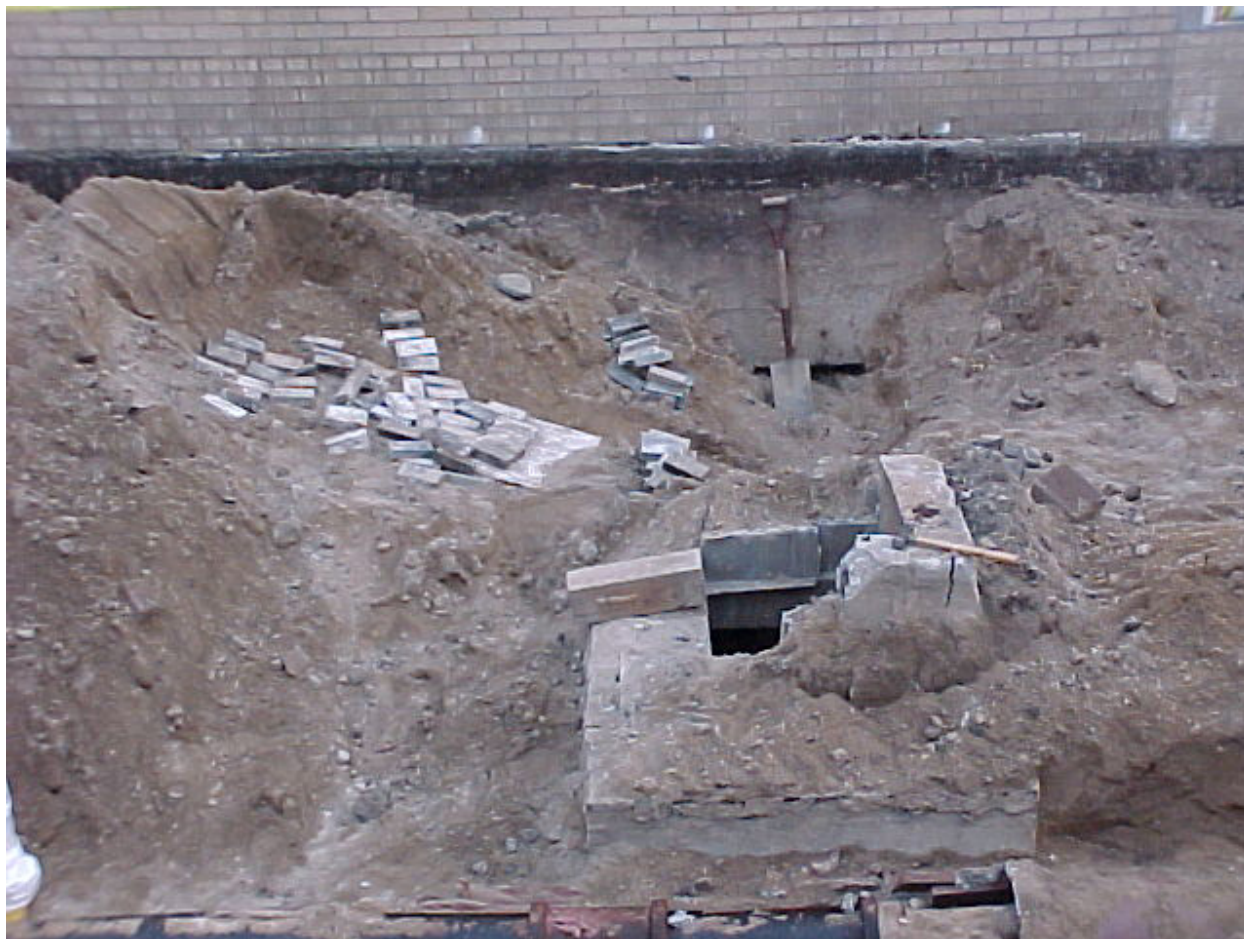
Excavation of the reactor's pneumatic transfer lines. As lines were being dug out, an unexpected shielded area of the piping was encountered where the lines turn north toward Building 703. Approximately 200 lead bricks, each approximately 2" by 4" by 8" and weighing 28 pounds, were removed from the area, along with the concrete blocks that formed the shielded cave. These lead bricks required special handling for waste disposal. Building 703 is at the top of the picture.

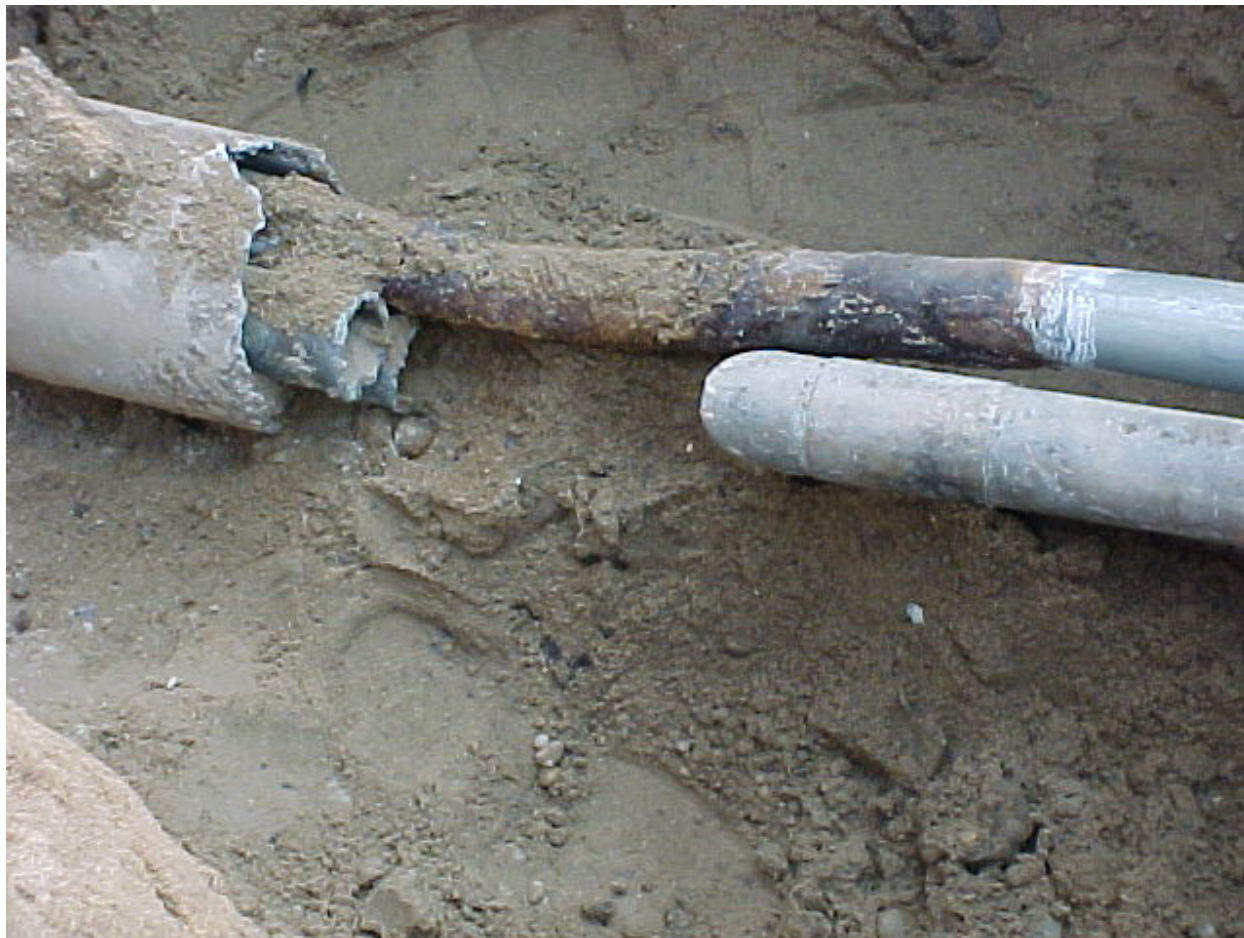
The pneumatic transfer lines at the Building 703 wall. There are four copper pipes, approximately 1 1/2" in diameter within the larger 6" cement line. One of the smaller lines has been cut; the other small line shows discoloration from the previous cutting process.

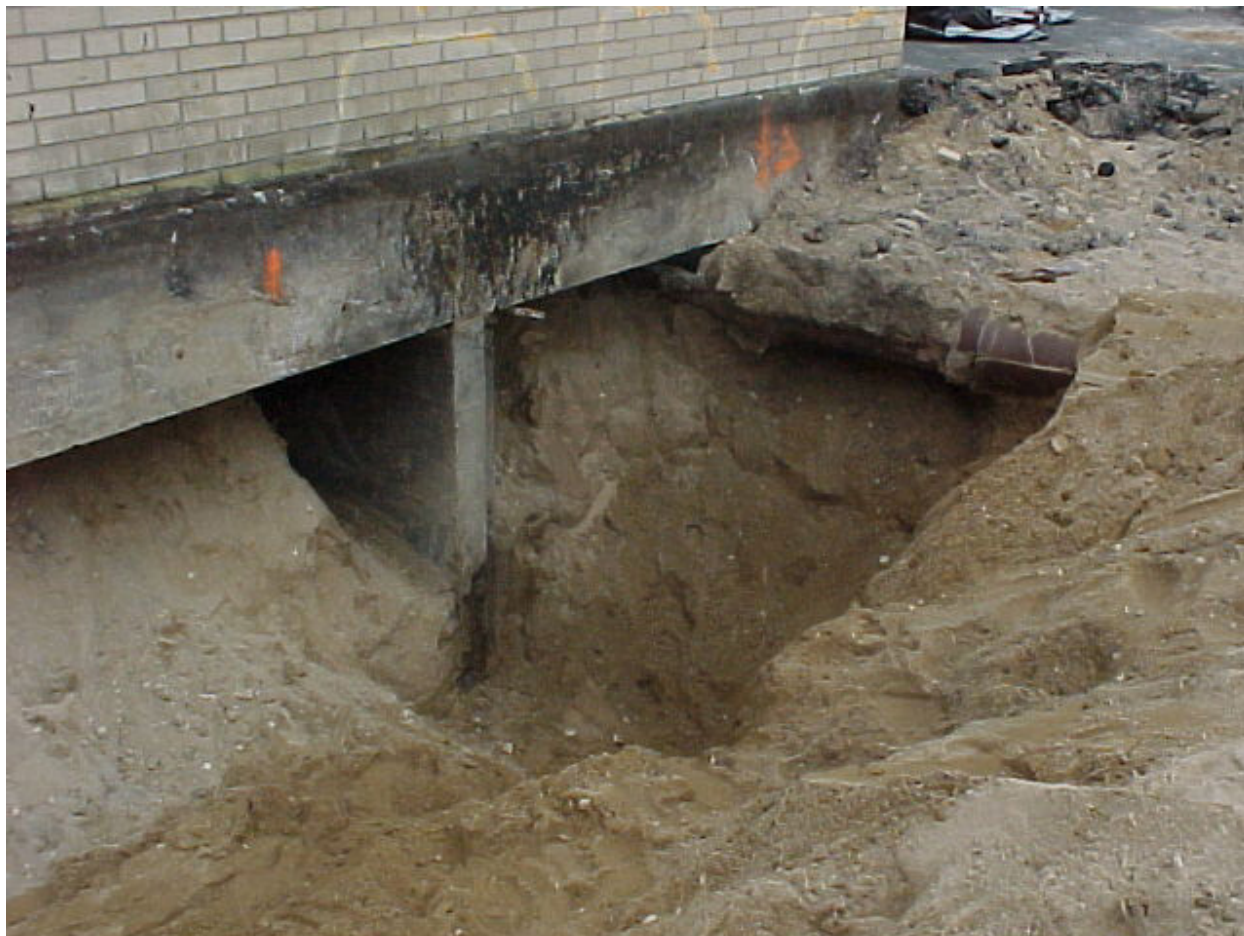
When removing the asphalt along the south side of Building 703, a pocket of contaminated soils was found extending under the overhang of the buildings basement wall. The contaminated soils were removed and the area verified clean through sampling and field-laboratory analysis.

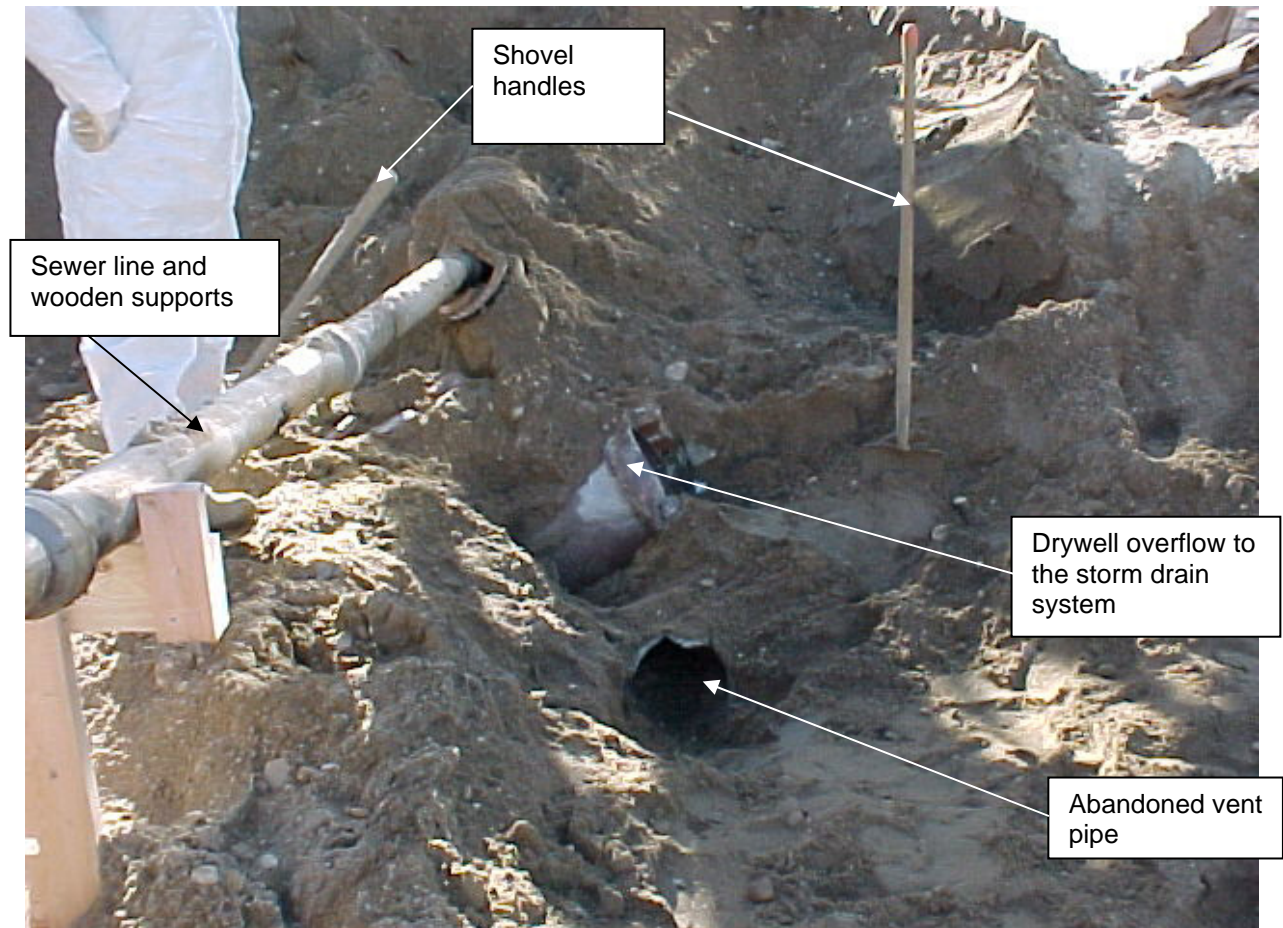
The excavation of the Canal discharge line from the east side of Building 703 westward toward the Canal. This was a very congested location. A storm-drain catch-basin turned out to be a drywell, located just to the right of the overflow pipe. The drywell was excavated and the contaminated soils below it were removed. The EPA and Suffolk County Department of Health Services (SCDHS) were notified. SCDHS field-personnel witnessed the follow-up soil sampling.

Two storm-drain catch basins were opened downstream of this contaminated drywell to sample for contamination. There was no contamination of the soil nor the two storm-drain catch basins downstream. The lowest opening is an abandoned vent line that was removed in the area of the Canal discharge line removal. The inclined tile line above the vent line was the overflow from the drywell to the storm drain system. The support line is a sewer line from Building 703 that connects to the eastward sewer catch basin.

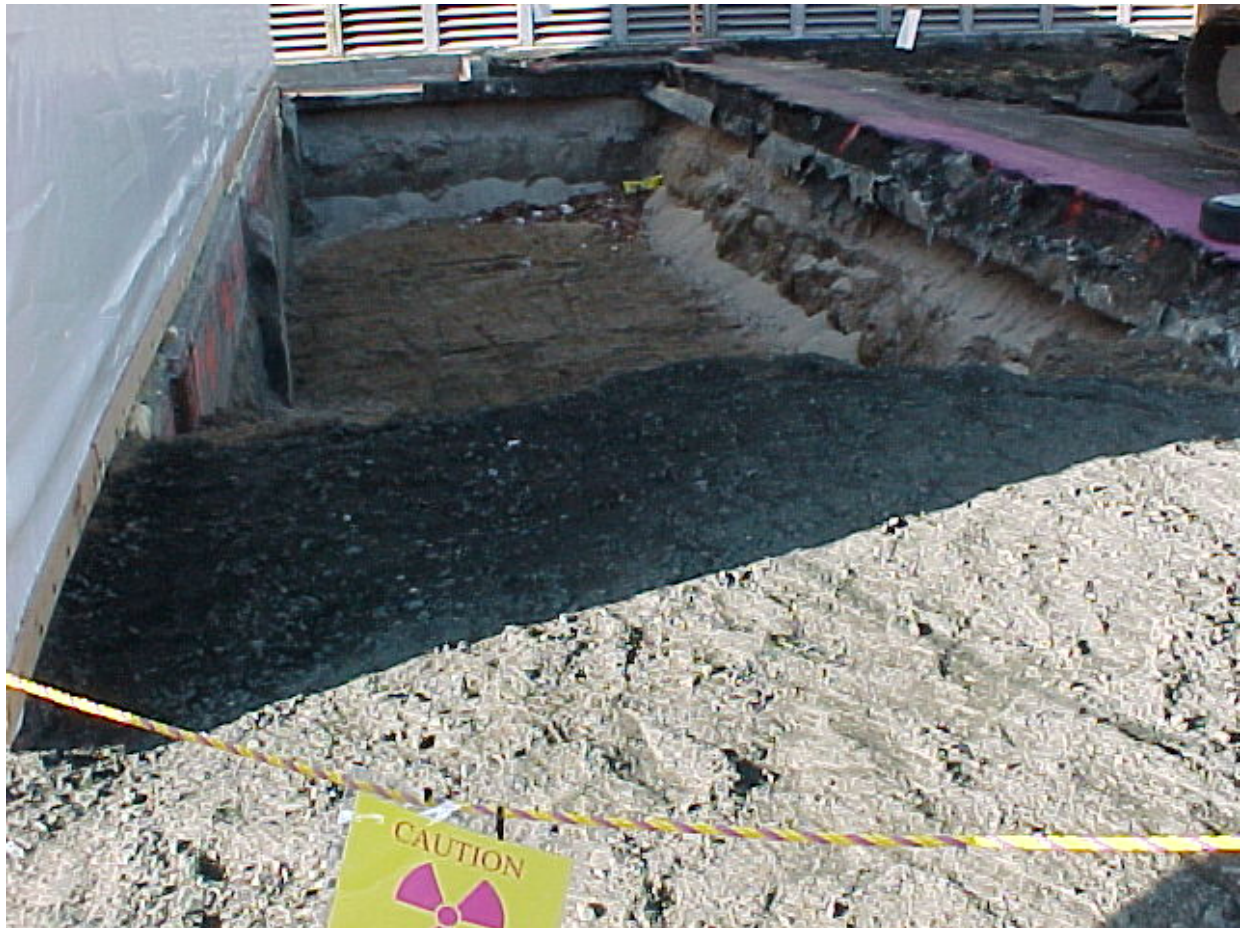
Looking west along the north side of the tent with Building 701's primary cooling air intake louvers at the top of the picture. The Water Treatment House has been removed, and the concrete on the left is the Canal's north wall, which is supporting the tent. The asphalt and concrete on the right side is the north pad of the Canal.

Here, contaminated soil extended below the foundation of the Water Treatment House's concrete slab floor. Apparently during operation, one of the floor drain lines leaked allowing contaminated water into the soil. The contaminated materials in this area could not be removed until the large tent that covered the Canal and Water Treatment House's was dismantled.

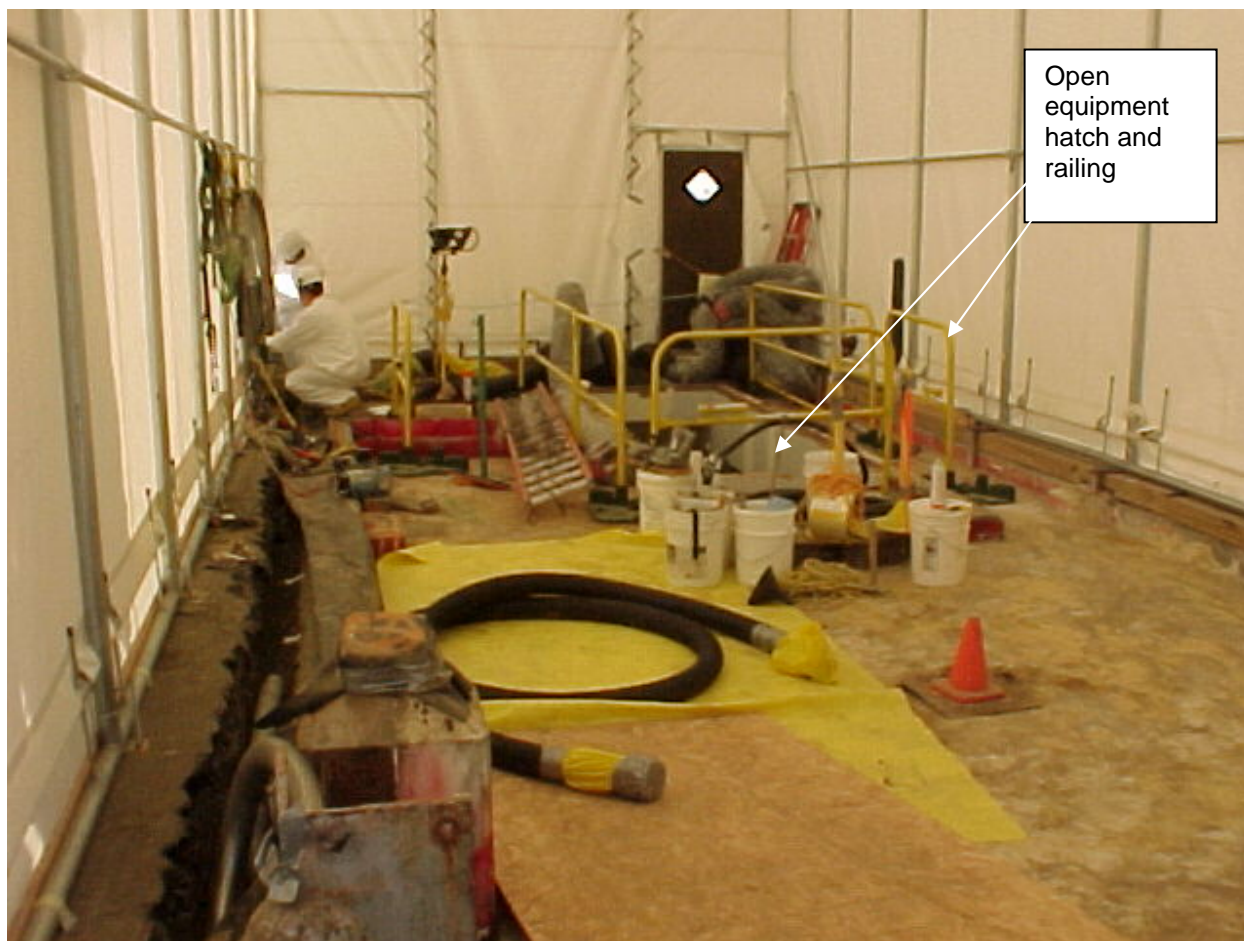
The remaining Canal floor after removing the removal of the Canal and Water Treatment building structures. The small tent covers the "footprint" of the Canal's main floor-area. The equipment hatch is open and is surrounded by yellow railings to warn workers that the hatch to the lower Canal is open. Workers are installing the vent line connection through the wall of the tent to the HEPA-ventilation exhaust system outside. The system maintained a negative pressure in the tent to ensure the air exhausting from the tent was filtered.

Before work could begin in the lower Canal, below the surface in the photo above, the peeling paint had to be scraped from all surfaces of the Canal and Canal area. Then Health Physics technicians performed operational surveys. Following this, in any areas where loose surface-contamination was identified at levels up to 1,000,000 disintegrations per minute per 100 square centimeters, a fixative was applied to prevent its spread.

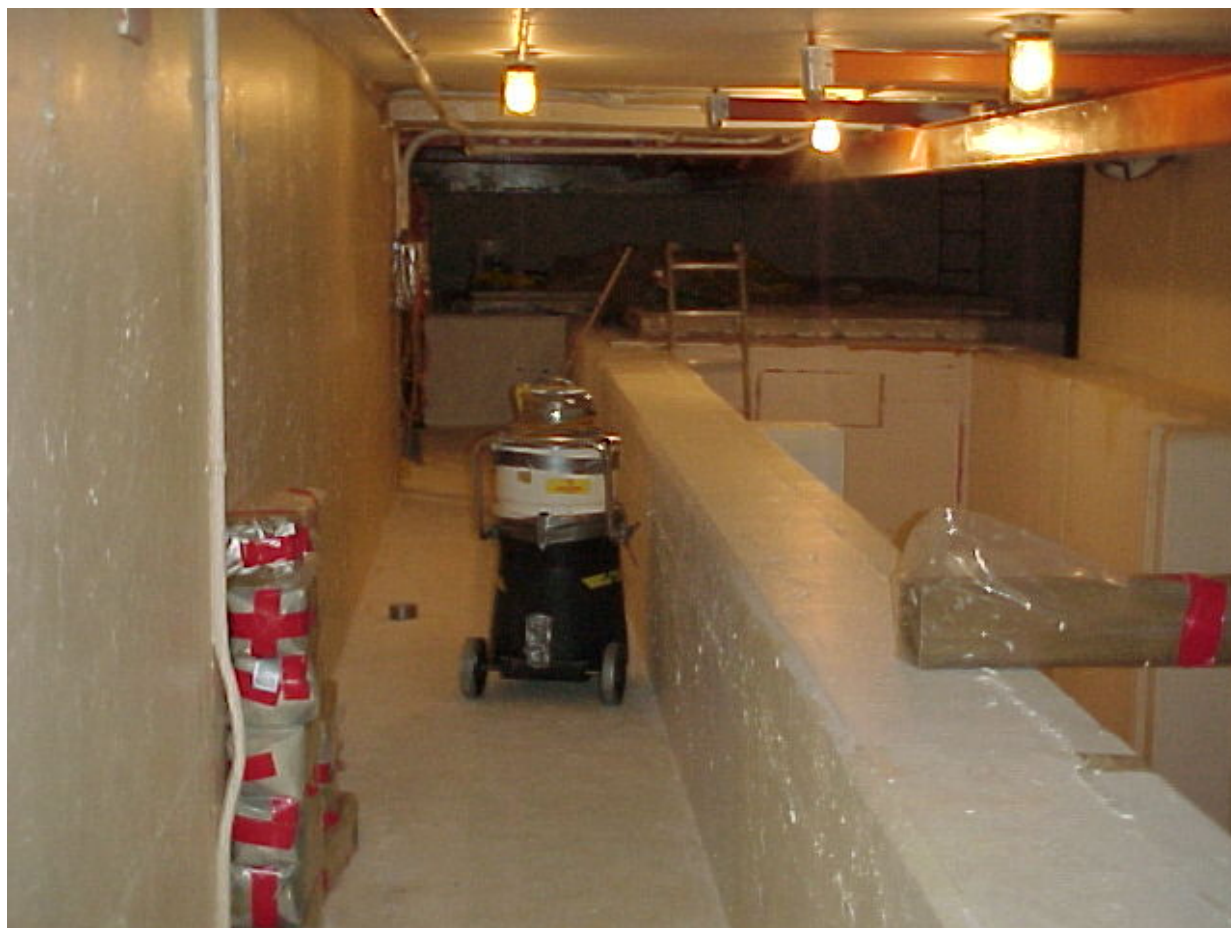
The Canal walkway looking west from the personnel ladder. The concrete covers have been removed from the Canal, and a fixative applied to the area to prevent the spread of loose surface-contamination.

This area was scabbled using hand-held and machine-mounted scarifiers and scabblers. This equipment was attached to a super-vacuum to reduce the amount of dust released and to remove the surface materials loosened by the scabblers into a waste container for disposal. Over 3,000 square feet of surface area had to be decontaminated. The packages on the left side are sample packages. The HEPA vacuum on the walkway was used to vacuum debris from scraping the walls to remove peeling paint. The wooden beam is wrapped in plastic to prevent its contaminating. Hoses used in the Canal were hung from it.

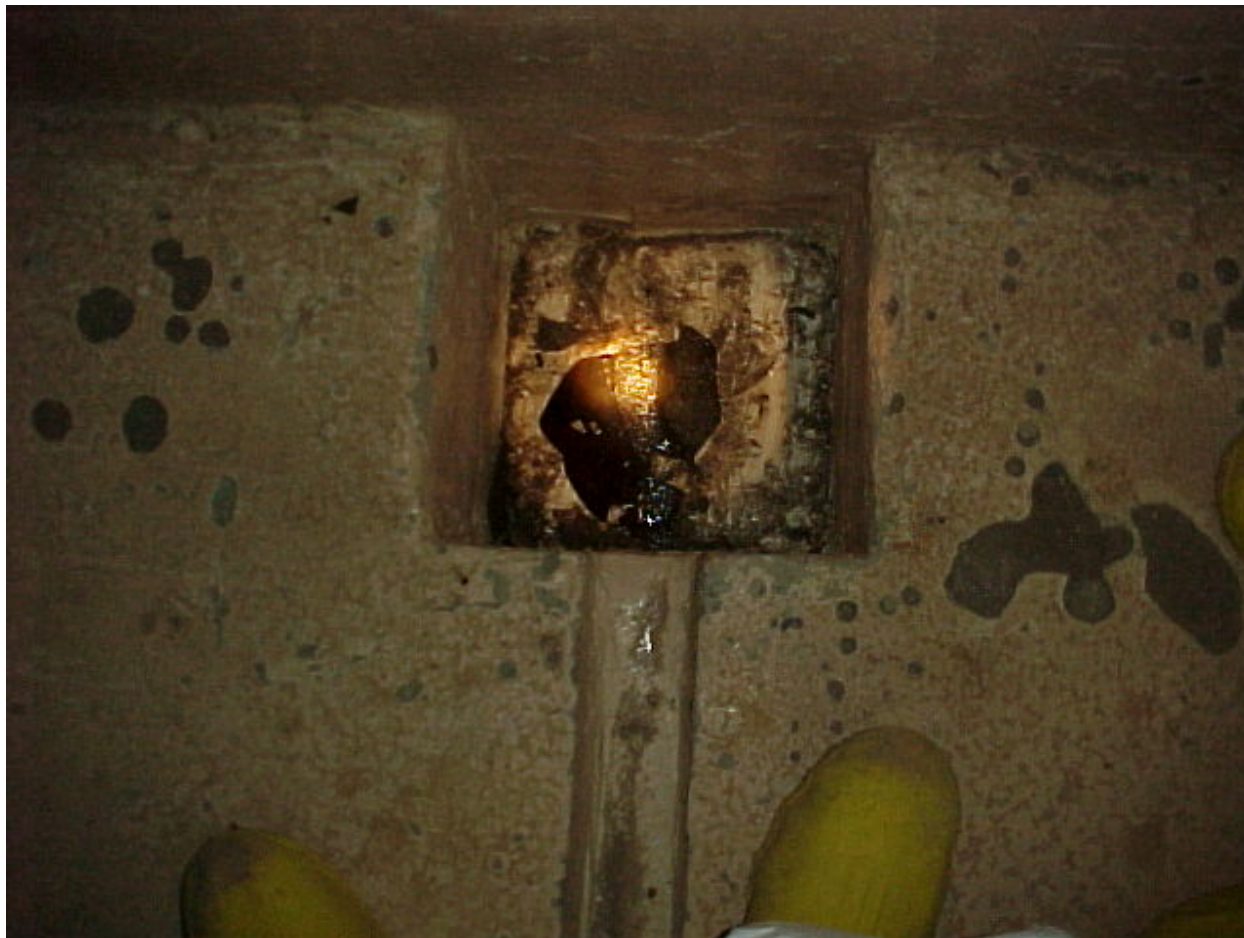
One of the Canal's three floor low-point drain sumps. A flashlight supplied the source of light for this picture; hence, the odd glow in the bottom of the sump. Note the paint peeling from the surrounding floor surfaces. The sumps were removed.

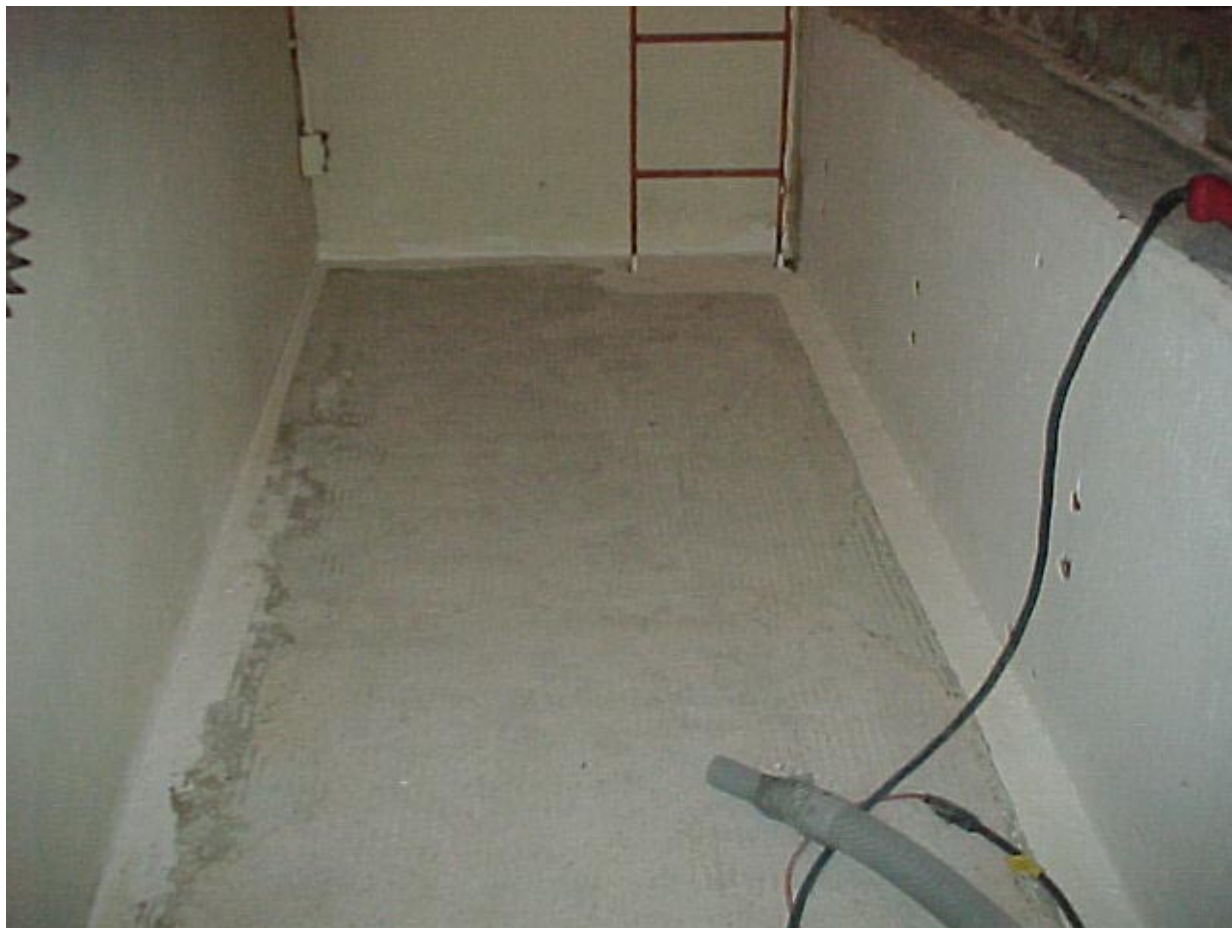
Initially, the Canal walkway was scabbled using a walk-behind floor scarifier. This removed contamination that was bound in the several layers of paint fixative. Additionally, a layer of epoxy was removed from the roughened concrete floor. The hose in this picture is attached to the scarifying equipment and to the super vacuum. The corners and walls surfaces were decontaminated next.

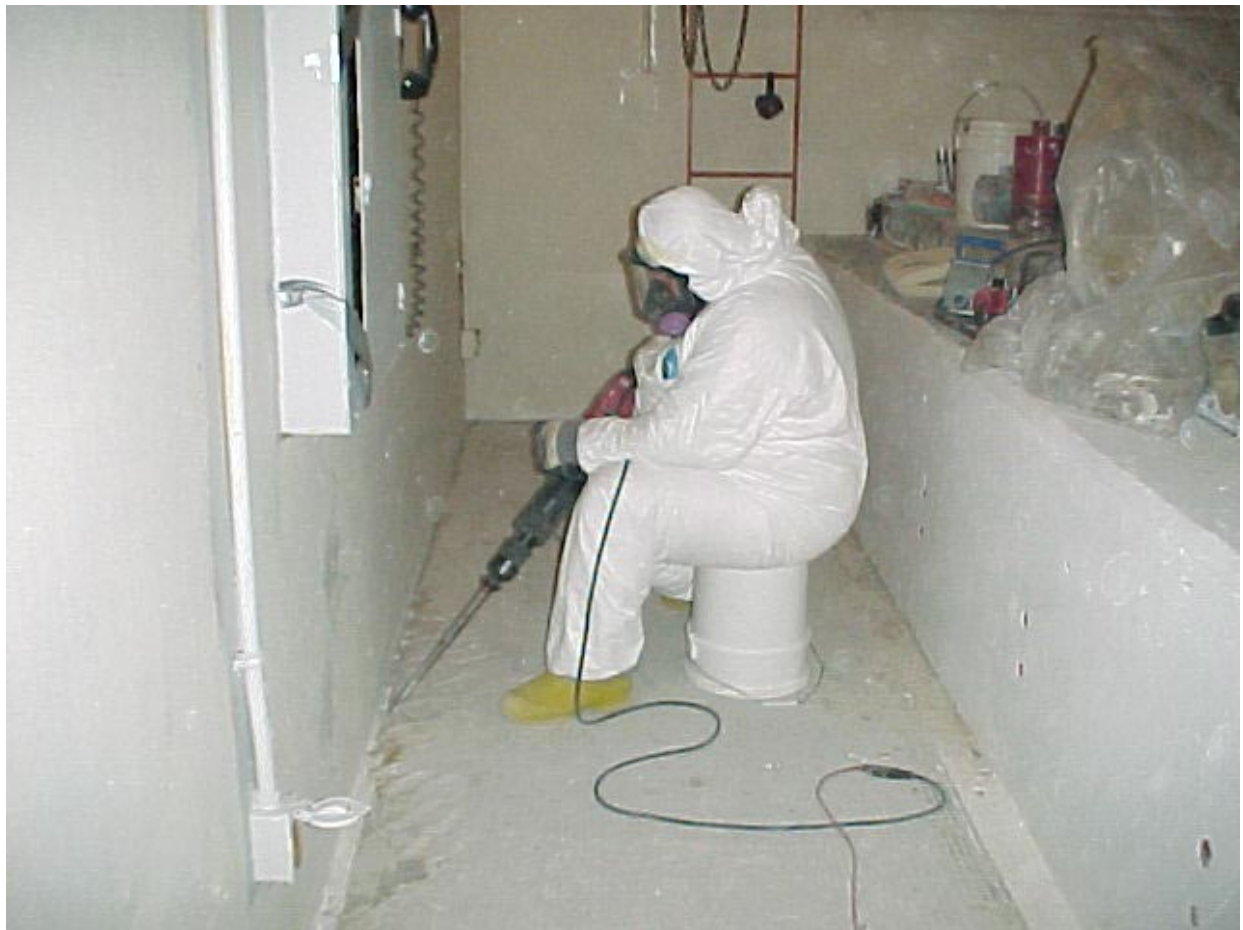
A worker is using an electric chipping hammer to remove the contamination from the corners where the walls and floor meet.

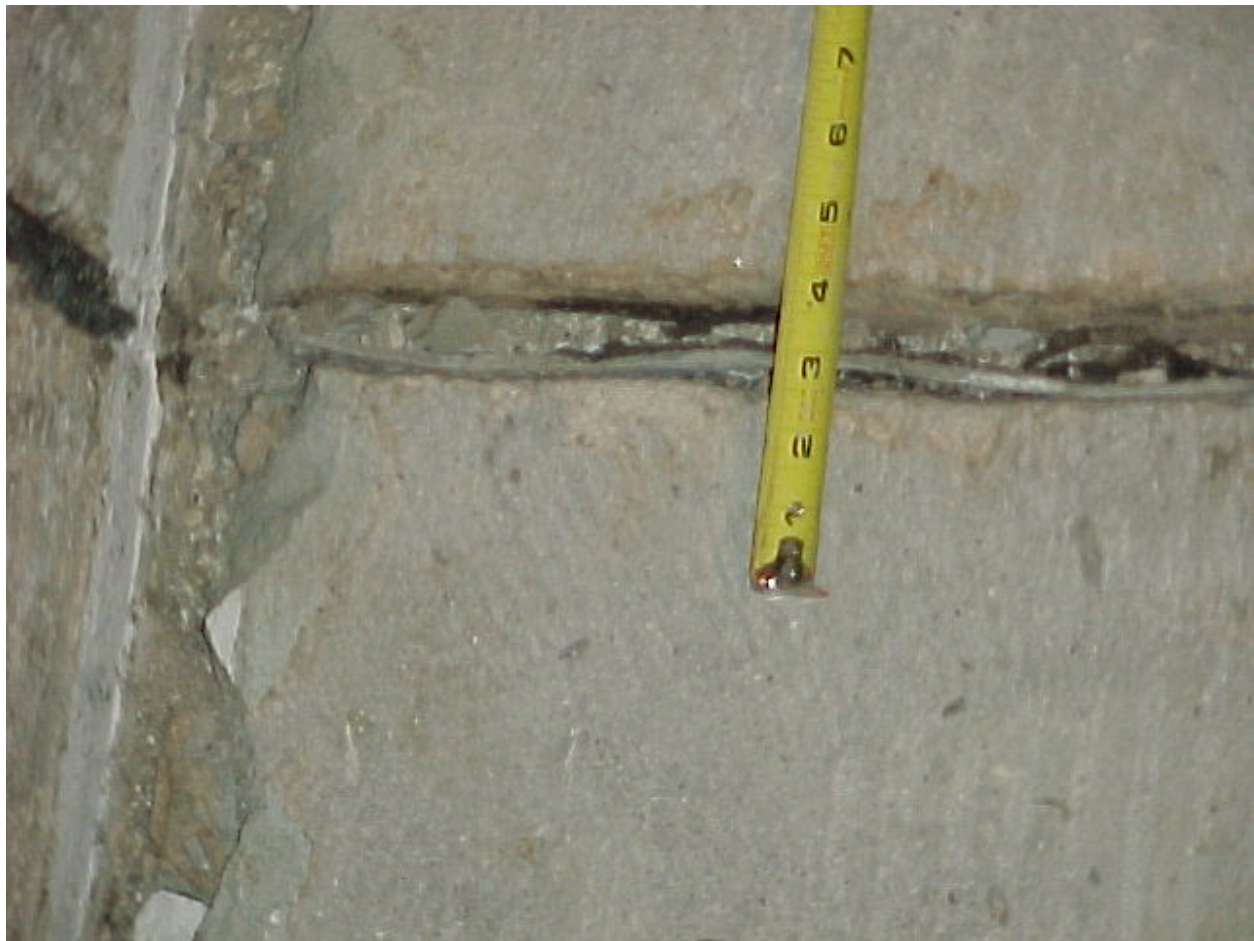
The Canal area construction joint following its decontamination. The joint runs along the Canal Walkway's floor.
