# **Brookhaven Graphite Research Reactor Decommissioning Project**

## **FINAL CANAL AND DEEP SOIL POCKETS EXCAVATION AND REMOVAL COMPLETION REPORT**

**August 22, 2005**

**BROOKHAVEN NATIONAL LABORATORY  
BROOKHAVEN SCIENCE ASSOCIATES  
Under Contract No. DE-AC02-98CH01886 with the  
UNITED STATES DEPARTMENT OF ENERGY**

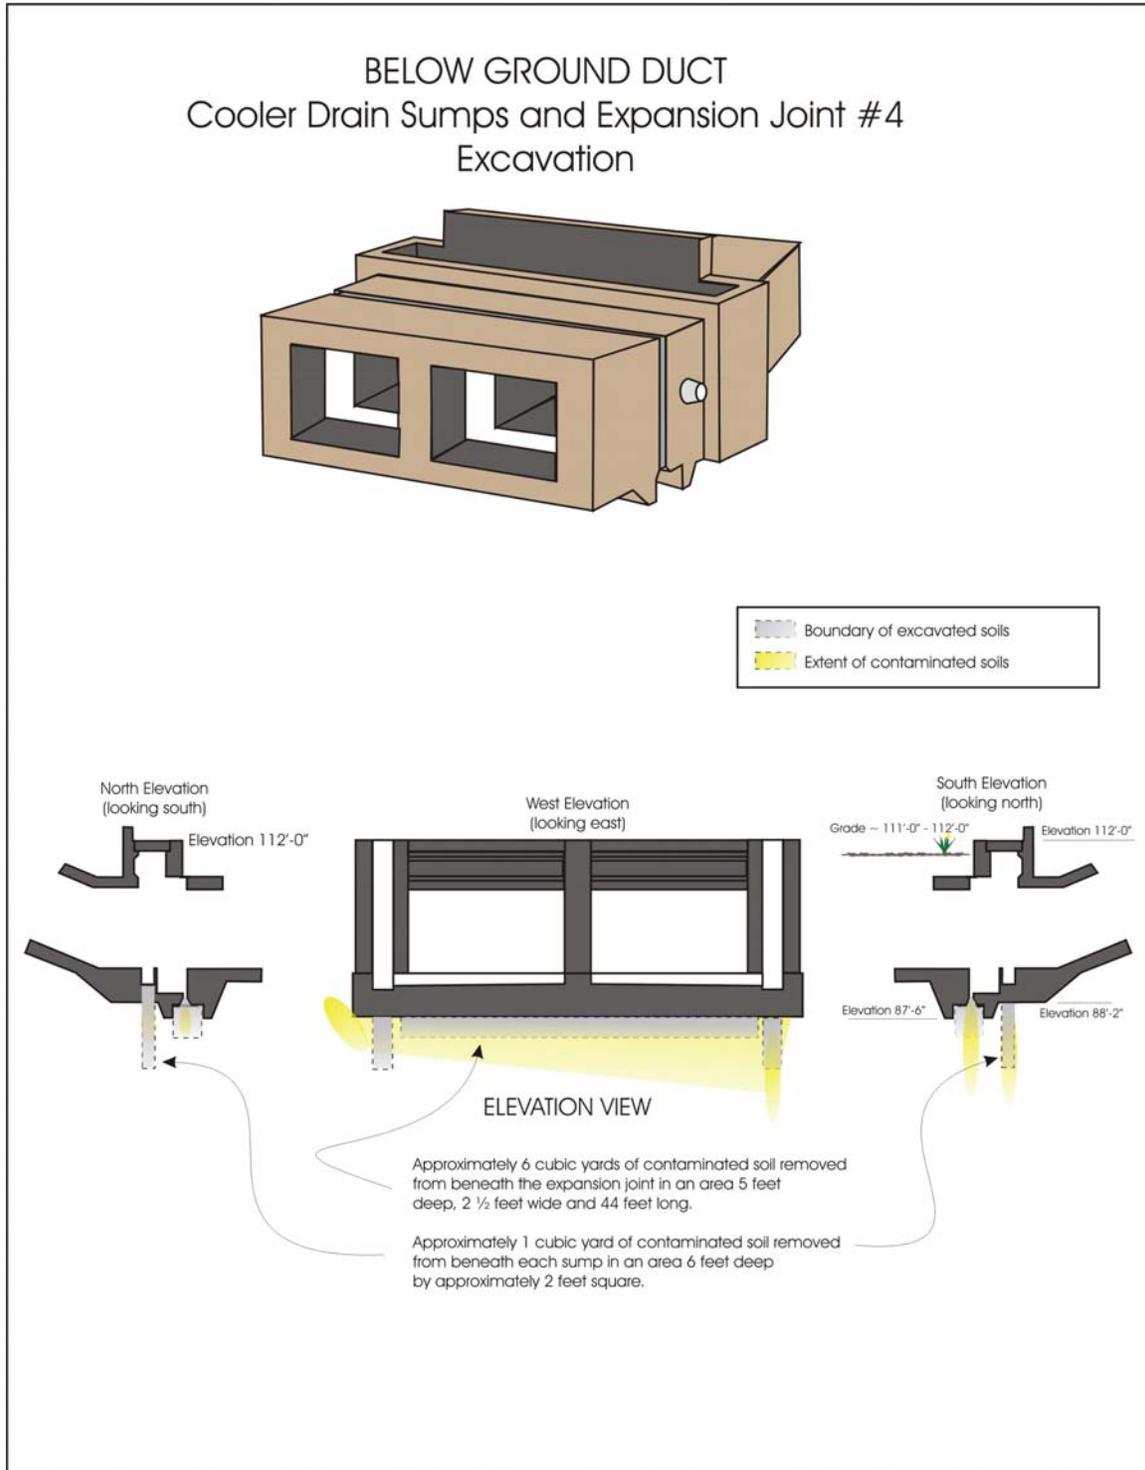
**Figure 4. Cooler Drain Sumps and Expansion Joint #4 Excavation**

Soil Pockets Beneath the Below Ground Ducts - The soil pockets beneath the below ground ducts were made accessible by boring 6 inch diameter holes through the concrete structure and/or the expansion joint. After holes were bored, a Hi-Vac vacuum unit was used to remove the contaminated soil from the following areas:

- North BGD cooler drain sump (1 cubic yard removed)
- South BGD cooler drain sump (1 cubic yard removed)
- North BGD expansion joint #4 (3 cubic yards removed)
- South BGD expansion joint #4 (3 cubic yards removed)

Any additional excavation would have resulted in a significant engineering and construction project because of shoring requirements and access limitations. Once the soil was removed from the above locations, soil samples were obtained to document the "as-left" condition. Residual contaminants included Cs-137 with a maximum concentration of 5907 pCi/g and Sr-90 with a maximum concentration of 676 pCi/g. Appendix 1 documents all "as-left" soil sample results.

The voids created by the soil removal were filled using clean sand; boreholes were plugged using a Bentonite mixture. Figure 4 provides a graphic illustration of the contaminated soil pockets removed beneath the cooler drain sumps and expansion joint #4.

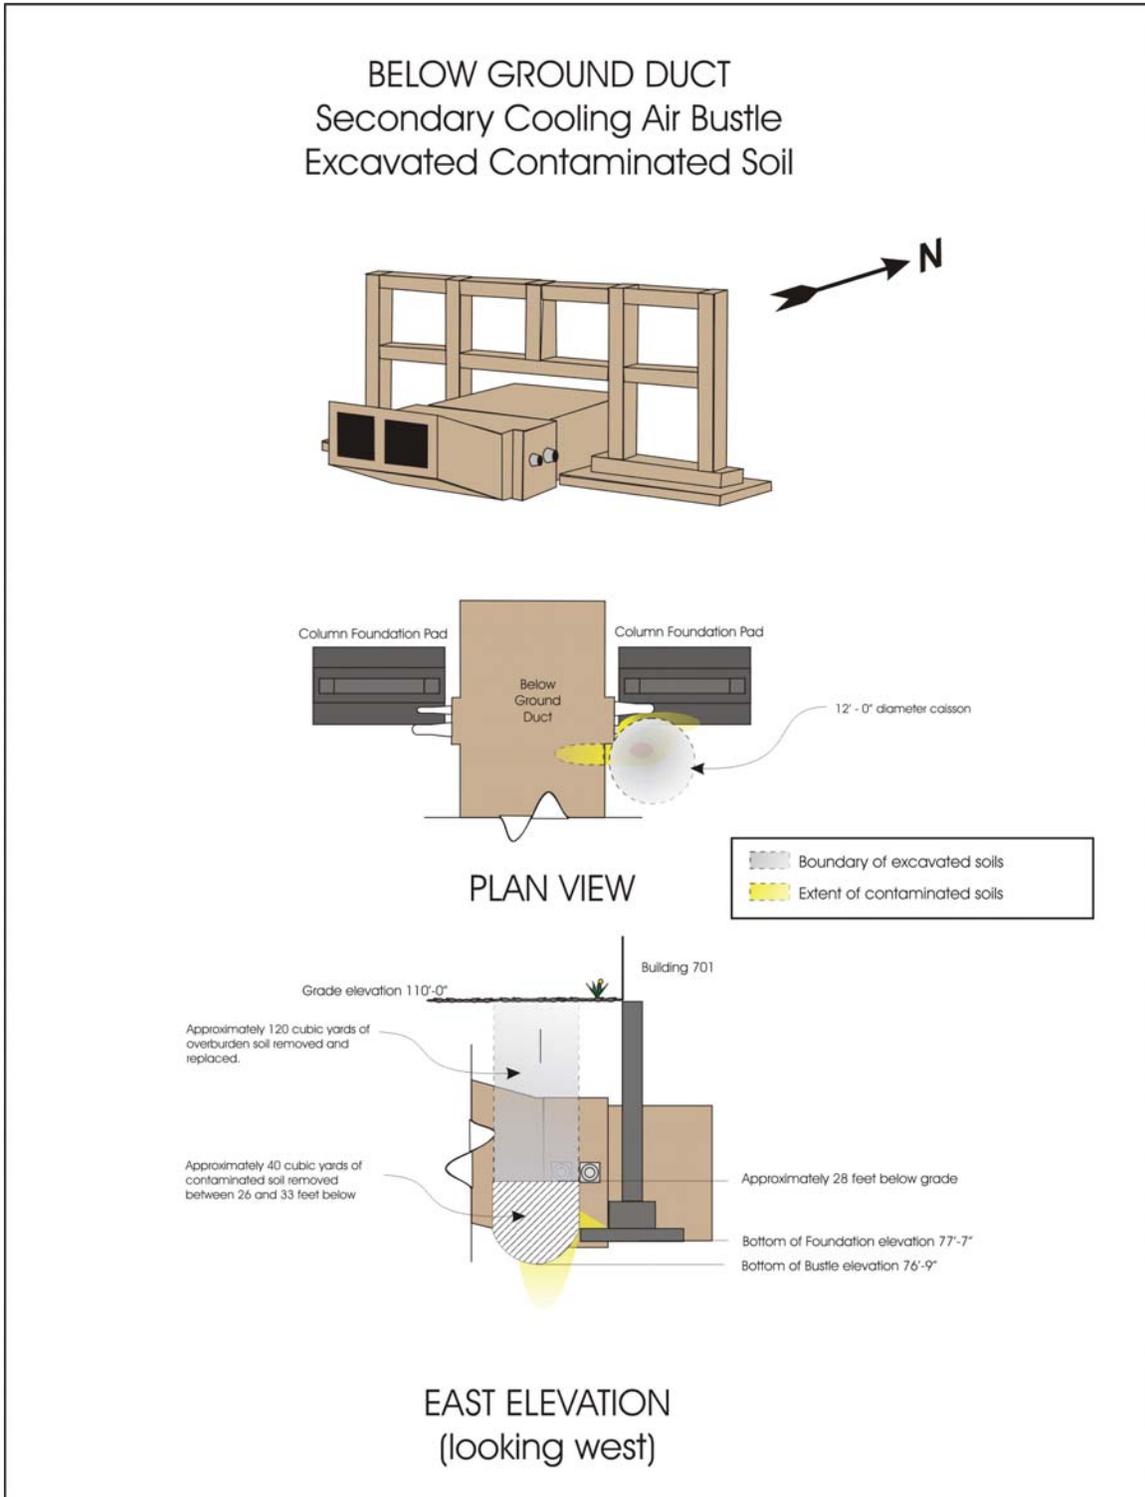
**Figure 5. BGD Secondary Air Bustle  
Excavated Contaminated Soil**

BGD Secondary Air Bustle Soil Pocket - The soil pocket located at the south bustle of the north below ground duct was located between 27 and 33 feet below grade. Prior to commencement of this work, an Excavation Plan was developed by a Professional Engineer to ensure safe work execution and to establish accurate soil and debris excavation volumes. To access and excavate this soil pocket a 12-foot diameter caisson was centered over the location of the pocket. Using a crane and clamshell bucket, the soil from inside the caisson was removed, allowing the caisson to advance downward. The soil that was excavated between grade elevation and 26 feet below grade was separated into 30 cubic yard stockpiles for reuse as clean overburden; each of the overburden stockpiles was surveyed to confirm that reuse criteria was met. Soil that was excavated below 26 feet below grade was loaded into waste containers as it was removed. Once the target depth of 33 feet below grade was reached, soil samples were obtained to document the “as-left” condition. No residual contamination was detected at Secondary Air Bustle. Appendix 1 documents all “as-left” soil sample results.

In summary, 120 cubic yards of overburden soil was excavated and re-used as backfill in the BGD secondary air bustle location of soil contamination. A total of 40 cubic yards of contaminated soil was excavated and disposed of. Figure 5 provides a graphic illustration of the secondary air bustle evacuated contaminated soil pocket.

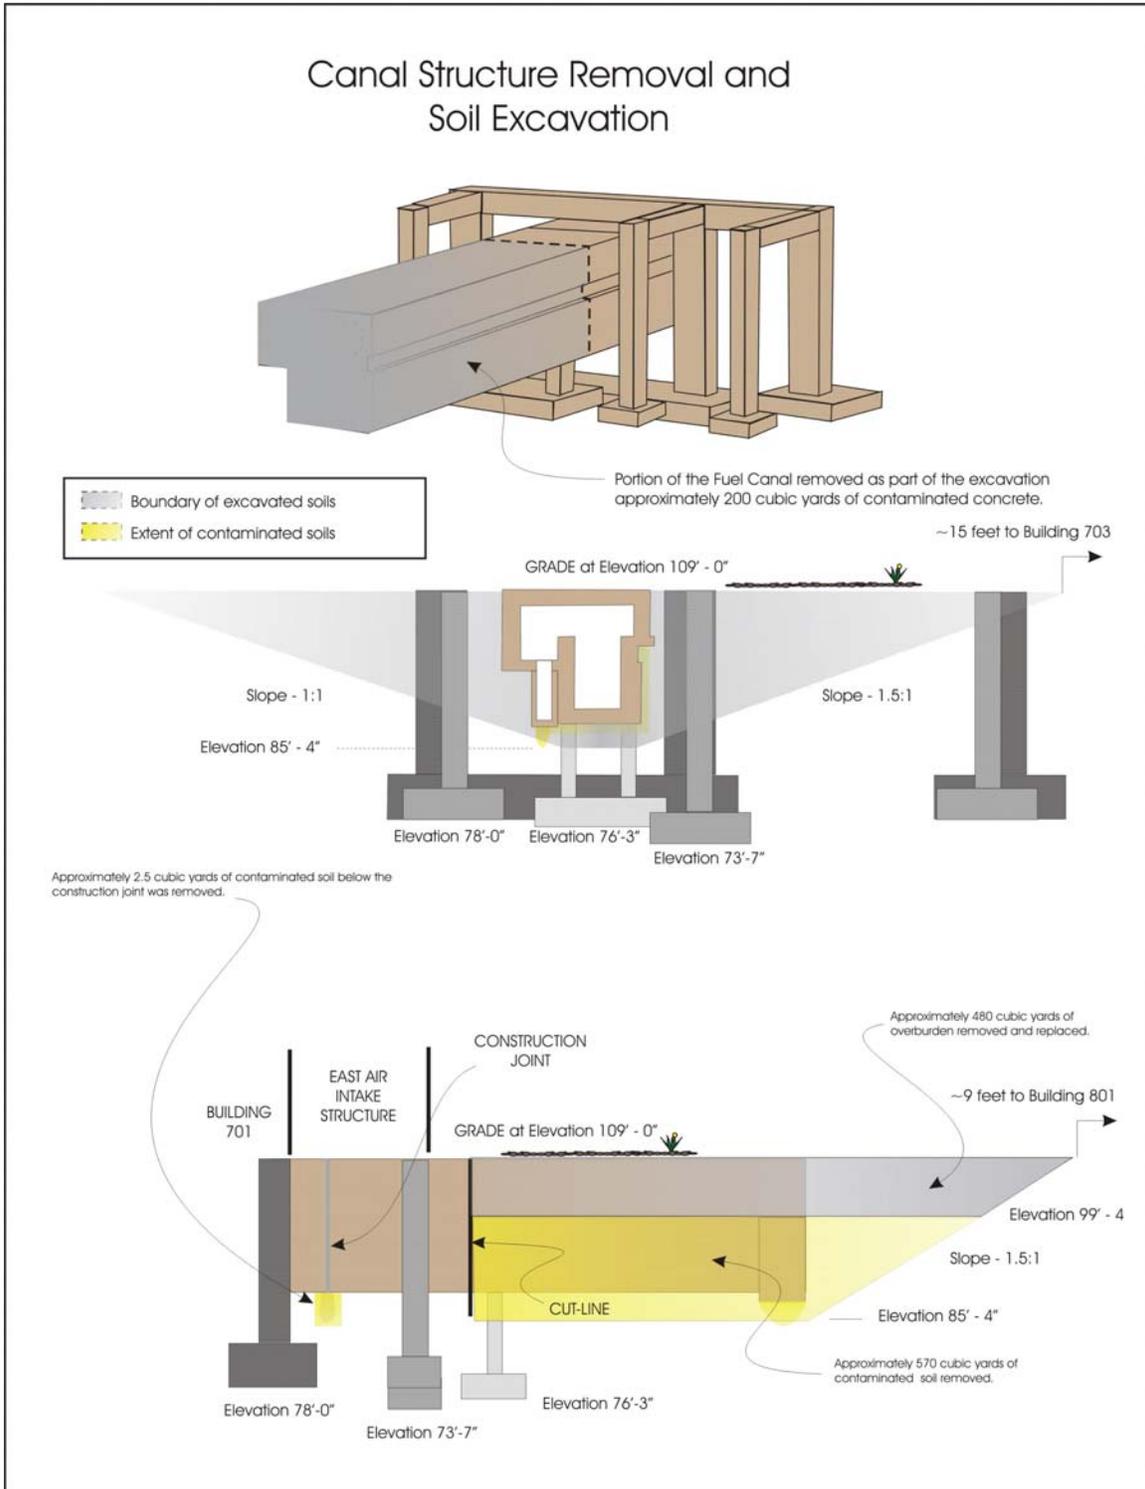
**Figure 6. Canal Structure Removal and Soil Excavation**

Canal Excavation and Removal - An excavation plan for the excavation and removal of the canal was developed by a Professional Engineer. As part of the approved Excavation Plan, a new 20-inch thick reinforced concrete isolation wall was installed immediately adjacent to the point where the canal was to be cut for removal. Once the new wall concrete had cured and the concrete tested to verify strength requirements, soil excavation began. Soil from grade down to 10 feet below grade was assumed to be radiologically clean since previous soil removal had been done in most of the area. This clean overburden soil was separated into 30 cubic yard stockpiles for reuse as clean overburden; each of the overburden stockpiles was surveyed for radiological contaminants to confirm that reuse criteria was met. Once the excavation reached 10 feet below grade, demolition of the canal concrete structure commenced in conjunction with excavation of contaminated soil. The canal concrete structure was rubbled in place using an impact hammer fitted to a long-reach excavating machine. Once the concrete was rubbled, a second long reach excavator was used to excavate the concrete, which was mixed with soil, directly into the shipping containers. Throughout the excavation and demolition process, dust control measures such as application of fixative and water misting were employed. These measures, along with continuous air monitoring, assured that there was no release of airborne radiological contaminants. Excavation of the canal area was limited to four feet below the bottom of the canal structure (elevation 85' - 4"). The excavation was limited to this depth to prevent the natural fallback of the Type C soil

Canal Walkway Sump Soil Pocket – Once the canal structure was removed, the contaminated soil in this area was accessible. Approximately two cubic yards of contaminated soil was removed in this area between elevations 89’ - 4” and 85’ - 4”.

In summary, approximately 480 cubic yards of overburden soil was excavated and re-used as backfill in the canal excavation. Approximately 770 cubic yards of contaminated soil, concrete, and steel debris associated with the BGRR canal and canal walkway sump was excavated and disposed of. Table 1 provides a comparison of soil and concrete expected to be removed to the actual volume of soil and concrete removed. Figure 6 provides a graphic illustration of the canal structure removal and soil excavation.

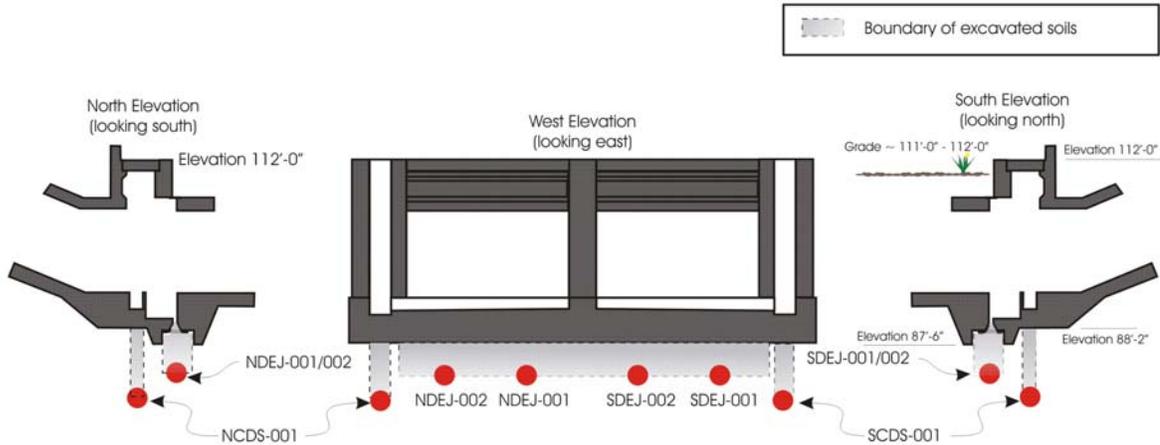
### Cooler Drain Sumps and Expansion Joint #4 Excavation "As-Left" Soil Sample Results

Exp. Joint #4 & Cooler Drain Sumps		Co-60		Cs-137		Am-241		Sr-90	
Sample ID#	Sample Mass (g)	Result (pCi/g)	MDA	Result (pCi/g)	MDA	Result (pCi/g)	MDA	Result (pCi/g)	MDA
SCDS-001	1,508	ND	0.2	7.7 +/- 1.2	0.2	ND	0.5	0.2 +/- 0.4	0.7
SDEJ-001	1,564	ND	1.2	4838 +/- 620	5.9	ND	9.6	676 +/- 15	0.7
SDEJ-002	1,610	ND	0.7	3266 +/- 419	4.2	ND	7.7	301 +/- 7.0	0.7
NDDS-001	1,531	ND	0.3	944 +/- 122	1.8	ND	4.4	7.4 +/- 0.5	0.7
NDEJ-001	1,560	ND	0.3	264 +/- 3.9	0.4	ND	0.8	100 +/- 2.5	0.7
NDEJ-002	1,568	ND	1.6	5907 +/- 757	6.8	ND	10.2	291 +/- 6.8	0.7

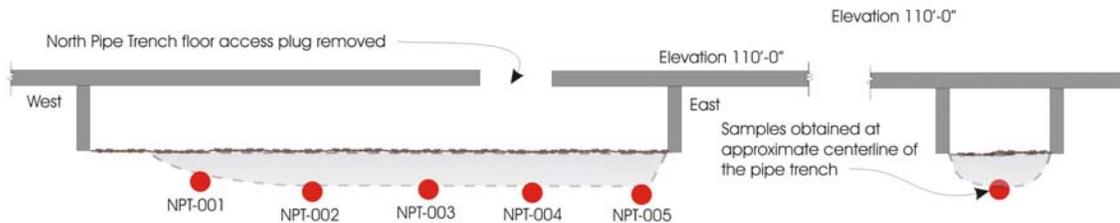
### Reactor Building North Pipe Trench Excavation "As-Left" Soil Sample Results

North Pipe Trench		Co-60		Cs-137		Am-241		Sr-90	
Sample ID#	Sample Mass (g)	Result (pCi/g)	MDA						
NPT-001	1,552	ND	0.2	9.3 +/- 1.5	0.3	ND	0.6	15.8 +/- 0.3	0.8
NPT-002	1,692	ND	0.2	ND	0.2	ND	0.3	0.2 +/- 0.5	0.8
NPT-003	1,651	ND	0.2	ND	0.2	ND	0.3	0.2 +/- 0.5	0.8
NPT-004	1,630	ND	0.2	0.3 +/- 0.1	0.2	ND	0.4	2.0 +/- 0.5	0.8
NPT-005	1,603	ND	0.2	10.9 +/- 1.5	0.2	ND	0.5	1.1 +/- 0.5	0.8

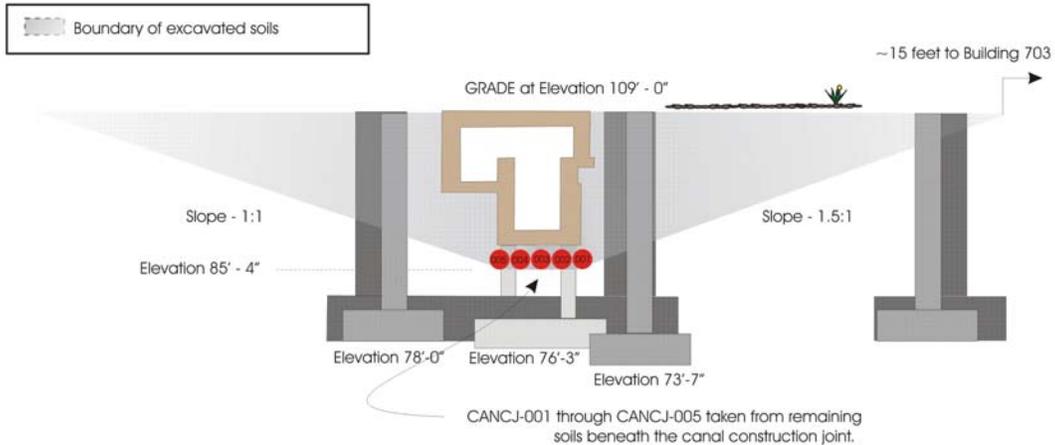
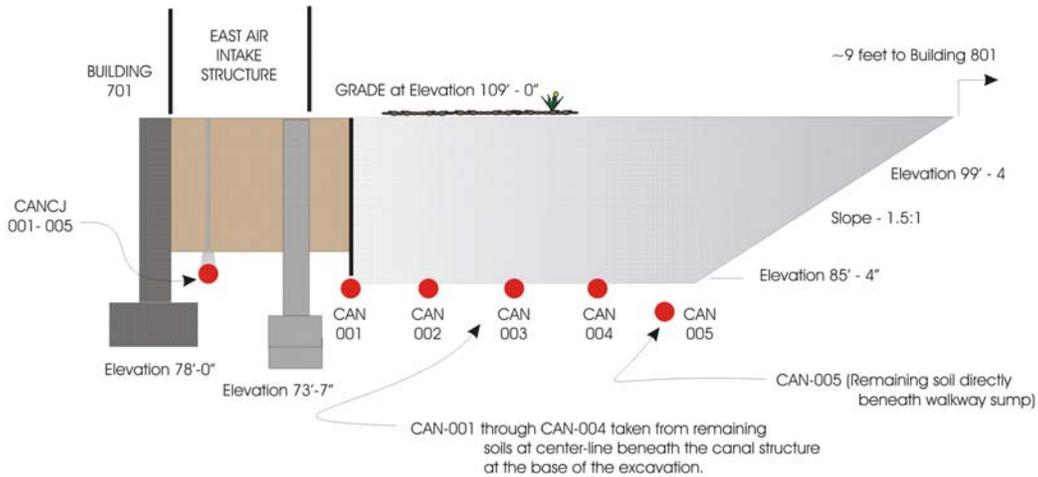
## Canal Structure Removal and Soil Excavation "As-Left" Soil Sample Results

Canal Construction Joint		Co-60		Cs-137		Am-241		Sr-90	
Sample ID#	Sample Mass (g)	Result (pCi/g)	MDA	Result (pCi/g)	MDA	Result (pCi/g)	MDA	Result (pCi/g)	MDA
CAN CJ-001	1,585	ND	0.2	ND	0.2	ND	0.3	0.4 +/- 0.3	0.8
CAN CJ-002	1,640	ND	0.1	ND	0.2	ND	0.4	0.4 +/- 0.3	0.8
CAN CJ-003	1,671	ND	0.2	ND	0.2	ND	0.3	0.4 +/- 0.3	0.8
CAN CJ-004	1,664	ND	0.2	ND	0.3	ND	0.4	0.3 +/- 0.3	0.8
CAN CJ-005	1,651	ND	0.2	ND	0.3	ND <td 0.3	0.4 +/- 0.3	0.8

Canal Excavation	Co-60		Cs-137		Am-241		Sr-90	
Sample Mass (g)	Result (pCi/g)	MDA						
1,758	ND	0.3	46.4 +/- 4.2	0.5	ND	0.7	54.3 +/- 1.5	0.7
1,447	ND	0.2	1.1 +/- 0.6	0.2	ND	0.2	0.4 +/- 0.4	0.7
1,367	ND	0.2	3.5 +/- 0.5	0.2	ND	0.3	14.3 +/- 0.6	0.7
1,420	ND	0.2	2.5 +/- 0.4	0.2	ND	0.3	1.8 +/- 0.4	0.7
1,451	5.2 +/- 0.5	0.3	269 +/- 23.6	1.0	ND	1.9	33.5 +/- 1.0	0.7

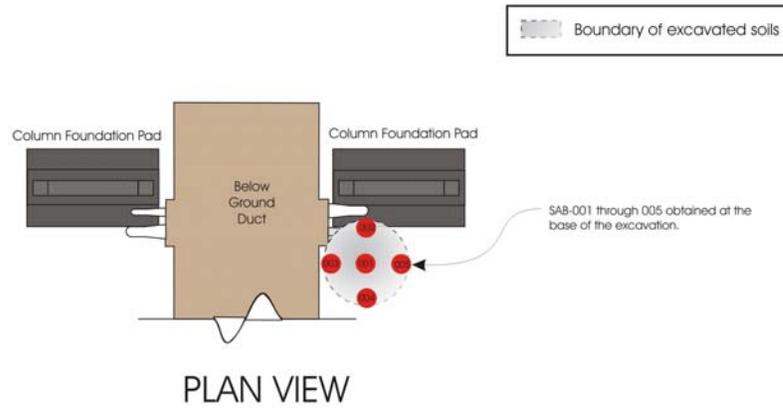
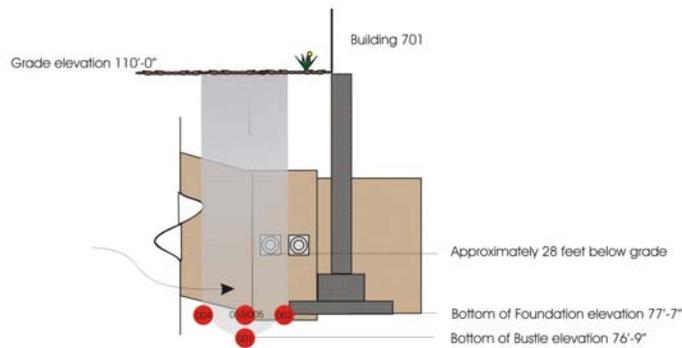
## Secondary Cooling Air Bustle Soil Excavation "As-Left" Soil Sample Results

Secondary Cooling Air Bustle		Co-60		Cs-137		Am-241		Sr-90	
Sample ID#	Sample Mass (g)	Result (pCi/g)	MDA						
SAB-001	1,215	ND	0.1	ND	0.2	ND	0.3	0.2 +/- 0.4	0.7
SAB-002	1,277	ND	0.3	ND	0.3	ND	0.4	0.3 +/- 0.4	0.7
SAB-003	1,199	ND	0.2	ND	0.2	ND	0.3	0.2 +/- 0.4	0.7
SAB-004	1,191	ND	0.2	ND	0.2	ND	0.3	0.2 +/- 0.4	0.7
SAB-005	1,176	ND	0.2	ND	0.2	ND	0.3	0.1 +/- 0.4	0.7

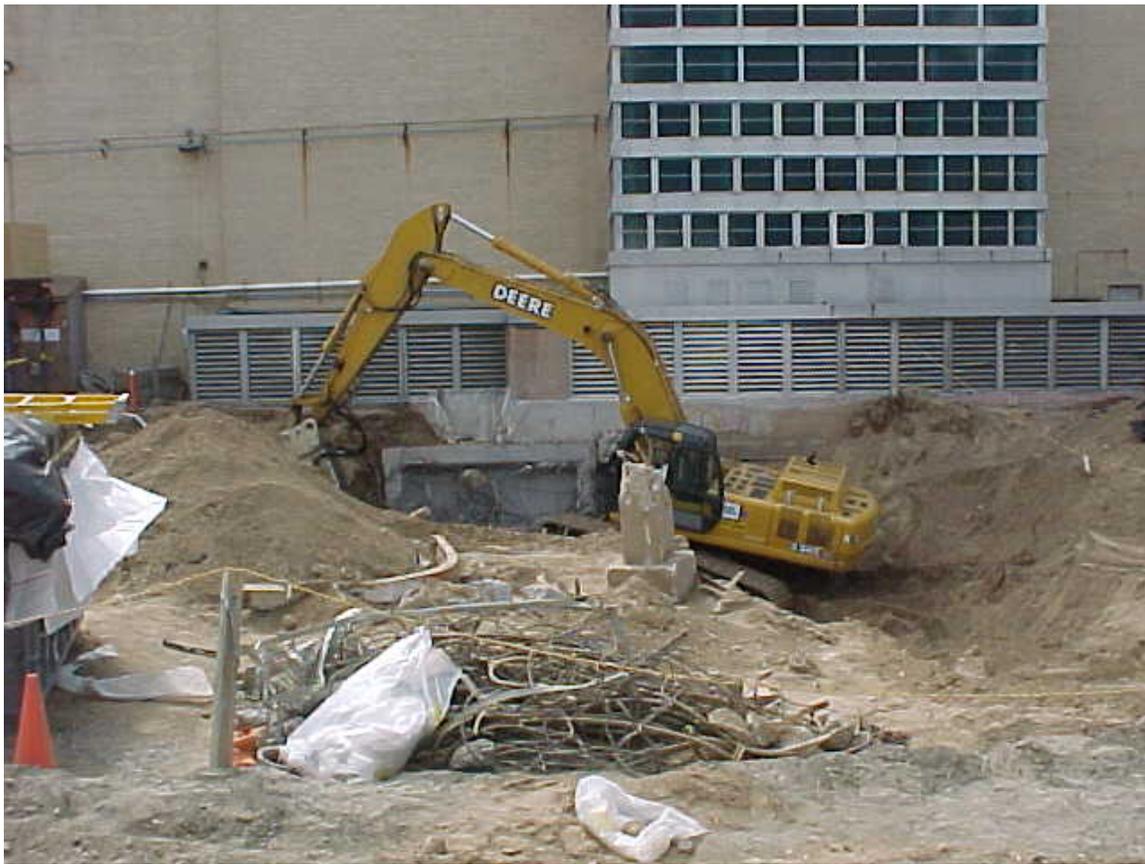
Canal excavation and demolition in progress. In the foreground is the steel rebar from the concrete. At center photo, part of a concrete buttress can be seen. In the background, the top of the canal can be seen at the cut line. The John Deere excavator is being used to demolish the sough canal wall at this time.

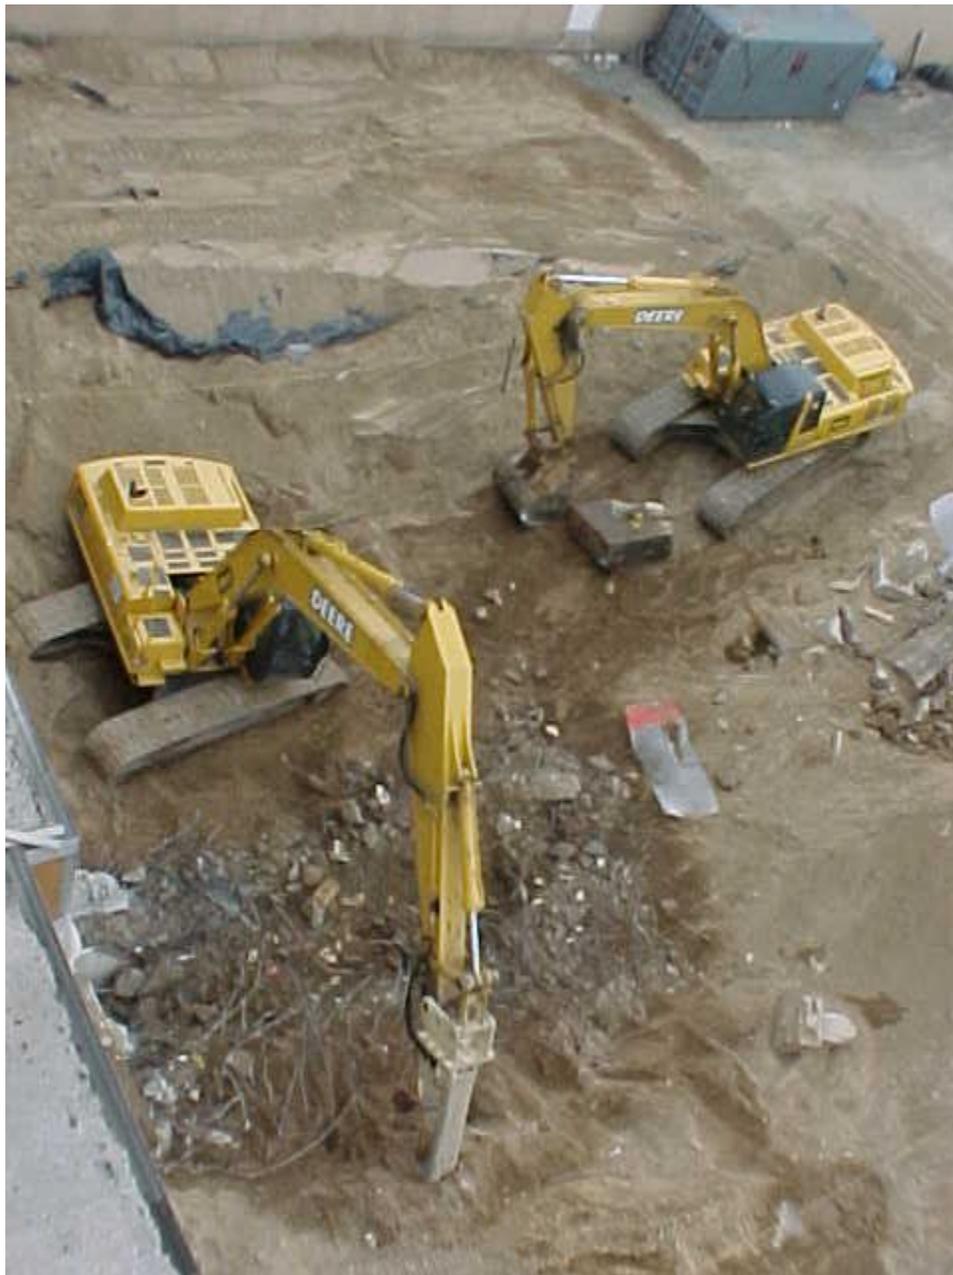
Canal excavation and demolition in progress. Here, one John Deere excavator is being used to demolish the south canal wall while the other is excavation soil.

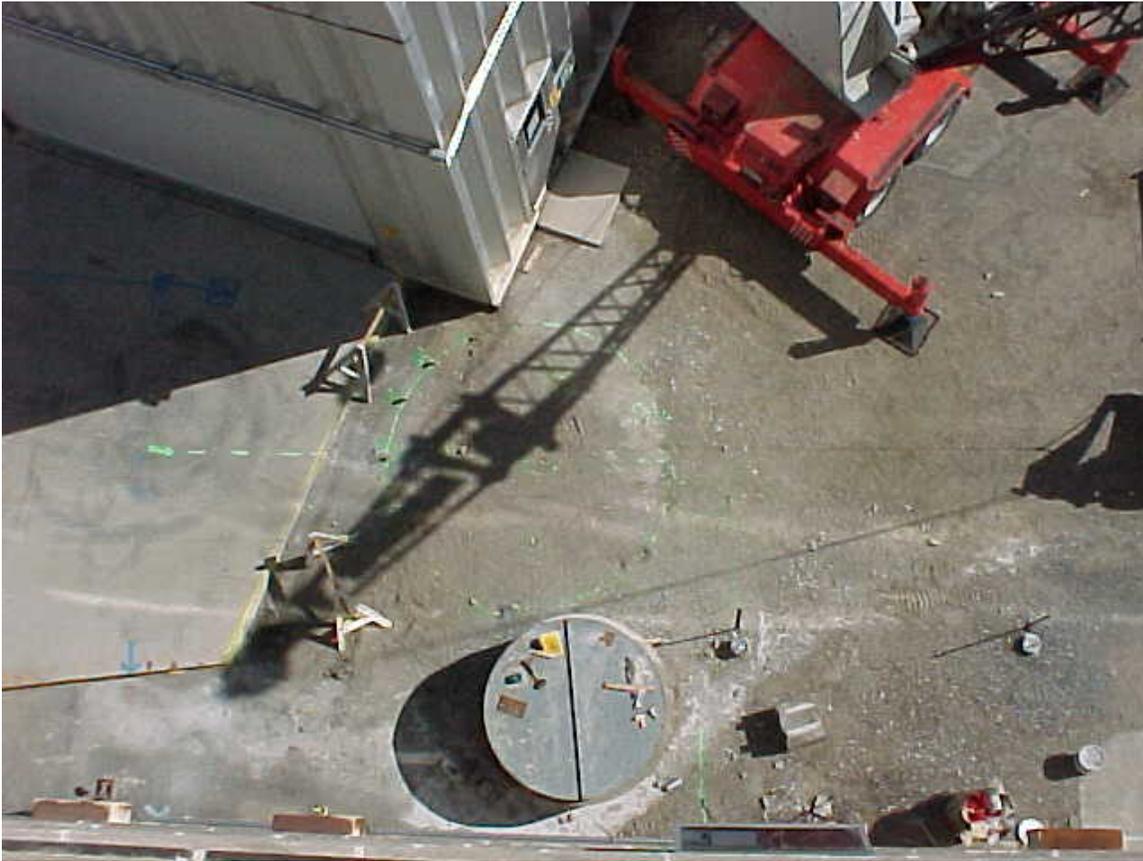
View looking down on the caisson that was used to access the below ground duct bustle soil pocket. The location of the contaminated soil pocket that was located between 27 feet and 30 feet below grade.

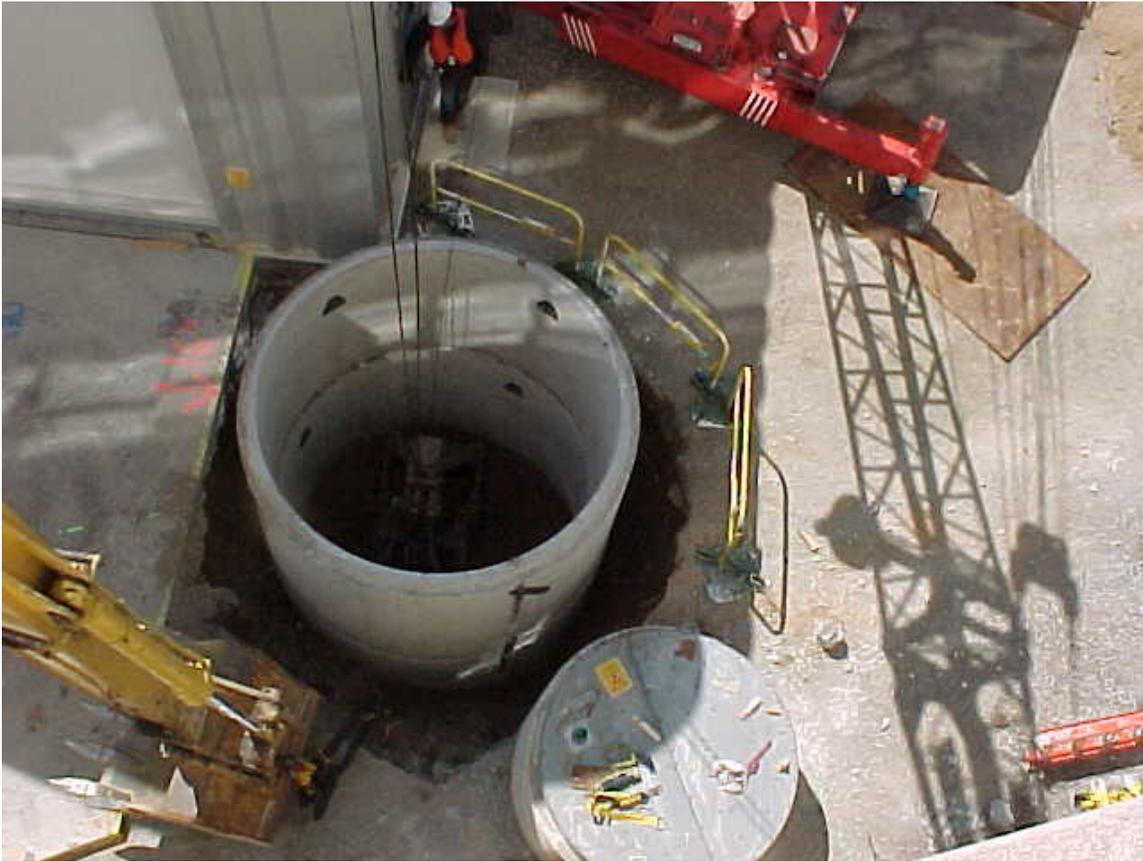
View looking down into the caissons at the below ground duct bustle soil pocket. The excavation process involved removal of soil from within the caisson, and as the soil was removed, the caissons advanced downward. Additional caissons were added as the depth increased.

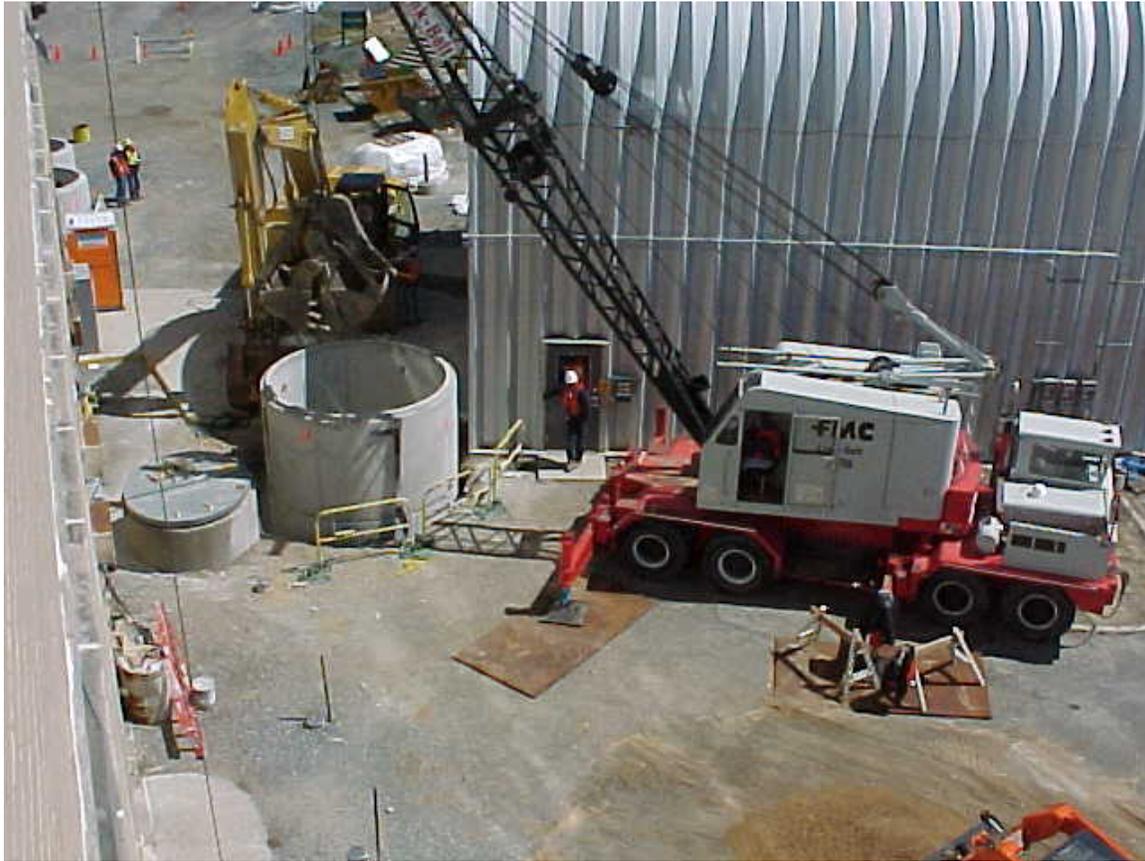
Installation of the third of four concrete caissons at the below ground duct bustle soil pocket.

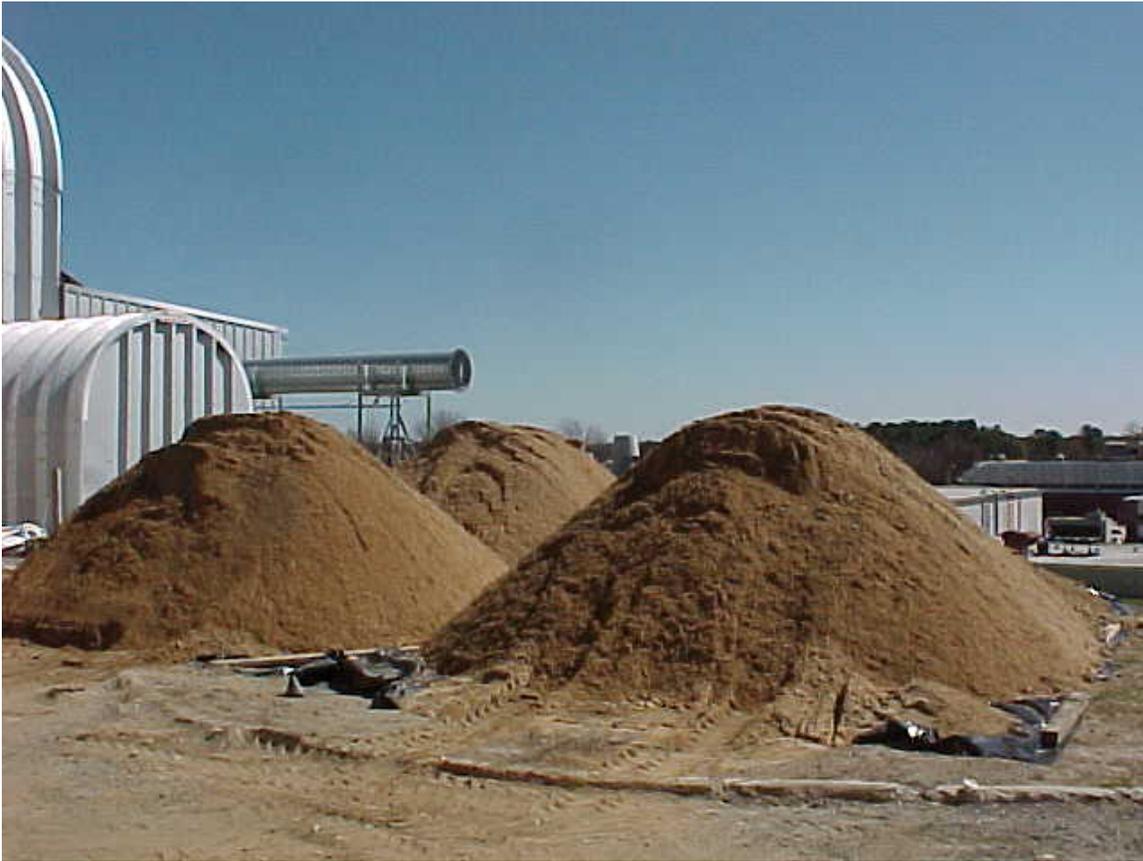
View of the clean overburden soil that was removed from the below ground bustle area above the known location of the contaminated soils that were located between 27' and 33' below grade.

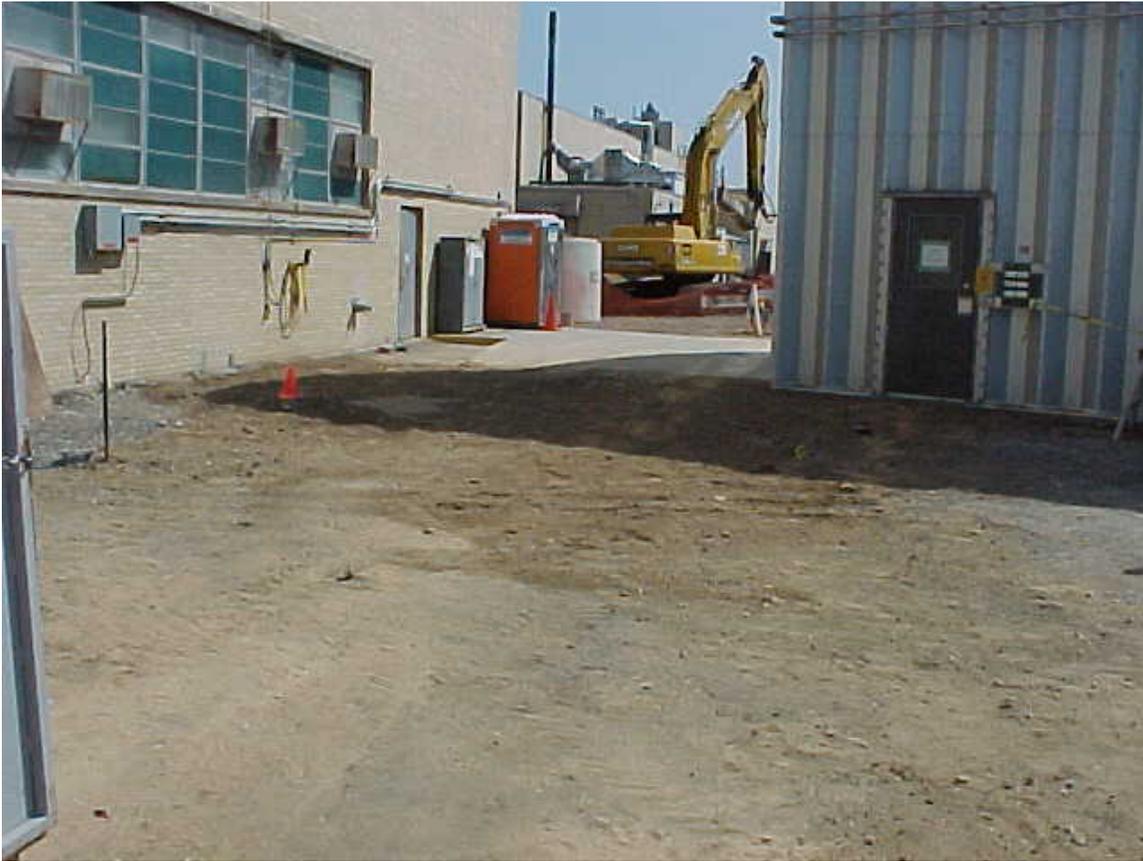
View of the area of the soil pocket removal at the below ground duct bustle after backfill and initial compaction.

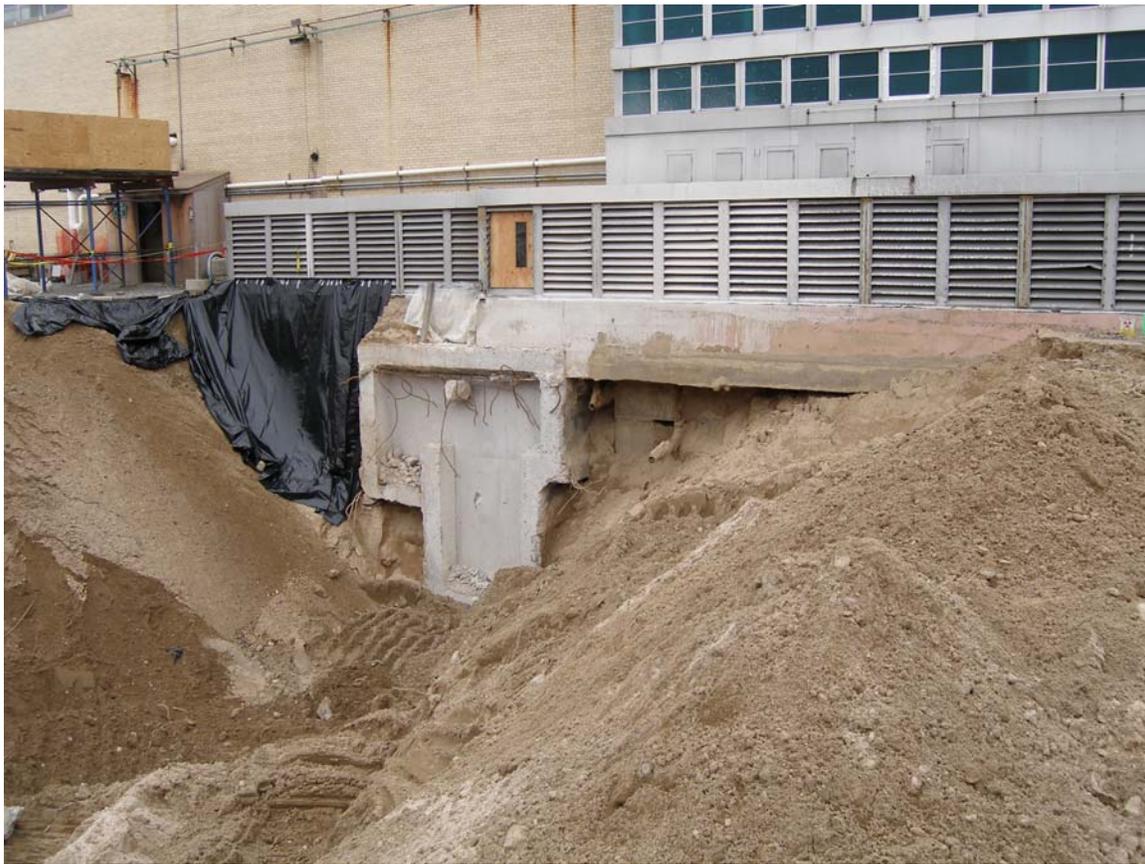
View of the 20" thick reinforced concrete wall constructed at the canal removal point. The cut line of the canal structure is located 4'-3" east of Building 701 column 101. Floor and roof drain lines that had been previously cut and abandoned can be seen hanging beneath the floor of the east intake structure.

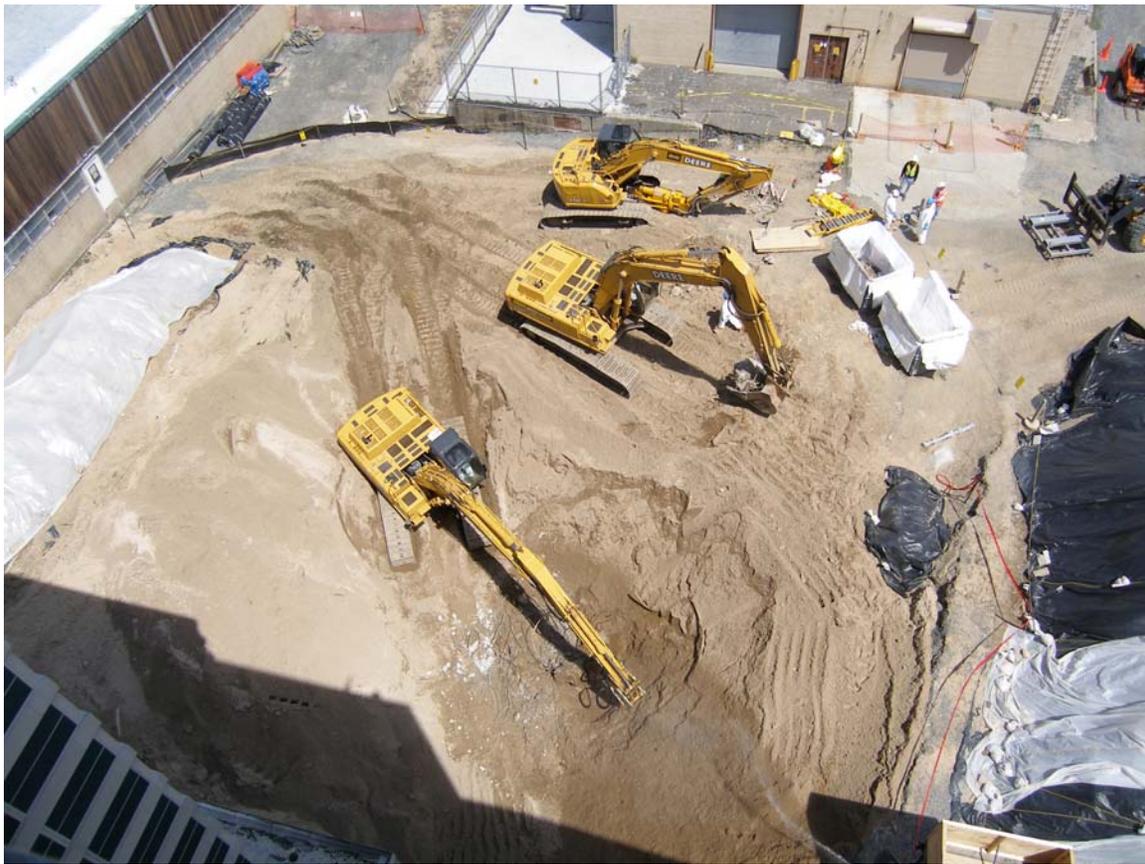
A view looking down on the canal excavation and demolition nearing its end. The John Deere excavator at the lower part of this picture is being used to demolish the canal walkway sump into smaller pieces that meet the Envirocare acceptance criteria. At the top of this picture, the forklift is carrying a MHF Waste Liner® to the staging area. Two empty liners can be seen staged and ready for filling.

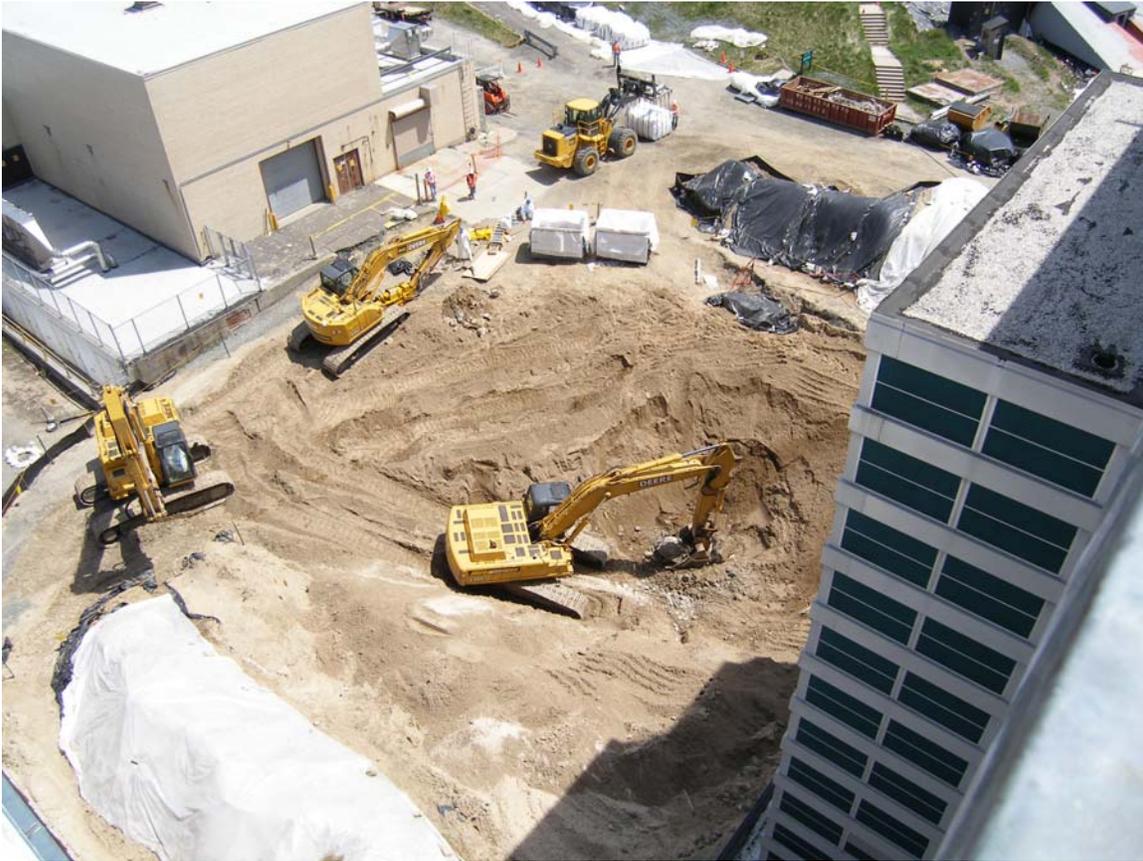
Canal excavation and demolition nearing its end. The John Deere excavator is being used to excavate the last remaining concrete debris and soil. At the top of this picture, the forklift is carrying a MHF Waste Liner® to the staging area. Two empty liners can be seen staged and ready for filling.

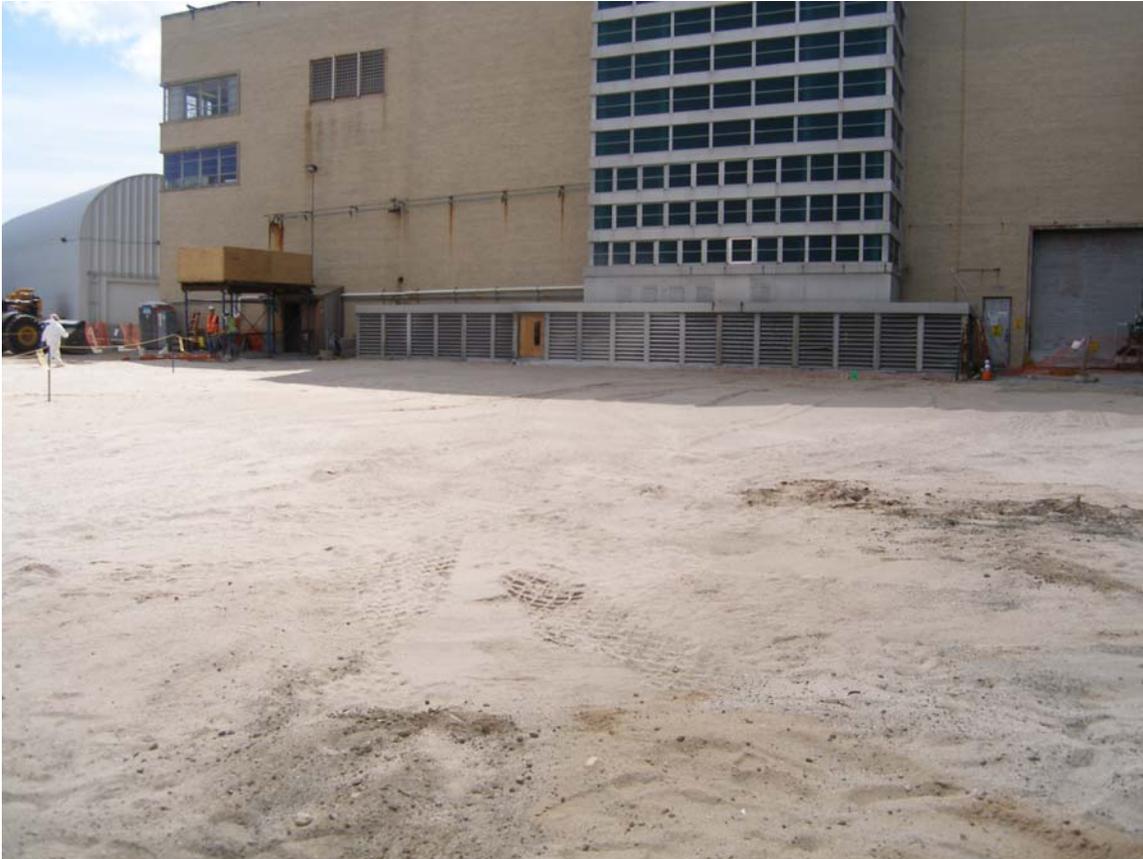
View of the canal excavated area after backfill and compaction to the pre-existing grade.

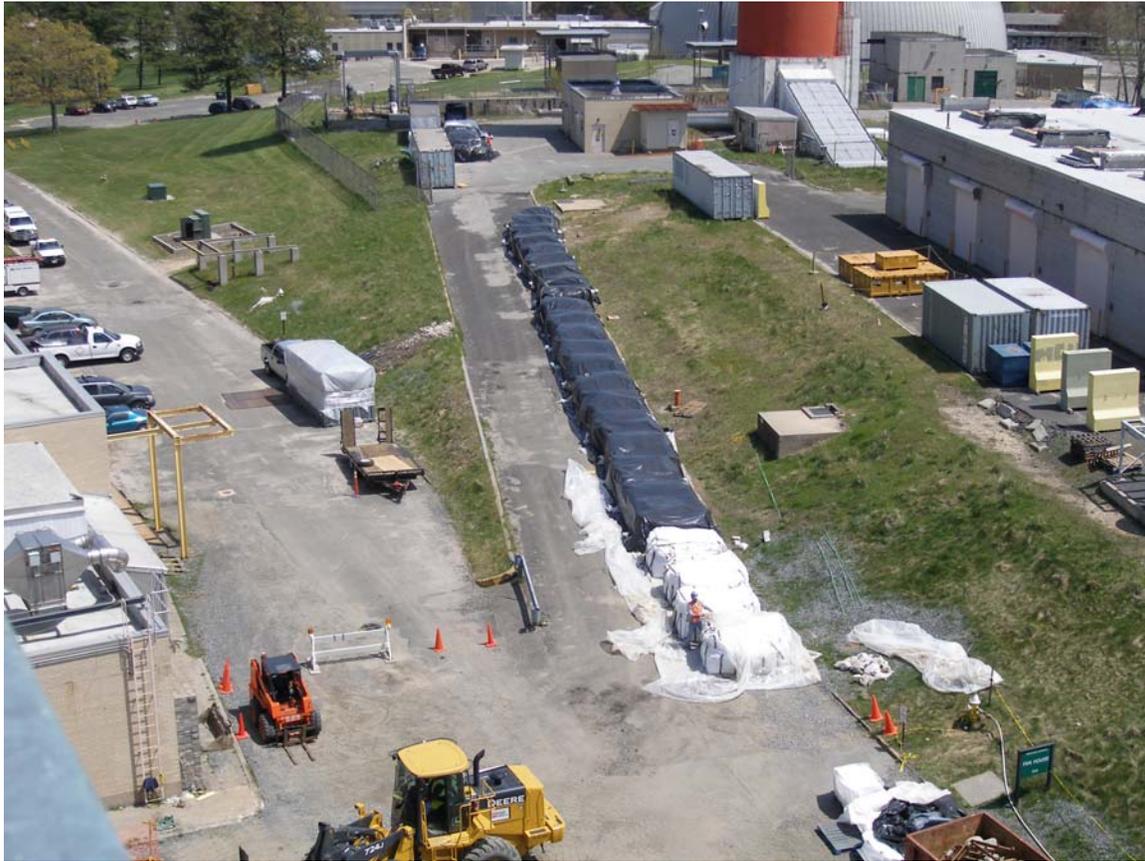
View from the roof of building 701 showing filled waste containers ready for transport to the rail siding for shipment to Envirocare of Utah.
