# **Brookhaven Graphite Research Reactor Decommissioning Project**

## **FINAL CANAL AND DEEP SOIL POCKETS EXCAVATION AND REMOVAL COMPLETION REPORT**

**August 22, 2005**

**BROOKHAVEN NATIONAL LABORATORY  
BROOKHAVEN SCIENCE ASSOCIATES  
Under Contract No. DE-AC02-98CH01886 with the  
UNITED STATES DEPARTMENT OF ENERGY**

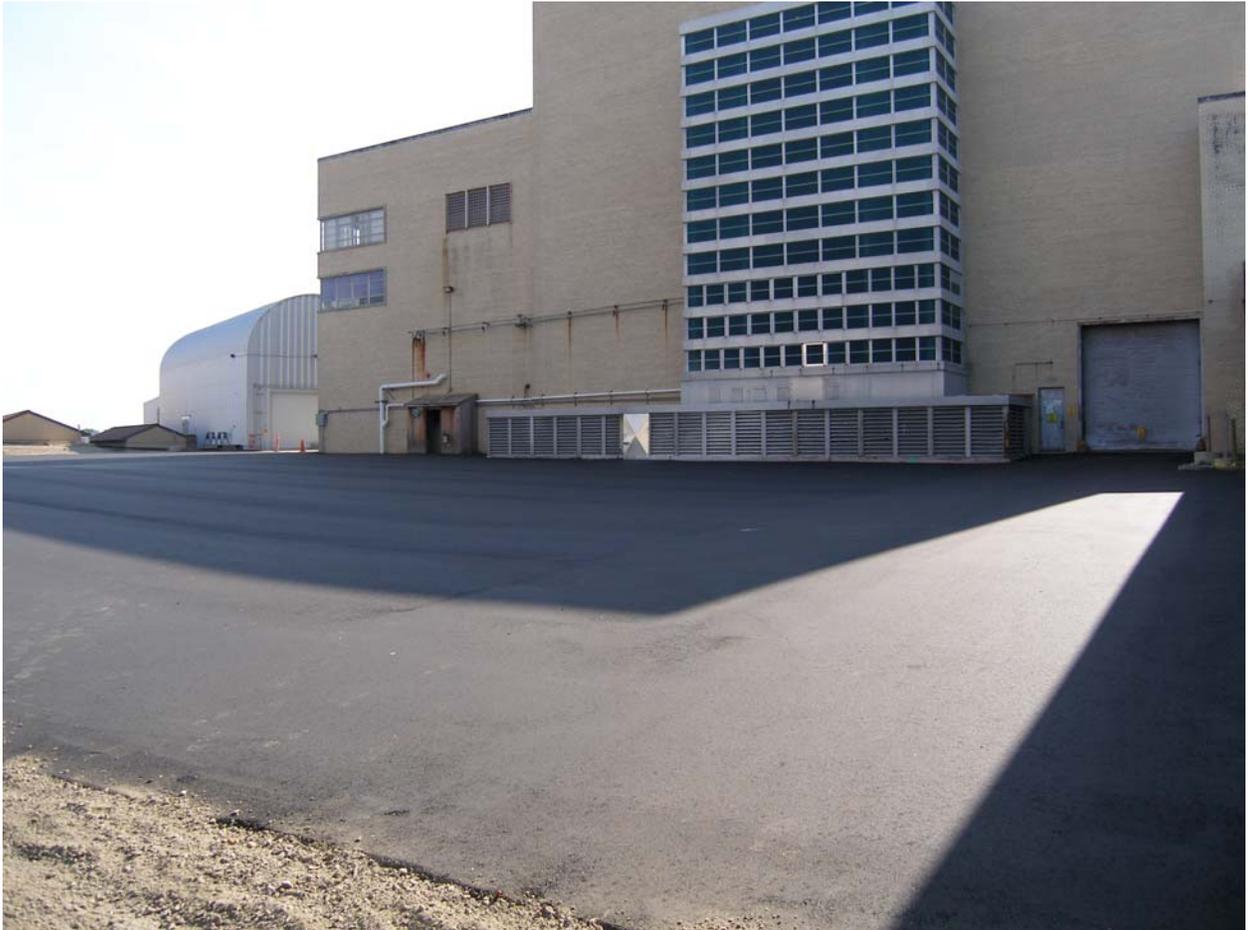
- View of the canal excavation area after placement of the temporary cap.

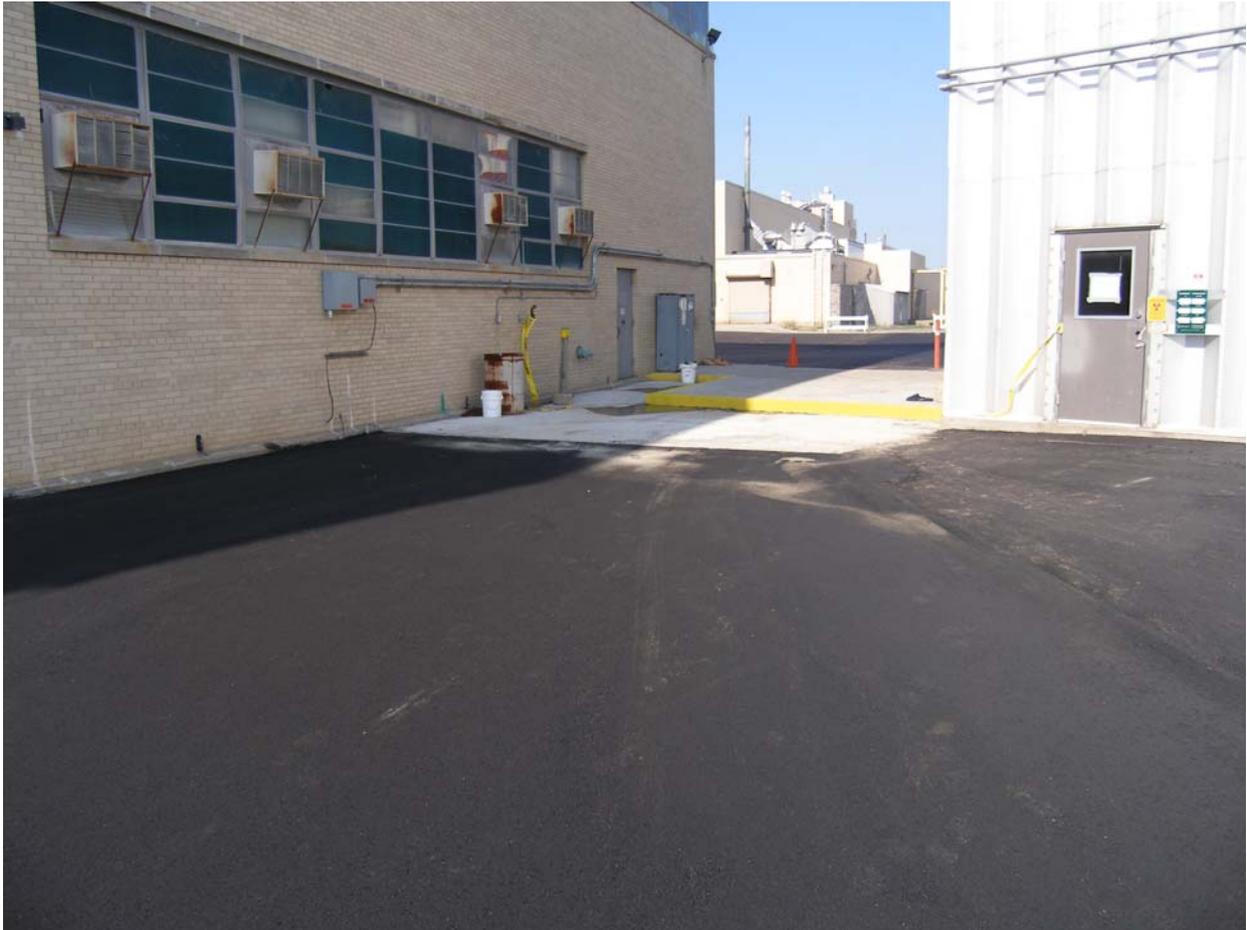
- View of the bustle excavation area after placement of the temporary cap.
