SITE WATER DISTRIBUTION ANALYSIS REPORT 2003

PREPARED BY MICHAEL KRETSCHMANN, PE

FIRE PROTECTION ENGINEERING GROUP

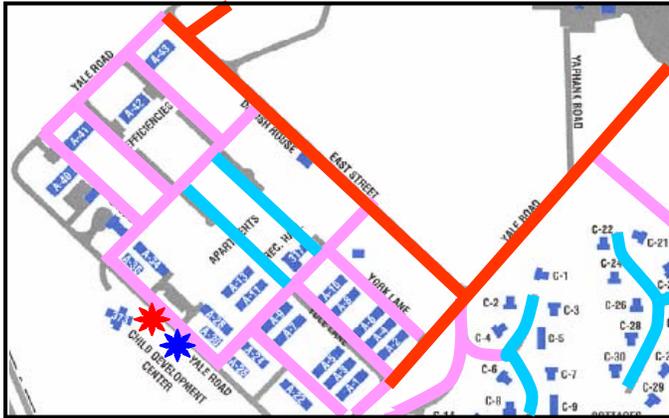
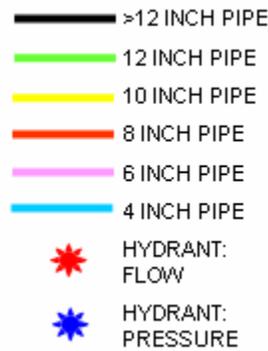
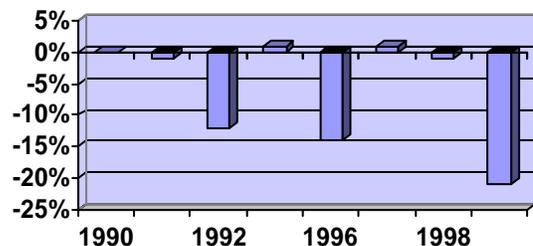
7.1 TEST POINT 1: APARTMENTS

MEFF 1,500 GPM	OCCUPANCY ORDINARY HAZARD	PIPING CONDITION POOR	FLOW CAPACITY POOR	PIPING NETWORK DEAD END
--------------------------	-------------------------------------	---------------------------------	------------------------------	-----------------------------------

The pressure hydrant was H003 and the flow hydrant H002. This test point is the most hydraulically remote from the supply wells and Water Treatment Facility. The nearest water supply source (300K Tank) is about 5,300 feet away. The local cross mains are less than 8 inch in size. The piping in this area has not been altered since the first relevant flow test in 1990 and is over 60 years old. The piping is a mixture of Cast Iron & Transite Cement Lined piping. The local mains are connected to an 8 inch loop supplied by a 12 inch feed along Upton Ave and two six inch feeds.

Occupancy is rated "Ordinary Hazard" due to the densely populated wood frame construction buildings.

Piping Condition is rated "Poor" since the flow trend is losing capacity at roughly 5% over the last 13 years.

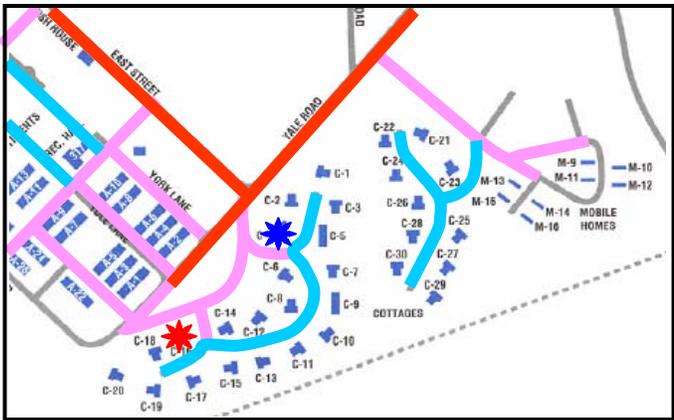
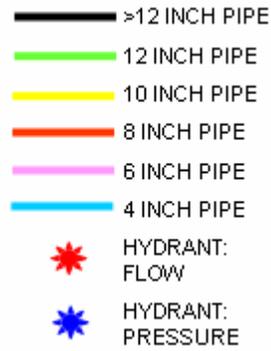
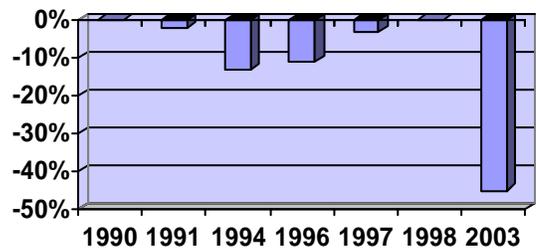
7.2 TEST POINT 2: COTTAGES

MEFF 1,500 GPM	OCCUPANCY ORDINARY HAZARD	PIPING CONDITION POOR	FLOW CAPACITY POOR	PIPING NETWORK DEADEND
--------------------------	-------------------------------------	---------------------------------	------------------------------	----------------------------------

SUMMARY TABLE	OVERALL	10 YEAR	5 YEAR
STATIC PRESSURE AVERAGE	59.3 PSI	59.0 PSI	61.0 PSI
FLOW AVERAGE @ 20 PSI	1127 GPM	1054 GPM	711 GPM
FLOW CHANGE FROM OVERALL	-	-6.9%	-58.6%

The pressure hydrant was H181 and the flow hydrant H191. The nearest water supply source (300K Tank) is about 4,800 feet away. The local cross mains are less than 8 inch in size. The local mains are connected to an 8 inch loop. The piping in this area has not been altered since the first relevant flow test in 1990 and is over 60 years old. The piping is a mixture of Cast Iron and Transite Cement Lined piping.

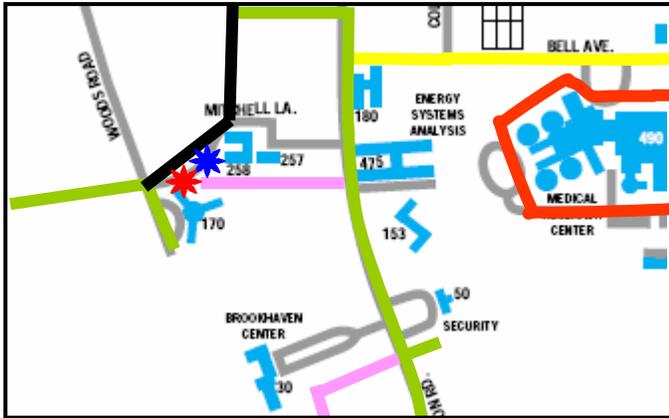
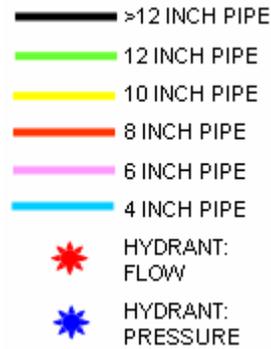
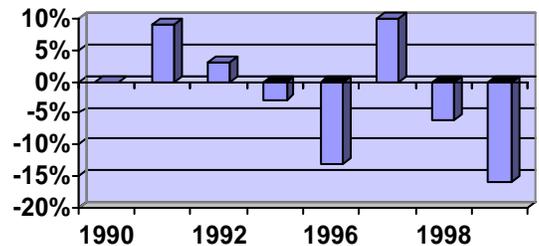
7.3 TEST POINT 3: GUEST HOUSE / CURIE- WOMEN'S RESIDENCE

MEFF 750 GPM	OCCUPANCY LOW HAZARD	PIPING CONDITION POOR	FLOW CAPACITY LIMITED	PIPING NETWORK DEAD END
------------------------	--------------------------------	---------------------------------	---------------------------------	-----------------------------------

SUMMARY TABLE	OVERALL	10 YEAR	5 YEAR
STATIC PRESSURE AVERAGE	54.8 PSI	54.6 PSI	55 PSI
FLOW AVERAGE @ 20 PSI	1329 GPM	1279 GPM	1206 GPM
FLOW CHANGE FROM OVERALL	-	-3.8%	-10.2%

The pressure hydrant was H059 and the flow hydrant H163. The nearest water supply source (300K Tank) is roughly 1,100 feet away. The local branch main is 6 inch in size. The local mains are connected to the 12 inch feed along Upton Ave. The piping in this area has not been altered since the first relevant flow test in 1990 and is over 60 years old. The piping is Transite Cement Lined piping

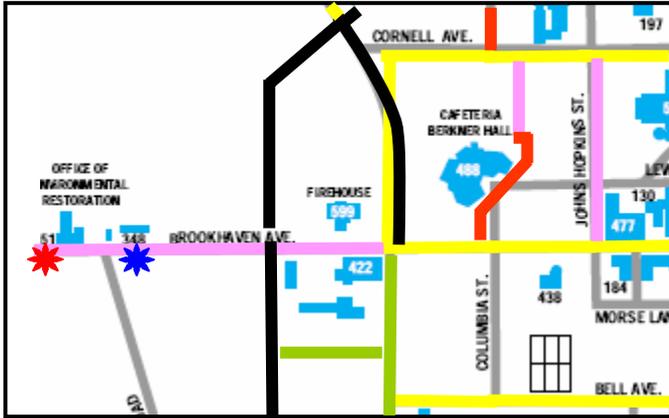
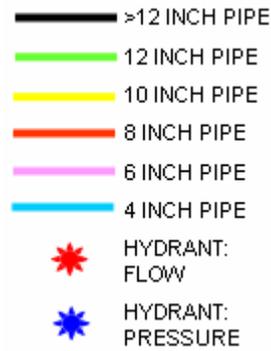
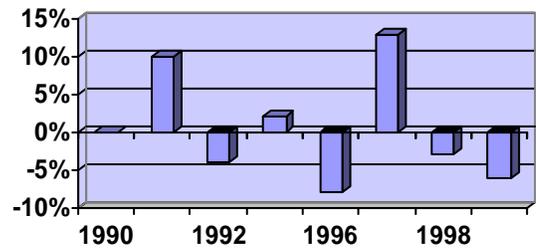
7.4 TEST POINT 4: WEST BROOKHAVEN AVENUE

MEFF 1,000 GPM	OCCUPANCY HIGH HAZARD	PIPING CONDITION POOR	FLOW CAPACITY POOR	PIPING NETWORK DEAD END
---------------------------	----------------------------------	----------------------------------	-------------------------------	------------------------------------

SUMMARY TABLE	OVERALL	10 YEAR	5 YEAR
STATIC PRESSURE AVERAGE	59.3 PSI	58.4 PSI	56.5 PSI
FLOW AVERAGE @ 20 PSI	1097 GPM	1087 GPM	1046 GPM
FLOW CHANGE FROM OVERALL	-	-0.9%	-4.9%

The pressure hydrant was H041 and the flow hydrant H042. The nearest water supply source (Water Treatment Facility) is roughly 1,200 feet away. The local branch main is 6 inch in size. The local main is connected to the 10 inch feed along Upton Ave. The piping in this area has not been altered since the first relevant flow test in 1990 and is over 60 years old. The piping is Transite Cement Lined piping

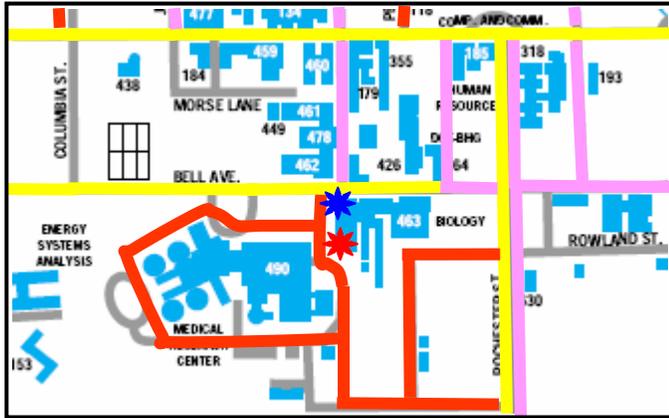
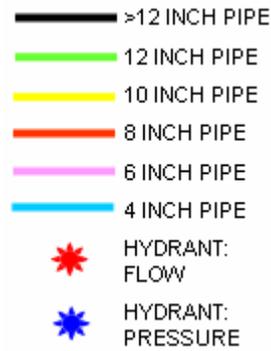
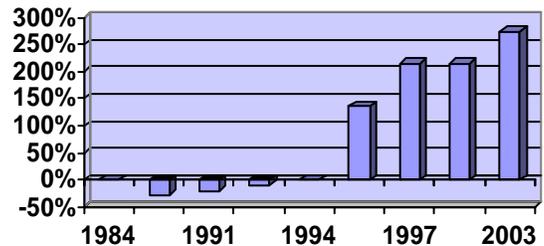
7.5 TEST POINT 5: BELL AVENUE

MEFF 1,000 GPM	OCCUPANCY HIGH HAZARD	PIPING CONDITION GOOD	FLOW CAPACITY GOOD	PIPING NETWORK MULTIPLE PATH
--------------------------	---------------------------------	---------------------------------	------------------------------	--

SUMMARY TABLE	OVERALL	10 YEAR	5 YEAR
STATIC PRESSURE AVERAGE	57.9 PSI	58.6 PSI	58.0 PSI
FLOW AVERAGE @ 20 PSI	3031 GPM	4336 GPM	5571 GPM
FLOW CHANGE FROM OVERALL	-	30.1%	45.6%

The pressure hydrant was H069 and the flow hydrant H068. The nearest water supply source (Water Treatment Facility) is about 2,200 feet away. The local mains are a combination of 8 and 10 inch grid piping and were replaced in the mid 1990's with Cement Lined Ductile Iron piping as part of the Bell Avenue project.

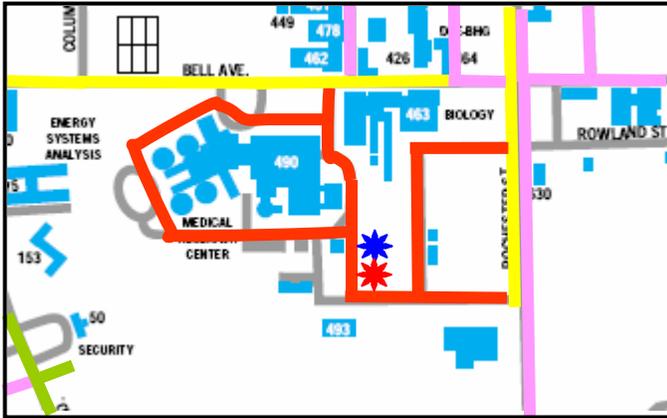
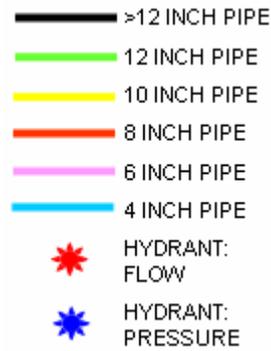
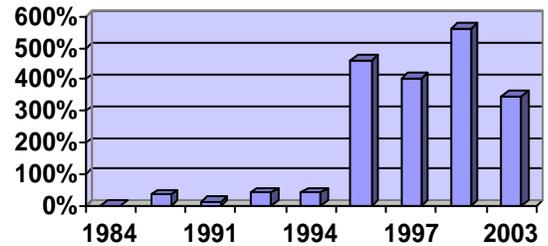
7.6 TEST POINT 6: AVERY STREET

MEFF 2,500 GPM	OCCUPANCY HIGH HAZARD	PIPING CONDITION GOOD	FLOW CAPACITY GOOD	PIPING NETWORK MULTIPLE PATH
--------------------------	---------------------------------	---------------------------------	------------------------------	--

SUMMARY TABLE	OVERALL	10 YEAR	5 YEAR
STATIC PRESSURE AVERAGE	54.5 PSI	55.4 PSI	55.0 PSI
FLOW AVERAGE @ 20 PSI	2242 GPM	3330 GPM	3981 GPM
FLOW CHANGE FROM OVERALL	-	32.7%	43.7%

The pressure hydrant was H067 and the flow hydrant H182. The nearest water supply source (Water Treatment Facility) is about 2,900 feet away. The local mains are 8 inch and were replaced in the mid 1990's with Cement Lined Ductile Iron piping as part of the Bell Avenue project.

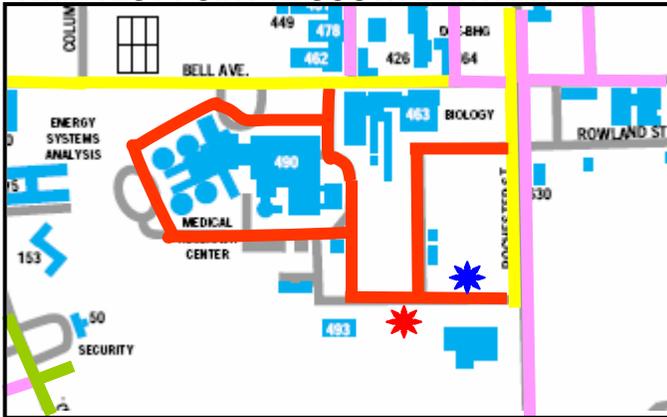
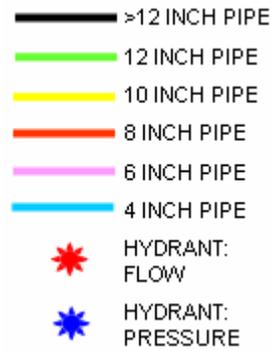
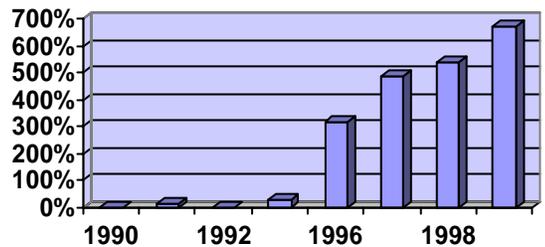
7.7 TEST POINT 7: SOUTH HARVARD

MEFF 1,000 GPM	OCCUPANCY LOW HAZARD	PIPING CONDITION GOOD	FLOW CAPACITY GOOD	PIPING NETWORK MULTIPLE PATH
--------------------------	--------------------------------	---------------------------------	------------------------------	--

SUMMARY TABLE	OVERALL	10 YEAR	5 YEAR
STATIC PRESSURE AVERAGE	62.3 PSI	61.0 PSI	61.0 PSI
FLOW AVERAGE @ 20 PSI	2523 GPM	3587 GPM	4971 GPM
FLOW CHANGE FROM OVERALL	-	29.7%	49.2%

The pressure hydrant was H090 and the flow hydrant H092. The nearest water supply source (Water Treatment Facility) is about 3,650 feet away. The local mains are 8 inch and were replaced in the mid 1990's with Cement Lined Ductile Iron piping as part of the Bell Avenue project.

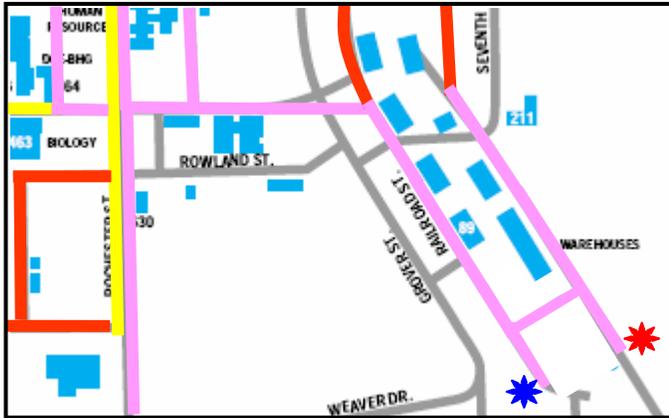
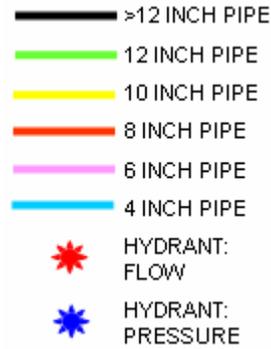
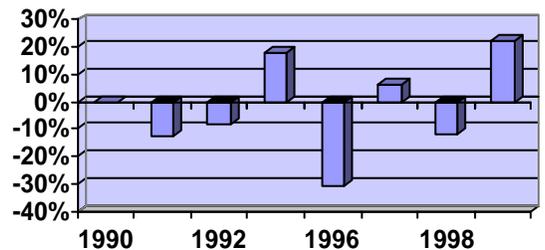
7.9 TEST POINT 9: WAREHOUSE AREA

MEFF 3,000 GPM	OCCUPANCY HIGH HAZARD	PIPING CONDITION GOOD	FLOW CAPACITY LIMITED	PIPING NETWORK MULTIPLE PATH
--------------------------	---------------------------------	---------------------------------	---------------------------------	--

SUMMARY TABLE	OVERALL	10 YEAR	5 YEAR
STATIC PRESSURE AVERAGE	69.0 PSI	68.0 PSI	68.5 PSI
FLOW AVERAGE @ 20 PSI	3076 GPM	3166 GPM	3307 GPM
FLOW CHANGE FROM OVERALL	-	2.8%	7.0%

The pressure hydrant was H183 and the flow hydrant H122. The nearest water supply source (Water Treatment Facility) is about 3,900 feet away. The local loop mains are 6 inch. The piping in this area has not been altered since the first relevant flow test in 1990 and is over 60 years old. The piping is Transite Cement Lined.

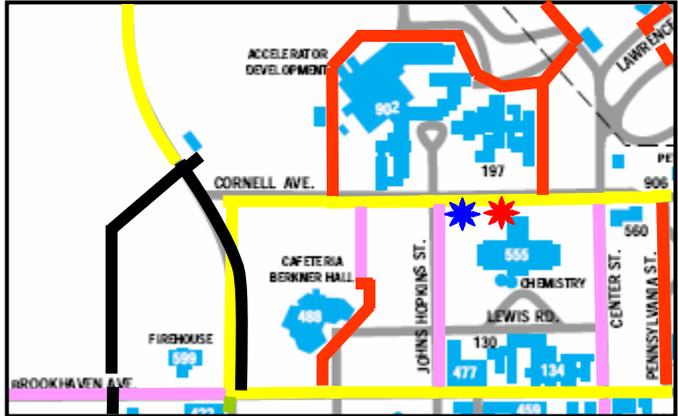
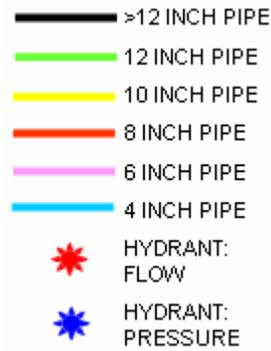
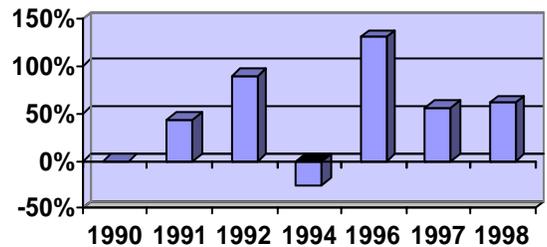
7.10 TEST POINT 10: WEST CORNELL AVENUE

MEFF 5,000 GPM	OCCUPANCY HIGH HAZARD	PIPING CONDITION GOOD	FLOW CAPACITY GOOD	PIPING NETWORK MULTIPLE PATH
--------------------------	---------------------------------	---------------------------------	------------------------------	--

SUMMARY TABLE	OVERALL	10 YEAR	5 YEAR
STATIC PRESSURE AVERAGE	54.9 PSI	55.3 PSI	52.0 PSI
FLOW AVERAGE @ 20 PSI	6489 GPM	6690 GPM	6947 GPM
FLOW CHANGE FROM OVERALL	-	3.0%	6.6%

The pressure hydrant was H055 and the flow hydrant H058. The nearest water supply source (Water Treatment Facility) is about 3,000 feet away. The local loop mains are 10 inch. The piping in this area has not been altered since the first relevant flow test in 1990 and is over 60 years old. The piping is Transite Cement Lined.

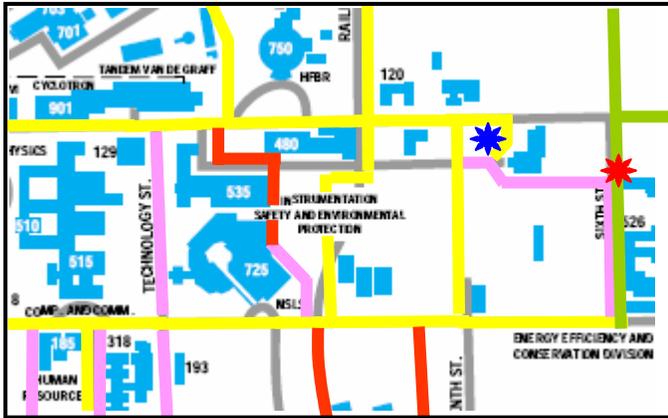
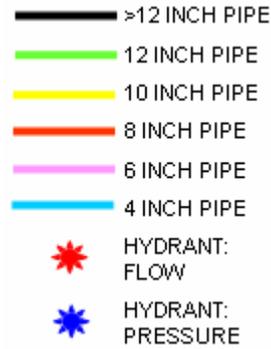
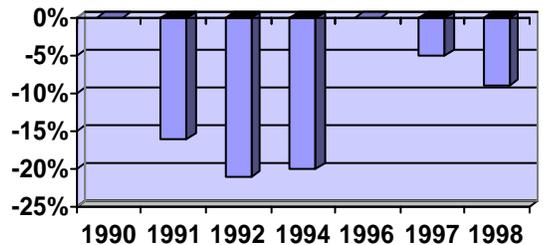
7.11 TEST POINT 11: SEVENTH STREET

MEFF 5,000 GPM	OCCUPANCY HIGH HAZARD	PIPING CONDITION FAIR	FLOW CAPACITY GOOD	PIPING NETWORK MULTIPLE PATH
--------------------------	---------------------------------	---------------------------------	------------------------------	--

SUMMARY TABLE	OVERALL	10 YEAR	5 YEAR
STATIC PRESSURE AVERAGE	66.6 PSI	66.0 PSI	65.0 PSI
FLOW AVERAGE @ 20 PSI	5878 GPM	5980 GPM	5946 GPM
FLOW CHANGE FROM OVERALL	-	1.7%	1.1%

The pressure hydrant was H132 and the flow hydrant H133. The nearest water supply source (1,000K Tank) is about 1,800 feet away. The local loop mains are 6 inch. The piping in this area has not been altered since the first relevant flow test in 1990 and is over 60 years old. The piping is Transite Cement Lined.

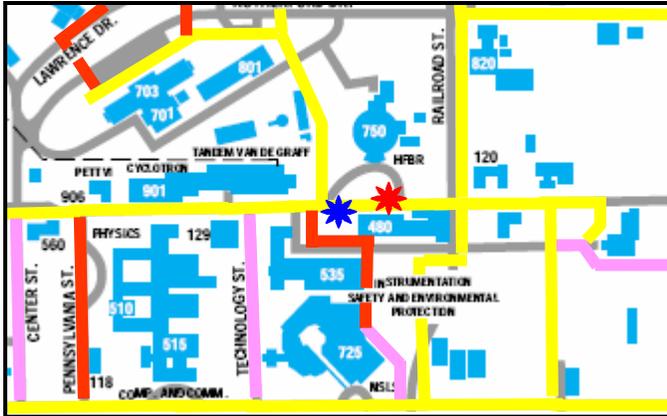
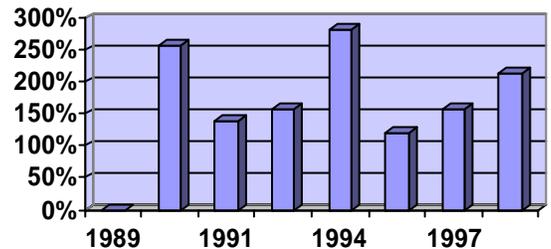
7.12 TEST POINT 12: EAST CORNELL AVENUE

MEFF 2,500 GPM	OCCUPANCY HIGH HAZARD	PIPING CONDITION GOOD	FLOW CAPACITY GOOD	PIPING NETWORK MULTIPLE PATH
--------------------------	---------------------------------	---------------------------------	------------------------------	--

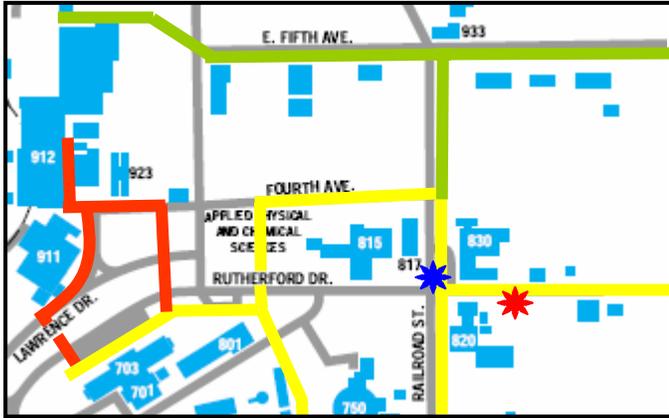
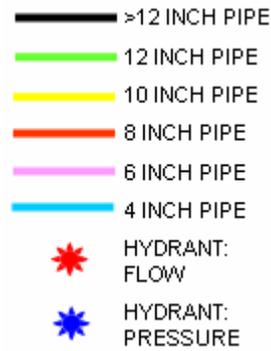
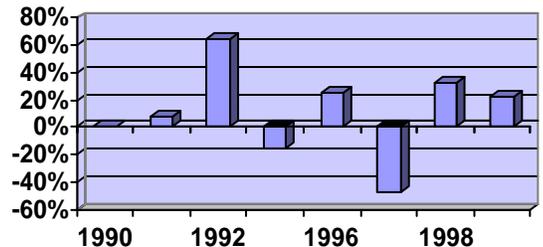
7.13 TEST POINT 13: RAILROAD ST. & RUTHERFORD AVE.

MEFF 2,500 GPM	OCCUPANCY HIGH HAZARD	PIPING CONDITION GOOD	FLOW CAPACITY GOOD	PIPING NETWORK MULTIPLE PATH
--------------------------	---------------------------------	---------------------------------	------------------------------	--

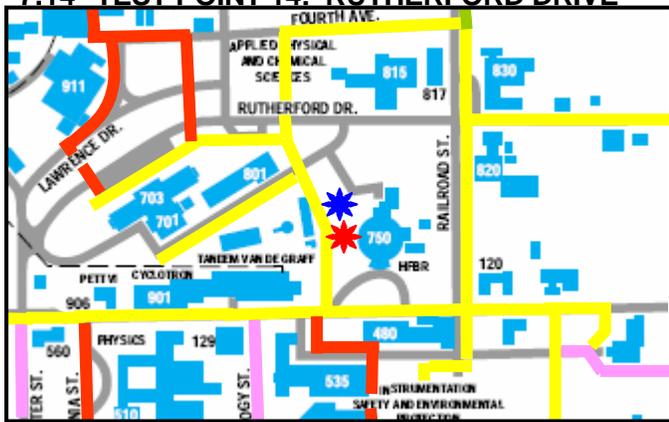
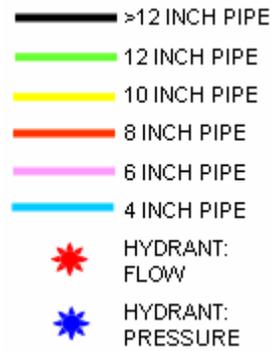
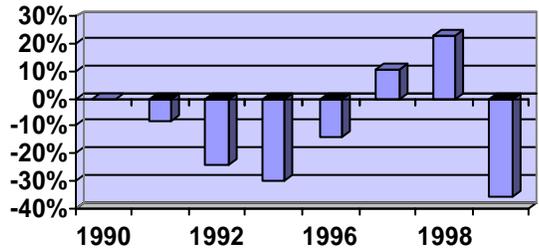
7.14 TEST POINT 14: RUTHERFORD DRIVE

MEFF 2,500 GPM	OCCUPANCY HIGH HAZARD	PIPING CONDITION GOOD	FLOW CAPACITY GOOD	PIPING NETWORK MULTIPLE PATH
--------------------------	---------------------------------	---------------------------------	------------------------------	--

Occupancy is rated "High Hazard" due to large fire loads (HFBR).

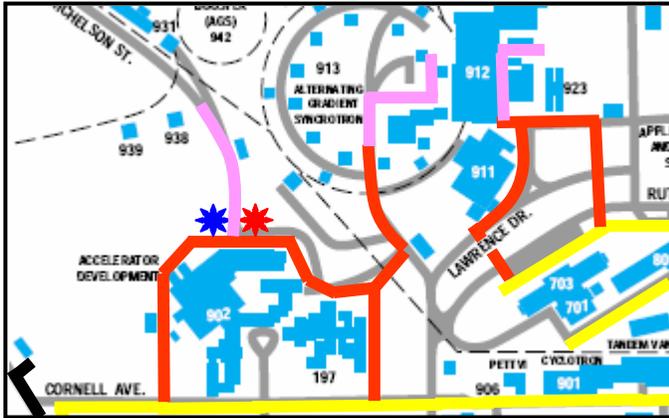
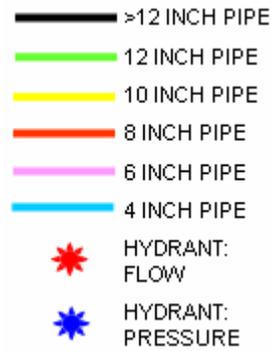
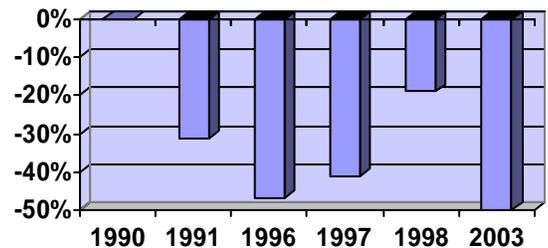
7.15 TEST POINT 15: COSMOTRON ROAD

MEFF 2,500 GPM	OCCUPANCY HIGH HAZARD	PIPING CONDITION FAIR	FLOW CAPACITY GOOD	PIPING NETWORK MULTIPLE PATH
-------------------	--------------------------	--------------------------	-----------------------	---------------------------------

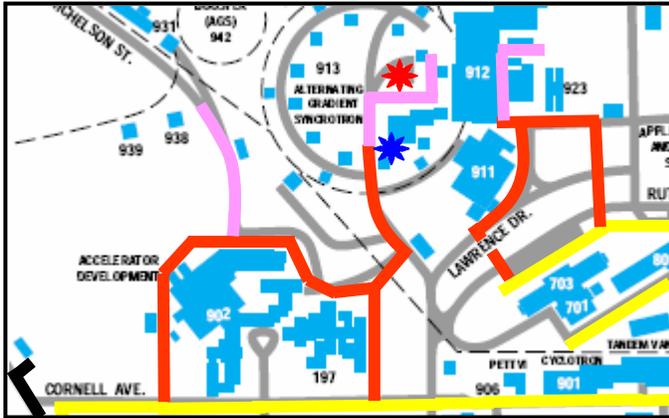
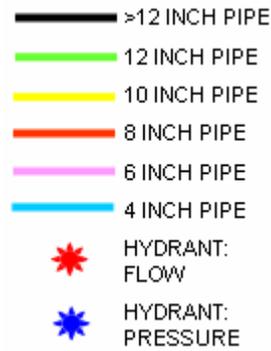
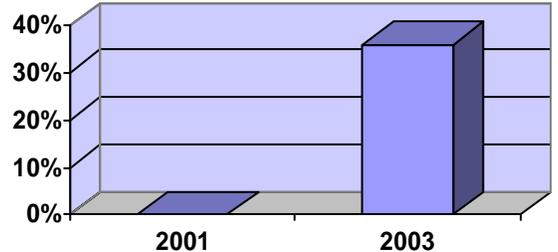
7.16 TEST POINT 16: COCKCROFT STREET

MEFF 2,500 GPM	OCCUPANCY HIGH HAZARD	PIPING CONDITION POOR	FLOW CAPACITY POOR	PIPING NETWORK DEAD END
--------------------------	---------------------------------	---------------------------------	------------------------------	-----------------------------------

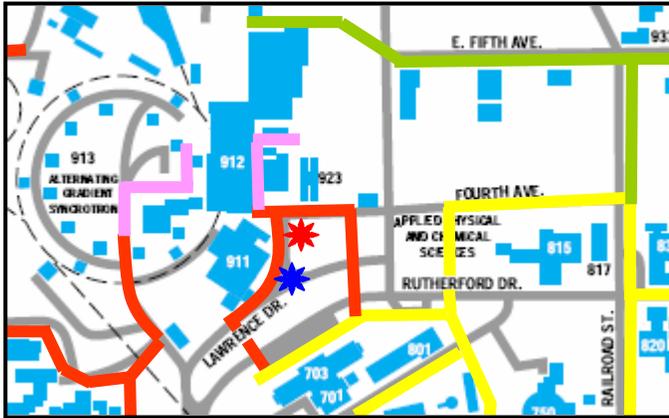
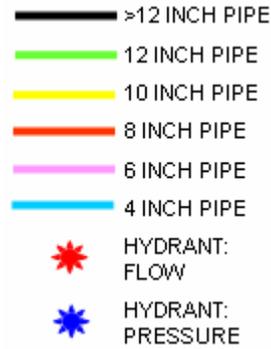
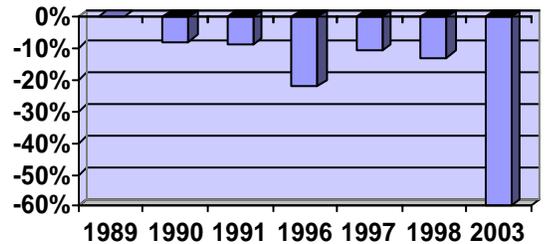
7.17 TEST POINT 17: LAWRENCE DRIVE

MEFF 2,500 GPM	OCCUPANCY HIGH HAZARD	PIPING CONDITION POOR	FLOW CAPACITY POOR	PIPING NETWORK DEAD END
--------------------------	---------------------------------	---------------------------------	------------------------------	-----------------------------------

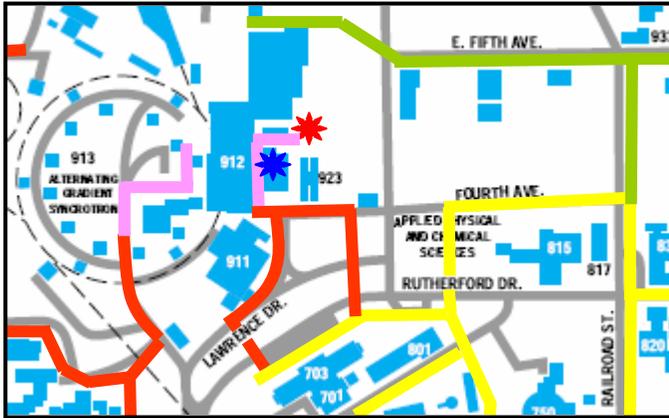
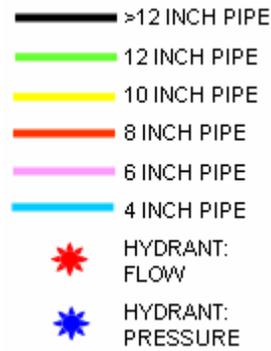
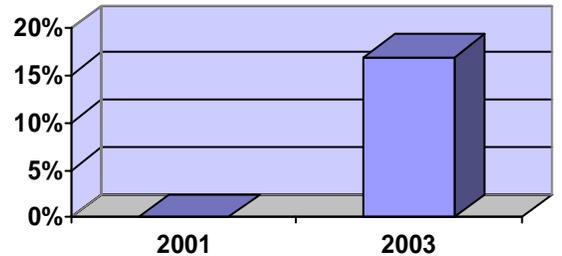
7.18 TEST POINT 18: EAST OF BUILDING 912

MEFF 2,500 GPM	OCCUPANCY HIGH HAZARD	PIPING CONDITION POOR	FLOW CAPACITY POOR	PIPING NETWORK DEAD END
--------------------------	---------------------------------	---------------------------------	------------------------------	-----------------------------------

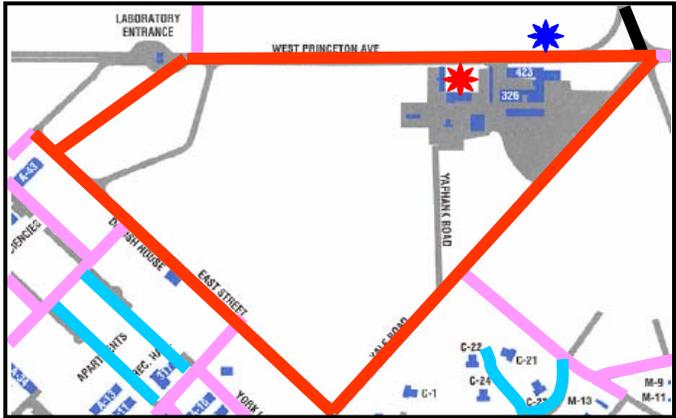
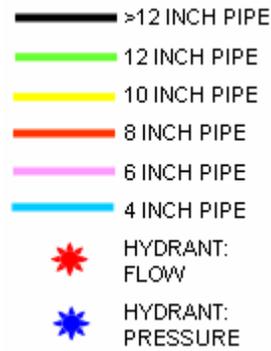
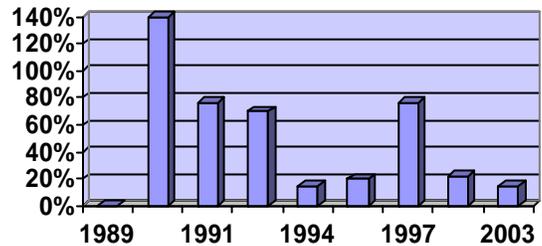
7.21 TEST POINT 21: WEST PRINCETON AVENUE

MEFF 3,000 GPM	OCCUPANCY ORDINARY HAZARD	PIPING CONDITION POOR	FLOW CAPACITY POOR	PIPING NETWORK DEAD END
--------------------------	-------------------------------------	---------------------------------	------------------------------	-----------------------------------

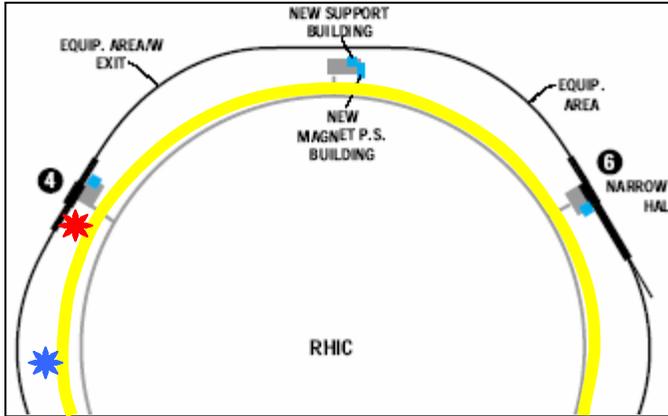
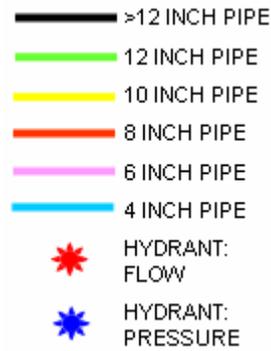
7.23 TEST POINT 23: RHIC RING

MEFF 2,500 GPM	OCCUPANCY HIGH HAZARD	PIPING CONDITION FAIR	FLOW CAPACITY GOOD	PIPING NETWORK MULTIPLE PATH
--------------------------	---------------------------------	---------------------------------	------------------------------	--

SUMMARY TABLE	OVERALL	10 YEAR	5 YEAR
STATIC PRESSURE AVERAGE	72.4 PSI	73.4 PSI	73.0 PSI
FLOW AVERAGE @ 20 PSI	3716 GPM	3515 GPM	3557 GPM
FLOW CHANGE FROM OVERALL	-	-5.7%	-4.5%
