Brookhaven National
Laboratory

Fire in the Debris Soil Pile DST-2, Chemical
and Glass Holes Project:
The Investigation Report

Brookhaven National Laboratory
Upton, New York

March 11, 2000

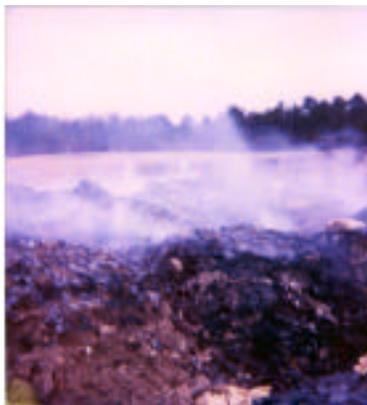
Polaroid picture made by the initial survey team of the smoking pile of debris. Note, the smoke is low and diffuse. One inch high flames were noted in one or two areas.

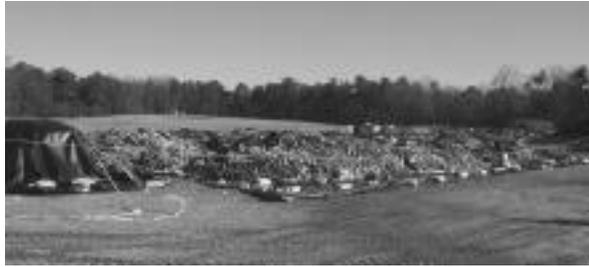
Debris pile after the fire. This view is looking to the northwest and shows the untouched pile to the south.

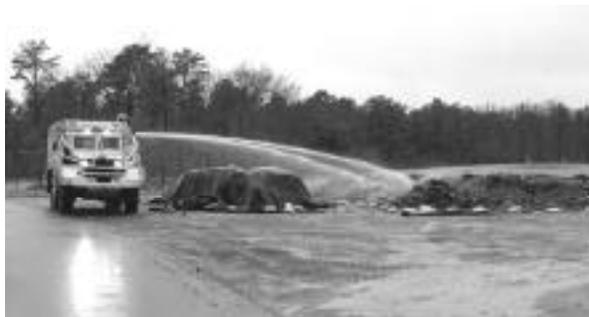
BNL's Brush truck spraying water on the fire from the south side of the debris pile. Two covered piles to the south of the main pile remain intact.

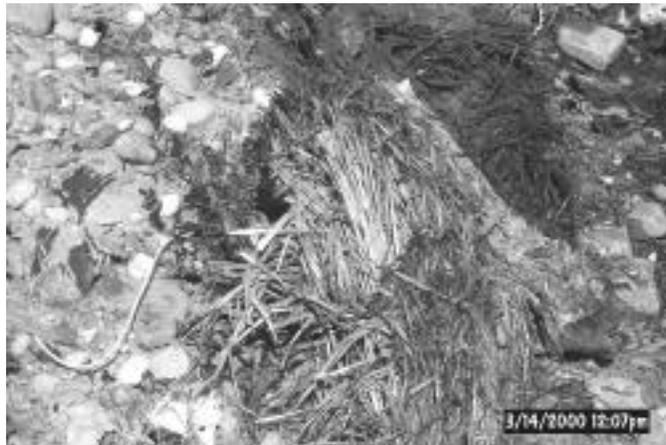
Bales of straw are known from their ability to ignite from heat generated by bacterial action. The presence of organic material, its contamination with bacteria from soil, moisture, heat, and air are required for bacterial activity. The straw is the organic material. Shredding it helped incorporate bacteria into the organic mass. The bales contained moisture from two prior days of rain. Under the correct conditions, the decomposition process raises interior temperatures and the straw will reach ignition temperatures. During the winter preceding the fire, the temperatures were low enough to avoid rapid bacterial growth. March was the beginning of spring. March 10 was the warmest day since September of the previous year. Placing a black tarp on top of the piles dramatically increases the soil pile's temperature. Soil surface temperatures could have exceeded 100°F on the day before the fire.

View of a partially exposed portion of the straw in the debris pile after the fire. This was located in the Northeast section, adjacent to the Personnel Protective Equipment bale.

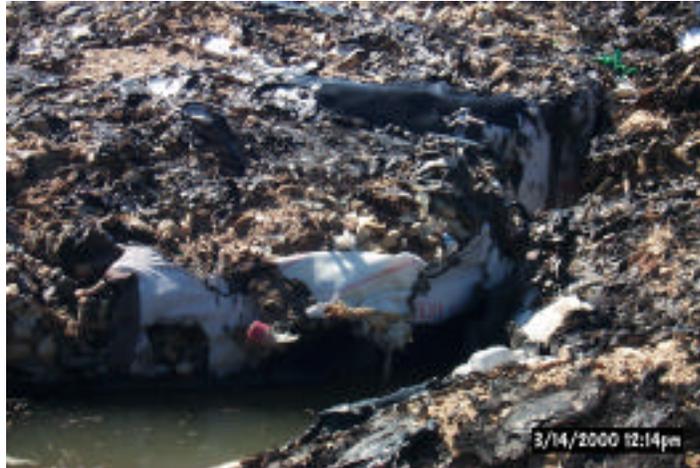
The fire area was evaluated in detail shortly after the fire. It was noted that almost the entire exposed sections of the lift liner system and the black polyethylene UV cover were consumed. Only at two locations did the polyethylene UV cover remain intact on the top of piles. The majority of lift liner materials were burned down below the visible soil line. The forceful water streams from the fire hoses during extinguishing may have exposed these areas of the lift liners.

Remaining portion of lift liner left below the soil line after the fire.

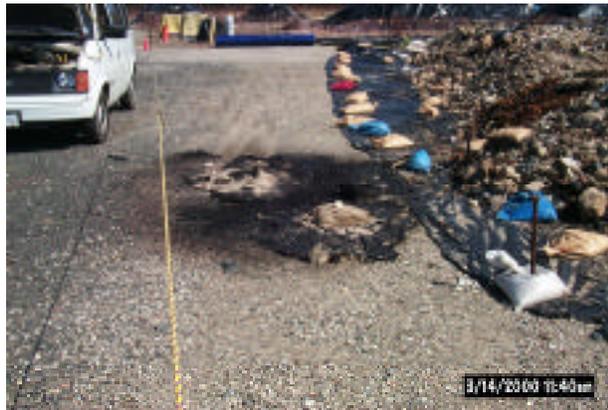
One section of the polyethylene cover had broken free of the pile and traveled west of the pile by approximately 5 feet (see the following picture). Sandbags holding down the 20-mil polyethylene cover were scorched only on the west side, indicating the area was not burned from the main pile. This damage may have been due to a forceful updraft from a hot burning spot in the pile. This region corresponds to an area where the Fire/Rescue Group reported difficulty in extinguishing the fire and experienced the rekindling of the flames.

Area to west of main pile indicating portion of the PVC cover blew off and burned.

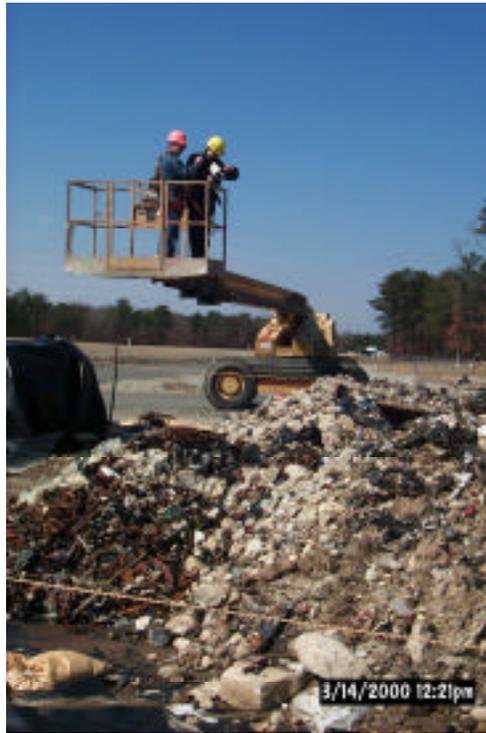
Following the fire, an infrared camera was used to examine the debris remaining from the piles. While the exterior temperatures were in the 40°F range, there were no indications of "hotspots." Three other storage areas existed. Some of the lift liner system containers from DTS-3 were hoisted and examined by the infrared camera. No hot spots were detected. Attempts to scan the remaining storage areas through the black polyethylene covering gave little information because the black covering masked any temperature differential.

Infrared camera being used from a manlift to scan the debris piles.
