# ESH Coordinators Meeting

## Stanford Linear Accelerator Center (SLAC) Contractor Hospitalized After Arc Flash

Presented by Ed Sierra  
Laboratory Lessons Learned Coordinator  
Quality Management Office  
January 26, 2005

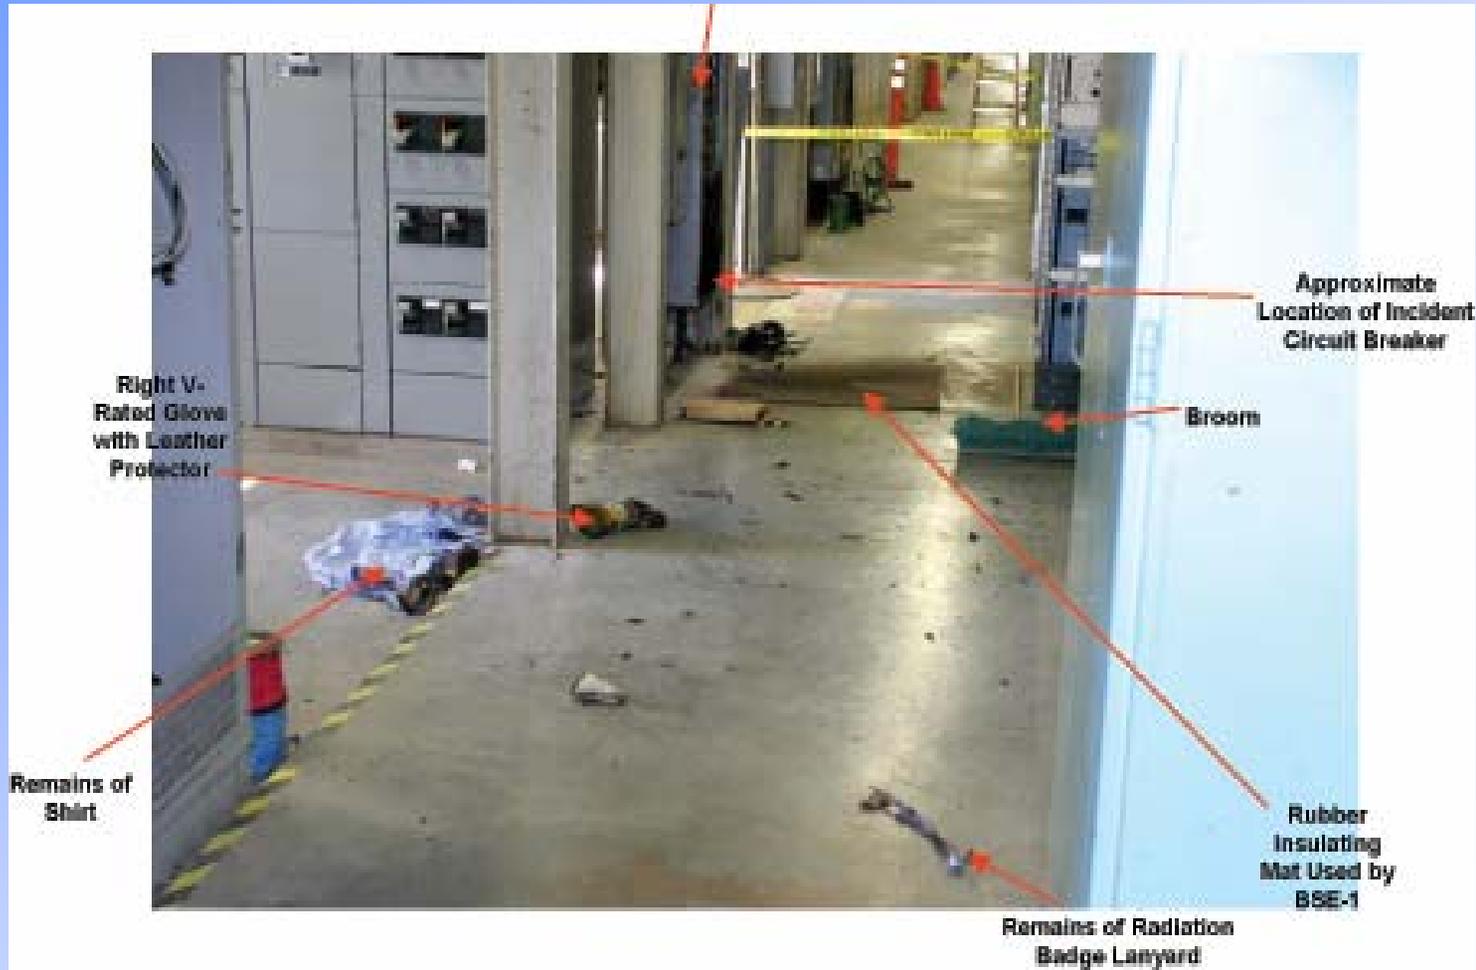
Figure 2-1. Scene immediately after the accident

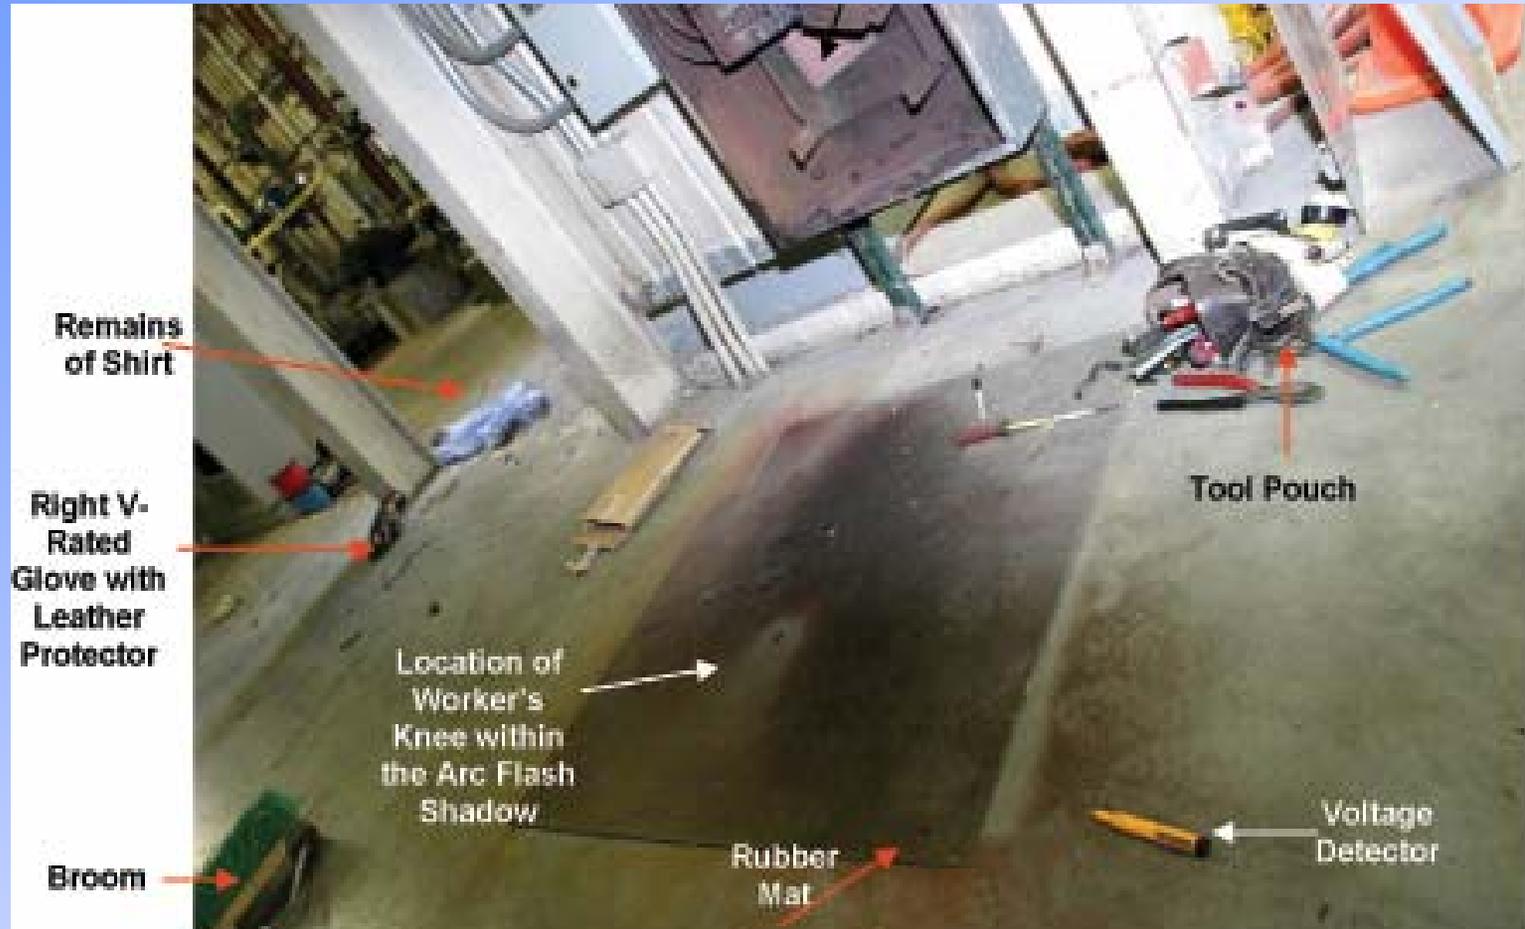
Figure 2-3. The insulating mat with the outline of BSE-1's knee in the arc flash shadow

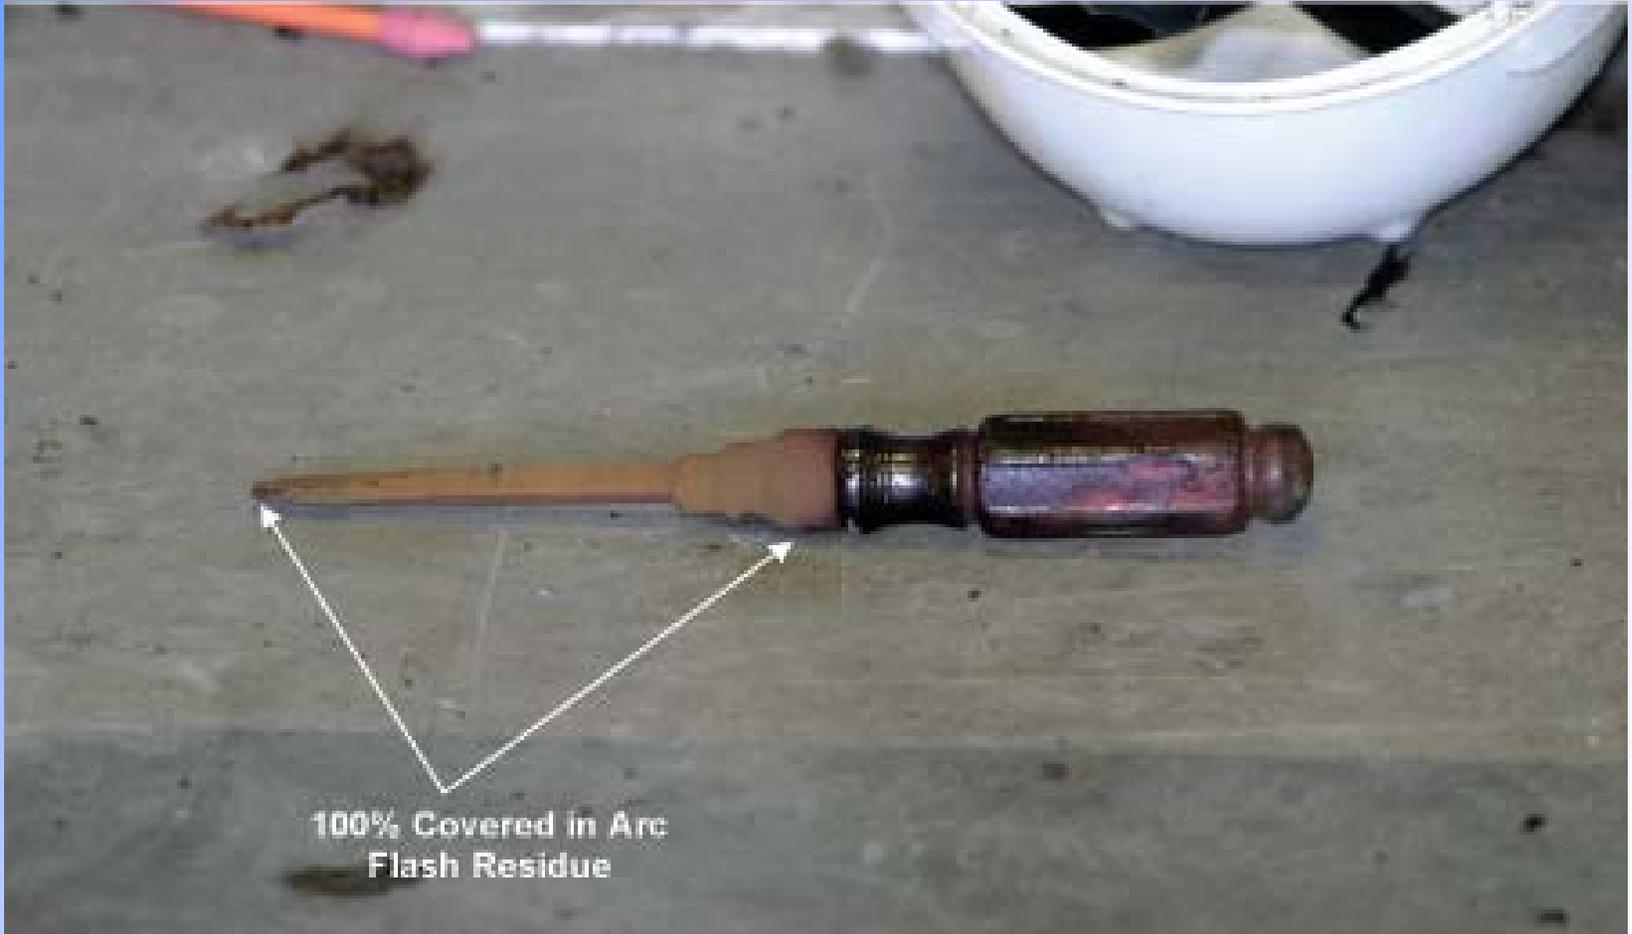
Figure 2-9. Closeup of the screwdriver the Board believes BSE-1 was using when the arc flash occurred

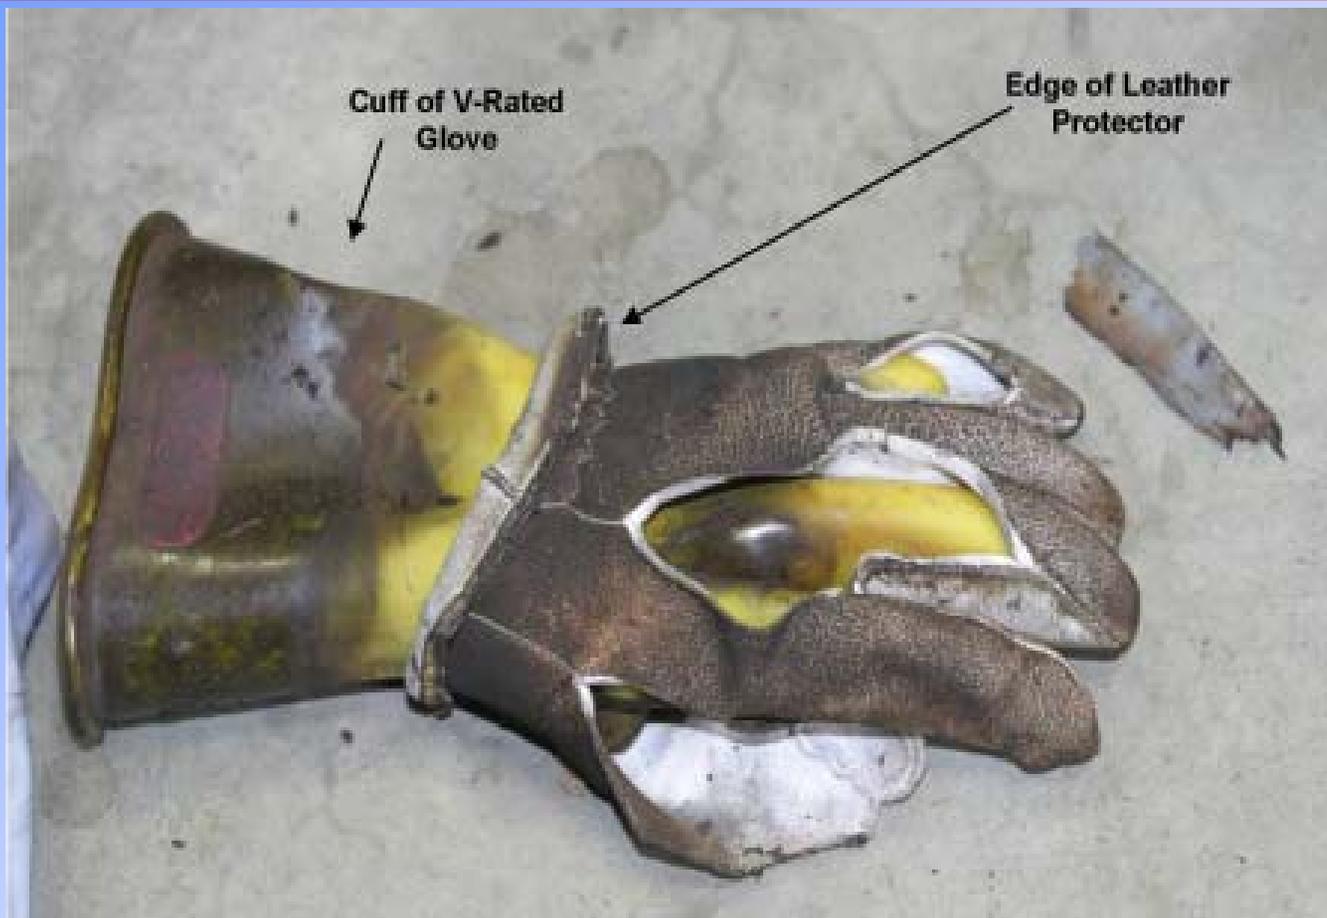
Figure 2-8. Closeup of one of BSE-1's burned gloves

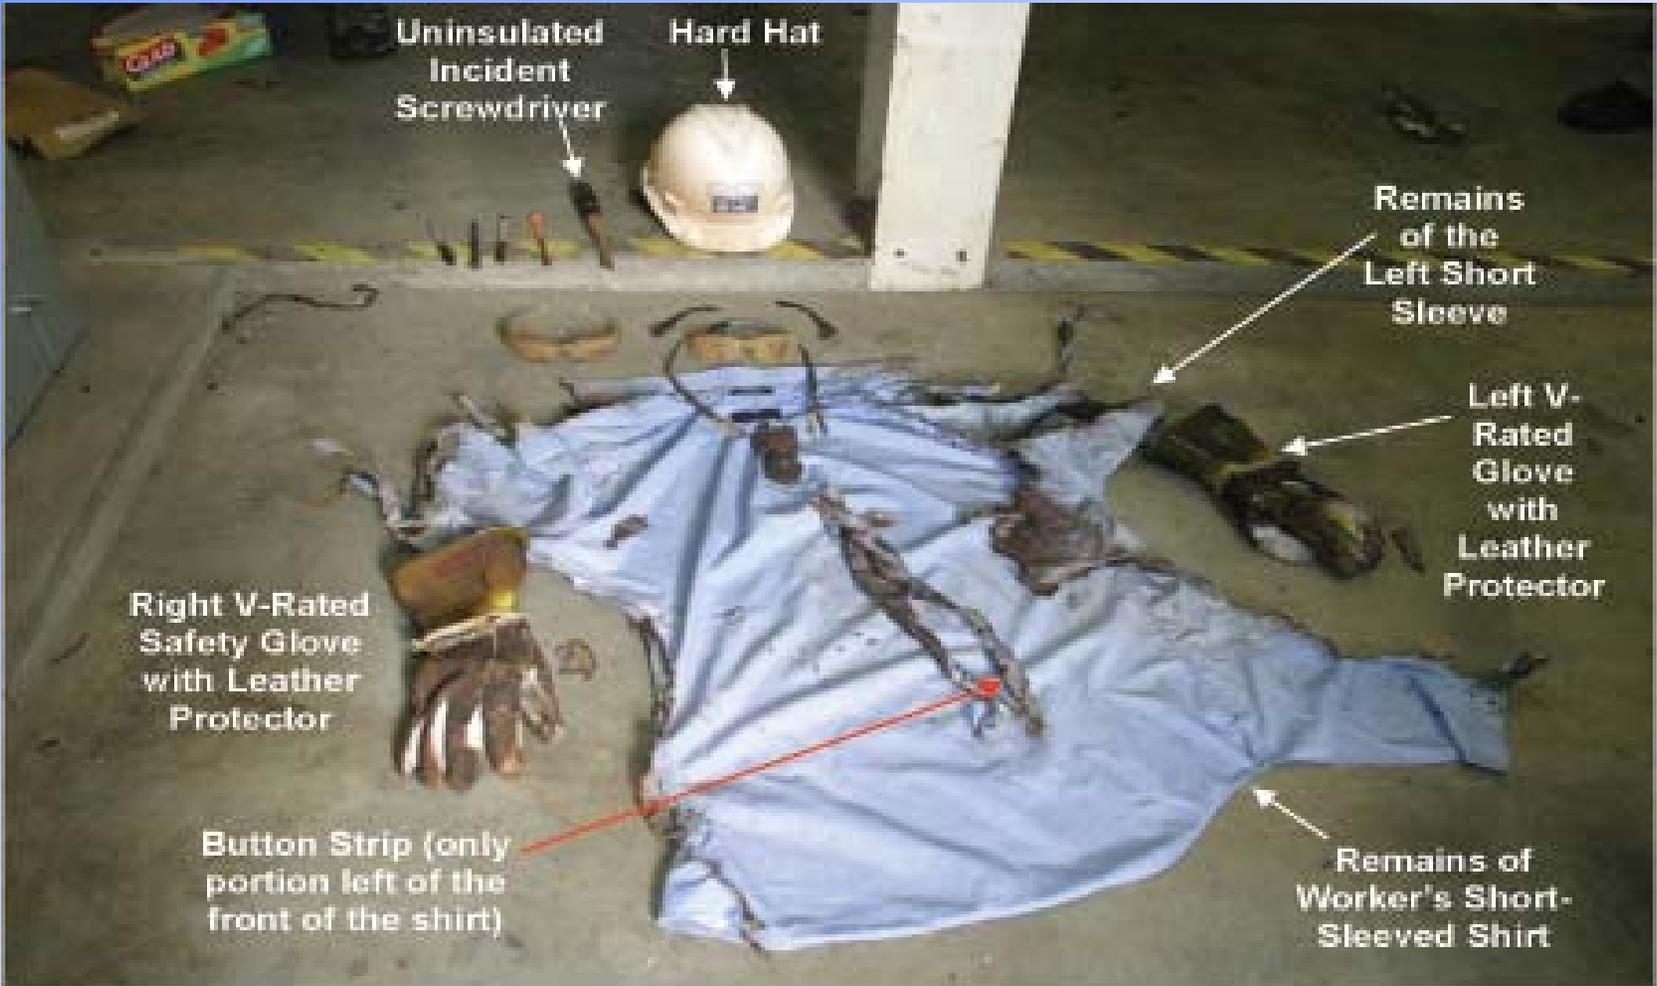
Figure 2-6. BSE-1's burned shirt and his flash-damaged PPE and tools

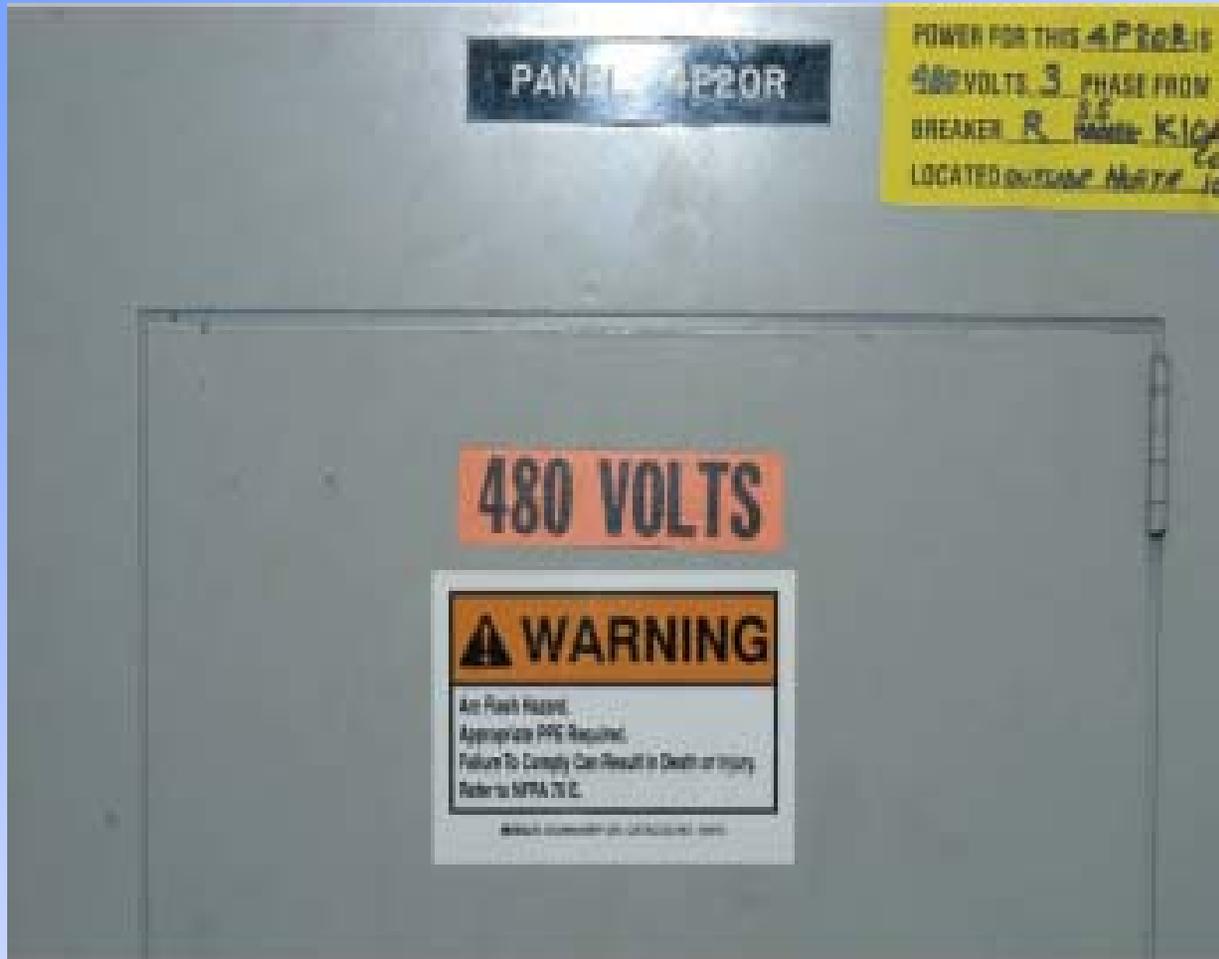
Figure 2-4. Warning label on Panel 4P20R

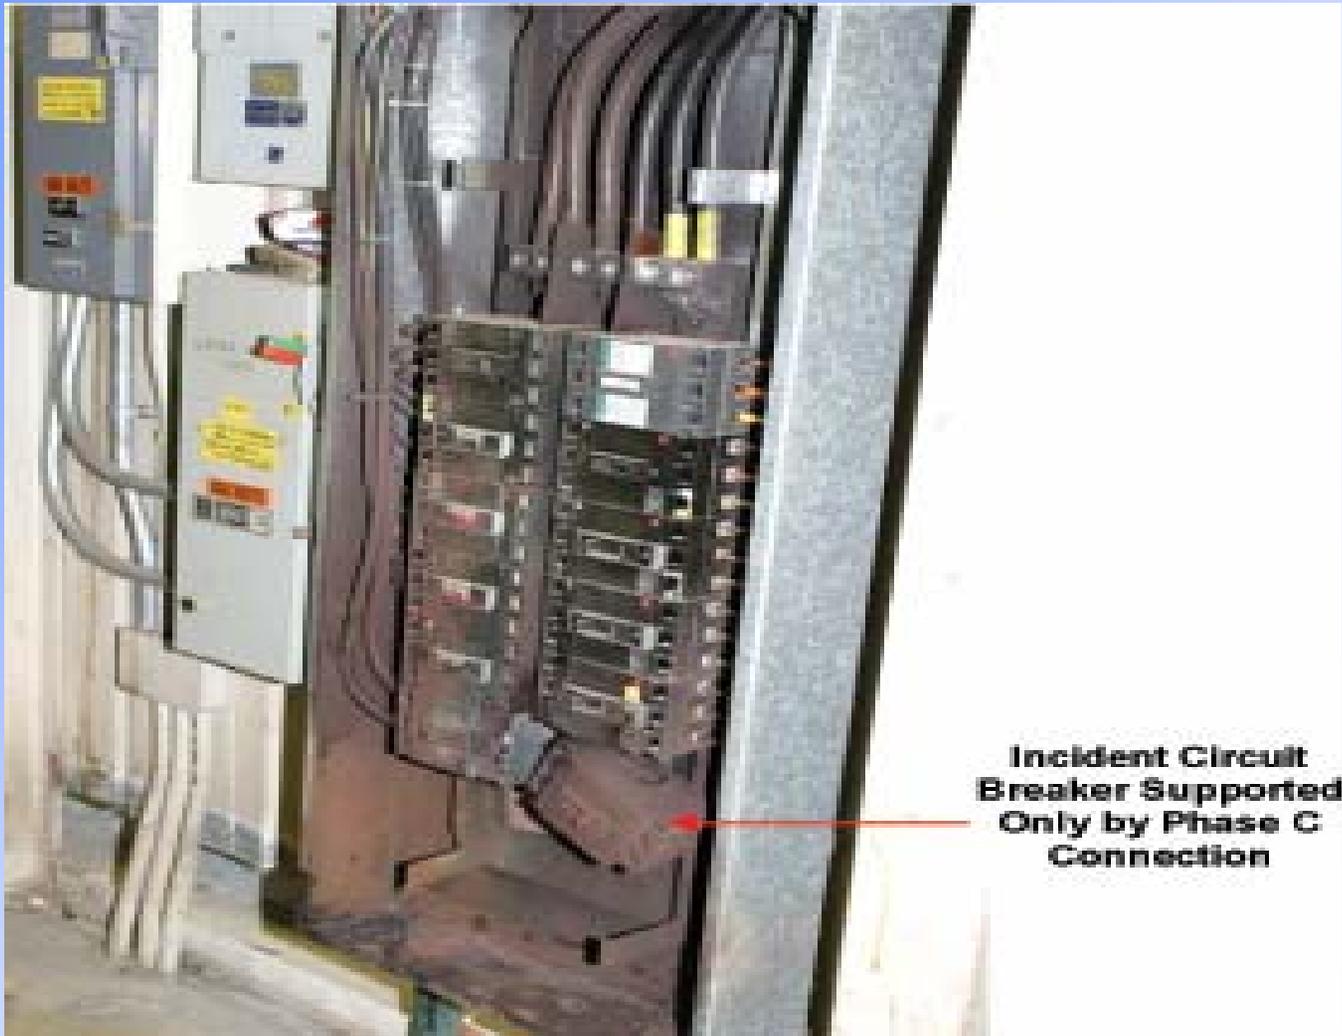
**Incident Circuit  
Breaker Supported  
Only by Phase C  
Connection**

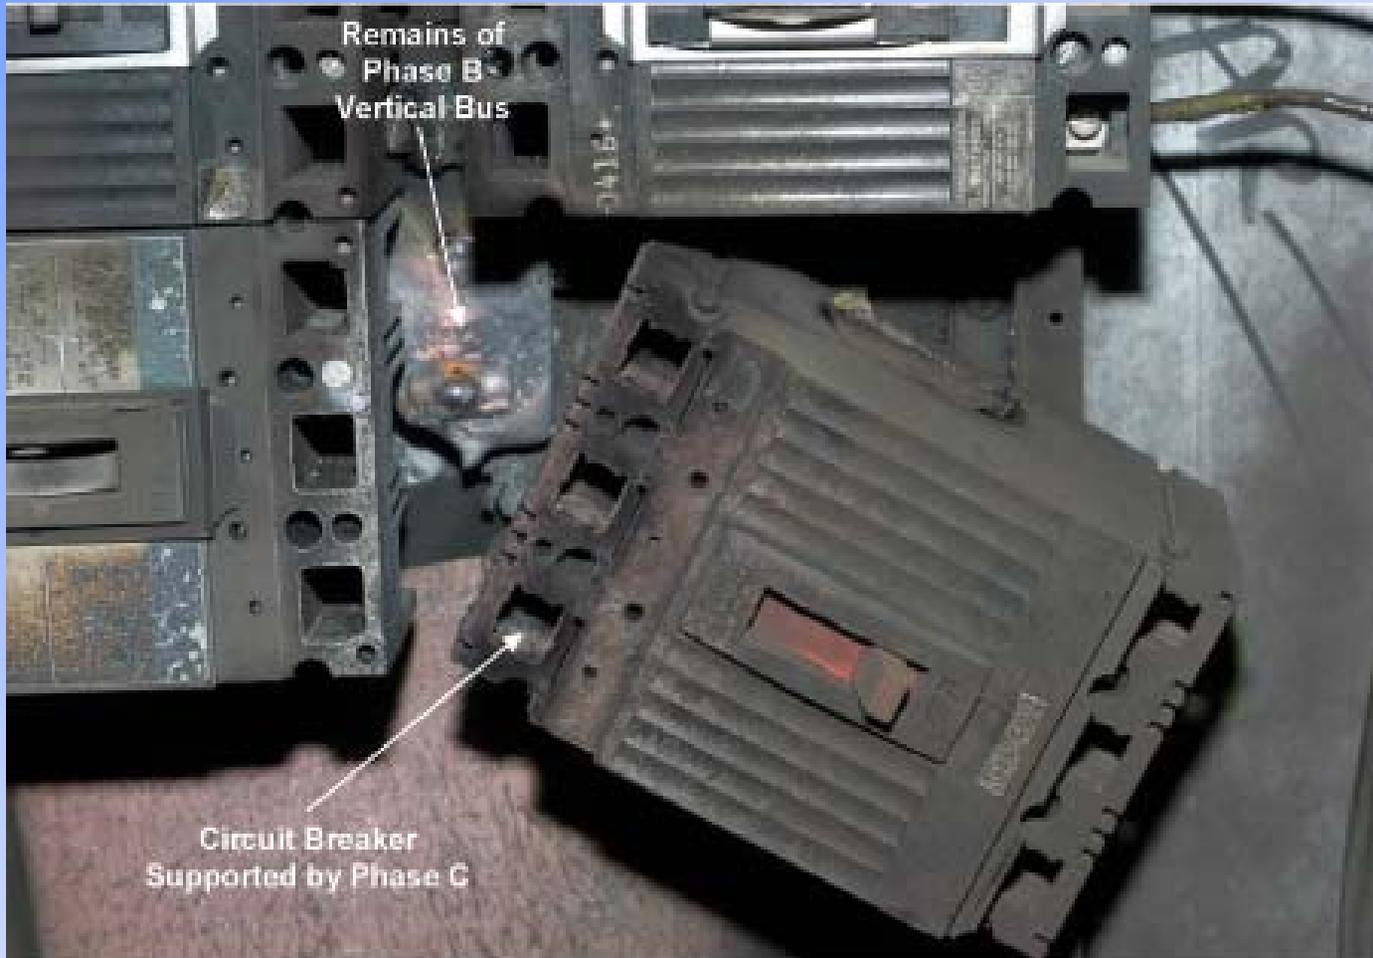
Figure 2-10. Closeup 1 of the damaged circuit breaker panel

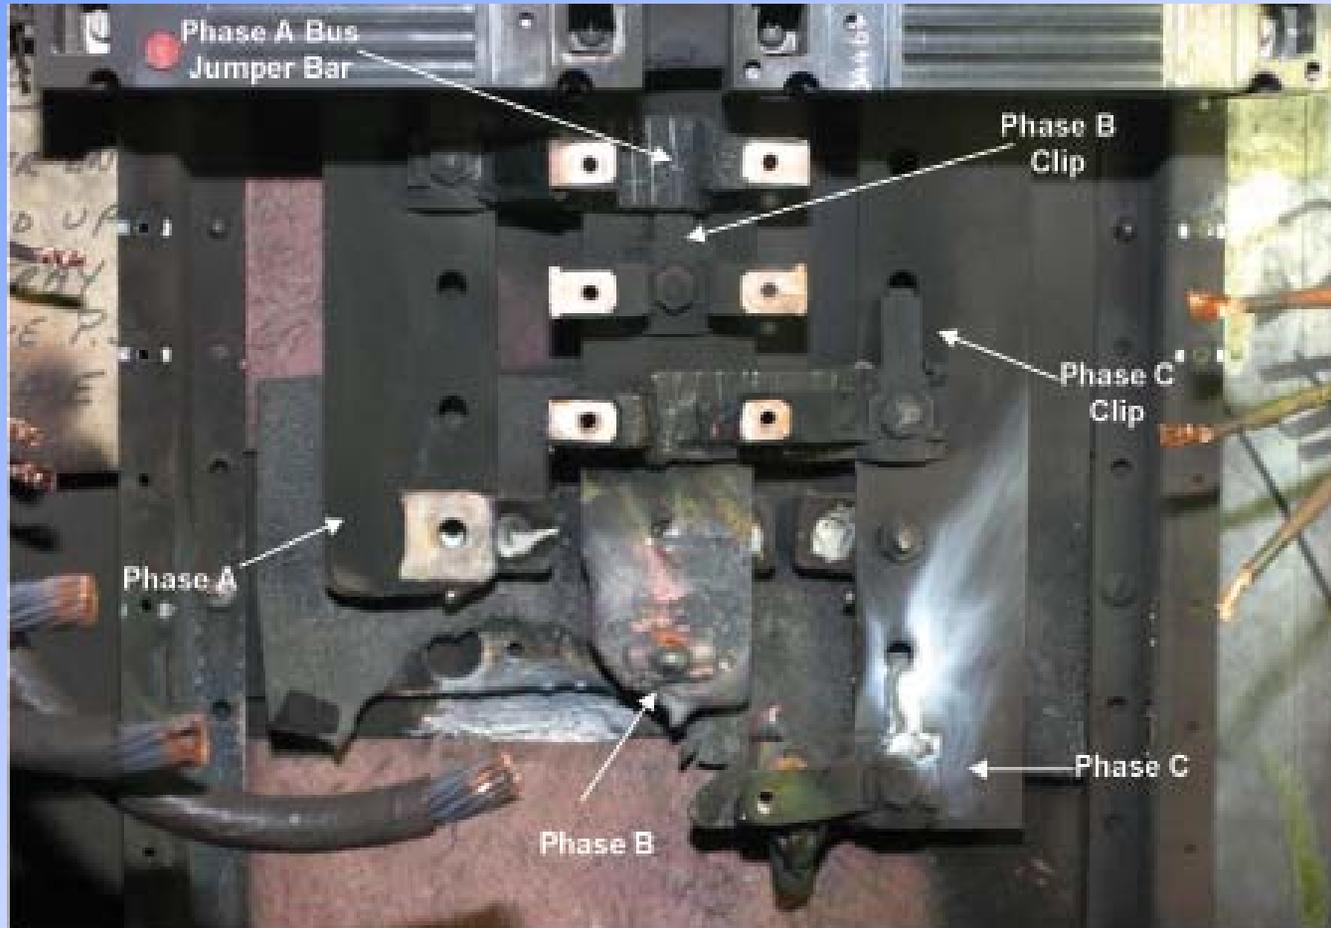
Figure 2-12. Circuit breaker panel after removal of the incident circuit breaker, adjacent circuit breakers, and the two circuit breakers above

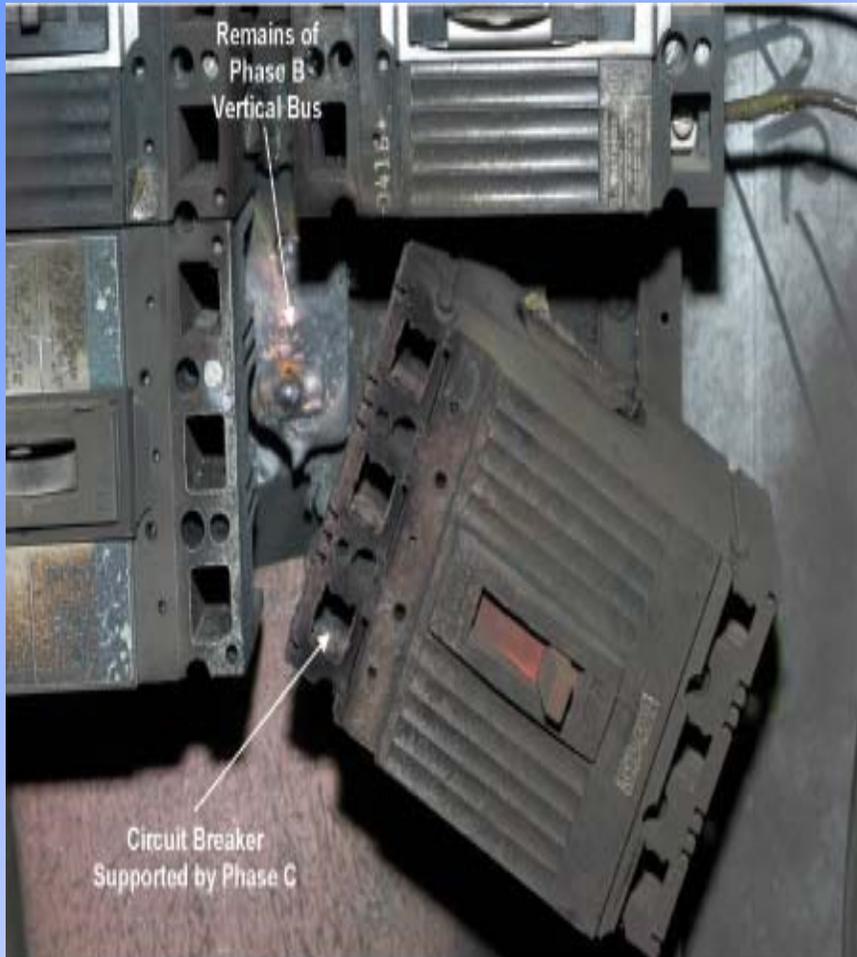
Figure 2-10. Closeup 1 of the damaged circuit breaker panel

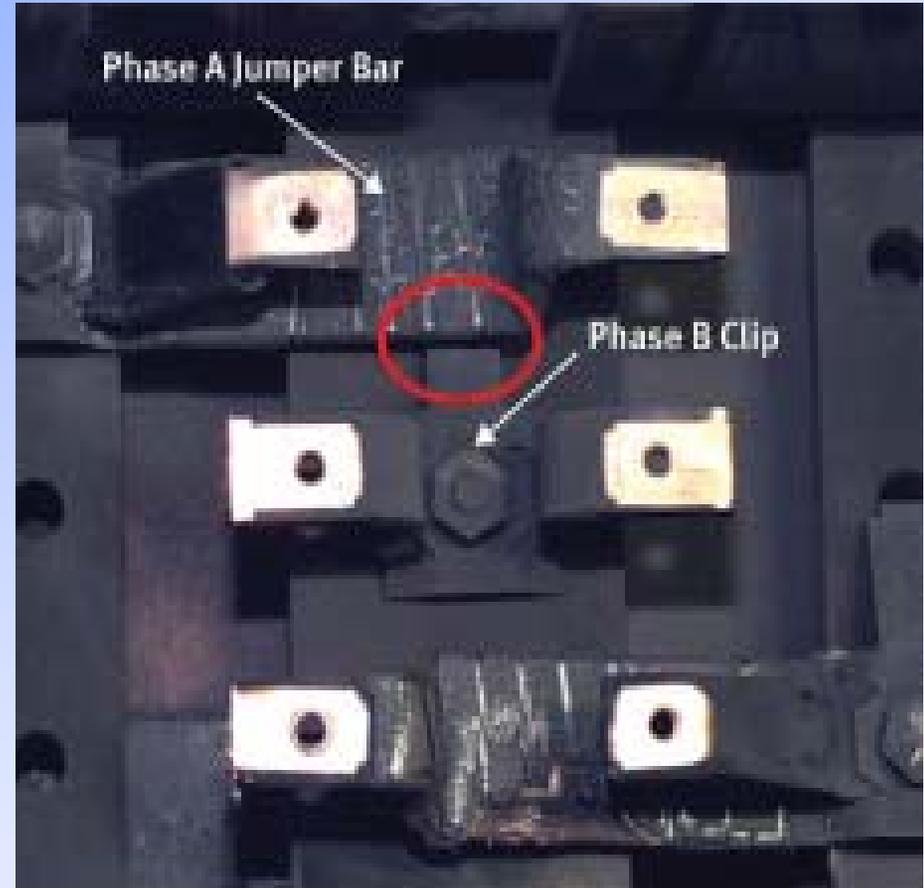
Figure 3-3. Close up of jumper bar and clip with the believed location of the fault circled in red

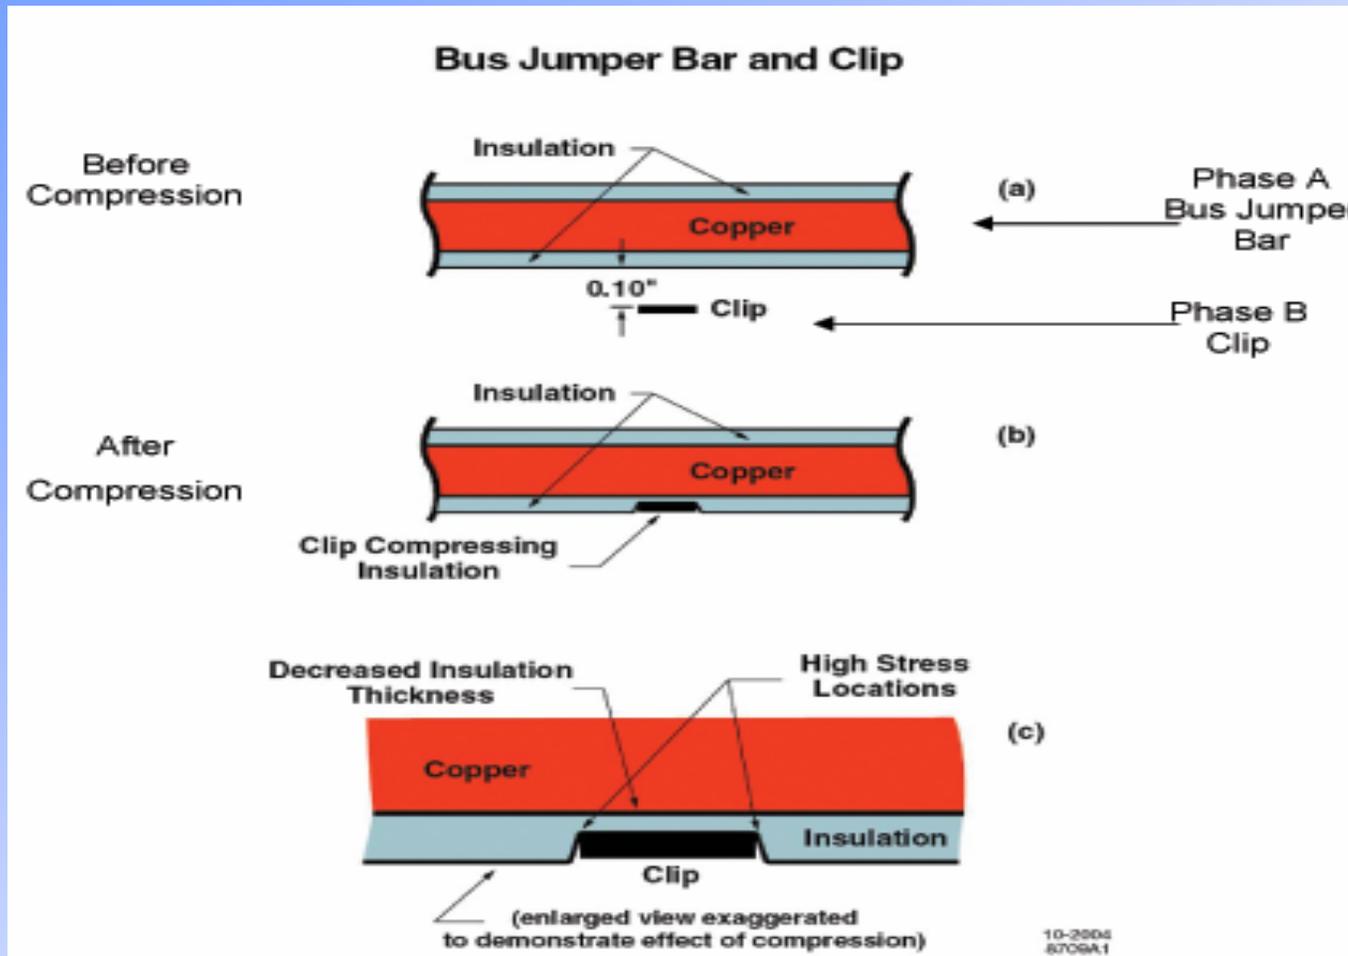
Figure 3-2. The effect of contact between the bus jumper bar and the clip (not to scale)
