Electrical Safety Incident

SC--BHSO-BNL-BNL-2006-0014

Bldg 490 – August 24, 2006

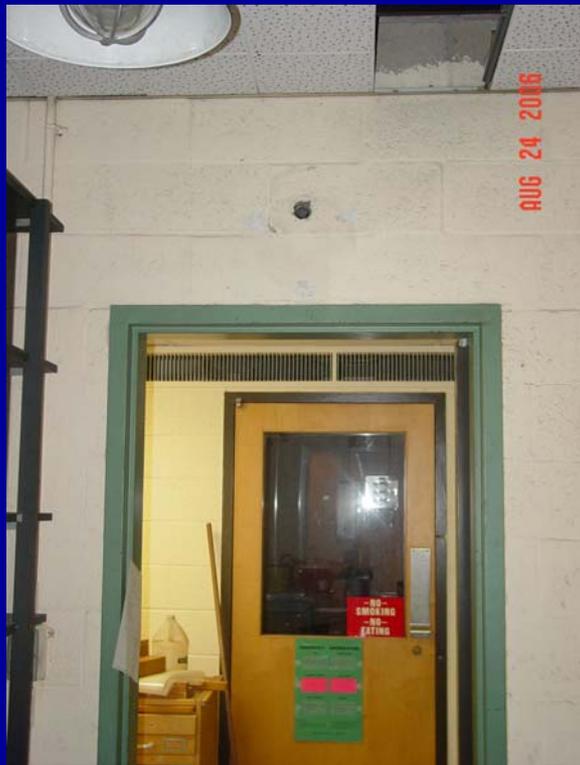
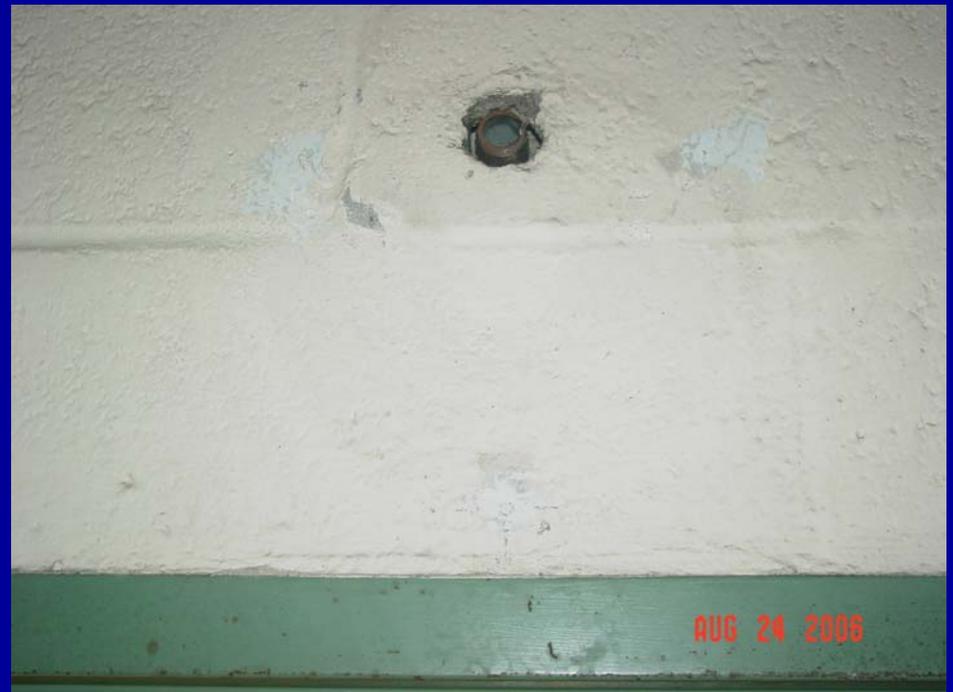
Ground Level View of Electrical Conduit

On August 24, 2006, a PE painter was scraping the walls in Bldg 490, Room 9-830, in preparation for painting when his spackling knife made contact with energized 110 Vac wires protruding through conduit pipe above a doorway. The painter observed sparks and heard a popping sound. As a result of this electrical transient a circuit breaker tripped and the room lights went out.

- Abandoned wires to be terminated from its power source and removed from the conduit. (Corrected 08/24/06)
- Conduct an inspection of similar decommissioned/unoccupied areas to see if they have similar incidents.

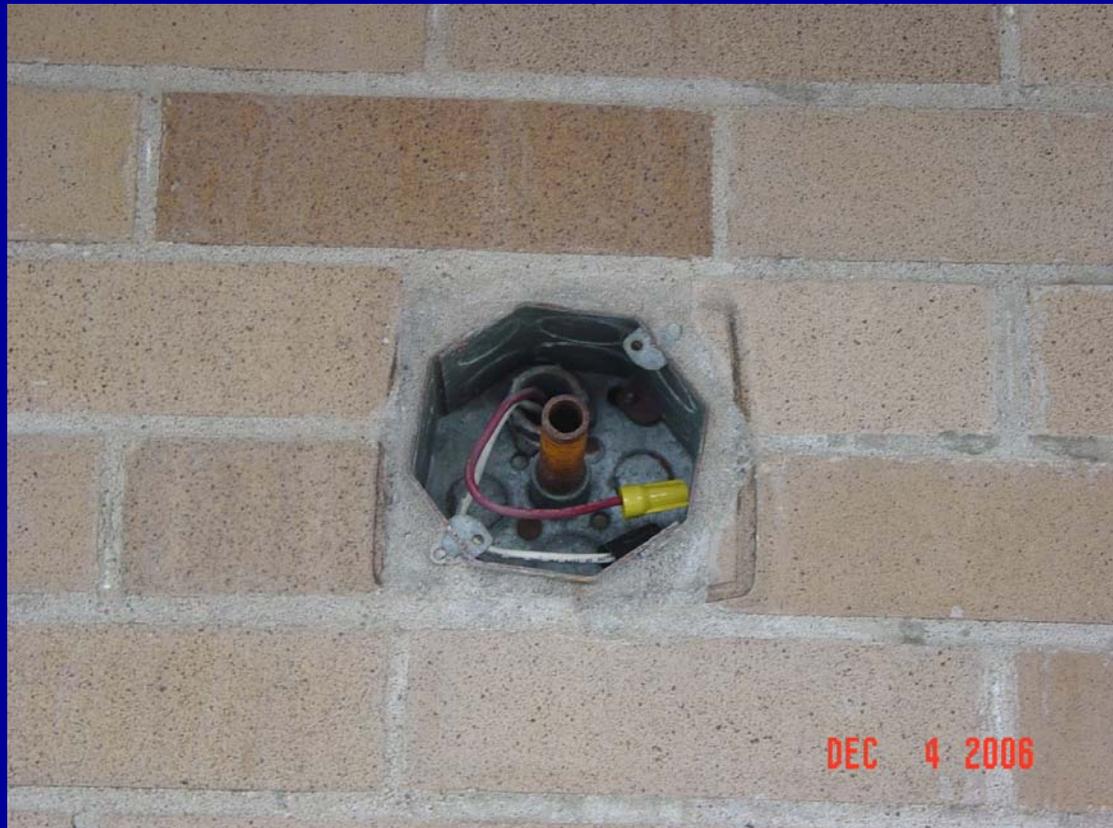
Bldg 490 Loading Dock

- All areas of concerns noted during this inspection were determined to be electrical wires abandoned in place that were isolated from it's electrical source, or low voltage signal wires.
