INVESTIGATION REPORT

LANL Investigation of a Laser Eye Injury

Submitted to: G. Peter Nanos
Director, Los Alamos National Laboratory

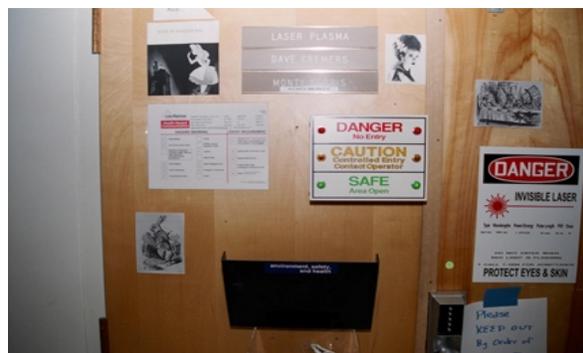
Figure 2.4. Laser warning lights on the hallway door leading into the laser lab in room 106.

- L2 was introduced into the lab without being interlocked to prevent personnel from being inadvertently exposed to laser-induced optical radiation hazards.
- Warning lights were improperly used.
- LEP requirements were not adhered to.
- Options for remotely viewing particles were not exercised.

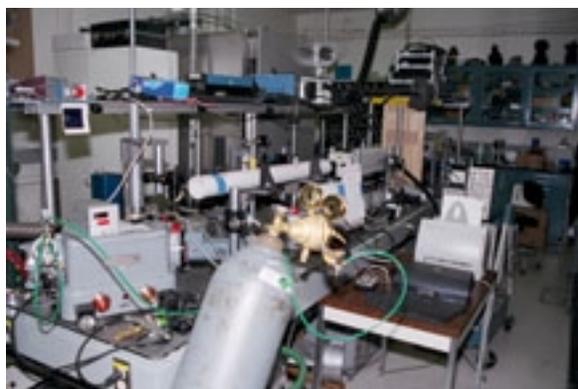
Figure 2.5. Poor housekeeping in room 106.

The Team observed a general state of poor housekeeping in room 106 (see Fig. 2.5). The area around the optics table was partially blocked by diagnostics on an additional table that had been positioned against the optics table and also by a gas cylinder and a vacuum pump. LEP was available for use throughout the lab, although the optical density (OD) rating labels on some were worn and therefore difficult to read.

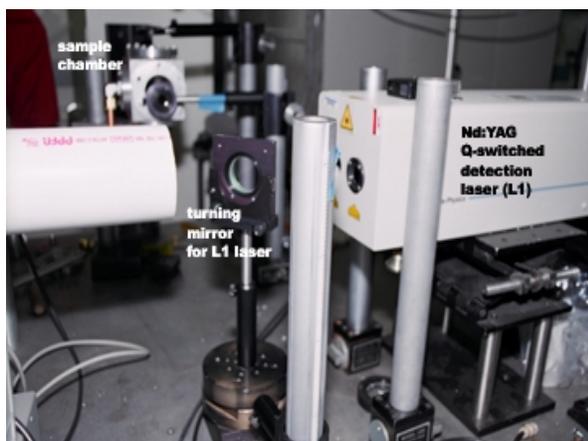
The PI used a turning mirror to direct L1's beam 90 degrees toward the target chamber, which contained a sample of powdered soil simulant. A focusing lens in front of the chamber focused the laser beam through a front window to strike the particles that L2 had suspended within the chamber. Figure 2.7 shows L1's position in relation to the chamber. This configuration did not yet include a fiber-optic port to allow spectroscopic monitoring. The detection laser (L1) remained unchanged from a typical factory INDI laser configuration operating at 1064 nm and using an externally triggered Q-switch. This configuration does not employ and was not required to have a mechanical shutter to block light emission from leaving the laser.

Figure 2.7. L1 output was turned 90 degrees toward the target chamber.

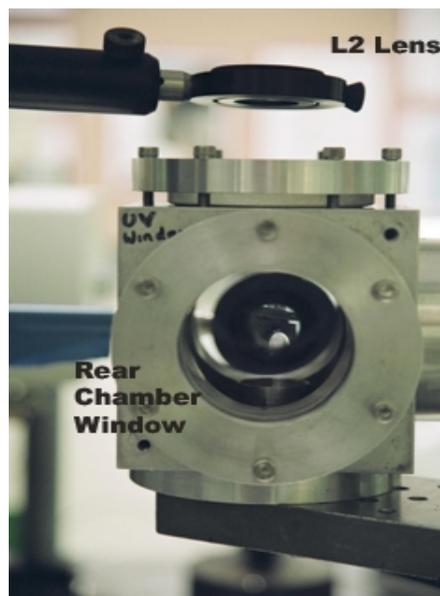
The IWD did not describe looking into the target chamber to view particles or using L1's flash lamps for illumination. Consequently, the hazards associated with these activities were not analyzed.

Figure 2.9. A view through the rear window of the target chamber, along the beam axis, toward the L1 beam source.

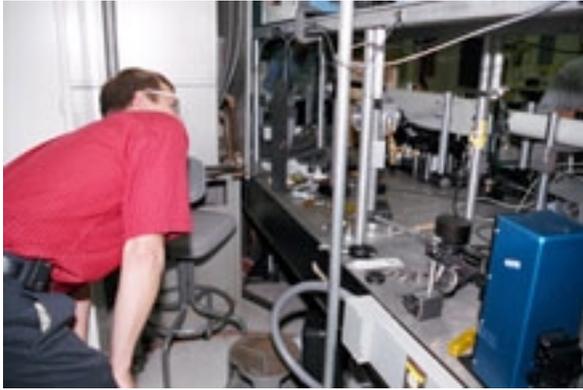
After turning the room lights out, the PI removed the beam stop and saw particles suspended inside the target chamber. S1 was now standing next to him. When the PI told her to look, she stepped forward and bent down to view the target chamber. She immediately saw a flash and a reddish-brown substance floating in her left eye. The reddish-brown floater was obscuring her vision. A re-creation of S1's position when looking into the target chamber is shown in Fig. 2.10.

Figure 2.10. A team member demonstrates S1's position when she looked into the target chamber on July 14.

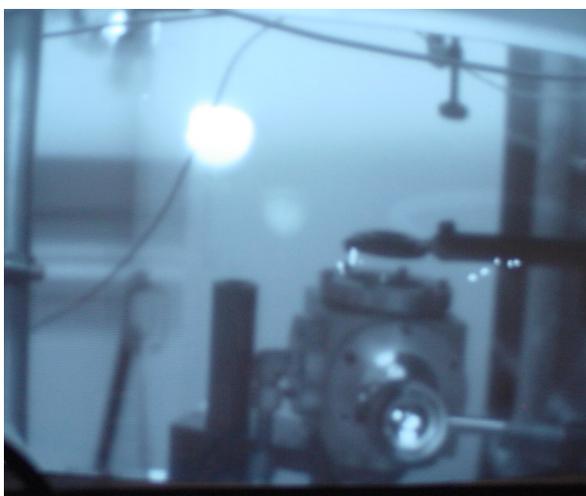
Because L1's beam entered the focusing lens low, off-axis, it was turned upwards through the chamber and, with the beam stop removed, hit the metal cabinet behind the fume hood 36 in. from the target chamber's rear window. S1's eye intersected this main beam path between the table and cabinet. Furthermore, the cabinet clipped the beam, and part of the beam impinged on a pressure gauge mounted on the back wall 59 in. from the floor and 83 in. from the target chamber's back window. After passing through its focal point in the target chamber, the beam expanded and was about 5 inches in diameter on the cabinet. (See Fig. 3.1)

Figure 3.1. IR image of the transmitted laser pulse image on the back wall.

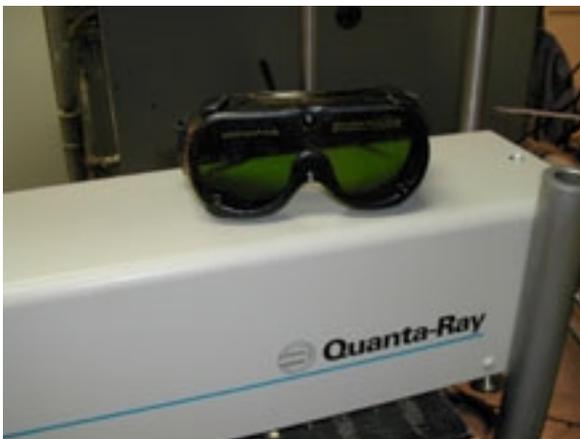
The PI did not routinely wear LEP (see Fig. 4.2). After aligning a laser, the PI was confident in his knowledge of the laser beam's position and character-

Figure 4.2. LEP available for use in room 106.

istics. He trusted his ability to avoid the hazard. He transferred this knowledge and practice to his co-workers and students, including S1. As a result, S1 was injured when an unexpected and unidentified hazardous laser beam hit her left eye during Class IV laser operations.

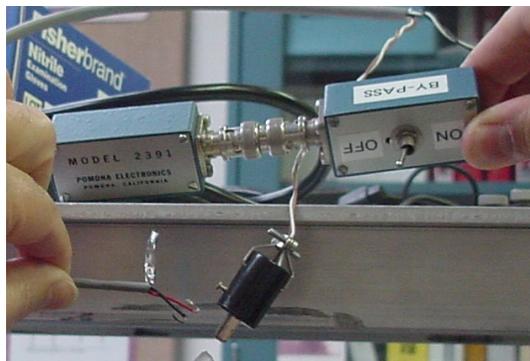
The room warning light system was functioning properly, indicating a green/yellow/red condition as set. The indicator lights functioned properly for all settings on the external warning lights to the hall and adjacent room. The room warning light system operates independently of the laser interlock system in this room. The room interlock system was functioning properly, interrupting LIBS laser operation when either of the two room doors was opened or a single panic button was pressed. The interlock system was only connected to the LIBS laser. The interlock system was wired with a bypass switch such that when “off,” the interlock system operated normally, and when “on,” the interlock system was defeated and LIBS laser operation could not be interrupted. A 12 V potential relative to building ground was observed on the case screws, switch, and case ground of the box containing the bypass switch. This caused a short to the table when in contact. This short typically caused an interruption of the interlock system. This box is shown in Figure 1.

Figure 1: The interlock bypass switch showing box that was floating at 12V.

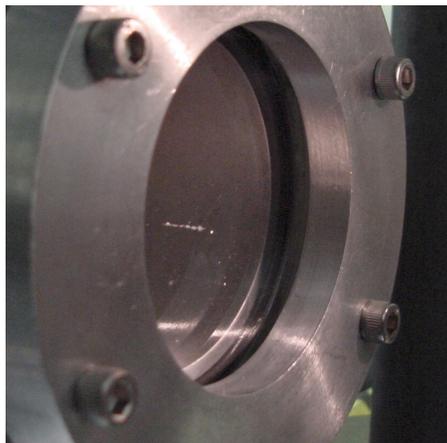
Figure 3: Back chamber window showing damage.

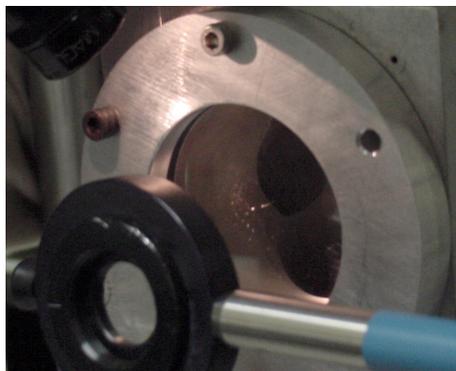
Figure 4: Front chamber window showing damage.
