**SITE CLOSEOUT REPORT REV 2**  
**– APPENDIX C PHOTOGRAPHS**

**U.S. DEPARTMENT OF ENERGY**

**HIGH FLUX BEAM REACTOR STACK (BLDG 705)**  
**DECOMMISSIONING AND DEMOLITION (D&D)**  
**BROOKHAVEN NATIONAL LABORATORY**  
**UPTON, NY**  
**CERCLIS NUMBER NY 789008975**

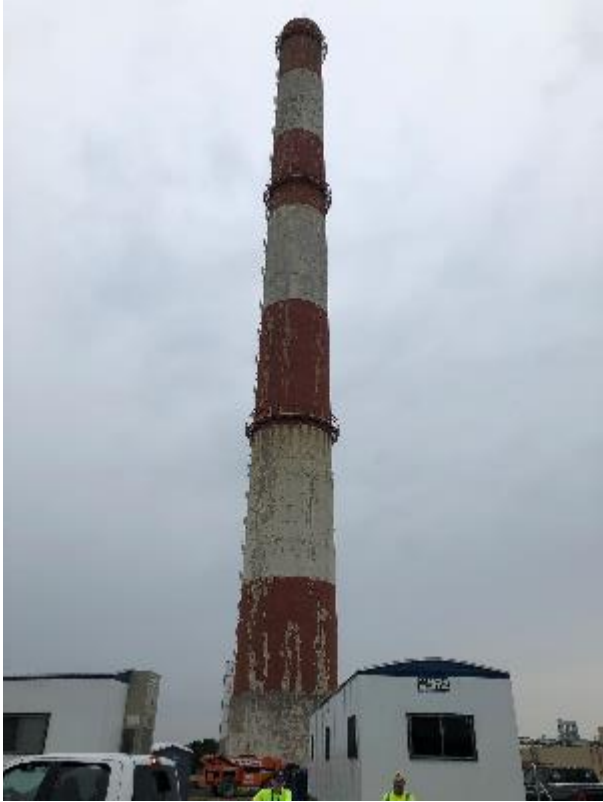
<b>Photo No. 05</b>	<b>Date:</b> 08/17/20

<b>Description:</b> Stack pre-abatement.		
<b>Photo No. 06</b>	<b>Date:</b> 8/22/20

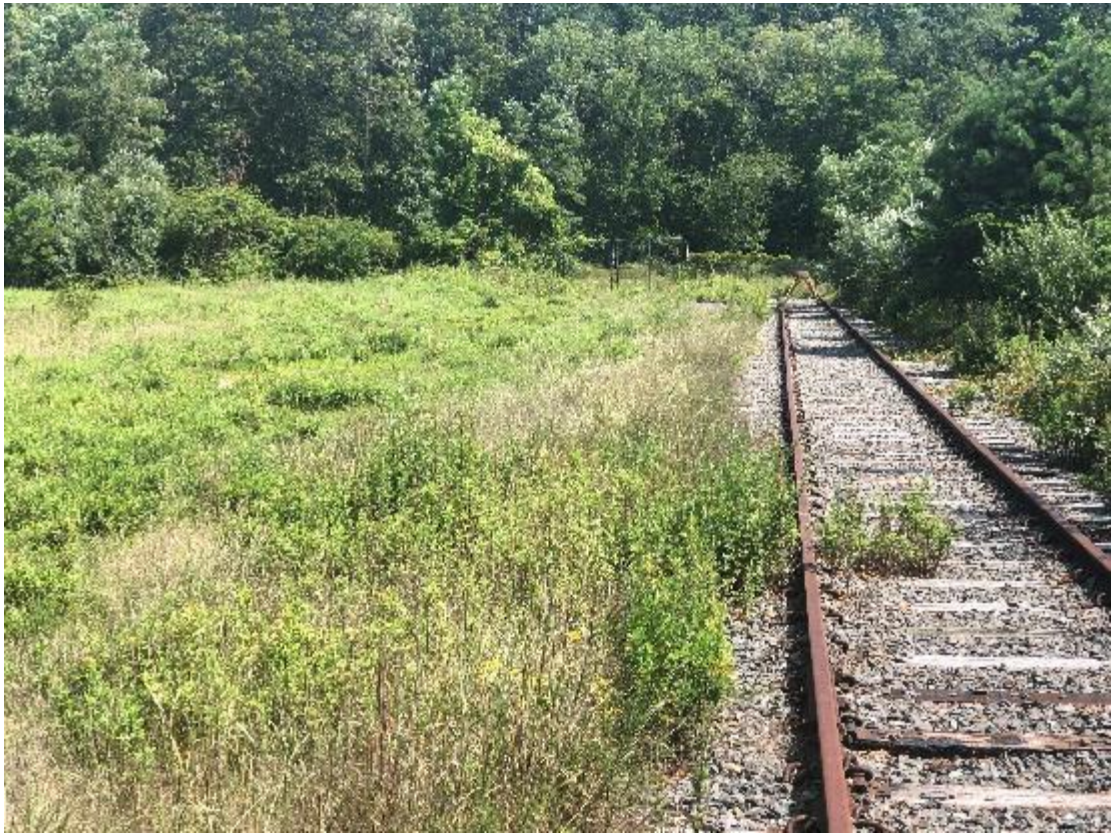
<b>Description:</b> Railroad tracks at BNL rail yard area, prior to repairs and load area set up.

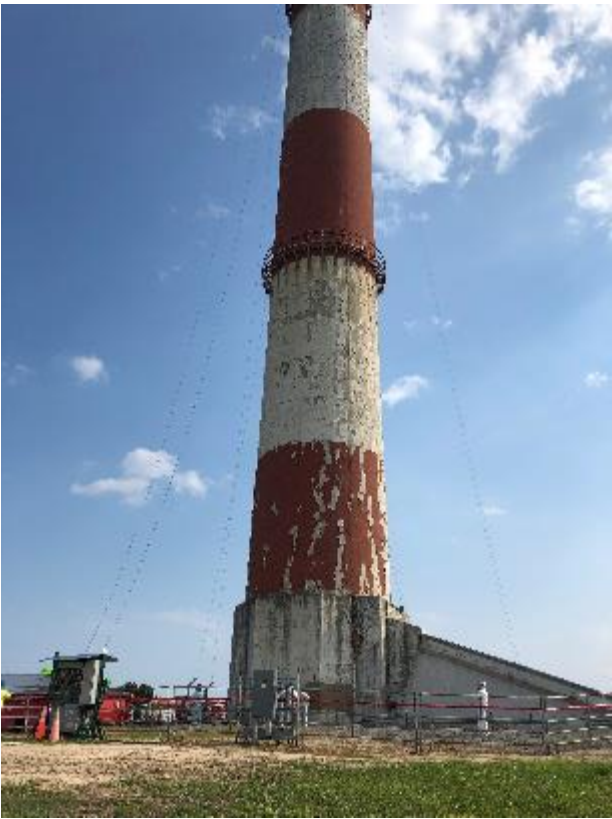
<b>Photo No. 07</b>	<b>Date:</b> 09/08/20

<b>Description:</b> Stack pre-abatement, during set up.

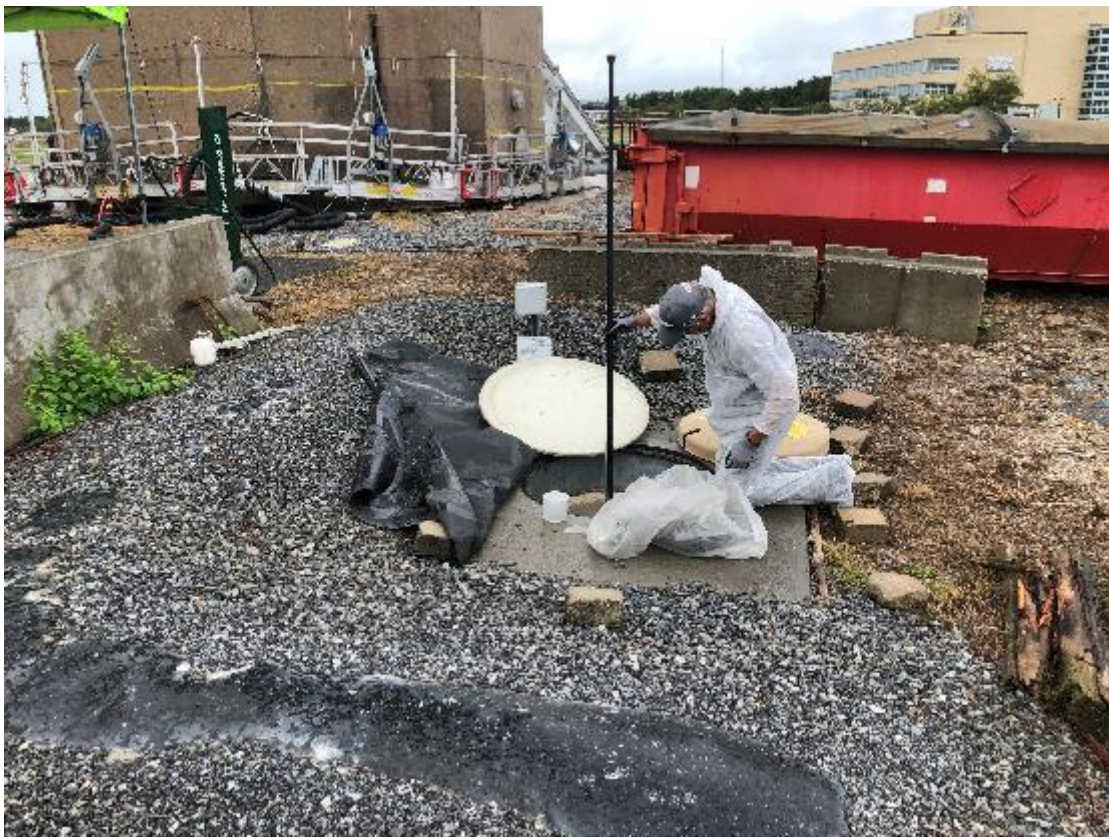
<b>Photo No. 09</b>	<b>Date:</b> 08/27/20

<b>Description:</b> Inspecting stack drain tank		
<b>Photo No. 10</b>	<b>Date:</b> 08/27/20

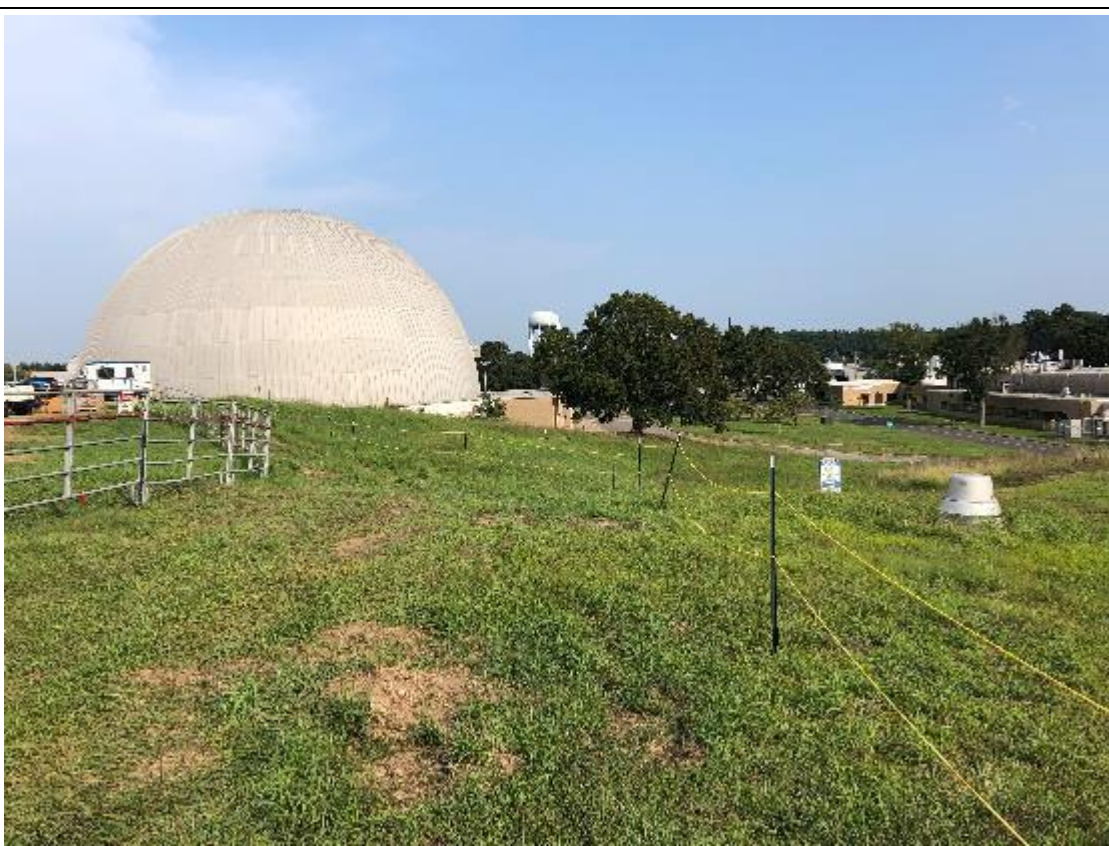
<b>Description:</b> Site control boundary fence at right, and exclusion zone boundary fence at left.

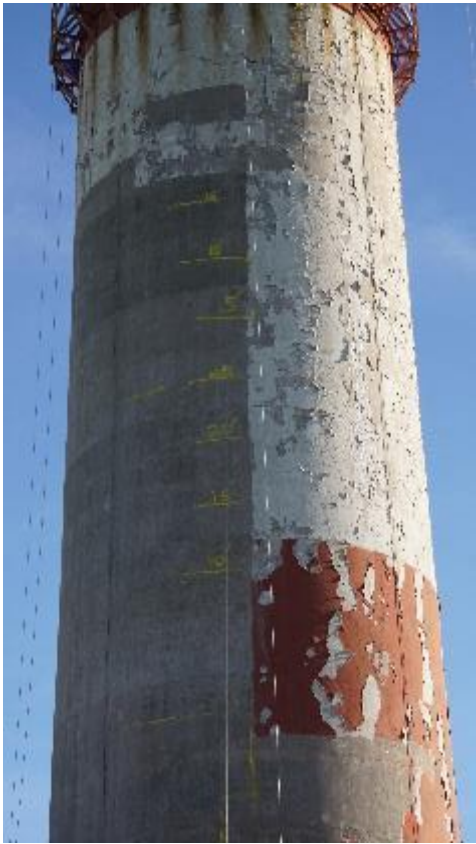
<b>Photo No. 13</b>	<b>Date:</b> 10/13/20

<b>Description:</b> Abatement progress. First platform (101 ft above grade, elev. 225.5 ft) visible at top of photo.		
<b>Photo No. 14</b>	<b>Date:</b> 10/13/20

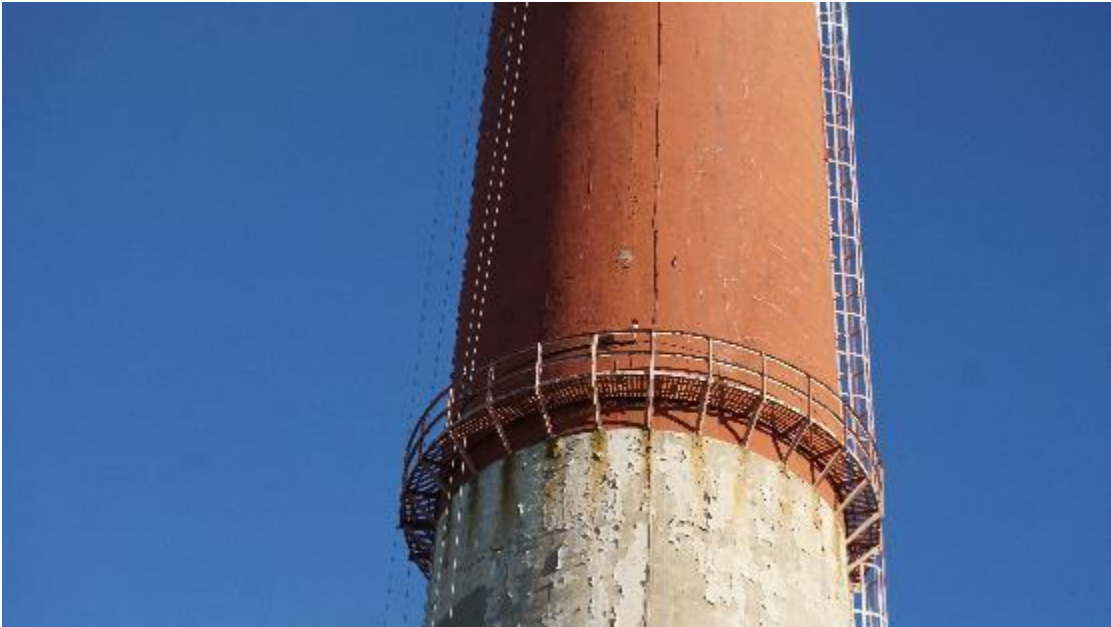
<b>Description:</b> Abatement progress to first platform (101 ft above grade).

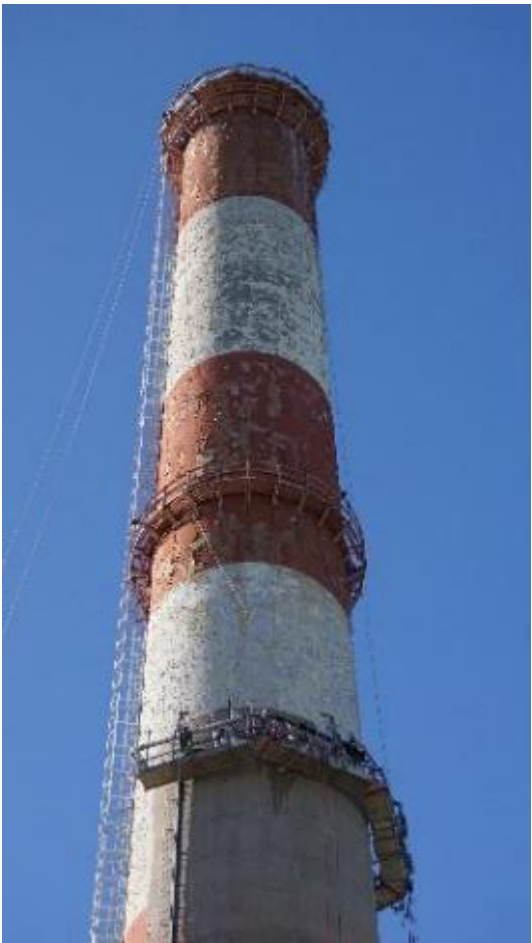
<b>Photo No. 19</b>	<b>Date:</b> 10/20/20

<b>Description:</b> Abatement approaching second platform (209 ft above grade).		
<b>Photo No. 20</b>	<b>Date:</b> 11/05/20

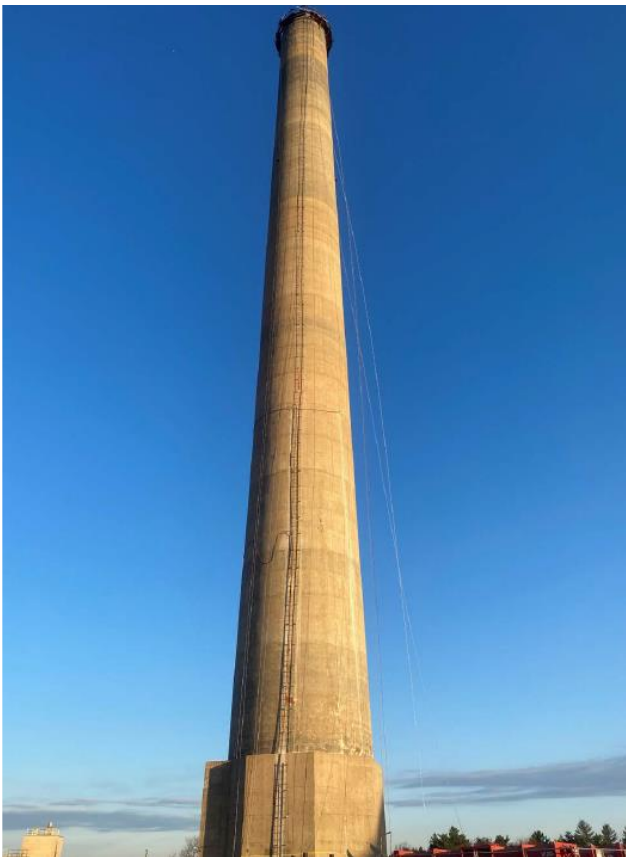
<b>Description:</b> Abatement completed to stack top cap.

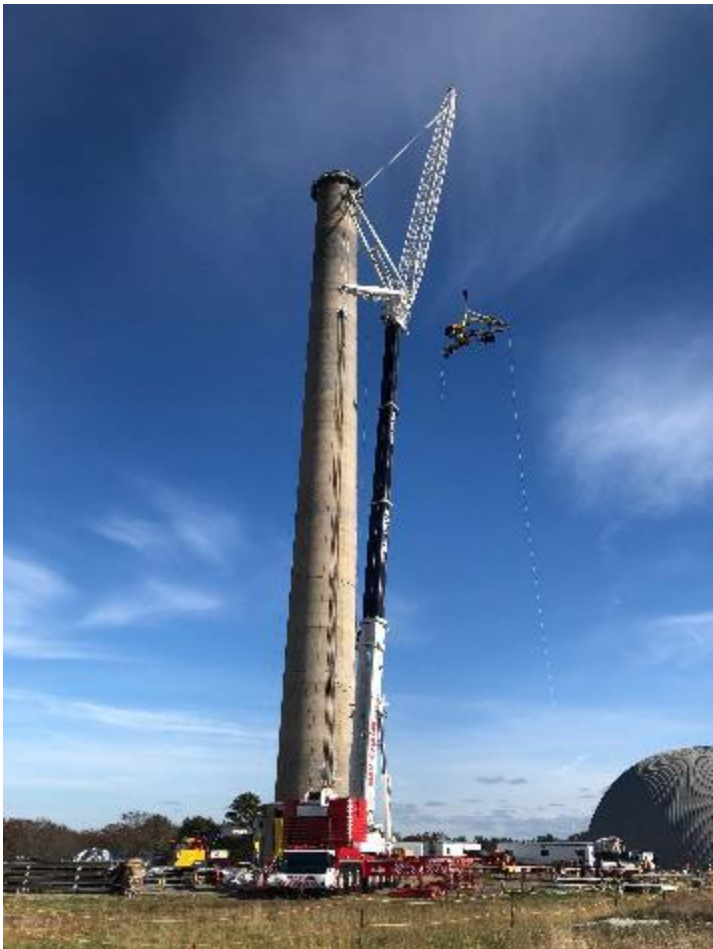
<b>Photo No. 27</b>	<b>Date:</b> 11/18/20

<b>Description:</b> Mantis lift by crane.		
<b>Photo No. 28</b>	<b>Date:</b> 11/18/20

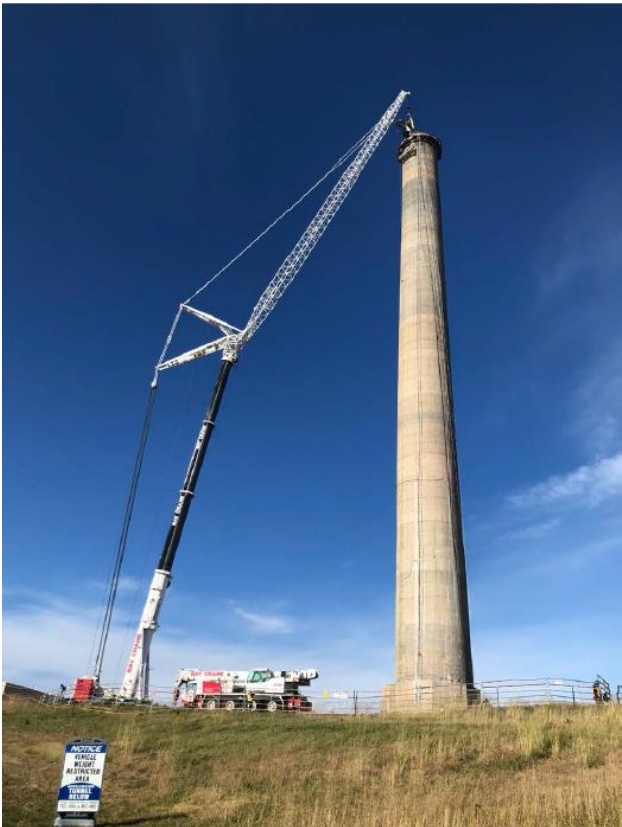
<b>Description:</b> Mantis lift by crane.

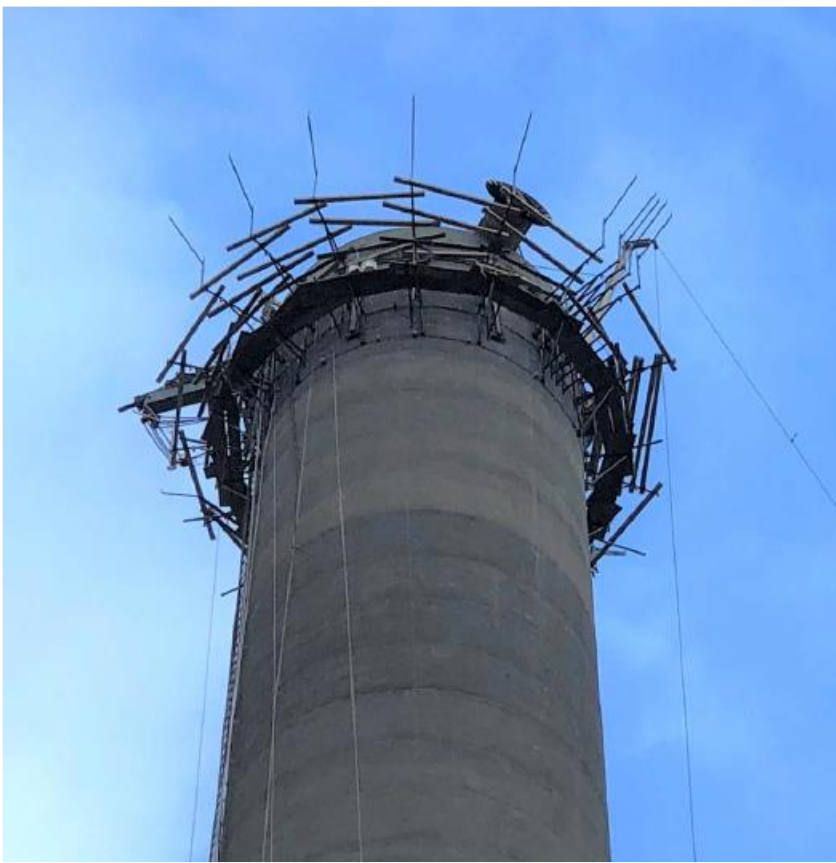
<b>Photo No. 29</b>	<b>Date:</b> 11/19/20

<b>Description:</b> Work platform (K-bracket) preparation.

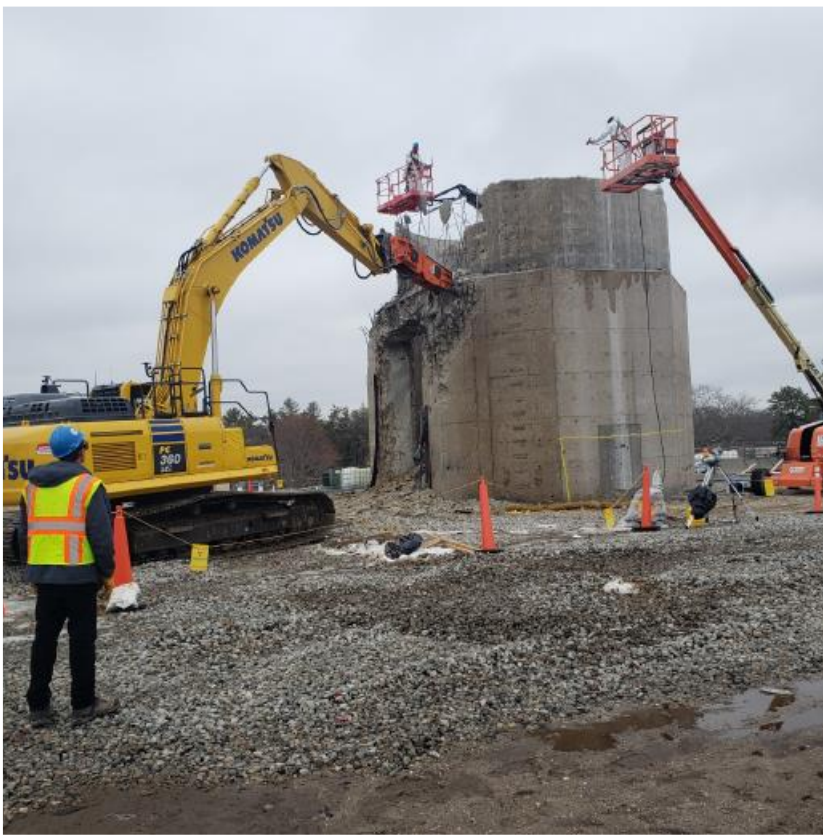
<b>Photo No. 41</b>	<b>Date:</b> 2/15/21

<b>Description:</b> Demolition of stack base.		
<b>Photo No. 42</b>	<b>Date:</b> 2/16/21

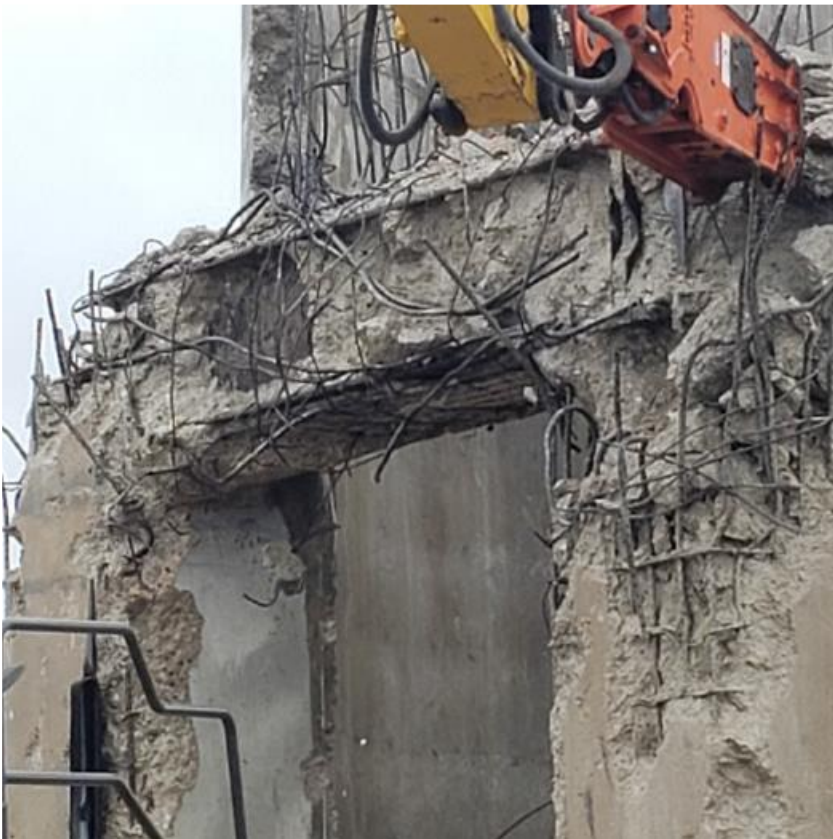
<b>Description:</b> I beam and rebar reenforces concrete over stack breach door.

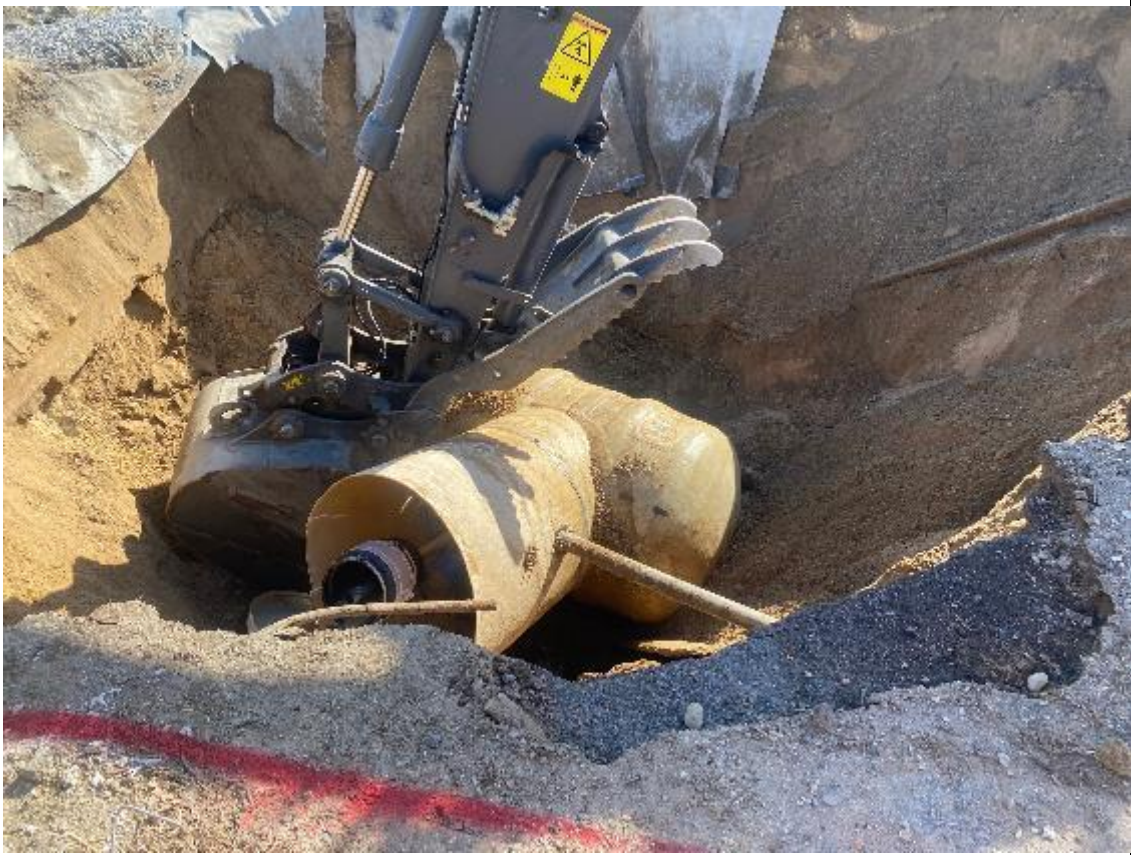
<b>Photo No. 53</b>	<b>Date:</b> 3/5/21

<b>Description:</b> Stack drain tank being removed		
<b>Photo No. 54</b>	<b>Date:</b> 3/23/21

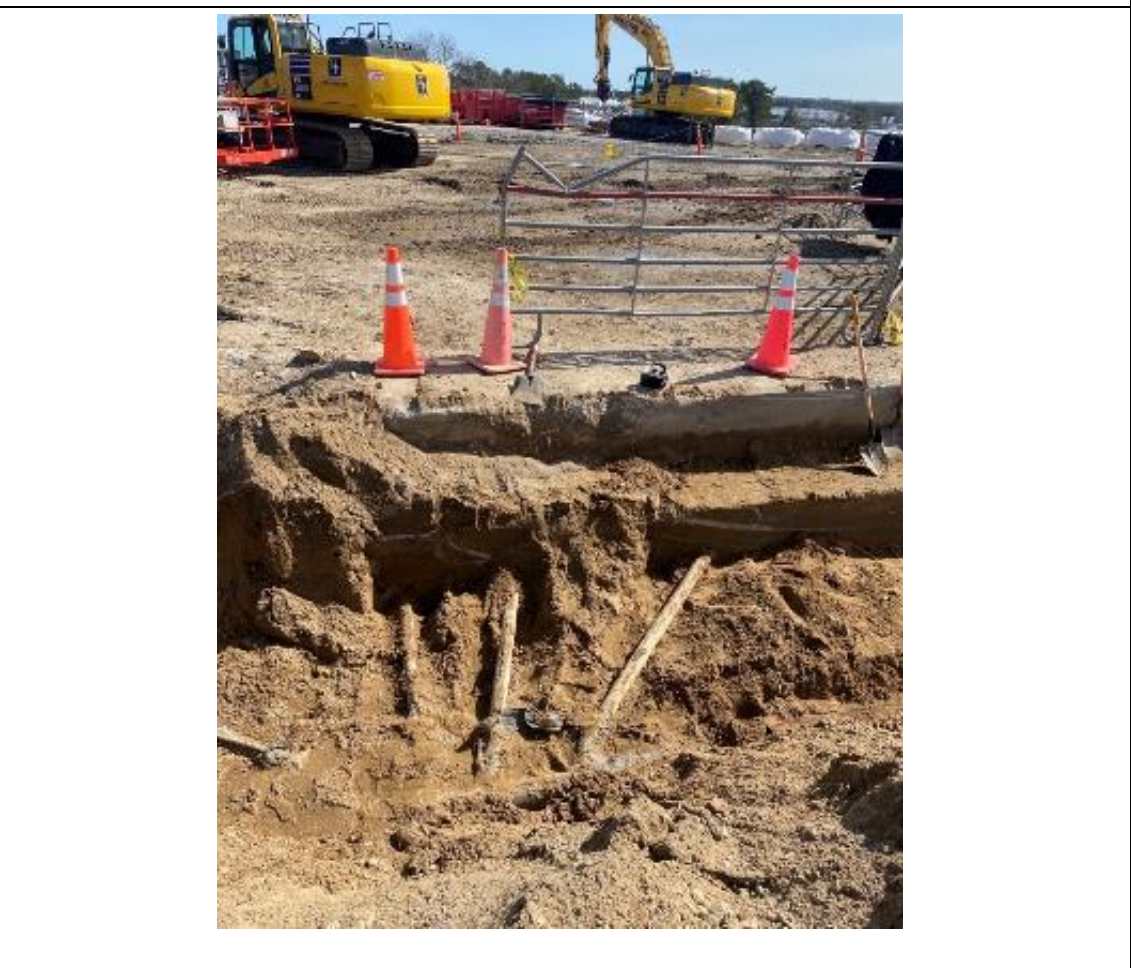
<b>Description:</b> Looking south at the three stack drain pipes entering the pedestal

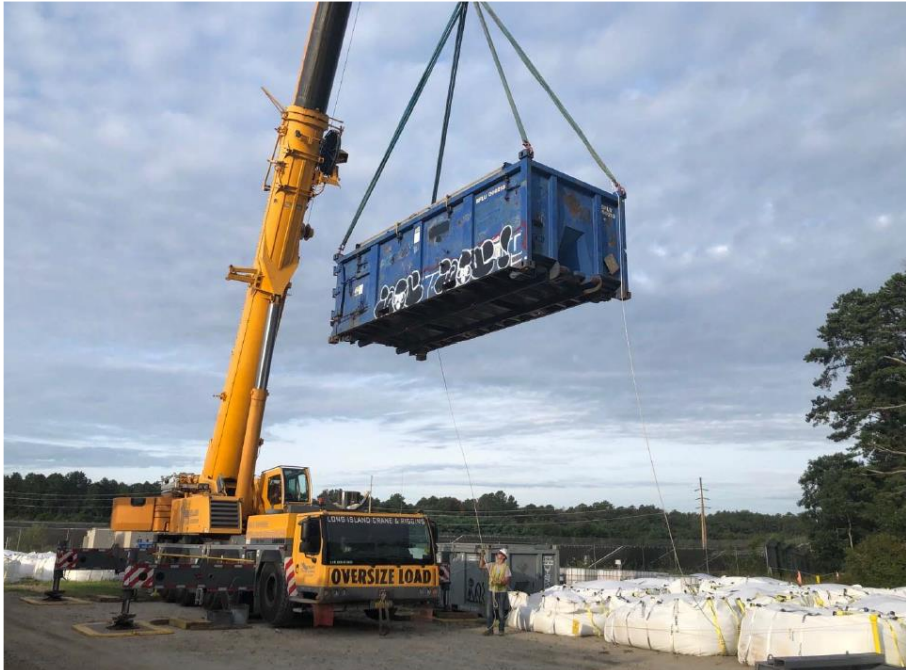
<b>Photo No. 91</b>	<b>Date:</b> 8/17/21

<b>Description:</b> Loading IMCs on a rail car		
<b>Photo No. 92</b>	<b>Date:</b> 8/24/21

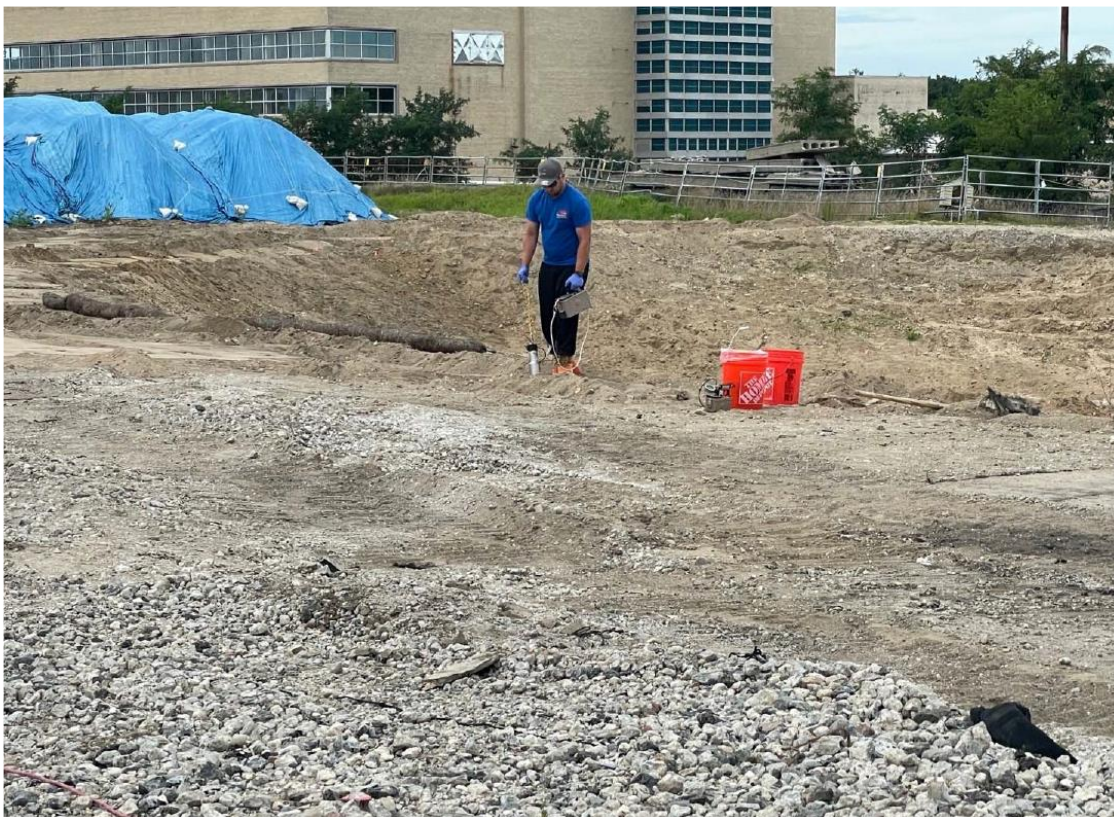
<b>Description:</b> FSS scanning.

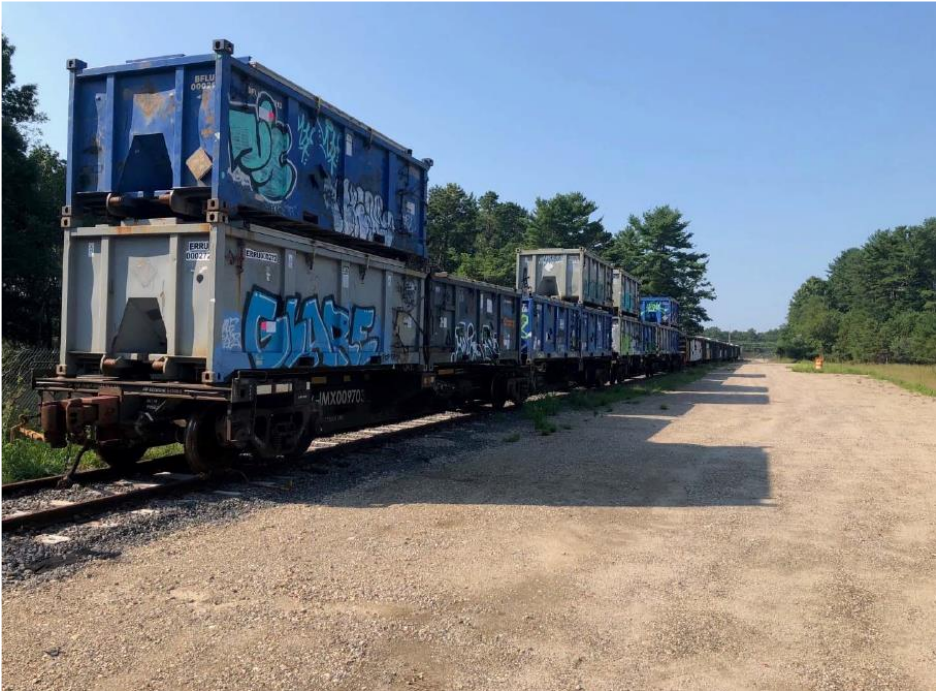
<b>Photo No. 97</b>	<b>Date: 8/29/21</b>

<b>Description:</b> Final rail shipment leaving site.
