# Cryogenic Summary - Testing D2L106 in MAGCOOL, Part 1 100 K Cooldown and Failure of Joint on Heat Shield Line

K. C. Wu  
6/19/03

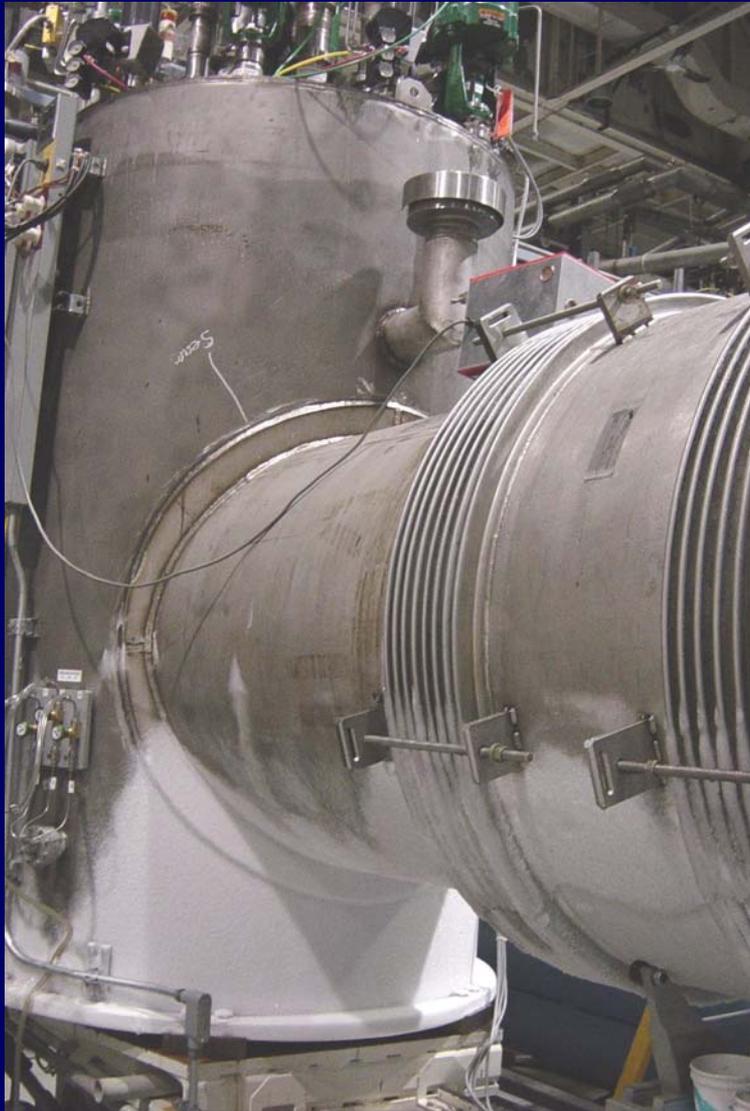
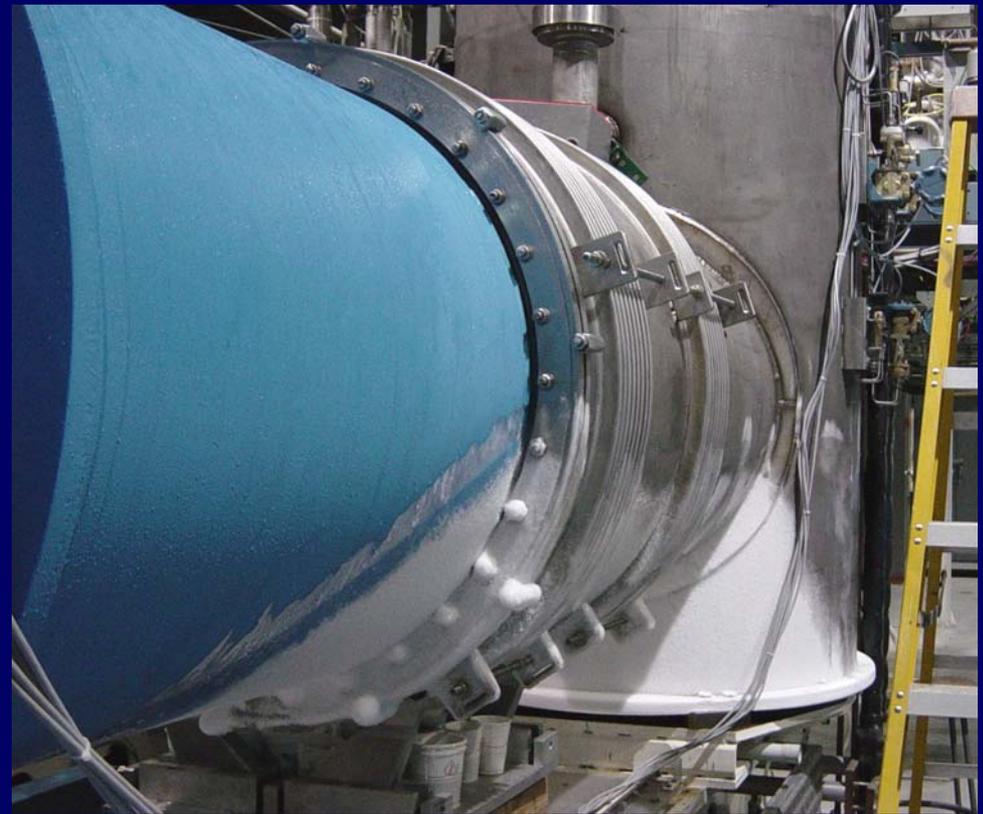
- In the morning of the 3<sup>rd</sup> day (6/14) of 100 K cooldown, significant frosting on Feed Can and Vacuum Bellow was found.
- The magnet is  $\sim 130$  K at that time. LN<sub>2</sub> flow through shield started overnight.
- From overall characteristics and time of occurrence, it is believed that failure in the LN<sub>2</sub> system occurs.
- We terminated cooldown and isolated the system.
- After confirming no helium in the insulating space on 6/16, proceed normal warmup.
- The magnet reaches room temperature on 6/17. The vacuum enclosure is opened for inspection. The leak is found on the joint between the bi-braze coupling and the end plate of the aluminum shield line.

# Frosting of Feed Can and Vacuum Bellow (Photo taken ~ 2 hours after shutdown on 6/14)

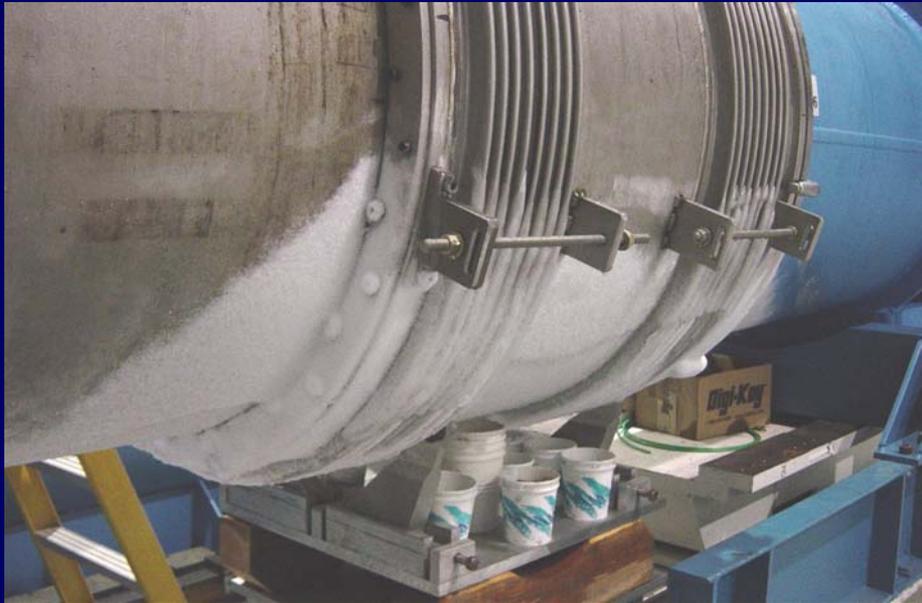
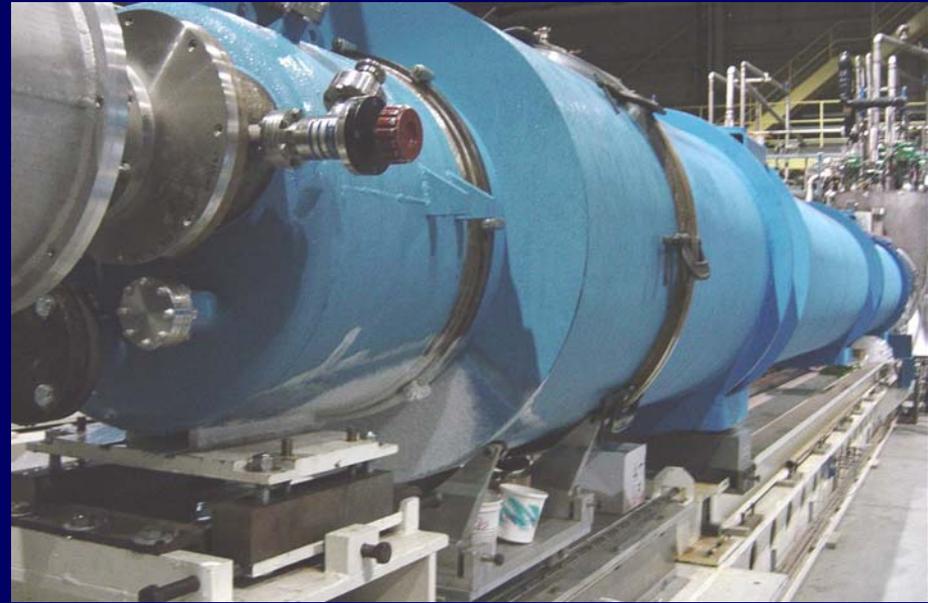
# Frosting of Vacuum Bellow and End Can (Photo taken ~ 2 hours after shutdown)

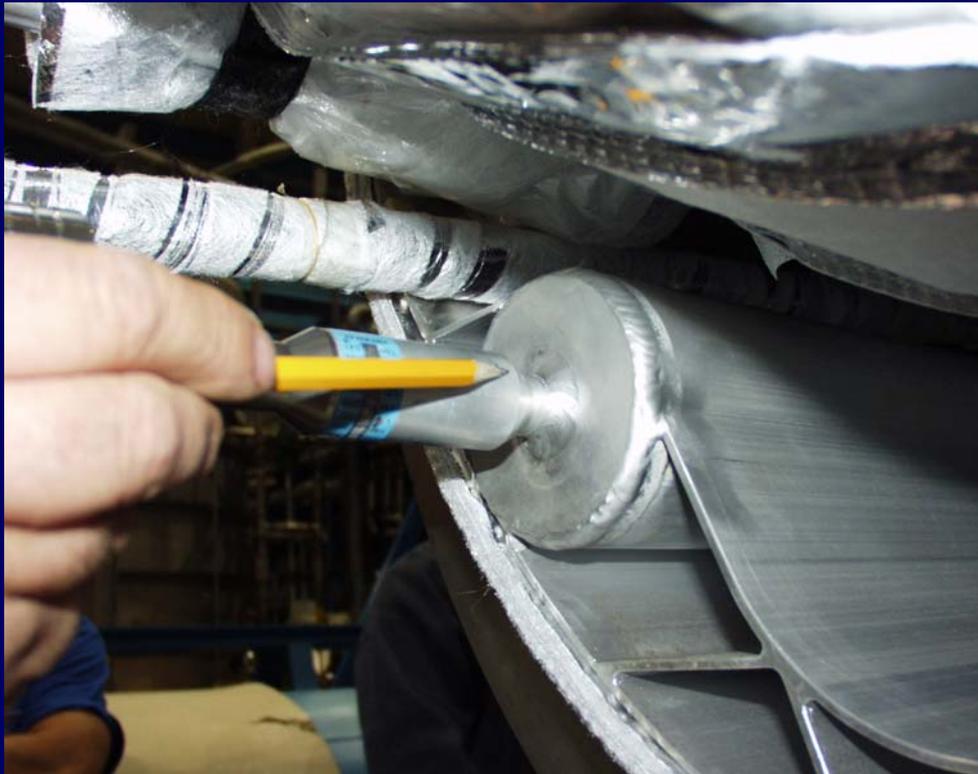
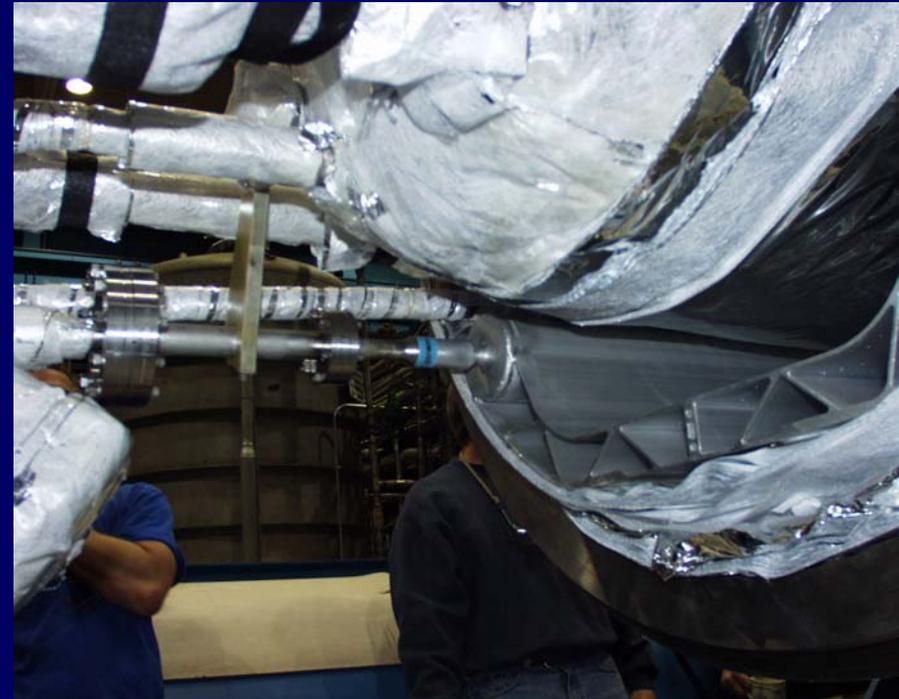
# Leak Occurred on the Joint Between the Bi-braze Coupling and the End Plate of Aluminum Heat Shield Line

- After D2L106 was warmed up, the vacuum enclosure is opened for inspection. Find leak on the joint between the bi-braze coupling and the end plate of the aluminum heat shield line.

- Leak is repaired. Pass vacuum leak check. Repair joint will be pressure tested after the magnet test.
- Carefully mount the supporting bracket. Make sure no stress is introduced on the piping system and pipe is easy to slide through the hole of the bracket.
- Establish insulating vacuum and ready for cooldown. However, check on electrical system and measuring device may be needed since D2L106 was cooled to  $\sim 130$  K and welding work was performed.

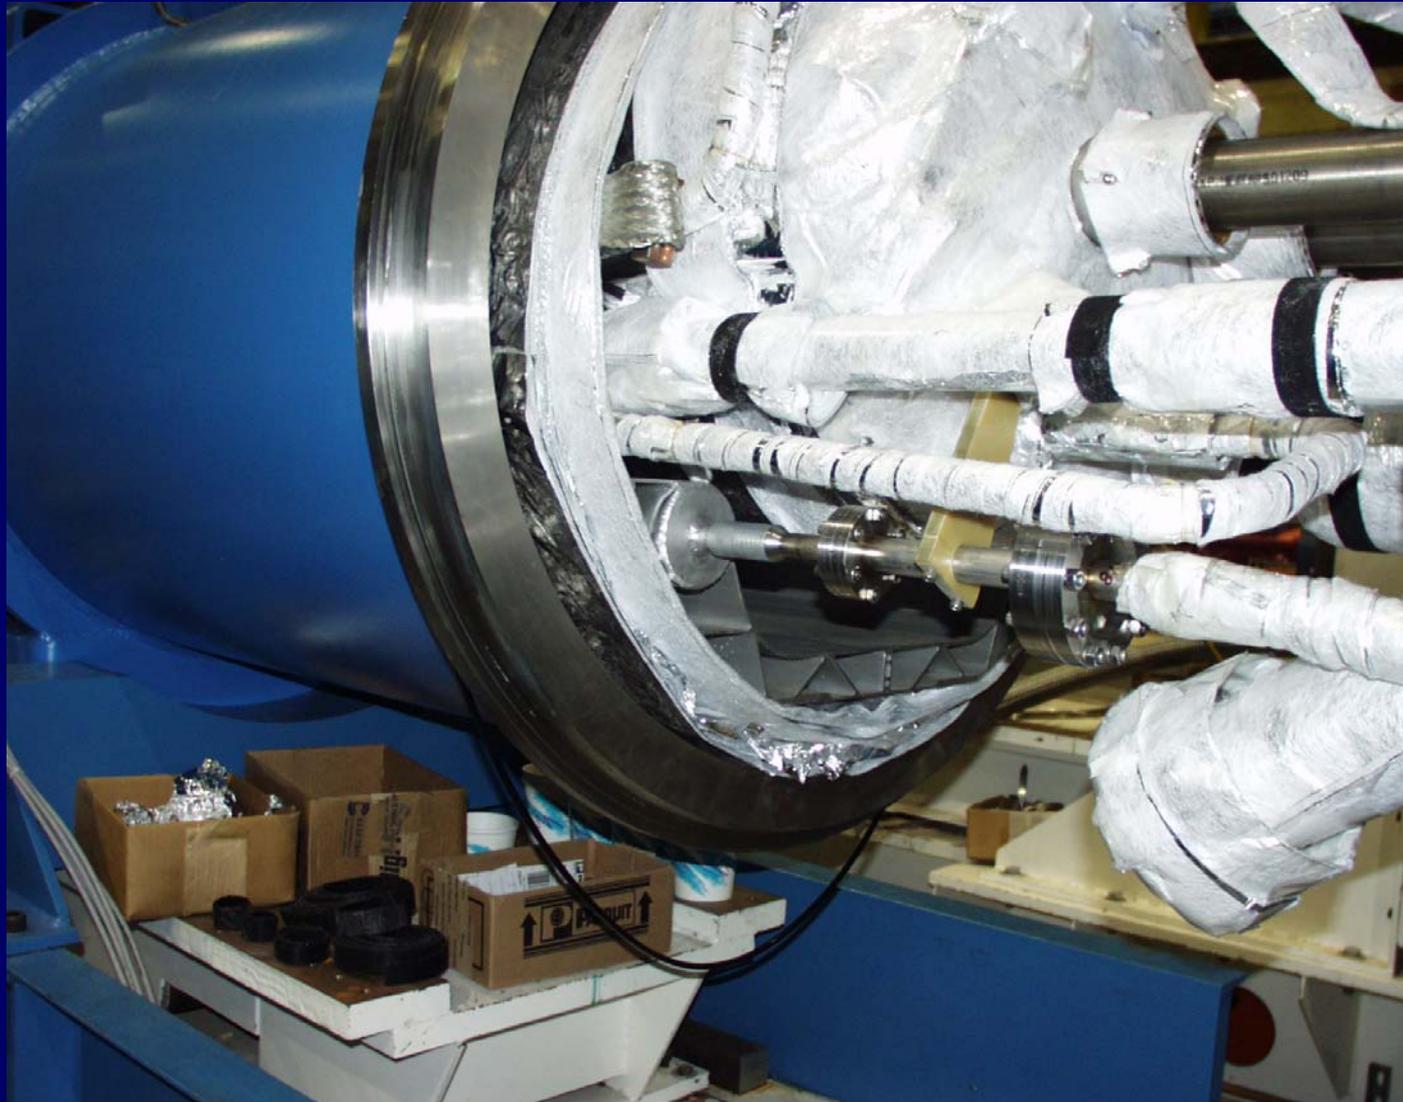
A G-10 Bracket is Used to Support the Bi-braze Coupling and the S.S. Flexible Line for the Test

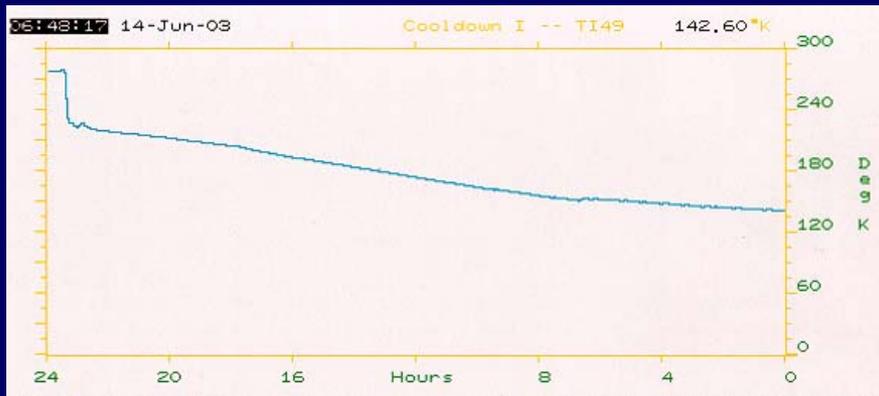
- 100 K Cooldown was terminated in the morning of 6/14 due to significant frosting on the Feed Can, Vacuum Bellow and End Can.
