Critique of Incident

"Omission of Lead glass cover from View Port on X-12C"

Issued: March 27, 2002

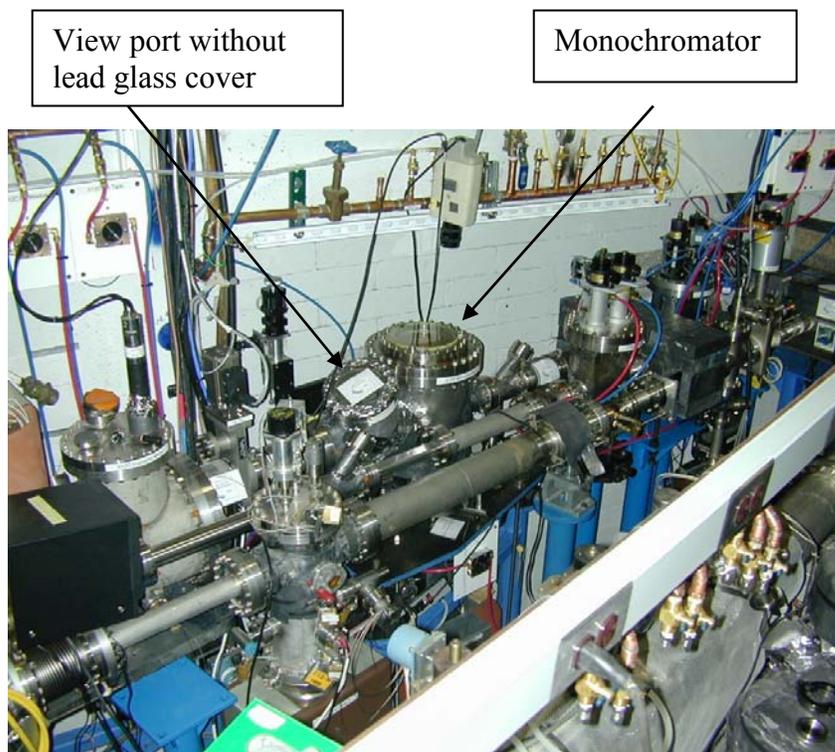
Figure 3

- On the morning of 2/22, the maintenance activities were completed and the beam line configuration was re-established for operation. When the view port was reinstalled by the beam line personnel, the lead glass cover was inadvertently omitted. Checklists were used by beam line and operations staff to confirm configuration before the beam line was enabled. Radiation surveys along the beamline were performed by RCTs following restart and no levels requiring shielding modifications were observed. Neither beam line, Operations, nor Health Physics personnel noticed that the lead glass cover was missing from the view port.

The lead glass plate was not reinstalled on the view port window at the end of maintenance on 2/22.

Inadequate configuration control was exercised following the installation of the view-port and the subsequent maintenance activity.

Photograph of X-12C Monochromator Box and View Port

3. Where possible, provide padlocks for existing and future lead glass covers and include them in the padlock checklist.
4. Conduct a review of all existing beam line safety checklists to ensure completeness.
