University of California, Irvine
Independent Accident Investigation

*Injury and Fire Resulting From
Benzene Vapor Explosion in a Chemistry Laboratory
Frederick Reines Hall,
University of California, Irvine
July 23, 2001*

FINAL REPORT
January 24, 2002

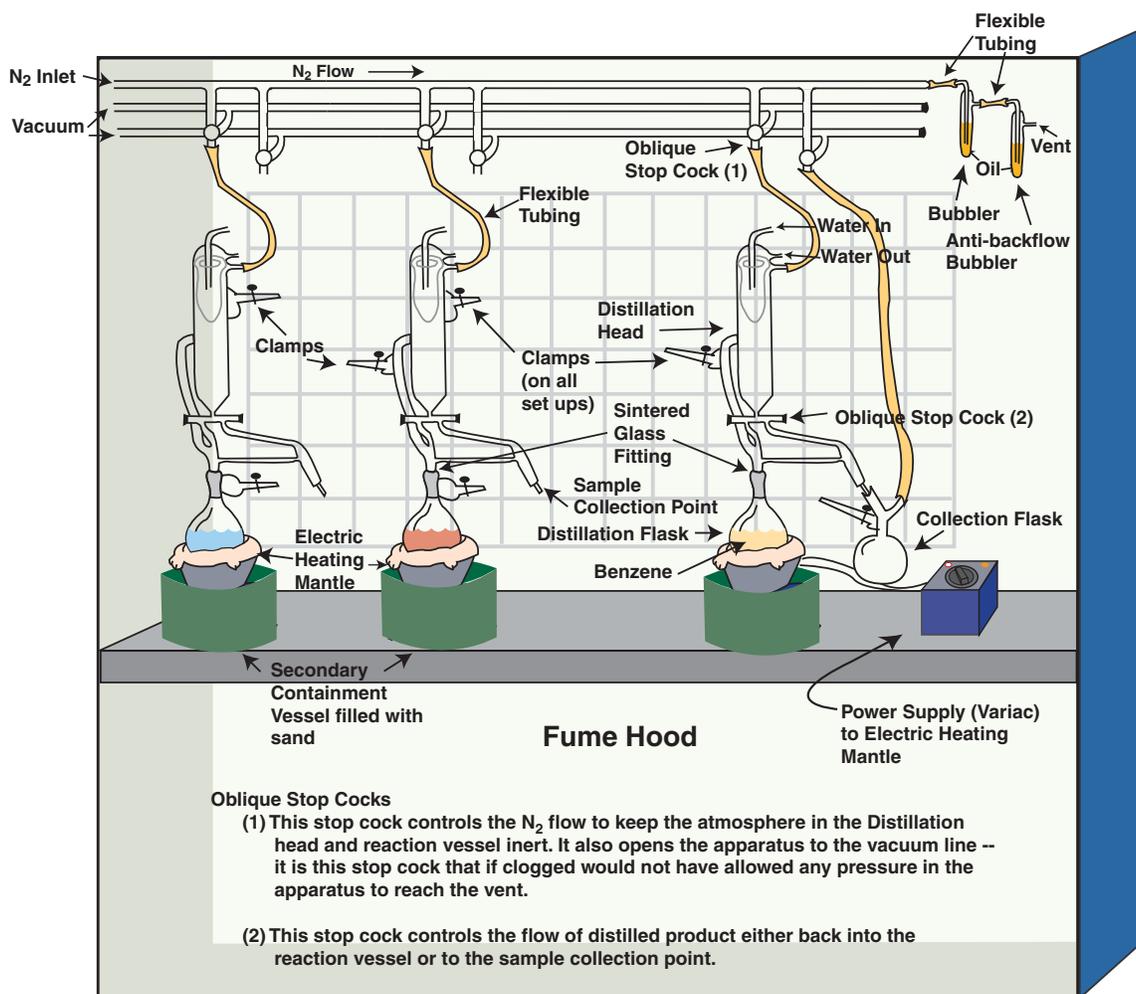
Diagram of Reflux/Distillation Process

The distillation procedure involves refluxing the solvent and a small amount of benzophenone in an inert atmosphere over sodium or sodium/potassium. As the reflux proceeds, and the moisture and oxygen are removed, the benzophenone ketyl develops a deep blue color, which indicates that the solvent is ready for recovery by distillation and subsequent use. Usually the reflux process is continued for several hours to ensure solvent purity. See diagram of the reflux/distillation process at the end of the Executive Summary.

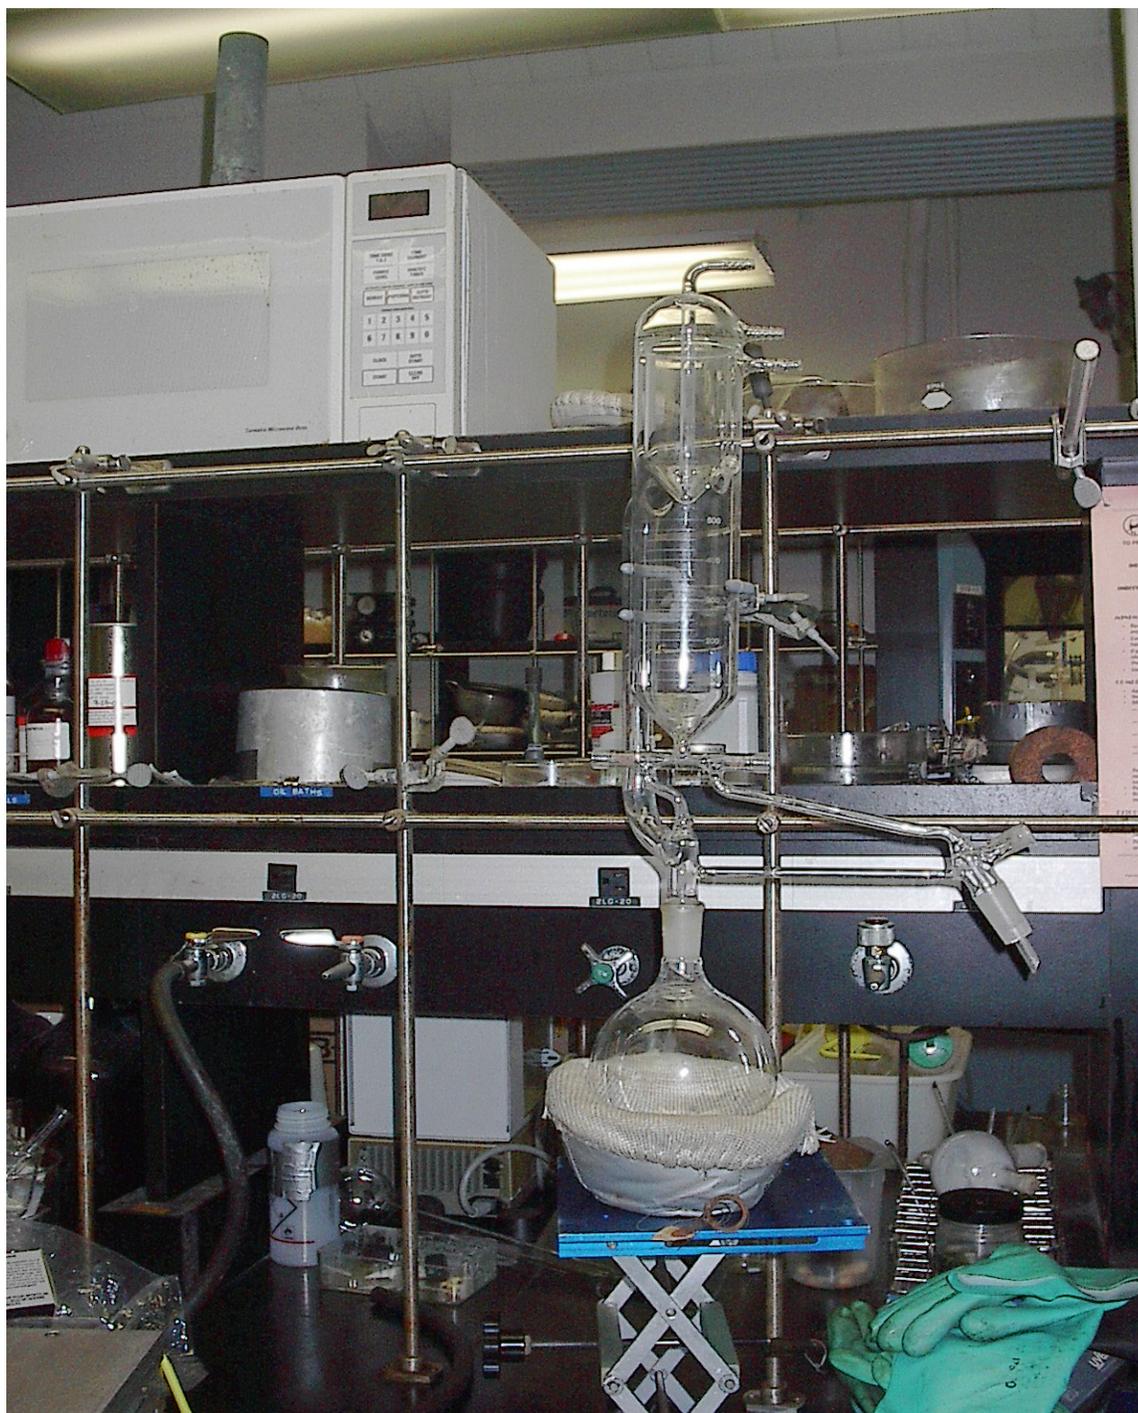
Photograph of the distillation/reflux apparatus that was involved in the incident in Reines Hall on July 23, 2001. This photograph shows the glassware used and was constructed by Dr. Evans to assist the Investigation Team visualize the set-up involved in the incident.
