# Operating Experience Summary

U.S. Department of Energy  
Office of Environment, Safety and Health  
OE Summary 2006-07  
June 16, 2006

## Risk-Taking and Shortcuts Result in Welder Fatality at BP Pipeline

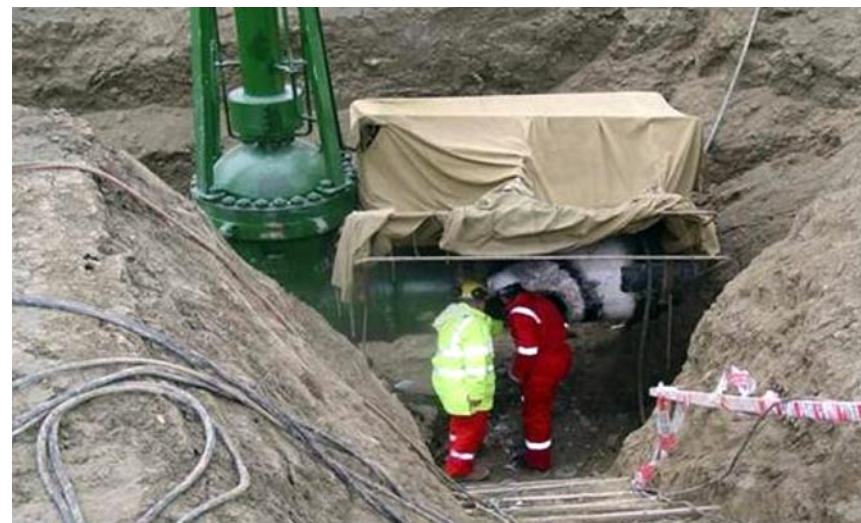
An experienced work crew had welded a 30-inch gate valve into a run of pipeline. The pipeline had been buried 9 months earlier, but was excavated to allow the pipe to be cut and the valve to be welded in place. Figure 1-1 shows the large gate valve and section of pipe in the excavation. After the gate valve was installed, radiographic inspections showed weld defects.

**Figure 1-1. Gate valve (green) and pipe section under tarp where fire occurred**

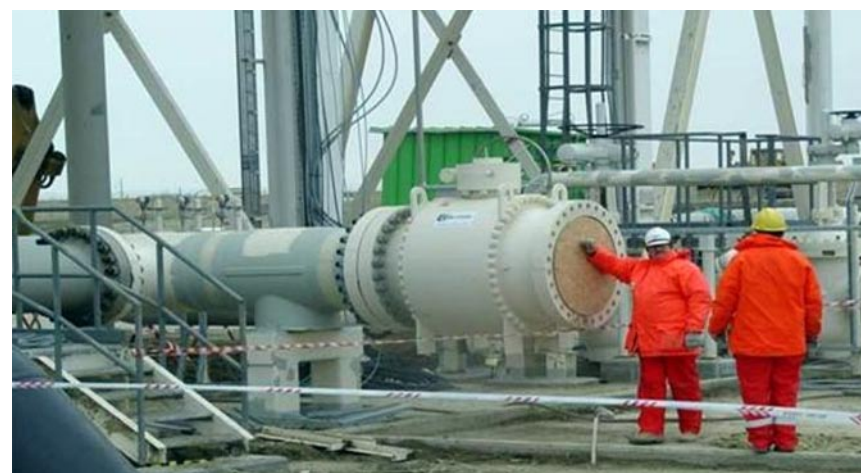
The welder entered the pipe feet first through a large above-ground ball valve. Figure 1-2 shows the ball valve and entrance point. The welder had a rope and welding cable tied to his body

**Figure 1-2. The ball valve and point of entry into the 30-inch pipeline**

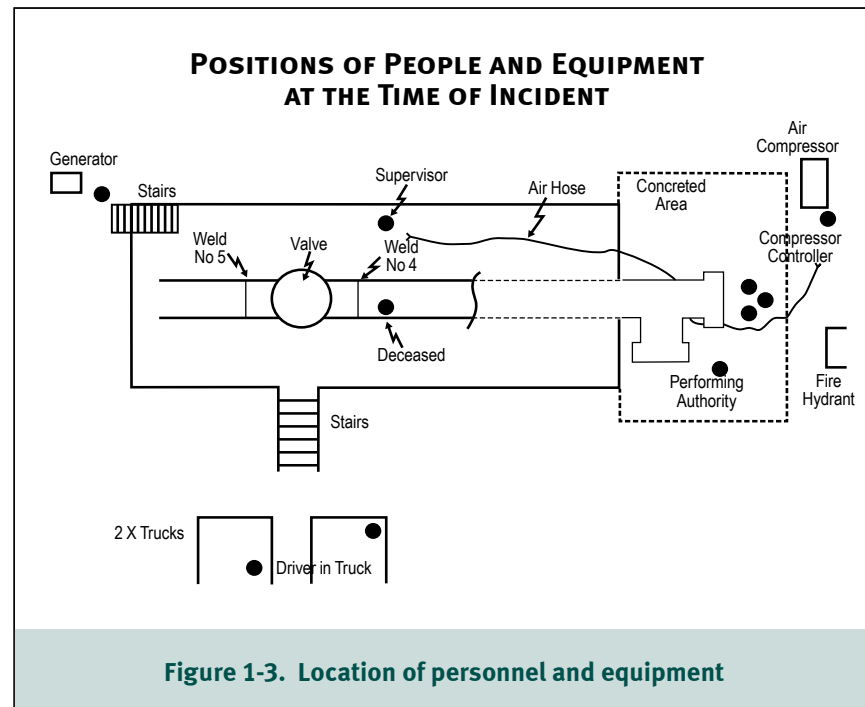
The welder had completed about 20 cm of the weld when the work crew heard him call out that he was burning. The crew attempted to pull the welder from the pipe, but the rope and welding cable became disconnected from the welder and pulled free. The crew heard no further sounds from inside the pipe as they saw smoke pouring from its open end. Rescuers later confirmed that the welder had died. Figure 1-3 shows the location of workers at the time of the accident.

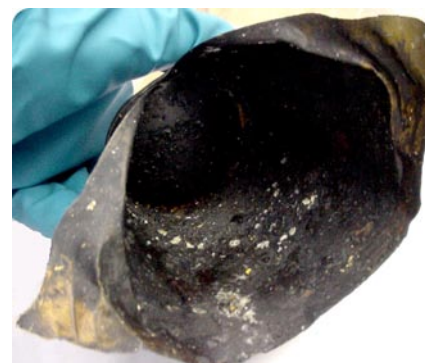
The manufacturer of the graphite product, Acheson Colloids, Inc., stated that there are two possible scenarios that would result in a can rupture: ambient temperatures at or above 120°F; and propellant leaking from the can and reacting with other substances. The temperature in the room was estimated to be 65°F. Investigators noted, however, that the can was rusted on its bottom edge (Figure 2-1). They also determined that the product's shelf life of 2 years (as stated on the manufacturer's [Product Data Sheet](#)) had been considerably exceeded, as the can was purchased in 1994. Figure 2-2 shows the internal corrosion and the failure points on the can.

Figure 2-2. Internal corrosion

- Wherever possible, substitute chemicals that are less hazardous, toxic, or volatile. (In the case of the graphite lubricant, for example, the product is also available in a non-aerosol brush-on form.)

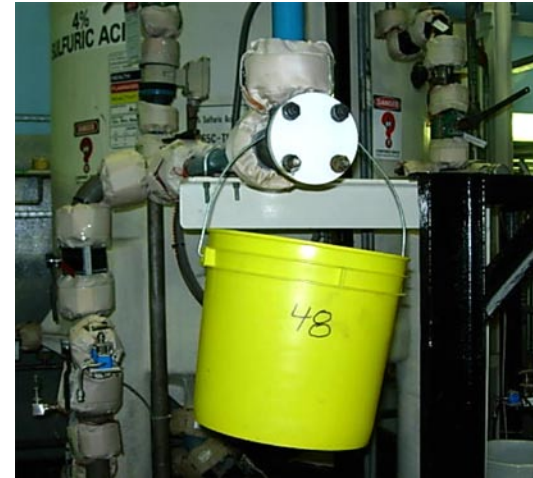
The work involved installing a metal blind flange cover over an existing Teflon® flange to reduce the potential for leakage. Figure 3-1 shows the flange. A shift operations manager prepared the TAF, which included instructions for boundary isolation and for draining the piping system. A technical reviewer walked down the TAF. Both the preparer and reviewer referred to a Piping and Instrument Diagram (P&ID) while performing their tasks.

**Figure 3-1. Blind flange with catch bucket**

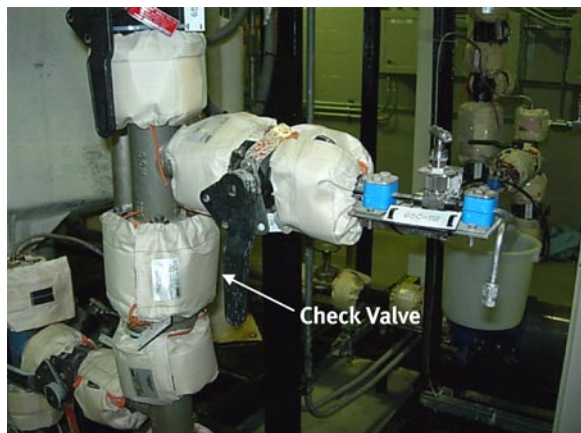
During the critique, investigators learned that there was a pump discharge check valve in the piping. The check valve, which allows flow in only one direction, caused liquid to be retained in the downstream piping. Figure 3-2 shows the check valve in a vertical run of pipe. In addition, there was approximately 27 feet of vertical head from where the blind flange was being worked on to where the line was vented.

**Figure 3-2. Check valve hidden by flange guard**

- Workers at ETF had installed flange guards throughout the piping systems to identify and control system leaks. The check valve was not visible in the field because it was hidden by the flange guard, and the valve label was also underneath the flange guard. This situation decreased the probability of identifying the check valve unless someone was specifically looking for it.

*Action: A system walkdown will be conducted to verify that all check valve labels are visible.*

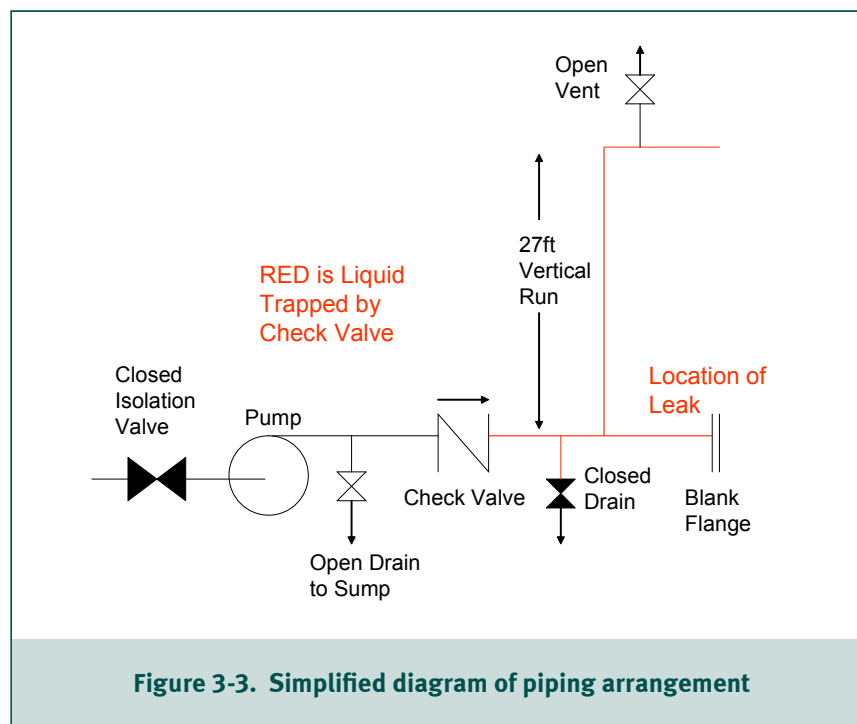
A simplified diagram of the piping arrangement is shown in Figure 3-3. The diagram shows the drain location selected

was on the wrong side of the check valve. Another valve, shown downstream of the check valve, could have been used to drain and depressurize the piping.

Because the TAF identified a drain valve that was located upstream of the check valve, the safe-to-work check did not effectively verify the safety and operational status of the system. The drain valve only drained liquid from a small portion of the piping associated with the pump discharge and recirculation line. This drained liquid was directed to a sump through a temporary hose. Operators had allowed the piping to drain to the sump for about 30 minutes before they noticed a small rise in the sump level. They assumed this level change was the drainage from all the piping covered by the TAF.

**Figure 3-3. Simplified diagram of piping arrangement**
