# OPERATING EXPERIENCE SUMMARY

**U.S. Department of Energy**  
**Office of Environment, Safety and Health**  
OE Summary 2003-23  
November 17, 2003

### 1. NEAR MISS: BREACHED PRESSURIZED FIRE EXTINGUISHER BECOMES A PROJECTILE

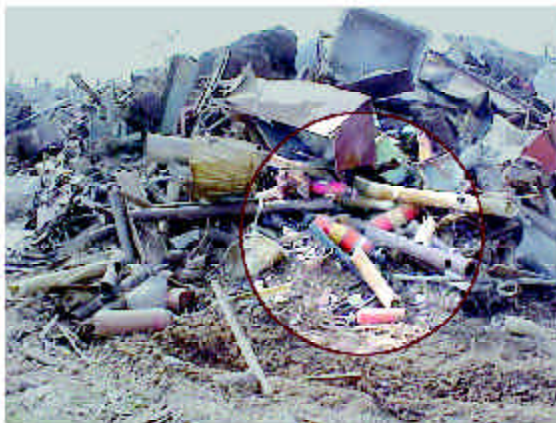
The debris in the scrap pile comprised legacy material that had been in the scrap yard for 15 to 45 years. The operator moved a large piece of metal and noticed some portable fire extinguishers at the base of the pile that had the discharge valves removed, so he knew they were depressurized. Figure 1-1 shows the debris pile and several discarded fire extinguishers. He decided to consolidate the pile and push it away from the roadway to improve access. The operator was pushing the pile, with the shear in the open position, when a fire extinguisher and another piece of metal lodged in the jaws of the shear.

*Figure 1-1. Debris pile with discarded fire extinguishers*

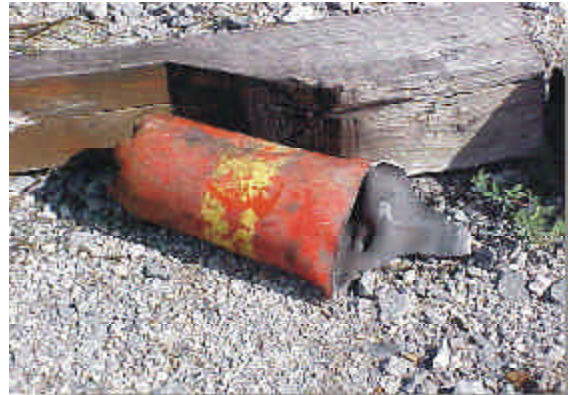
On October 13, 2003, at the Paducah Gaseous Diffusion Plant scrap yard, the cutting attachment (shear) on an excavator breached the cylinder wall of a pressurized fire extinguisher while the excavator operator was sorting and segregating debris. Rapid depressurization of the cylinder caused the lower section to become a projectile that arced 250 to 300 feet in the air, flew across a road into another scrap yard a few hundred feet away, and fell to the ground about 60 feet from two scrap yard workers. How the pressurized fire extinguisher got into the scrap pile has not been determined. No injuries resulted from this near-miss incident. (ORPS Report ORO--BJC-PGDPENVRES-2003-0016)

The valve end of the fire extinguisher was obstructed by the piece of metal, so the operator could not see it, but he had no reason to believe that its discharge valve had not been removed as those on the other extinguishers he'd seen had been. When he closed the jaws of the shear to dislodge the debris, the fire extinguisher broke in half and rapidly depressurized. Figure 1-2 shows the portion of the fire extinguisher that became a projectile, and Figure 1-3 shows where it came to rest.

*Figure 1-2. Portion of the fire extinguisher that became a projectile*

Corrective actions taken as a result of the incident and implemented before scrap yard operations resumed included the following.

- All personnel attended a safety stand-down meeting that included a detailed presentation on the incident, training on heavy equipment safety, compressed gas cylinder awareness, Integrated Safety Management, and reinforcement of on-the-job safety practices.
- Safety analysts revised the Activity Hazards Analyses for project tasks to specifically address pressurized containers.
- ES&H personnel walked down accessible scrap yard areas to search for any other pressurized containers. (They found a pressurized carbon dioxide cylinder, last hydrotested in 1963, and safely depressurized it.)
- Site management personnel walked down accessible scrap yard areas to identify any other potential safety hazards or concerns.
- Managers reminded site workers of their stop-work authority/responsibility when they identify suspect pressurized containers or other hazardous conditions.

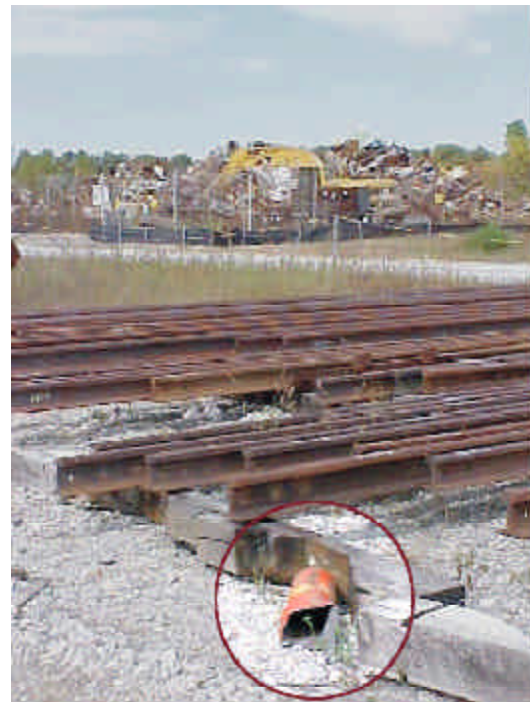
*Figure 1-3. Final location of the fire extinguisher projectile*

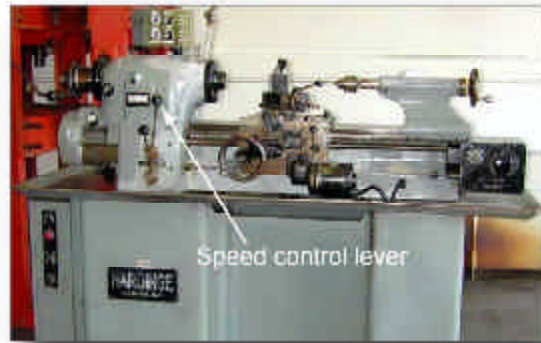
Figure 3-1. Hardinge Brothers lathe

The operator was trained and designated for independent lathe operation. He had set up the lathe (Figure 3-1) to machine a 38-inch length of 3/8-inch brass tubing, with the machine shop supervisor observing. A critique committee determined that three factors contributed to the accident.

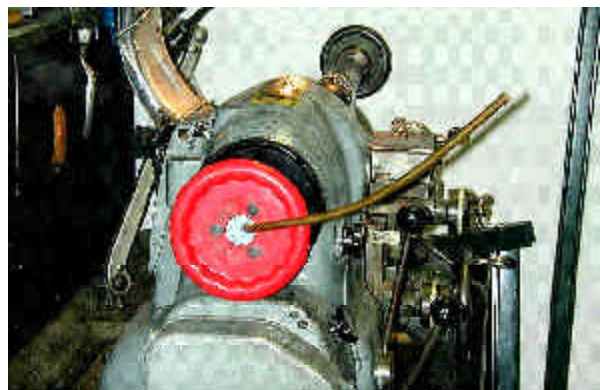
1. The tubing extended approximately 13 inches beyond the collet drawer bar take-up wheel and was not supported (Figure 3-2). Although the job requirement was to machine a bushing no longer than 1 inch, the operator chose not to cut the stock to the proper length before machining.

2. A single speed control lever is used to start the lathe in low or high speed and to stop the lathe. Before machining the tubing, the operator determined that the low speed setting of 900 revolutions per minute (rpm) was satisfactory for the job, but he did not consider that the high-speed setting was 2,700 rpm.
3. When the operator set up the lathe, he inadvertently started it at high speed. This caused the extended portion of the tubing to bend from the force of the higher rotational speed.

Figure 3-2. Lathe with bent tube extension

- Do not permit metal stock to extend beyond the collet take-up wheel of the headstock. If the metal stock must extend beyond the collet take-up wheel, support the extended material.
- When machining material in low speed, adjust the high speed setting to the low setpoint to avoid inadvertently over-speeding the lathe.

Caution signs have been posted on all lathes warning operators to support all work piece extensions, and operators will receive new, written guidance for safe lathe setup and operation that incorporates the recommendations of the critique committee.

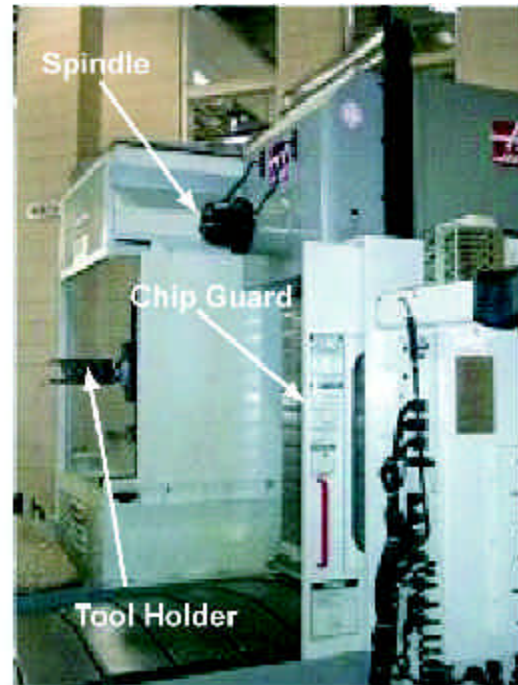
*Figure 3-3. Haas milling machine*

Shop personnel designed and fabricated the tool arbor specifically for use with a Haas Model HS-6R horizontal milling machine (Figure 3-3) that would be used to machine 40 pieces in 10 batches. Because each batch would be cut differently, the night shift supervisor prepared a new machine program for each batch. During pre-job testing, the supervisor and a machinist determined that the optimum pro-grammed spindle speed was 750 rpm. Machinists completed work on seven batches between August 4 and August 7 without incident. On August 8, a machinist began loading the eighth batch into the milling machine. He started the program without verifying the spindle speed, and the machine accelerated toward 7,500 rpm emitting a high-speed sound that led the machinist to push the Emergency Stop button. As the spindle was braking, the tool arbor started to bend from decelerating forces and broke at the point where it was clamped into the tool holder. Figure 3-4 shows the arbor and cutting blades after the accident.

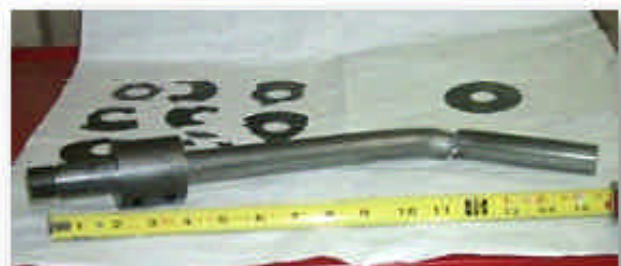
On August 8, 2003, at the BNL heavy machine shop, the night shift supervisor incorrectly programmed a horizontal milling machine, causing it to overspeed and break the tool arbor. A piece of the arbor flew up and struck an I-beam, a horizontal structural member, and the milling machine electrical panel before falling to the floor. No one was injured, and only the tool arbor was damaged. (ORPS Report CH-BH-BNL-BNL-2003-0012)

- The night shift supervisor erroneously entered a spindle speed of 7,500 rpm instead of 750 rpm into the machine program, which caused the spindle to rotate at speeds greater than the critical speed for the arbor.
- There was no procedure or requirement for the machinist to verify the programmed spindle speed before running the milling machine.
- The night shift supervisor proposed an arbor 2 inches in diameter with a 1-inch end-step for attaching the cutting saws. However, the day shift

- Because BNL considered the tooling job as “skill of the craft,” they performed no work planning or safety review before fabricating the tool arbor. The arbor configuration may have contributed to its failure when decelerating from 7,500 rpm.
- No physical barriers were in place to protect personnel and equipment.

*Figure 3-4. Broken tool arbor and cutting blades*

1. Rewrite the machine program to display a text message directing the machinist to verify the programmed speed before starting the machine.
2. Test the programmed speed of the machine arbor behind protective barriers before starting a job.
3. Establish exclusionary zones around the machine in accordance with the manufacturer's recommendations.
4. Revise the work planning procedure to require a safety review and work planning meeting before fabricating special tools for the milling machine.
5. Conduct toolbox talks with heavy machine shop personnel to discuss good practices and the lessons learned from this event.
6. Review and evaluate other BNL machine shops for safe operations and work practices.
