# Poll from October 8, 2015 BNL Community Advisory Council Meeting

## **Five-Year CERCLA Review**

Community Advisory Council Input October 8, 2015

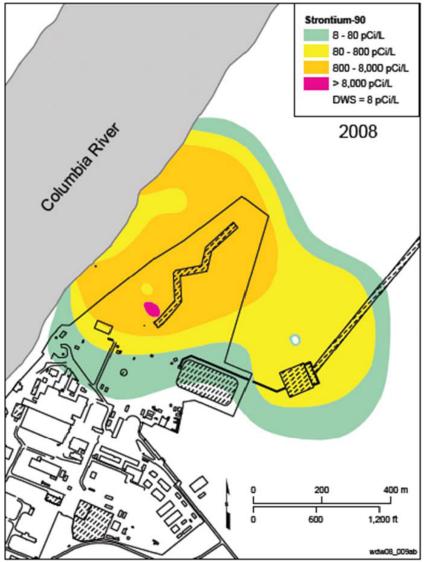
The continued high-level of Sr-90 near the river led to the development of another approach to remediation. In 2008 a permeable reactive barrier (PRB) using Apatite-forming minerals was created by injection into 10 wells along the Columbia River shoreline to create a 90-meter (300-foot) long barrier. Apatite minerals sequester elements into their molecular structures via substitution, whereby elements of similar physical and chemical characteristics replace calcium, phosphate, or hydroxide in the hexagonal crystal structure. Sr-90 replaces calcium and becomes immobilized. The data from this work indicates that apatite sequestration is effective for immobilizing Sr-90 in situ. In 2010 the Record of Decision (ROD) was amended and the selected remedy became the apatite PRB. The PRB was extended to a length of approximately 760 m (2,500 ft.), immediately adjacent and parallel to the Columbia River. This will provide increased protection of the Columbia River by immobilizing, and therefore, removing Sr-90 from the groundwater before it enters the river.

Figure 1 Strontium plume at the Hanford site along the Columbia River in 2008.

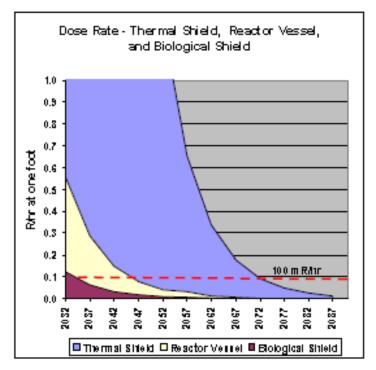
In 2007 the estimated inventory of the HFBR complex was 65,000 Curies and the peak dose rate from the most activated component was close to 1000 Rem/hr at a distance of one foot in air. The most radioactive components were the thermal shield, control rod blades, and reactor internals. The activated components are large and would require cutting to fit into transportation casks. The initially high dose rate would make handling of the activated components difficult and would require cutting operations to be performed under water to provide shielding. The nuclear industry standard to separate a high radiation area from a radiation area is a dose rate 100 mrem/hr at 1 foot in air. For this reason, a dose rate of 100 mrem/hr was chosen as the level to begin dismantlement of the reactor components if a long storage period was selected. Figure 1 shows the predicted dose rate at 1 foot from the major reactor components over time. The dose rate from the highest activity component will decrease below 100 mrem/hr in 2072.

Figure 1 Predicted dose rate in various components in 2032 - 2087.
