***Restoring a Damaged 16-Year-Old Insulating
Polymer Concrete Dike Overlay: Repair Materials
and Technologies***

Toshifumi Sugama

September 2006

**Final Report
(February 2002-July 2006)**

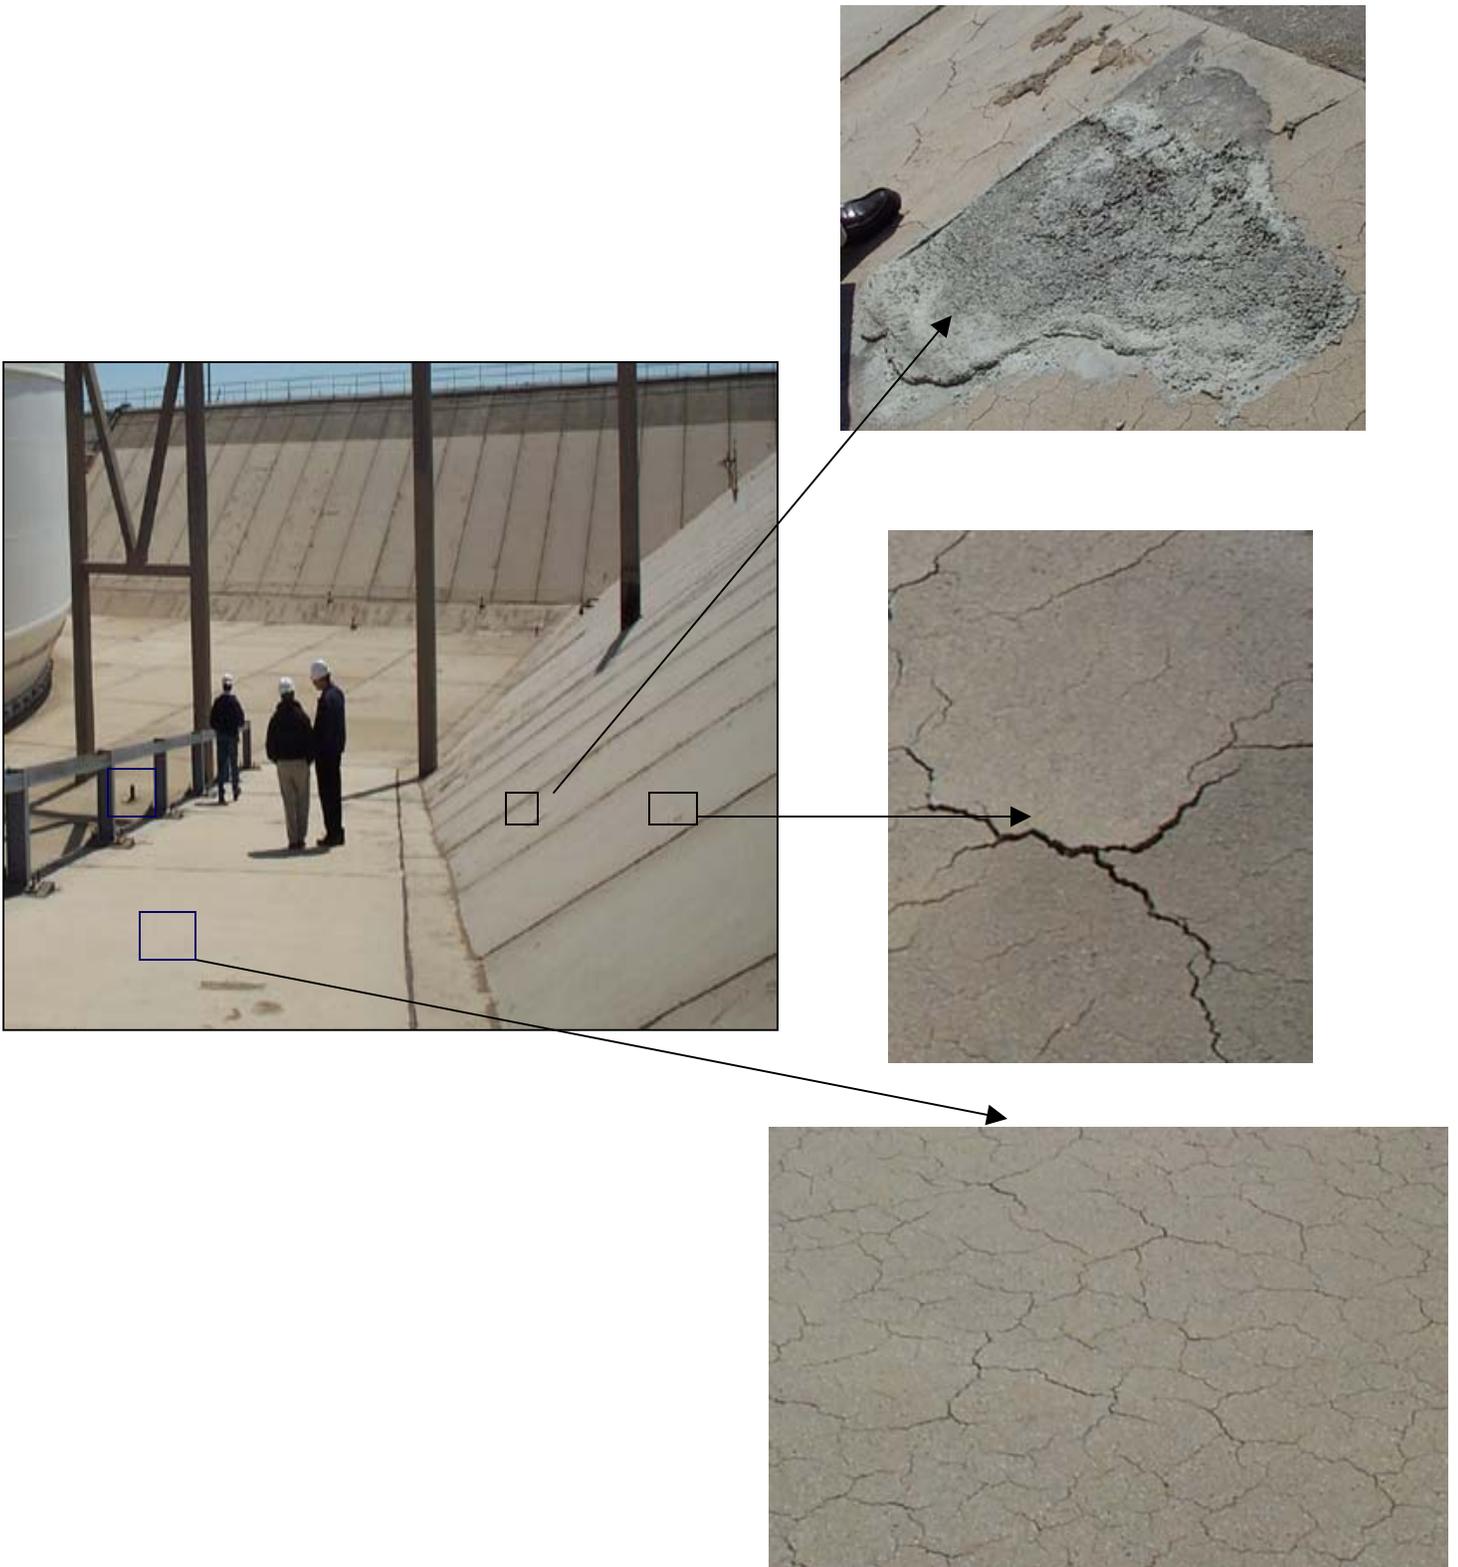
The damage assessments of the 16-year-old ILPC overlays consisting of a polyester polymer as the binder and lightweight multi cellular glass beads as thermally insulating aggregates revealed that the polyester binder had degraded due to exposure to ultraviolet (UV) radiation during those 16 years, which then promoted its saponification. Although the insulating property of ILPC remained in effect, the degradation of the polyester by the combination of UV radiation and saponification caused some degree of shrinkage of ILPC overlays, thereby resulting in the development of three different types of damage: 1) potholes created by spalling of the ILPC; 2) delamination of ILPC layers from the underlying concrete and their blisters; and, 3) evolution of map cracks and fissures. Type (1) damage was negligible; most of damages were types (2) and (3).

In June 2002, KeySpan Utility Services LLC and BNL visually inspected the 16-year-old ILPC panels to assess any damages and deteriorations. The assessment revealed that there were primarily three types of damages that needed to be addressed (Figure 1). First, spalling of the ILPC had created potholes; second, delamination of the ILPC had uplifted it from the underlying concrete; and, third, map cracks had developed in the ILPC's surfaces. All the types of damage were observed on the sloped sidewall panels. The failure mode of the floor overlay was due mainly to the last type of damage. Fragments of the damaged overlay were brought back to BNL to assess why such failure occurred. The results from the microprobe and spectroscopic analyses for these fragments were as follows:

Figure 1. Three types of ILPC's damages, potholes (top), uplift (middle), and map-cracking (bottom).

For damage types (2) and (3), our vacuuming-impregnation-coating finishing technology was adapted to rebind structurally the dormant and map cracks, and to hold the disrepair or broken pieces together; it also served to rejoin between the delaminated overlay and underlying concrete. Under the vacuum condition of -28 in.Hg, repairs were made with a wicking of 2wt% benzoyl peroxide (BPO)-catalyzed methyl methacrylate (MMA) monomer (Fox Industries Inc.) with a low viscosity of ~ 15 cps that permeated readily through the fine cracks of a less than 0.004 in. width and one in. depth existing in the ILPC layers. Nearly 20 minutes after the vacuuming-impregnation operation was completed, the MMA monomer that had penetrated in the cracks and fissures was cured, and had sealed these open spaces. Also, the permeated MMA satisfactorily filled the interstices between the delaminated ILPC and underlying concrete, thereby rejoining between them. In this technology, the surfaces of repaired ILPCs and patched potholes were coated with an anti-flammable, UV resistant, and water-compatible material to protect the underlying ILPC overlays against fire, UV attack, cryogenic LNG spill, and more than 200 freeze-thaw cycles. We succeeded in modifying the commercial epoxy coating (Fox Industries Inc.) to meet all these criteria. The formula of the modified epoxy coating was 56.5wt% epoxy (FX-489 Part A), 28.2wt% epoxy (FX-489 part B), 12.7wt% ammonium polyphosphate anti-flammable reagent (Exolite AP422, Clarian Corp.), 1.6wt% 2,4-di-tertiary-butylphenyl phosphate anti-UV reagent (Naugard 524, Uniroyal Chemical Corp.), and 1.0wt% aminopropylsilane triol silane coupling agent (SIA 0608, Gelest Inc.).

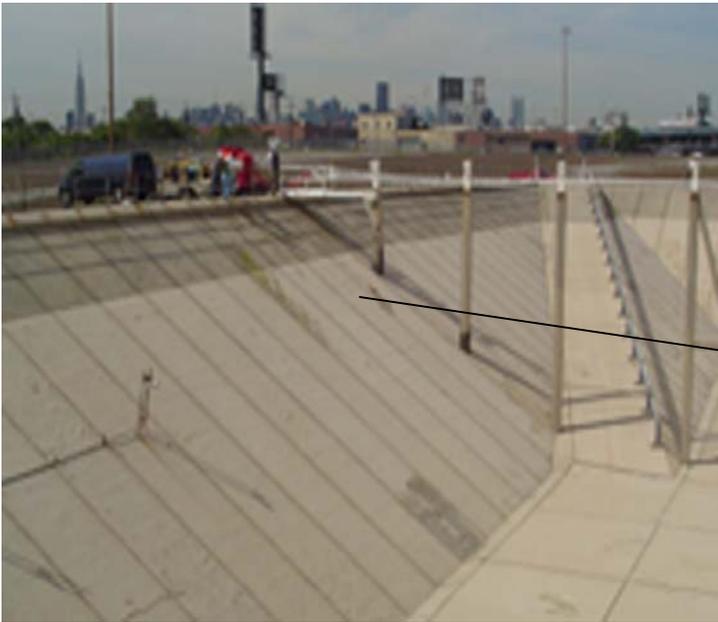
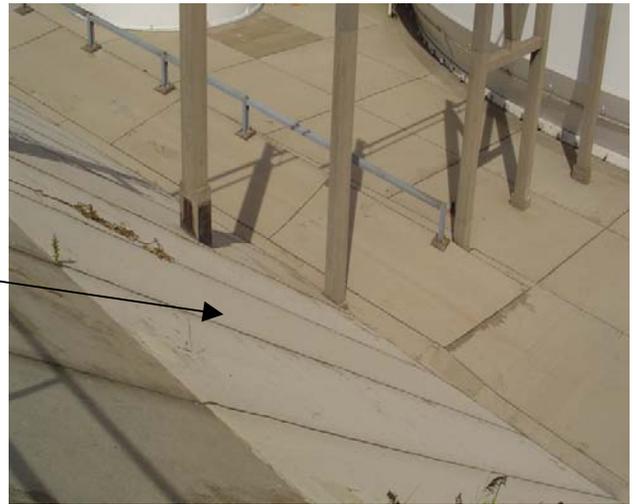
Figure 31. Sloped sidewall ILPC test panel located in south side of dike at a LNG facility in Greenpoint, Brooklyn NY.

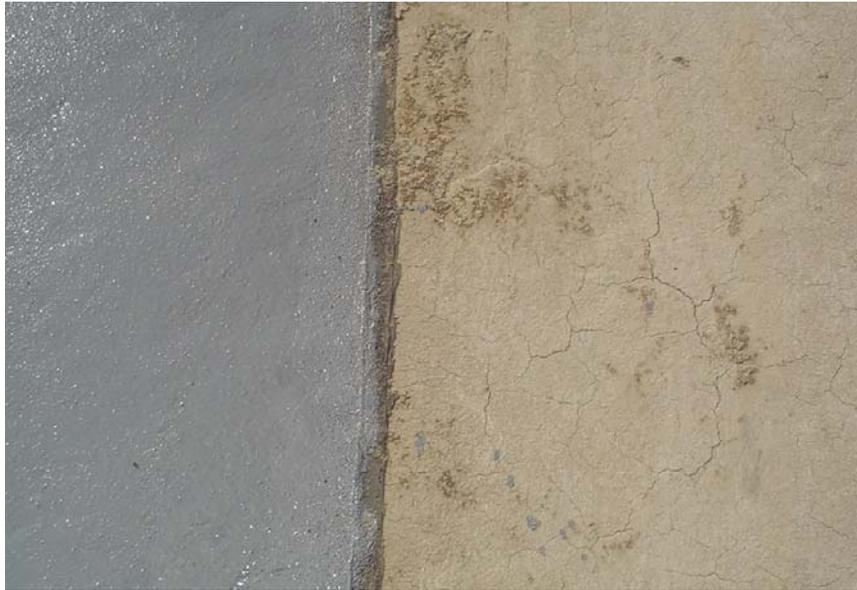
Figure 47. Comparison of appearance between the repaired (left) and non-repaired (right) ILPC panels.

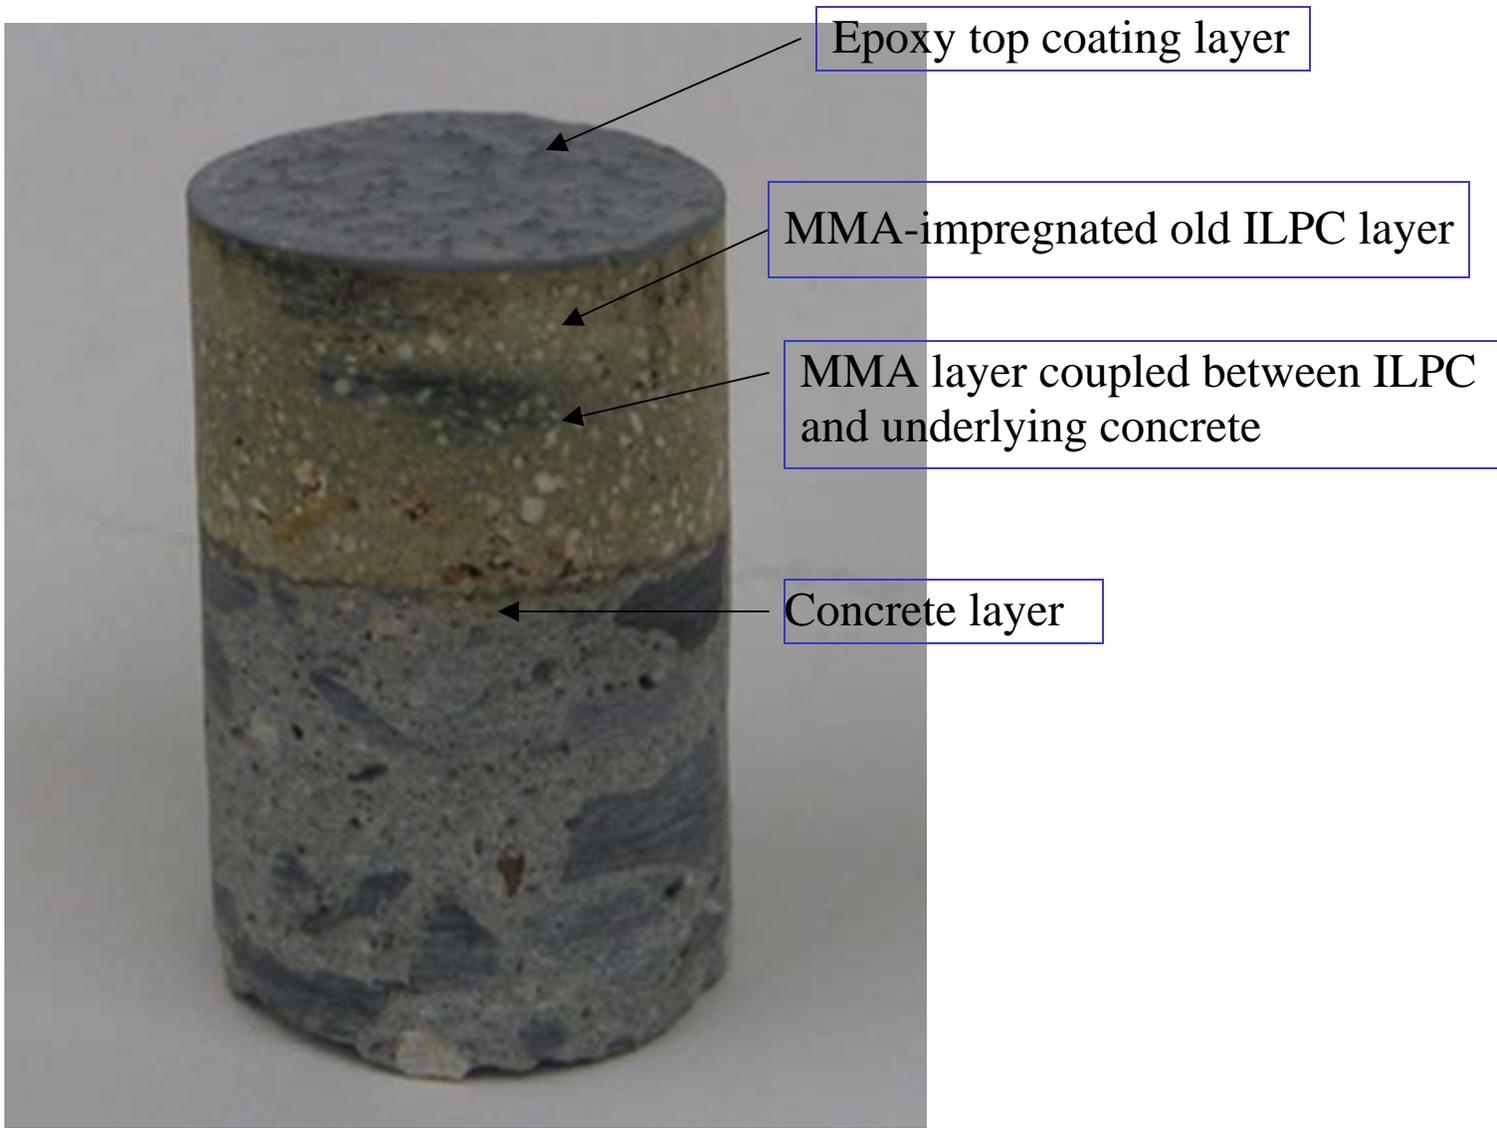
Figure 49. Cross-sectional profile of repaired ILPC core sample.

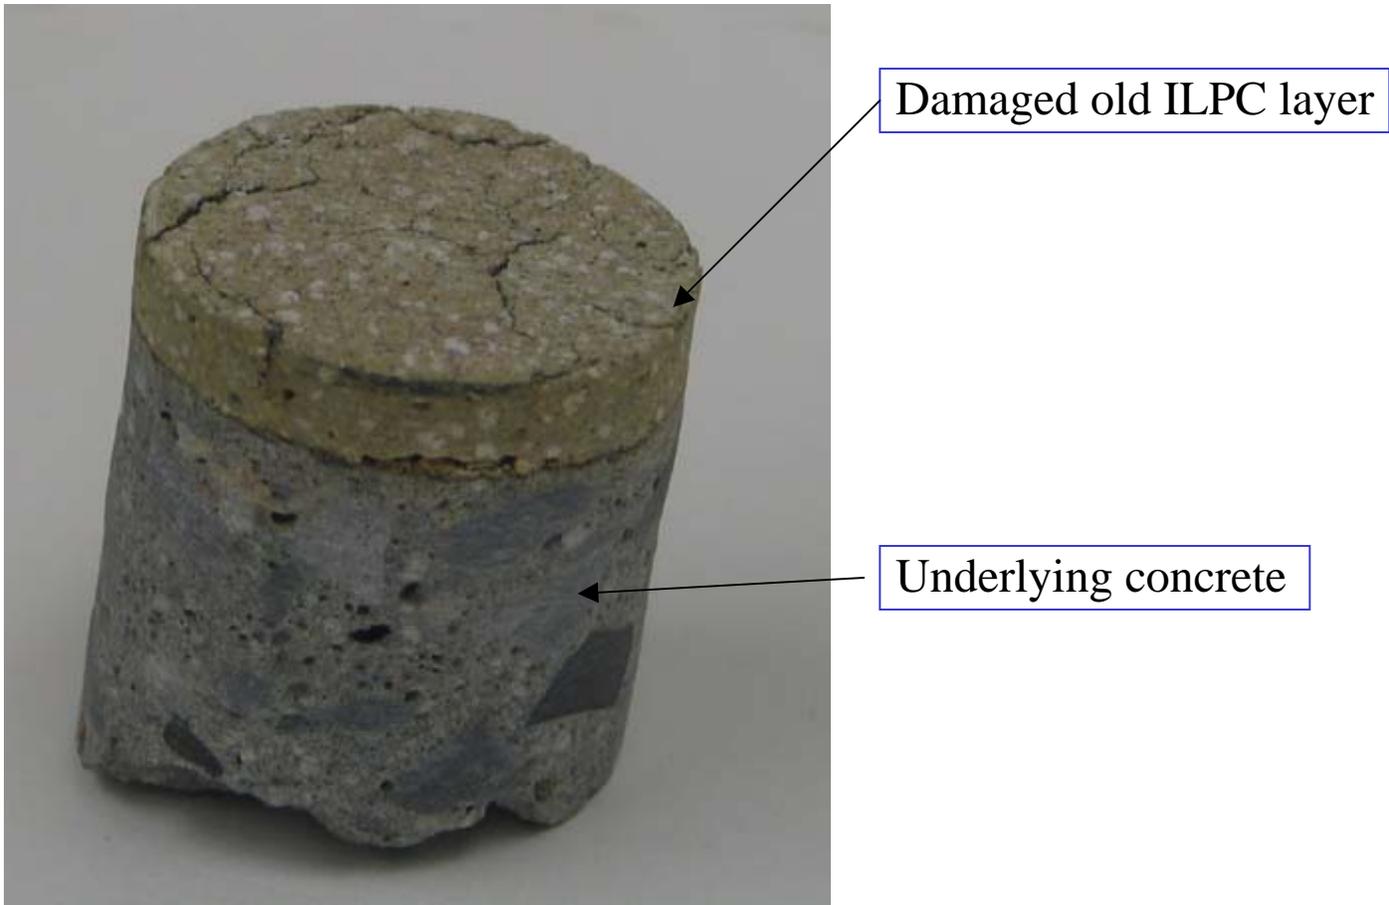
Figure 50. Core sample of non-repaired ILPC.

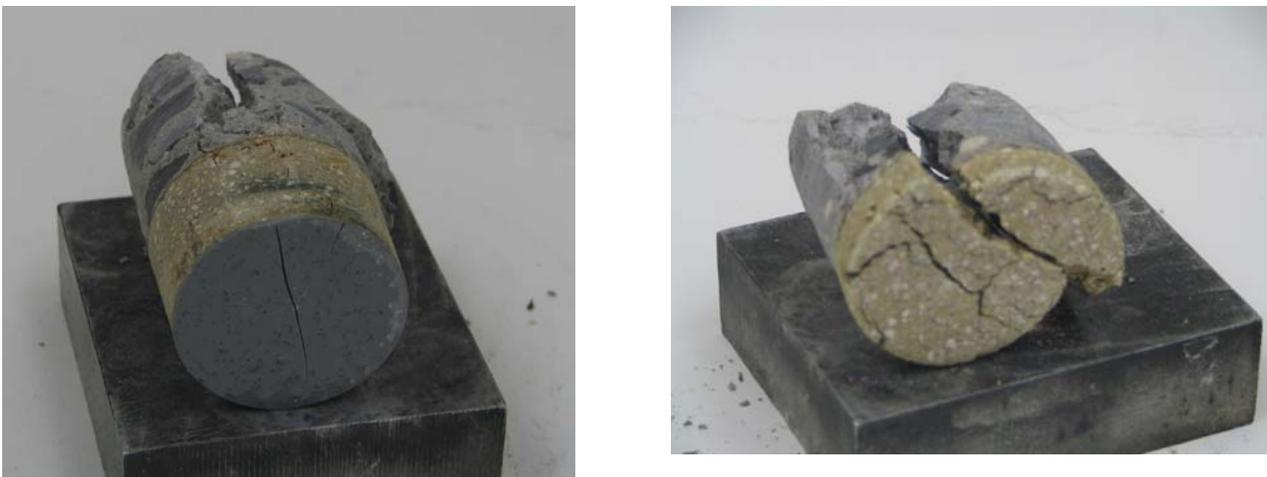
Figure 51. Repaired ILPC (left) and non-repaired ILPC (right) after tensile spread destructive test.

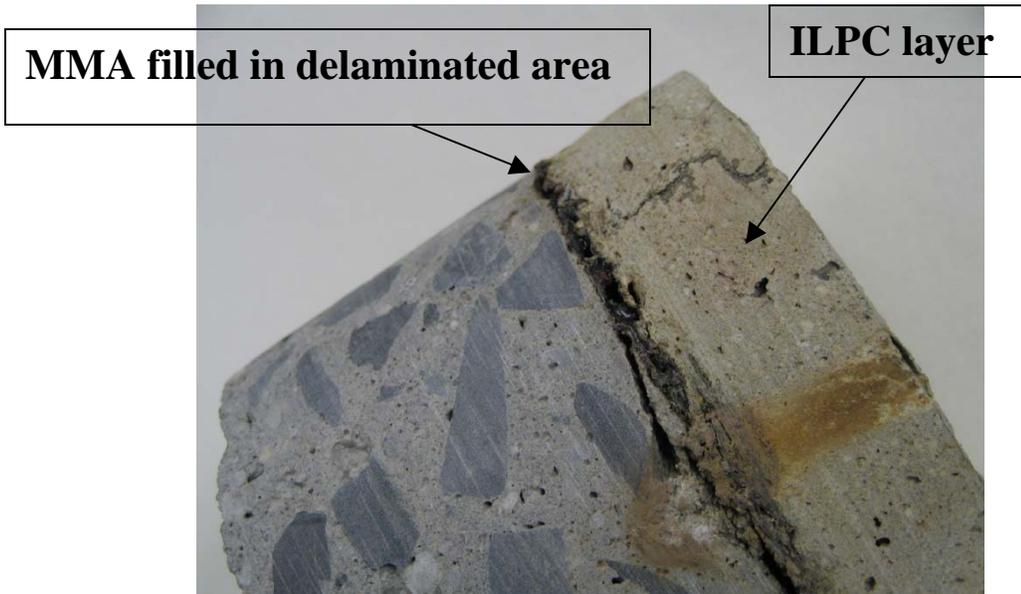
Figure 54. First core specimen taken from the repaired ILPC overlays.

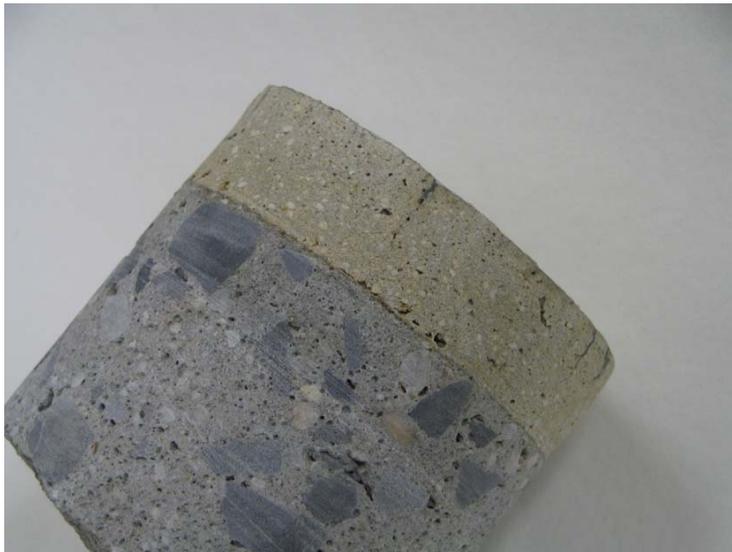
Figure 55. Second core specimen.
