Analysis of RHIC beam dump pre-fires

Presented at the 2011 Particle Accelerator Conference (PAC'11)
New York, N.Y.
March 28 – April 1, 2011

ANALYSIS OF RHIC BEAM DUMP PRE-FIRES*

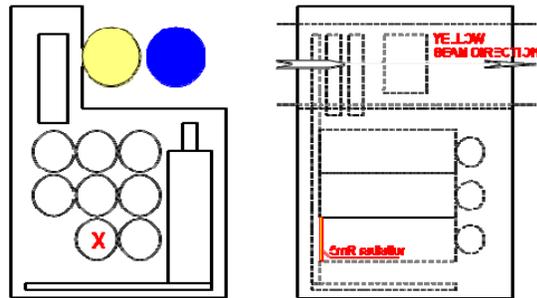
A radiation technician and pulsed power group technicians alerted us of localized radiation phenomena. After replacement of a capacitor during 2009 operation, the radiation survey showed the concentration of radiation at the ground end of the damaged capacitor only, as shown in Figure 1. Coincidentally, the damage, a fine crack line on capacitor case caused a minor oil leak, was at the ground end with abnormal radiation reading. Since the internal arcing of the capacitor happens usually at the high voltage end, this damage at ground end raised alarm of possible radiation damage to capacitors.

Figure 1: The yellow modulator 4 front view and side view and the location of the damaged capacitor.

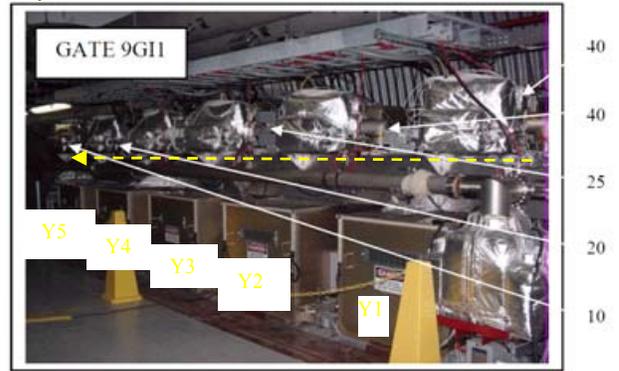
The correlation of the modulator location and the residual radiation in blue seems clear, but not in yellow. The blue module 4 had the highest number of capacitor replacement and the highest residual radiation in survey. However, the yellow module 5 that had a total of 13 capacitors replaced had low reading in radiation survey.

Figure 3: The yellow abort kicker modulators rear view and radiation survey result in μRem . The dashed yellow line is the yellow beam direction.

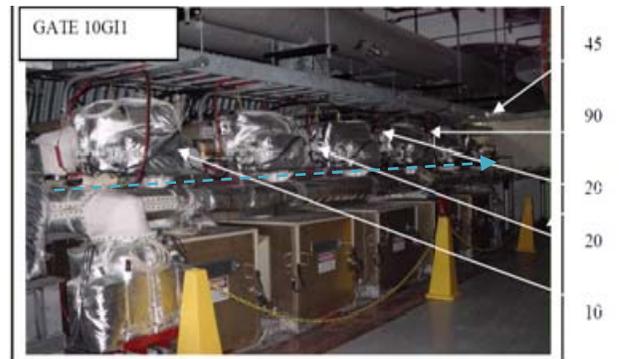
Figure 4: The blue abort kicker modulators rear view and radiation survey result in μRem . The dashed blue line is the blue beam direction.
