BNL-97197-2012 -IR

***Investigation into Cause of Cs-137 Source
Leakage***

April 2012

Brookhaven National Laboratory

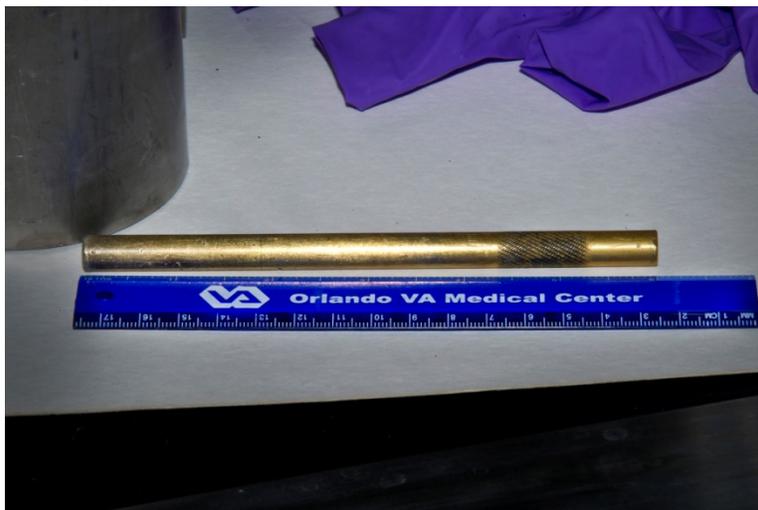
- Figure 1 is a photograph of the source that leaked. It is approximately 6 inches (15.34 cm) in length. The source is a copper alloy, probably brass that has machined knurling off-center on the source.

Figure 1. Photograph of the leaking source.

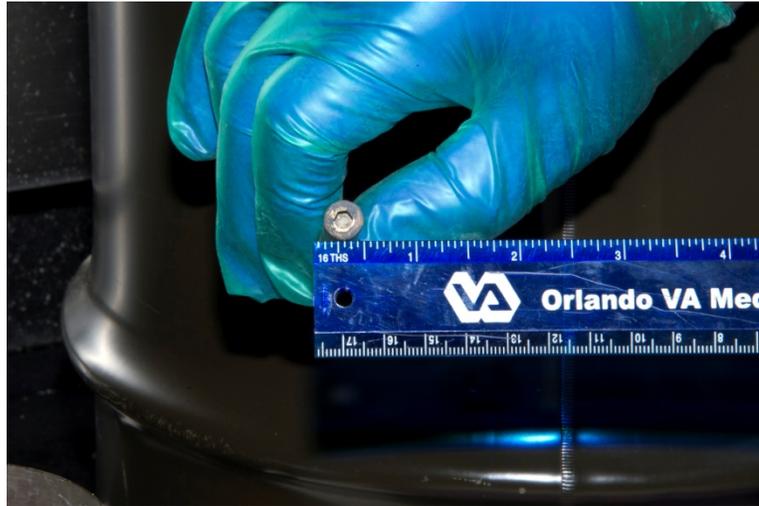
- The source was approximately ½ inch (1.27 cm) in diameter as is represented in Figure 2.

Figure 2. Photograph showing diameter of source and Allen-head type fitting on the end,

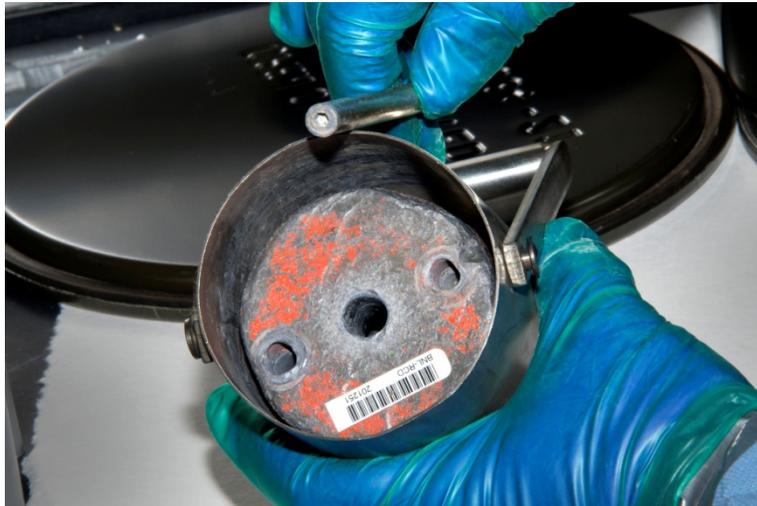
Figure 3. Photograph of the “pig” and source.

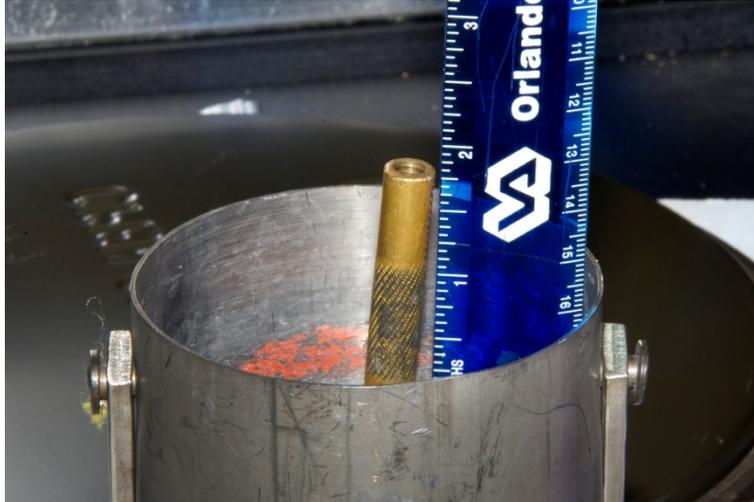
- The source would normally be placed in the center hole of the “pig”. Its relative position in the “pig” is shown in Figure 4.

Figure 4. Photo showing “pig” and demonstrates how the source would typically be inserted.

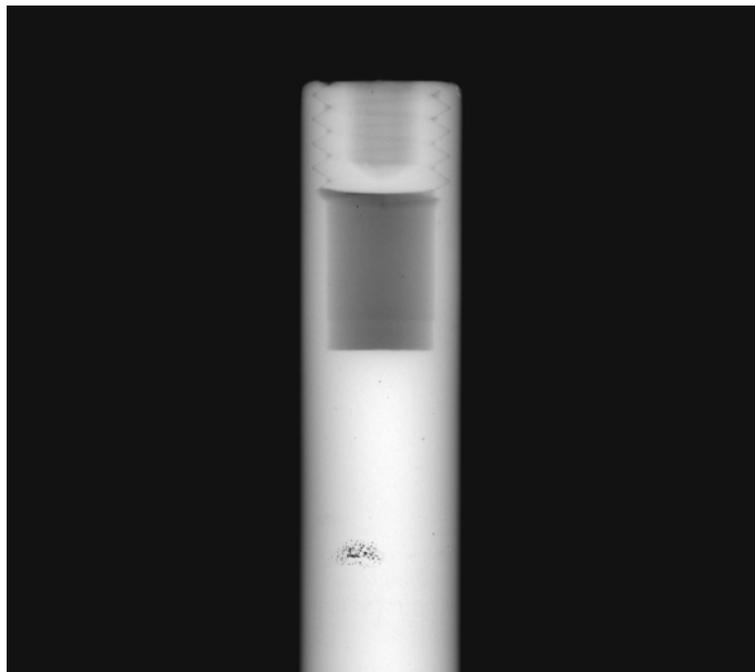
- The source was examined by radiography. The radiographs showed two interesting items
Figure 6 is the overall radiograph of the source. Figure 5. is a close up area of the threaded section.
 - The first was an area that on initially review resembled a large area of possible pitting on the surface of the source. (3/4 of the way down on Figure 5).On further examination, this area is probably an “artifact” associated with the radiography techniques utilized. Figure 5.
 - The second item was the amount of clearance visible between the threads in the close up radiograph. Figure 5.

Figure 5. Close-up of threaded area in source and the artifact below threads. Note the clearance between threads.

- The radiograph of the threaded end (Figure 5) does indicate a fairly large gap in the interference fit of the threads on the source end. So, even after tightening the end, there are probably numerous crystals lodged in between the threads that have migrated during the numerous impacts that the source must have received during its lifetime. This hypothesis is somewhat substantiated by the increase in loose contamination after a second “rap” on a hard surface.

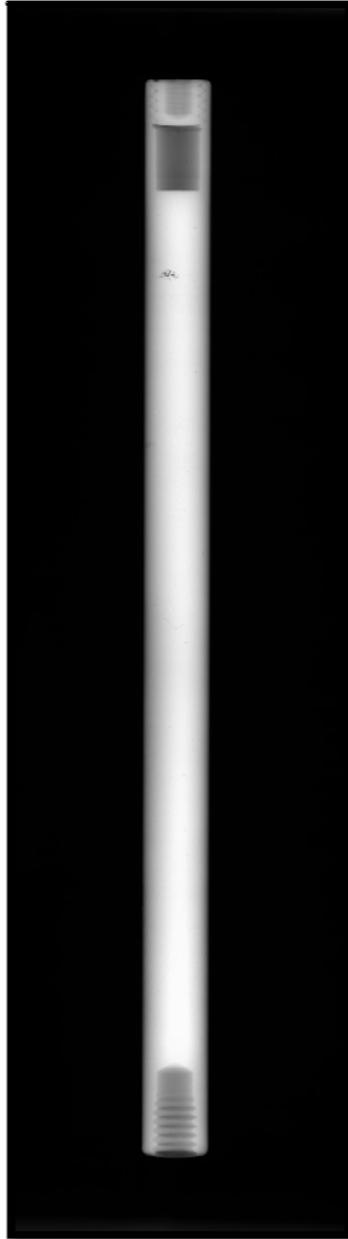
Figure 6. Overall radiograph of the source.
