BROOKHAVEN NATIONAL LABORATORY

Close Out Report

NSLS Hazard Removal Project

4/9/2016

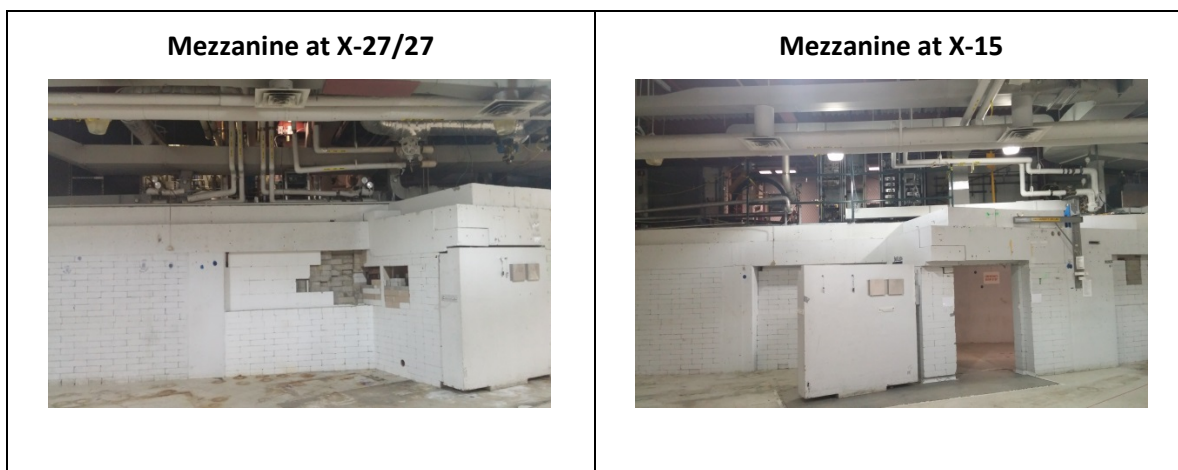
However, there are two locations on the X-Ray tunnel mezzanine where research equipment remains:

Completed Removal Actions: Removal of the electrical and mechanical commodities that were part of the research systems is substantially complete. These systems have been physically and permanently removed at their points of interface with the Building 725 infrastructure.

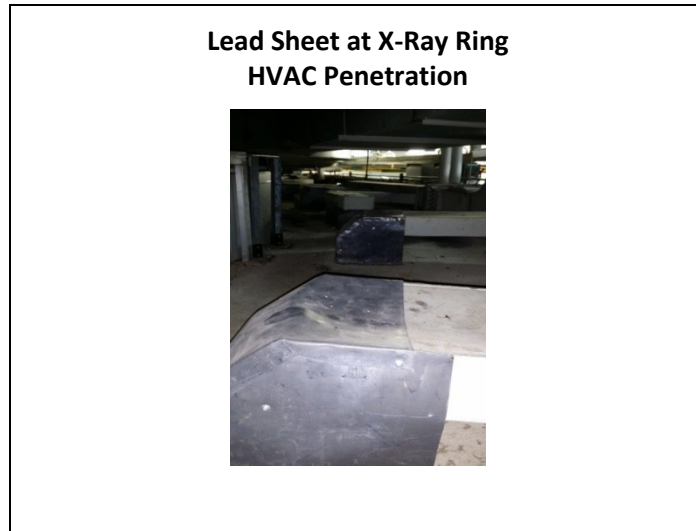
Remaining lead: The X-17 hutch contains steel encased lead that does not pose a risk or facility hazard; there is no safety or industrial hygiene driver for X-17 removal. In addition, there are inaccessible locations at many HVAC penetrations on top of the X-Ray tunnel mezzanine with bare, lead sheet that must be removed. It is estimated that 400 pounds of lead (total) remains in these locations; representative photograph provided below.

Completed Removal Actions: Except as noted herein, all lead shielding has been removed from the NSLS. The removed lead was recycled with the exception of approximately 200 pounds that were transferred to the BNL Waste Management Facility for disposal as mixed waste.

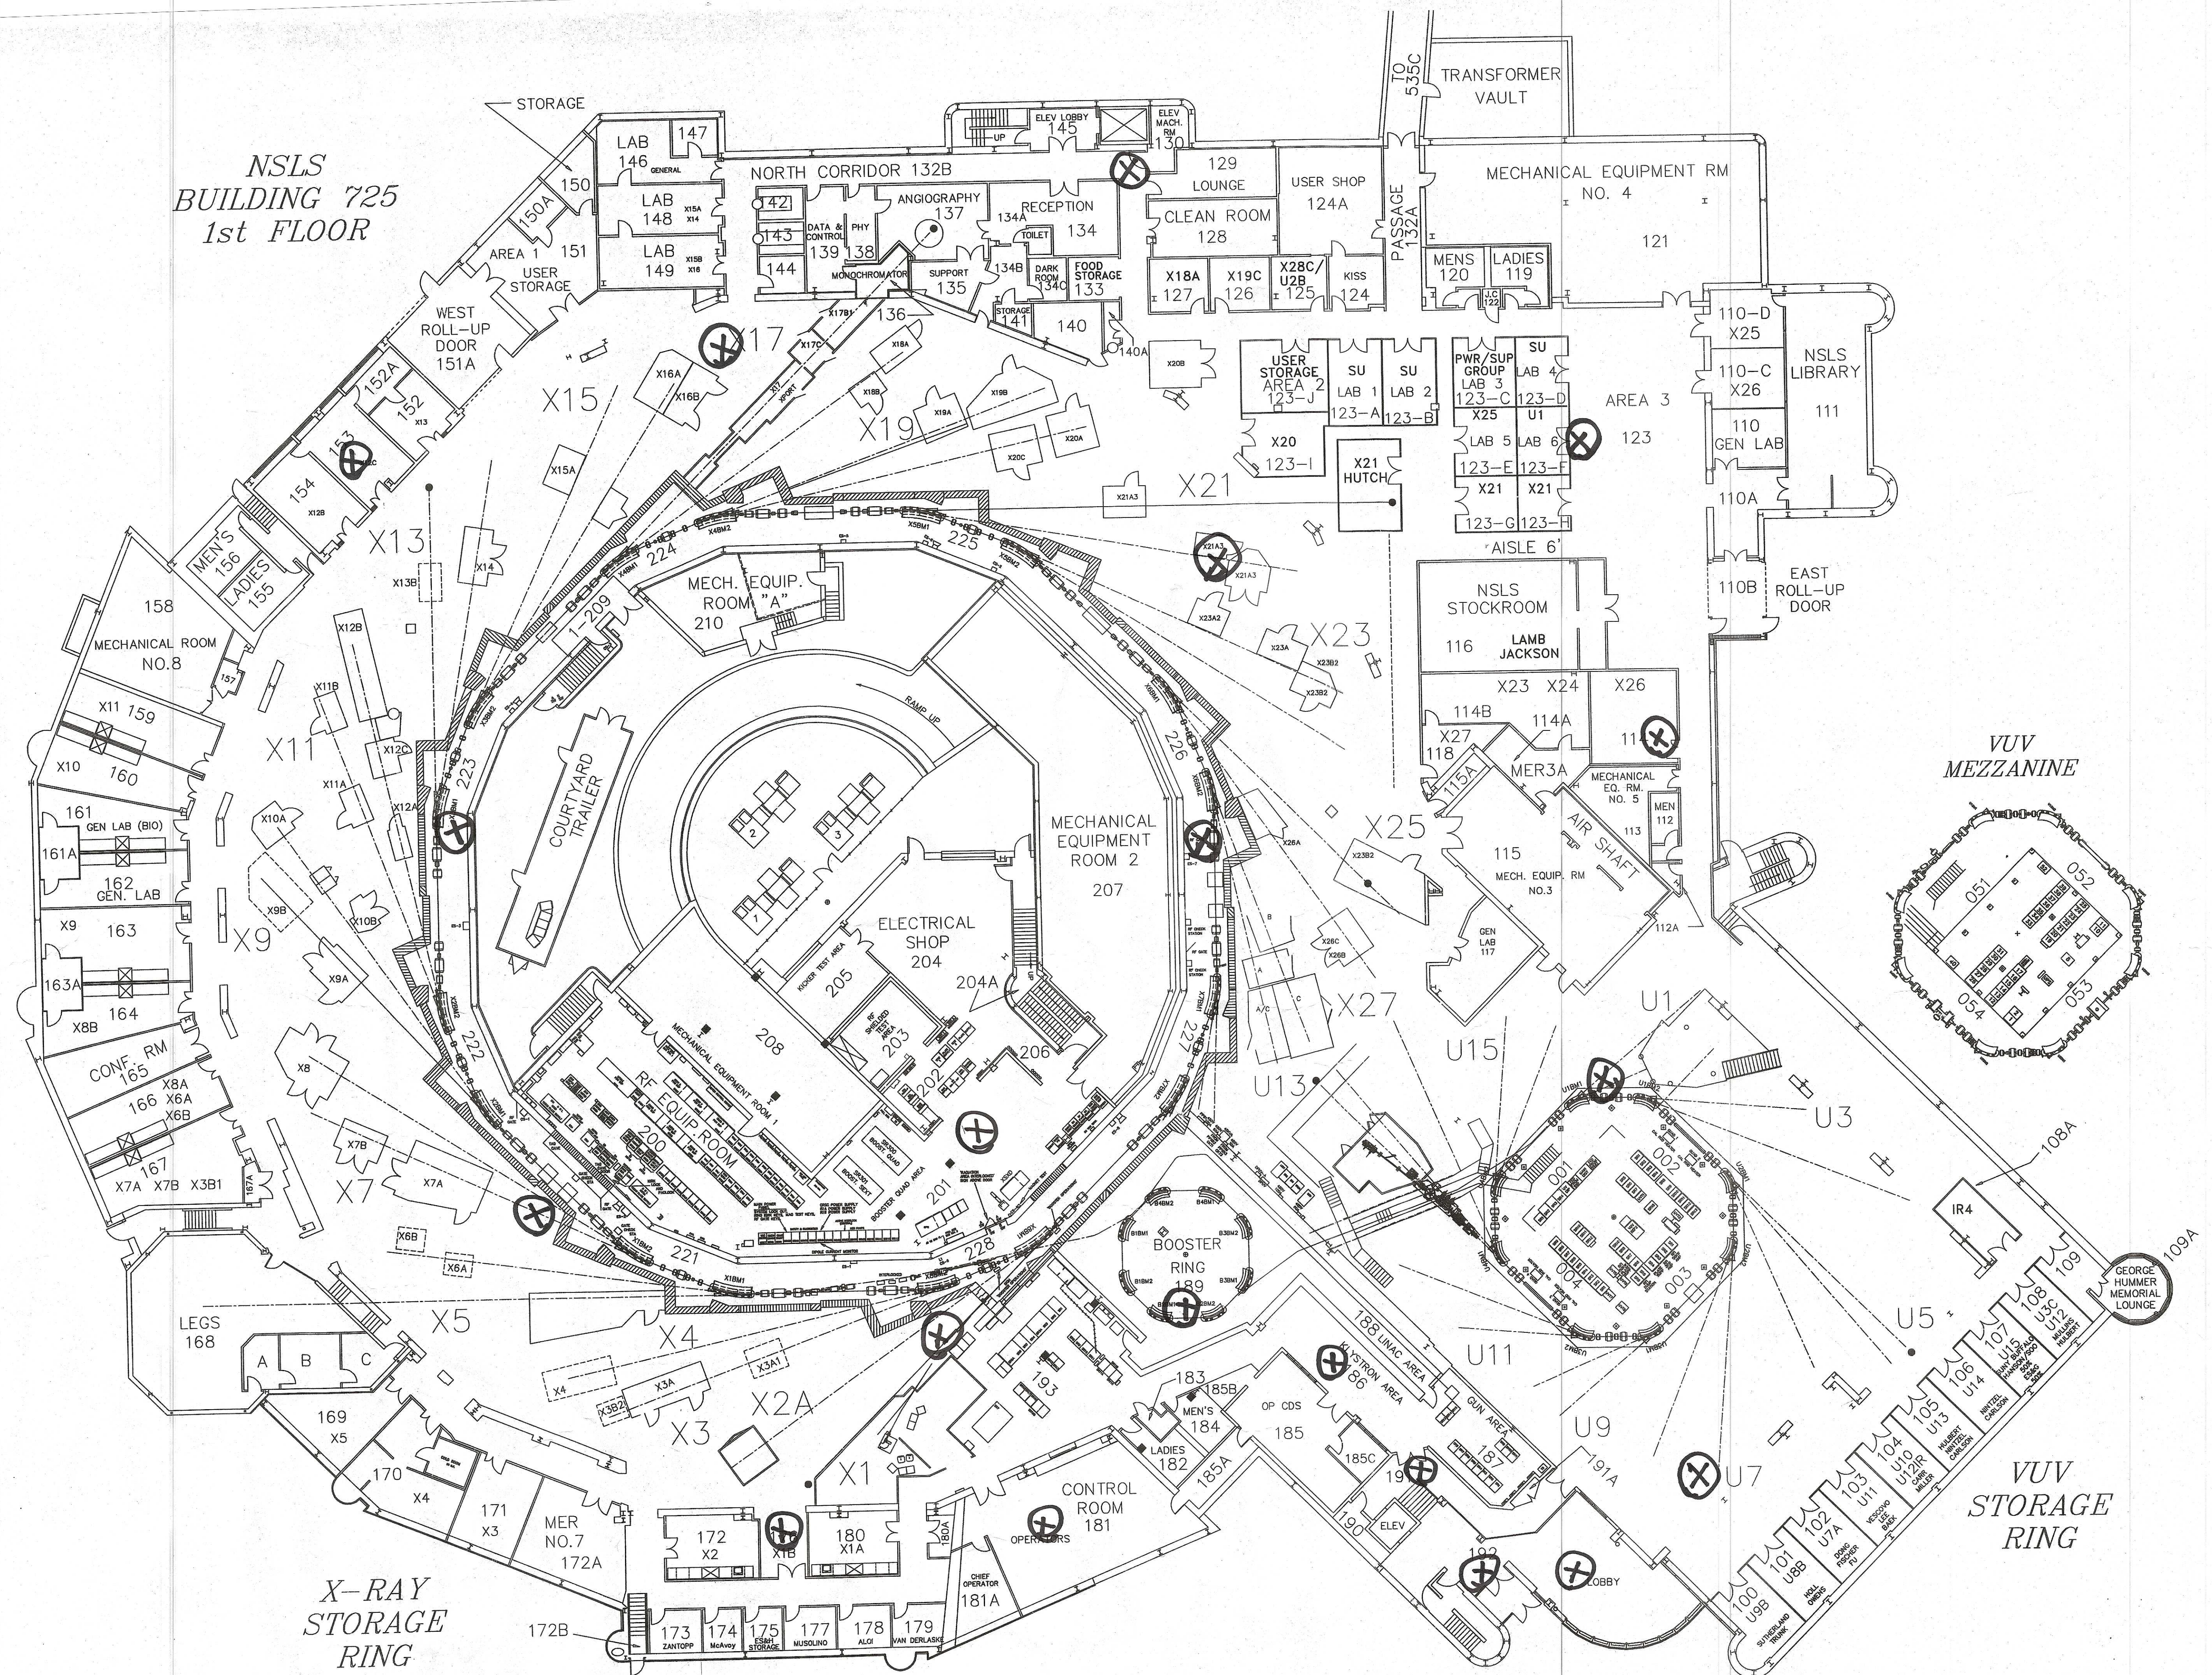
NSLS
BUILDING 725
1st FLOOR

The supplemental survey wipe sample results are provided as Attachment B, *Supplemental Metals Wipe Survey Results*. Attachment C, *1st Floor Final Wipe Survey Locations* illustrates the physical locations on the 1st Floor where the wipe samples were collected.
