Summary of response to IRR concern about the FXI mirror hard-stop

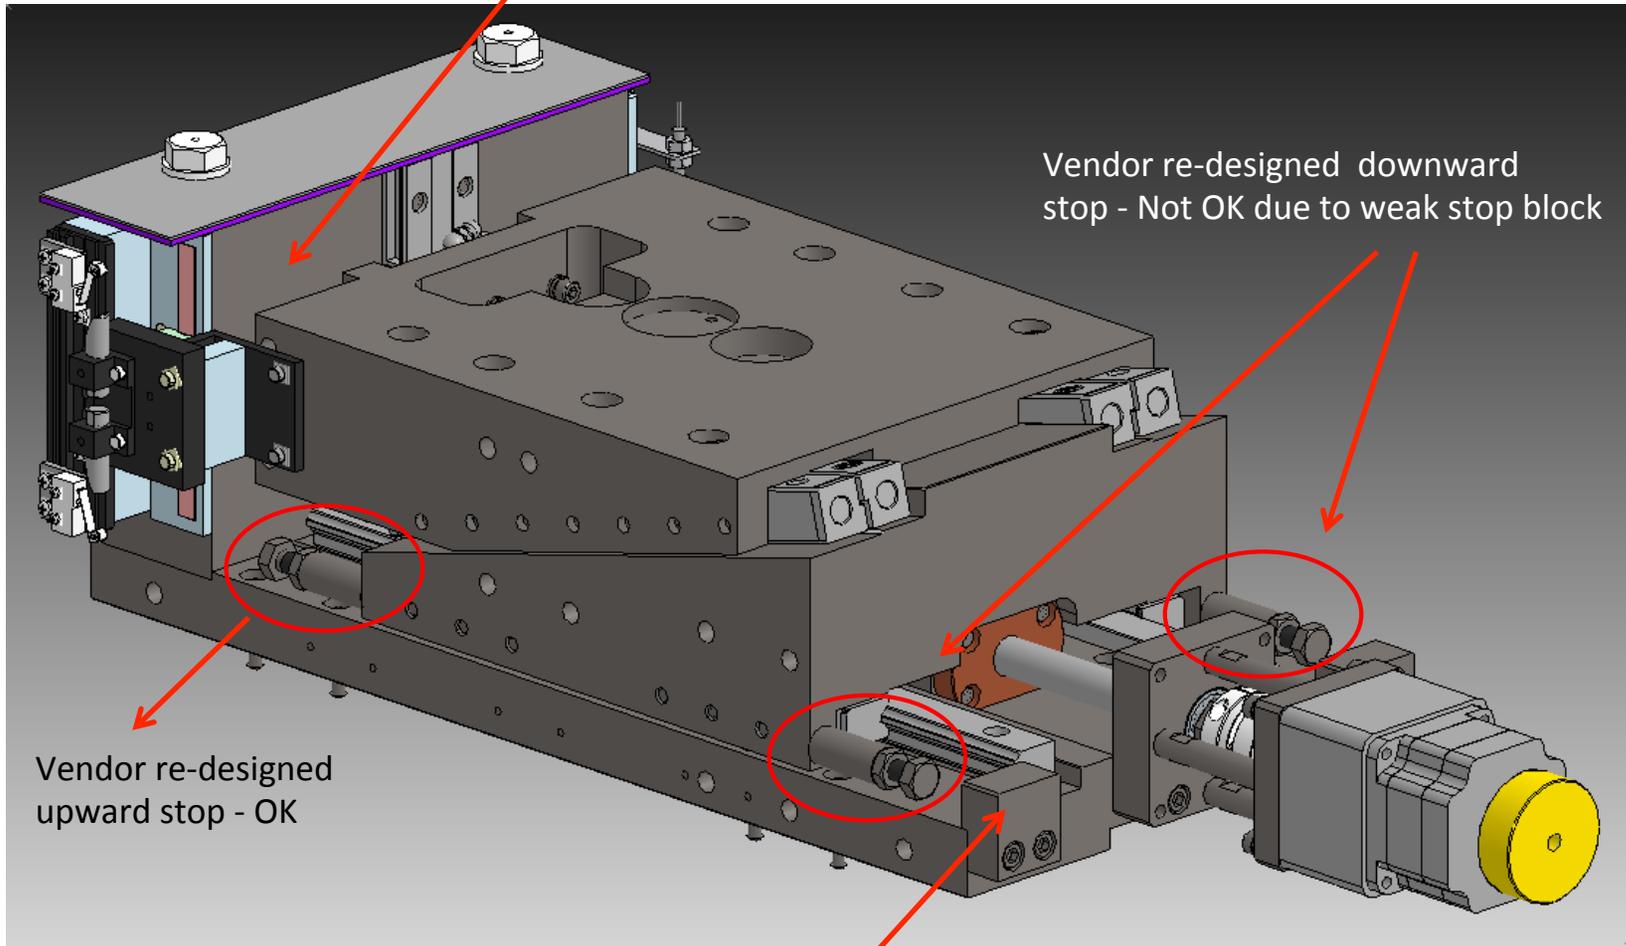
Location of 'stop blocks'.

1. Vendor re-designed hard-stop. NSLSII design review of this was held on Nov 7. Reviewers did not think it will work for the 'downward' side of the stage. The problem is that at the 'downward' limit of the stage, the stop block is held by two M6 screws in tension, which FEA shows is insufficient to resist the maximum force. Made suggestions for alternative solutions. (see next page and *FXI_Hardstop_DesignReview_Nov7 & PS-DRR-1064 – Collimating Mirror Hardstop PDR*)

Upward side stop block- held by eight M8 screws in shear from below

Vendor re-designed downward stop - Not OK due to weak stop block

Vendor re-designed upward stop - OK

Downward side stop block – held by two M6 screws in tension

2. Engineer Bernie Kosciuk came up with a new idea. Held a design review for his new idea on Dec 6. Review panel approved Bernie's design for the 'downward' limit and the vendor design for the 'upward' limit. The reason that the vendor design is approved for the 'upward' limit is because there, unlike the 'downward' side, the stage has a stop block that is held by eight M8 screws in shear that can easily withstand the maximum force. (see next page and *FXI_Hardstop_DesignReview_Dec6 & PS-DRR-1065 – Collimating Mirror Hardstop FDR*)
