INSTRUMENT READINESS REVIEW

NSLS-II 18-ID FULL FIELD X-RAY IMAGING (FXI) BEAMLINE AND FRONT END

October 25, 2017

NSLSII-18ID-RPT-003

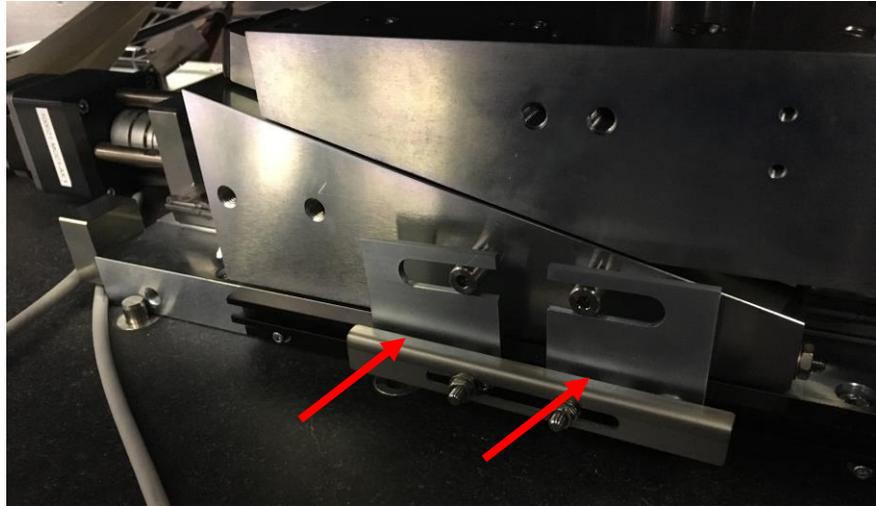
- 2.2.1.1. **Pre-Start 1 Condition:** Initial observation of the Radiation Safety Checklist components found that a number of these components were missing the required photos documenting the configuration. These photos were eventually added by the end of the review. However, the photo documenting the collimator mirror did not show the hard stops for this component as required.

- 2.2.1.3. **Pre-Start 3 Condition:** The collimator mirror in the FOE is a radiation safety component whose motion is required to be constrained by a pair of hard stops (see Fig. 1). Analysis of the radiation safety considerations assume that the motion of the mirror will be fully constrained by the hard stops and no further analysis of the potential missteering due to failure of the hard stops to constrain the motion of the mirror was completed. Furthermore, no engineering analysis of the ability of the hard stops to constrain the motion of the mirror was produced by NSLS-II despite concerns by the team that the hard stops did not appear to be adequately robust and might shift in a manner that would not be immediately apparent, leading to potential beam missteers that lie outside of the scope of the present analysis.

Figure 1: Hard stops for collimating mirror shown with arrows.

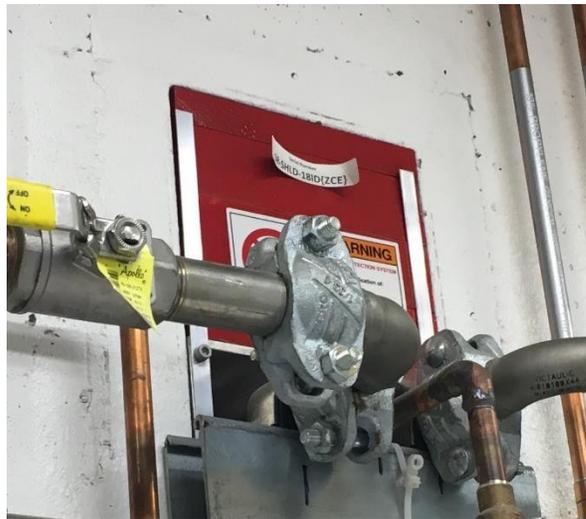
Figure 2: Note loose label on radiation safety component SR-SHLD-18ID{ZCE}.

- 2.2.5.6. Observed loose label for a radiation safety component. Recommend inspecting labels to ensure that they are securely affixed to equipment (see Fig. 2).
