INSTRUMENT READINESS REVIEW

NSLS-II 7-ID SPECTROSCOPY SOFT AND TENDER (SST) INSERTION DEVICE AND FRONT END

November 8, 2017

NSLSII-7ID-RPT-001

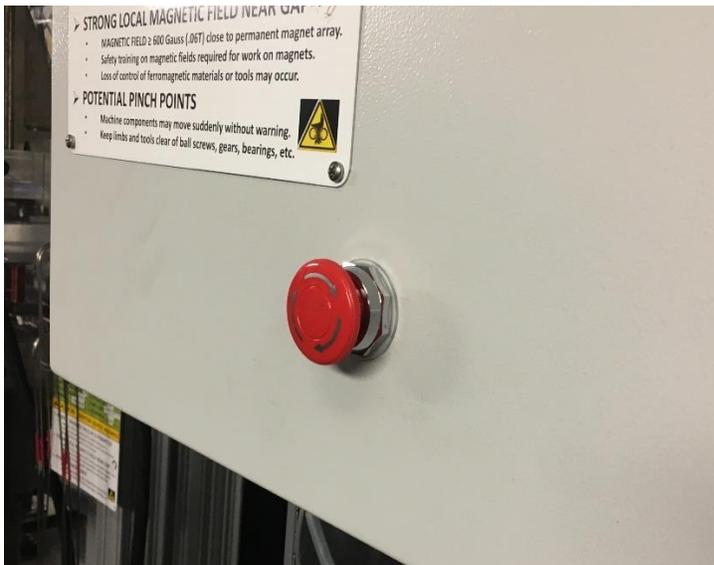
2.2.2.3. **Post-Start 3 Condition:** The team observed that the e-stop on the EPU60 control panel should include a yellow ring behind the actuator in conformance with accepted consensus standard NFPA-79 Electrical Standard for Industrial Machinery (see Fig. 1):

- ¶ 10.7.3 Emergency Stop Actuators. Actuators of emergency stop devices shall be colored RED. The background immediately around pushbuttons and disconnect switch actuators used as emergency stop devices shall be colored YELLOW. The actuator of a pushbutton-operated device shall be of the palm or mushroom-head type and shall effect an emergency stop when depressed. The RED/YELLOW color combination shall be reserved exclusively for emergency stop applications.

- **Post-Start 3 Finding:** The e-stop on the EPU60 control panel lacks a yellow ring behind the actuator in conformance with the accepted consensus standard NFPA-79 Electrical Standard for Industrial Machinery.

Figure 1 - Emergency stop button for the EPU60 undulator.

- 2.2.5.5. No labels on e-stops to indicate their function. Consider adding appropriate labeling around the e-stop (see Fig. 1).
- 2.2.5.6. The downstream EPU has cooling fans on the downstream end that protrude beyond the guard, inviting tampering or accidental breakage. Upon discussion with staff members, it was suggested that these fans may not be necessary. Consider removing the fans or guarding them better.
- 2.2.5.7. Observed that there are no formal requirements in procedure for warning signage for insertion devices. Recommend that requirements and formatting for insertion devices be added to NSLS-II procedures.

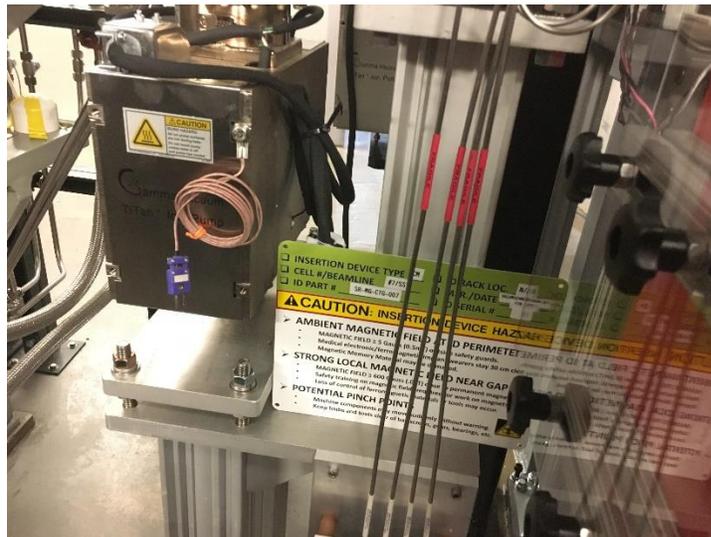
- 2.2.5.4. At least one of the insertion device warnings was placed in a position that was not obvious. Consider placing the signage in more useful and prominent locations (see Fig. 2).

Figure 2 – Warning sign for insertion device placed in a location that partially obscures sign.
