Status on the Explosion of Building 637 at Brookhaven National Laboratory

Presentation to the Community Advisory Council

Building 637 – Well House 12

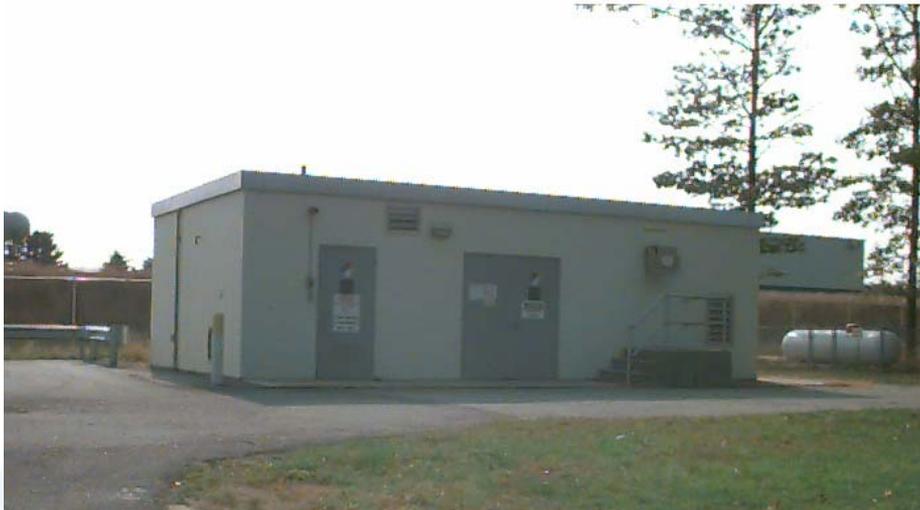
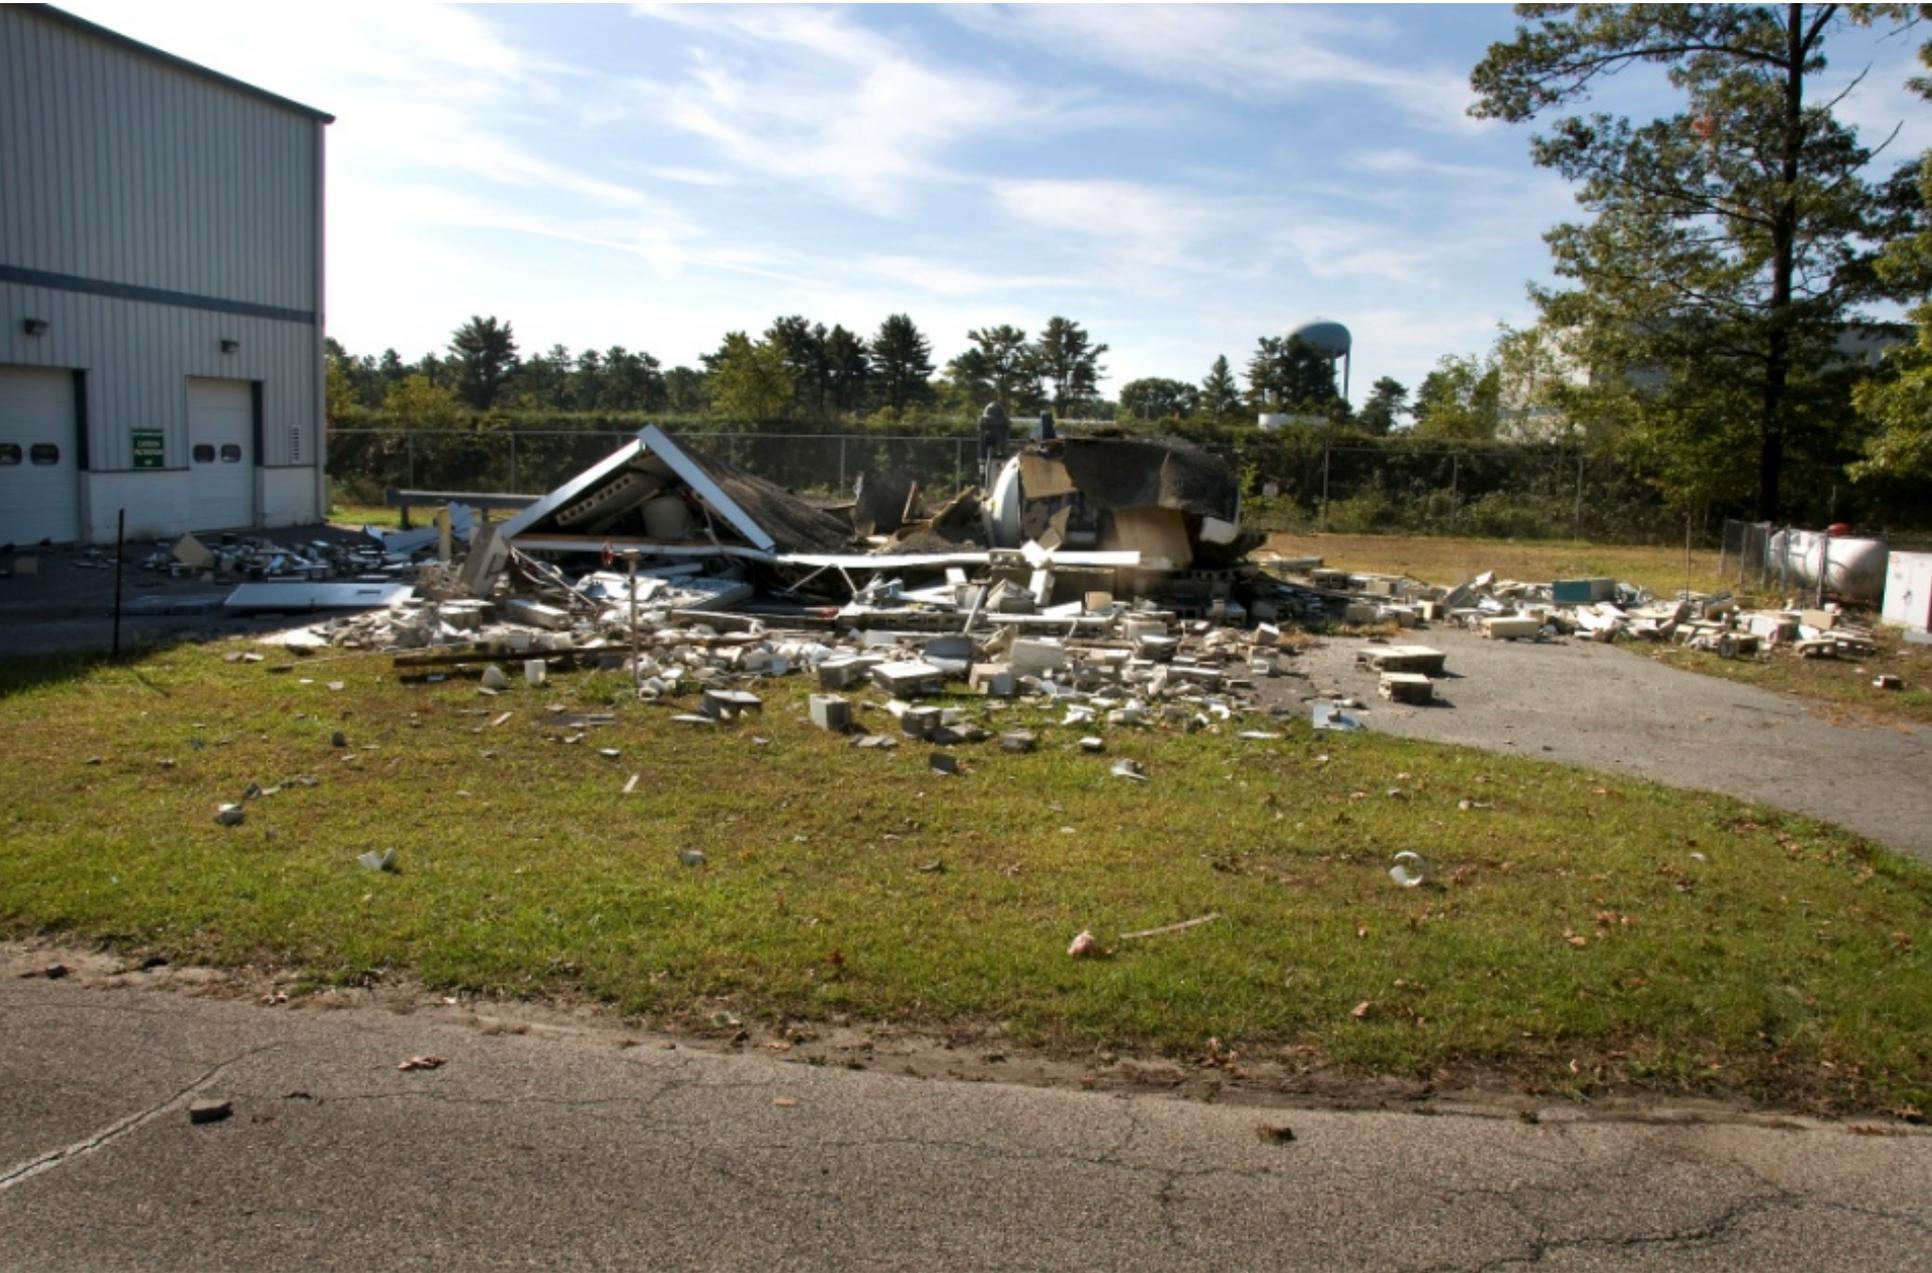
- On October 13, 2008, 9:35 p.m., a loud explosion was heard. An immediate search was conducted by the Laboratory Protection Division.
- Building 637, a normally unoccupied water “well house” in the eastern service area of the site was found demolished. It was later confirmed that it exploded from an internal accumulation of propane.

- Well house was built in 1985 to provide physical protection for the pump and treatment systems.
 - 680 sq. ft., concrete block walls, precast concrete roof.
 - Electric driven well with propane auxiliary drive.

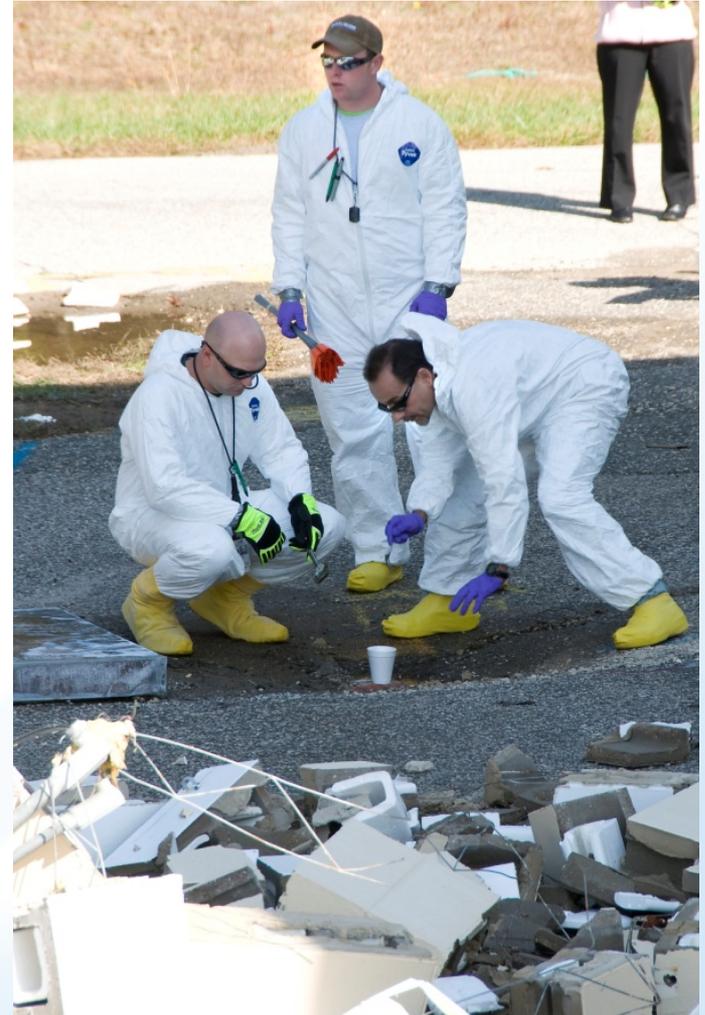
- Preventative maintenance was being conducted on the propane auxiliary engine during the days leading up to the event.
- Two inadvertent actions during the maintenance activity provided for release of the propane gas.
- The propane explosion occurred after a 5 ½ hour build up of propane gas in the building.
- Ignition was from within a motor control center.

- The facility was not designed to required standards
 - Appropriate ventilation or explosion venting was not provided.
 - Design reviews, construction reviews, and subsequent assessments did not identify code deficiencies.
- The interlock systems for the propane gas delivery to the engine were bypassed.
- Work planning did not properly consider the hazards of propane and workers were not adequately trained to work with propane systems.
- Changes in maintenance procedures were not properly communicated.
