**Final
CLOSEOUT REPORT**

**Brookhaven Graphite Research Reactor
Biological Shield Removal
Area of Concern 9
Brookhaven National Laboratory
Upton, New York**

September 20, 2012

Prepared by:
Brookhaven Science Associates
Upton, NY 11973

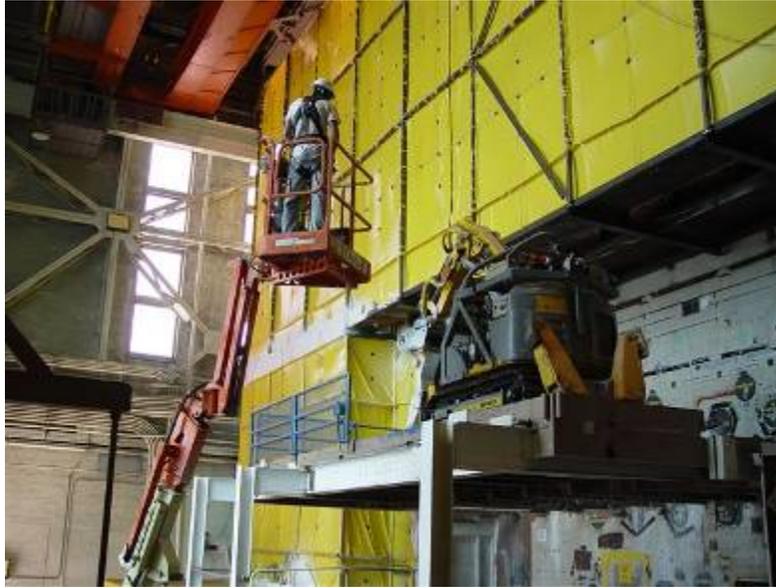
Photograph 1 – Removing Concrete from the West 127' Balcony with the Brokk Remote Manipulator

Upon completing of the removal of ACM tiles and mastic, the single north and the two west experimental balconies were removed by first breaking the concrete floors with the Brokk Model 330D remote manipulator fitted with a hydraulic breaker hammer. Once the concrete floors were removed, the 3-inch thick balcony floor joists were removed using hand-held oxy-propylene cutting torches. The concrete rubble from the floor demolition was loaded into 20-cubic yard intermodal containers and disposed as Low-Level Radioactive Waste (LLRW). However, the majority of the steel floor joists were placed over the upper bedplates of the biological shield to reduce the dose rate to the workers. During the removal of the west lower balcony, several tons of lead shielding was discovered hidden in the floor, and resulted in a schedule slip of over one week due to the additional controls required to handle the lead. Eventually, the majority of this lead, along with the lead shielding in the Chemo-Nuclear system discussed in 3.1.4, was recycled.

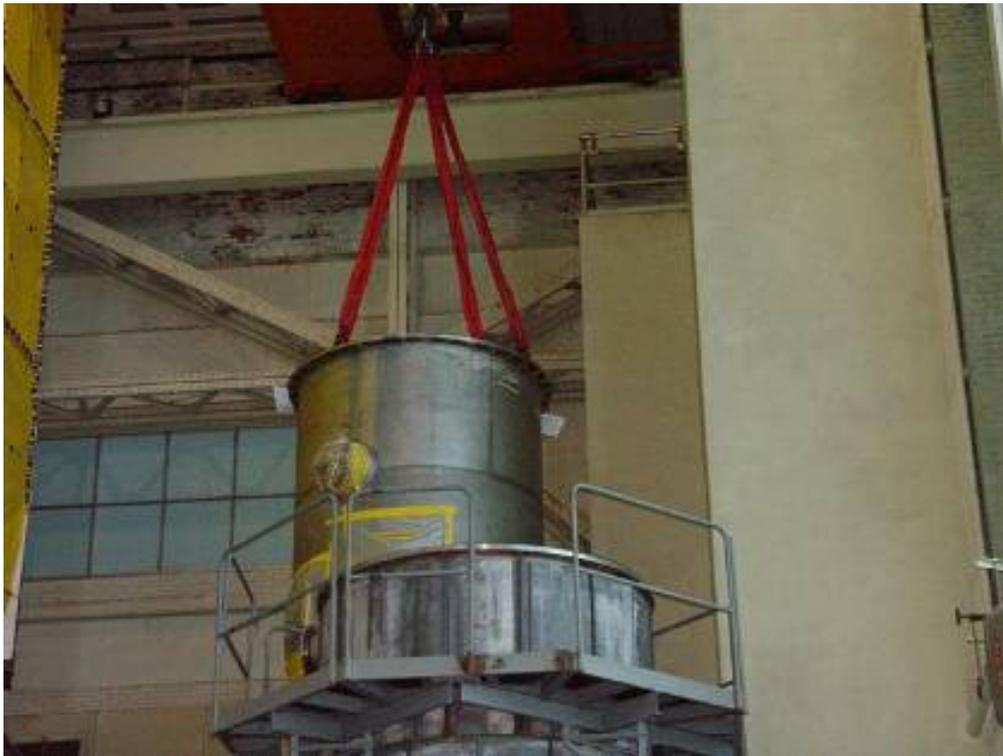
Photograph 2 – Removal of the Chemo-Nuclear System

The Chemo-Nuclear System within the high bay area was removed in its entirety prior to commencement of the demolition of the biological shield. During its removal, over 100,000 pounds of lead shielding was removed and staged for several months until, after extensive surveying to assure lack of radiological contamination or activation, it was sold to a commercial recycler.

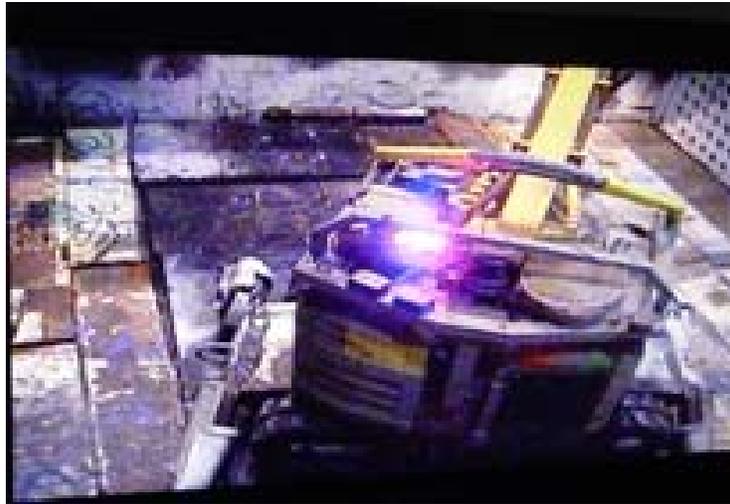
Photograph 3 – Placement of 3-Inch Steel Plates Over Upper Pile Bedplates

Prior to initiating removal of the neutron shields, 3-inch thick steel plates from the previously-removed experimental balcony were placed over the upper pile bedplates to provide additional radiological shielding for workers. After the plates were in place, they were secured in place with concrete grout (approximately 10 inches thick) to prevent movement during the upcoming heavy demolition activities.

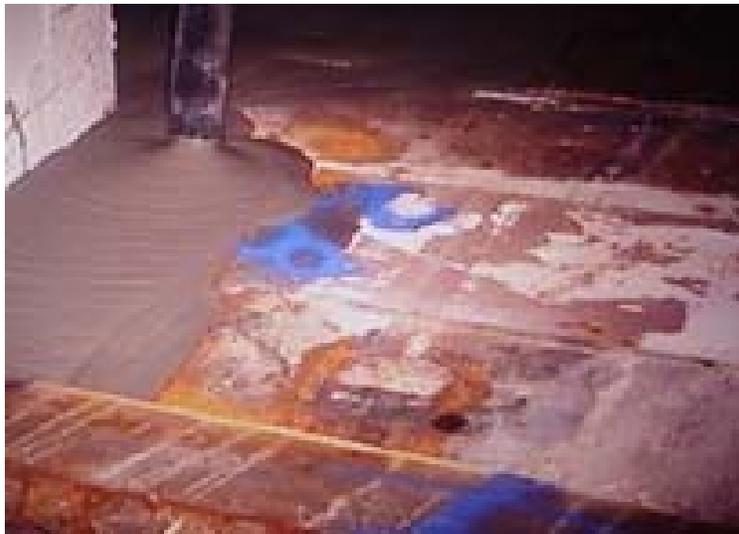
Photograph 4 – Securing 3-Inch Steel Plates In Place Over Upper Pile Bedplates

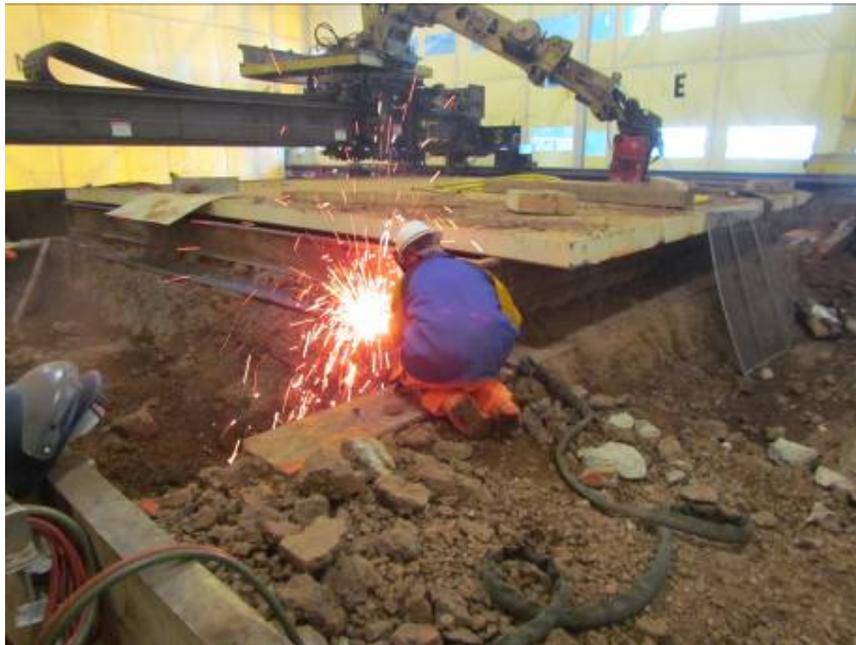
Photograph 5 – Workers Cutting Steel I-Beams on Biological Shield Roof (Gradall excavator is in background)

Removal of the 5'-9" thick roof commenced on January 10, 2011 and was completed approximately three months later. The demolition of the roof was complicated by the unanticipatedly high compressive strength of the concrete, estimated to be greater than 9000 pounds per square inch (psi), and the difficulty in getting this unusual concrete to delaminate from the steel reinforcing structure.

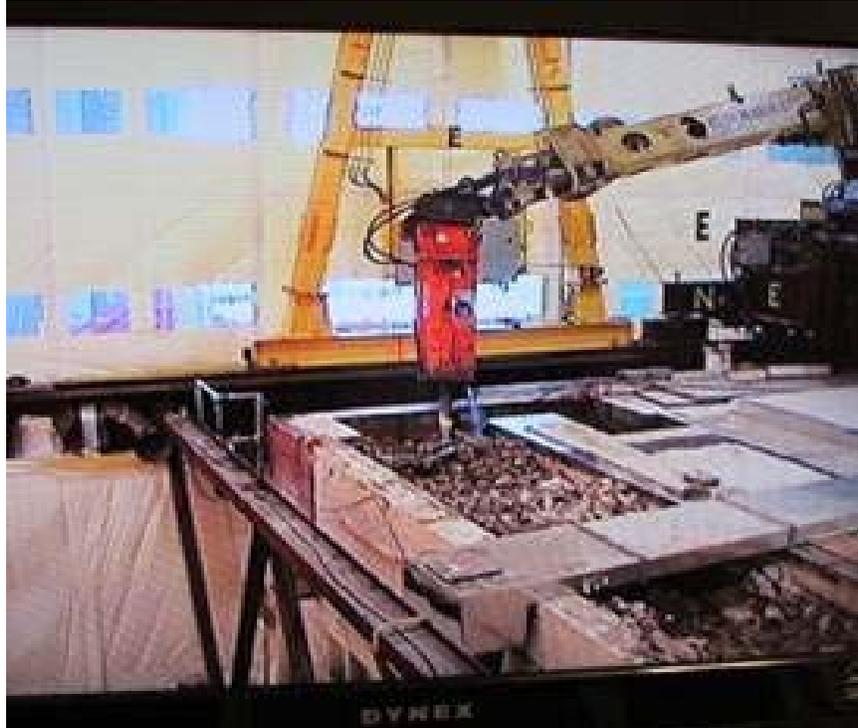
Photograph 6 – Gradall Excavator Breaking Roof Concrete (NE corner shown)

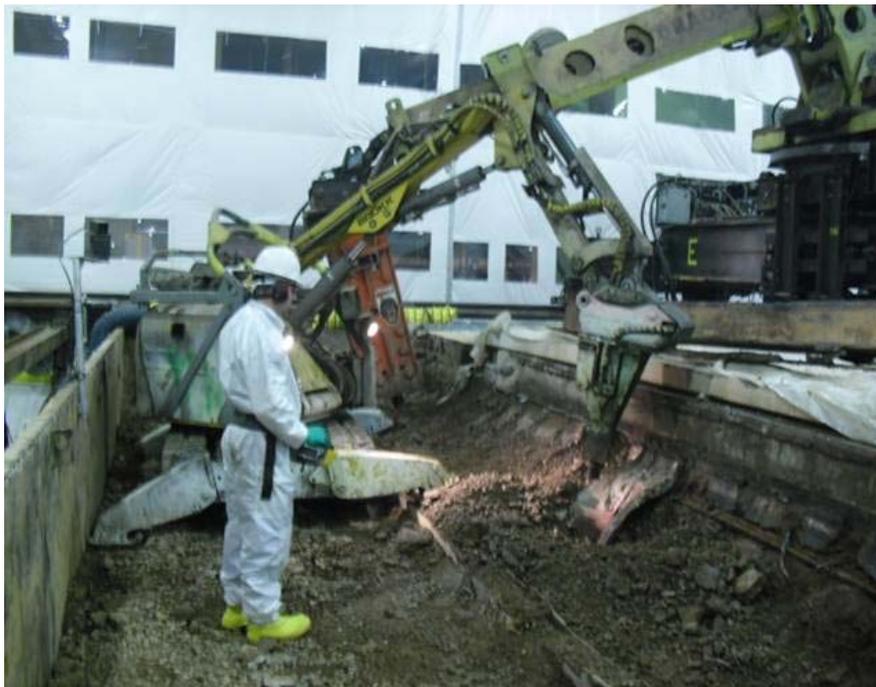
Photograph 7 – Technician Operating Brokk Manipulator to Break Roof Concrete

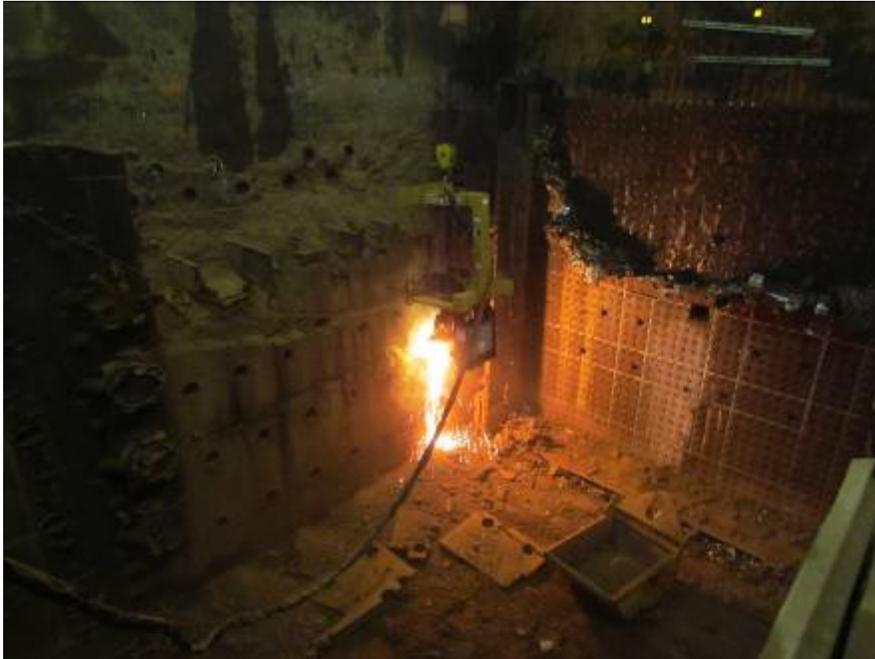
Photograph 8 – Cutting West Inside Steel Wall Plates with the Robotic Arm

Once the biological shield roof was removed, demolition of the walls commenced. The sequence of the wall demolition was top-down; first cutting and removing a row of inner wall plates, then breaking the concrete between the inner and outer wall plates. Both the magnetically-secured, track-mounted remote-controlled system fitted with oxy-propylene torches and the robotic arm suspended from the gantry crane were used to cut the inner wall plates.

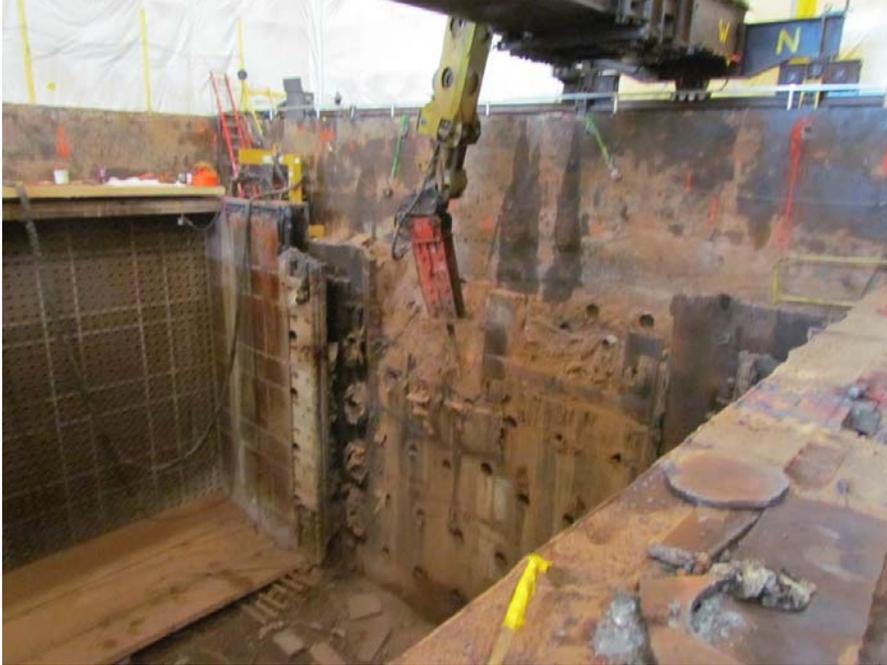
Photograph 9 – Gradall Excavator Breaking West Wall Concrete

The concrete breaking continued to proceed slowly. The concrete would not separate from the embedded steel angles or experimental and fuel channel ports, and did not break into large pieces. The significant amount of ferrous aggregate included in the wall contributed to the resistance that slowed progress. It was also discovered that the walls contained significantly more rebar than depicted on the design drawings.

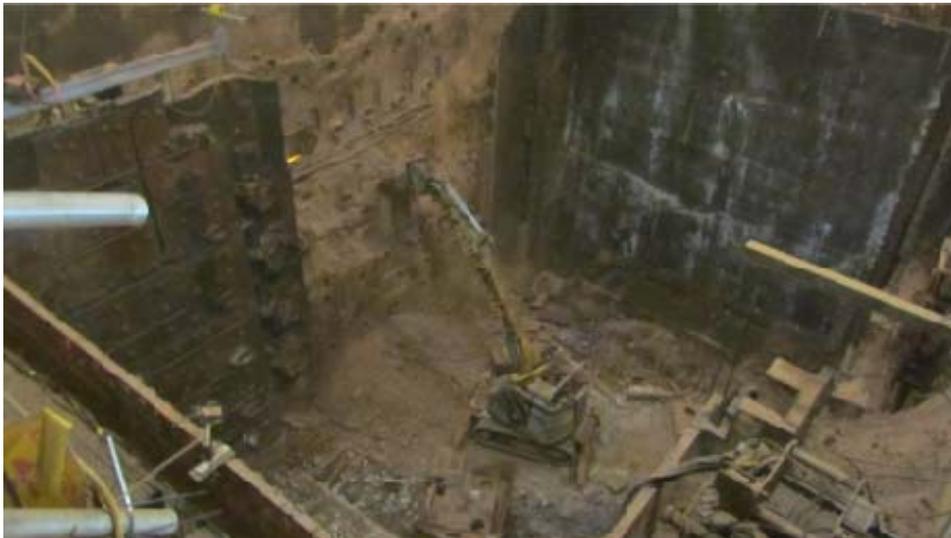
Photograph 10 – Brokk Manipulator Creating Opening in West Wall for New Holland Access

- Creating an opening in the west biological shield wall large enough for the excavator to enter and exit;
- Reinforcement of the exterior High Bay floors to support the weight of the large excavator (estimated at 40-tons). This included grouting void spaces beneath the floor and placement of steel plates over the floor;
- Placement of a one-foot thick reinforced floor inside the biological shield footprint to support the weight of the large excavator;
- Filling the north and south outlet air plenums to support the new one-foot thick reinforced concrete floor mentioned above; and
- Extending the CCE on the west side to enclose the opening in the west biological shield wall and provide a service area for the large excavator.

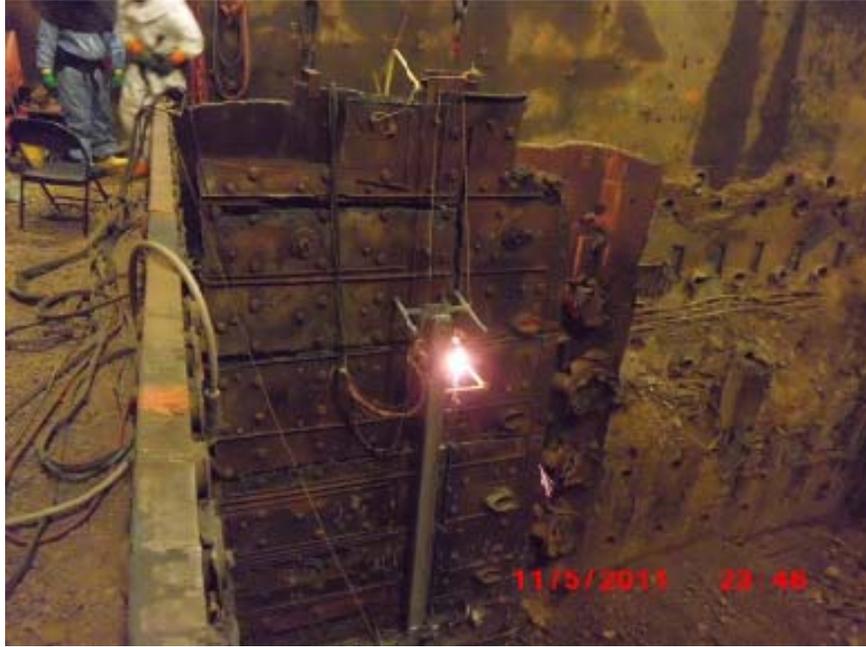
Photograph 11 –Tool Fitted With Torch Cutting South Plenum Binding Plates

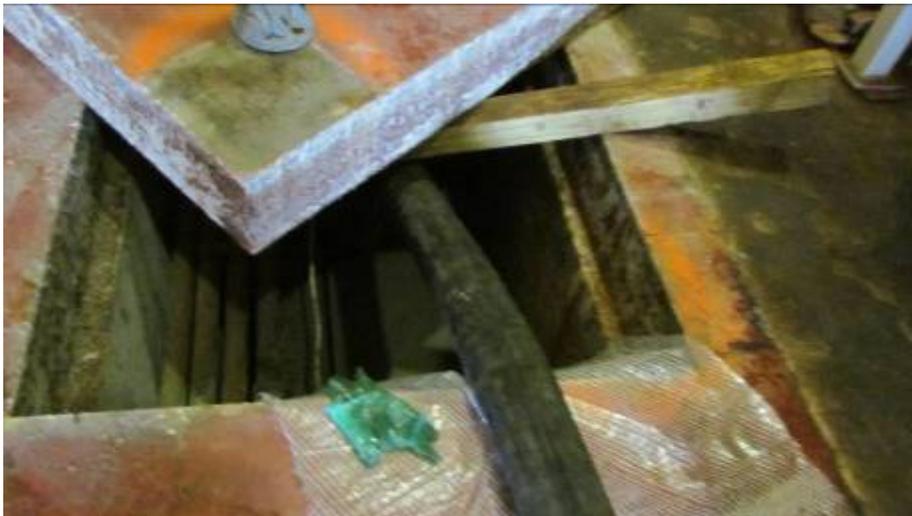
Photograph 12 – Filling Void Areas beneath the High Bay Area with Grout

Due to the weight of the New Holland excavator (40-tons), void areas (West Animal and Instrument Tunnels, and the North Pipe Trench) beneath the Building 701 high bay area outside of the biological shield footprint were filled with grout up to the floor level (elevation 110'). In addition, steel plates were placed atop this floor after the void areas were filled with cementitious grout. These steps provided a stable floor for the excavator/hammer unit that was used to dismantle the biological shield.

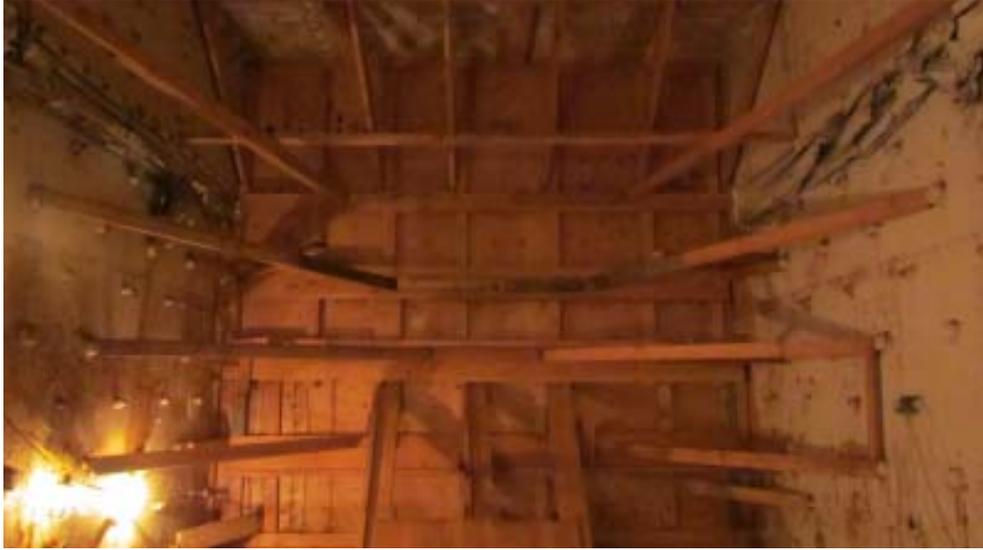
Photograph 13 – Concrete Form in One of the Outlet Air Plenums

To provide support for the excavator, the north and south outlet air plenums were also filled with cementitious grout up to the existing floor level (~elevation 109'). Photograph 13 shows the wooden formwork that was constructed in one of the below ground ducts at the bottom of the outlet air plenum. Once the plenums were filled, a 10-inch thick reinforced concrete floor was placed over the entire interior footprint of the biological shield.

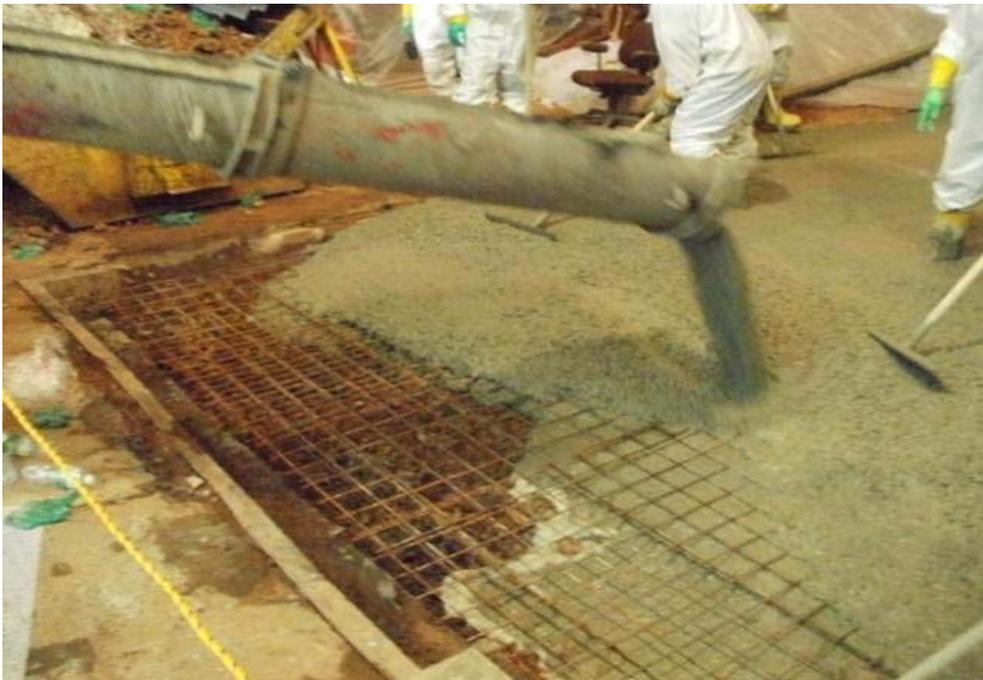
Photograph 14 – Initial Concrete Placement over Biological Shield Footprint

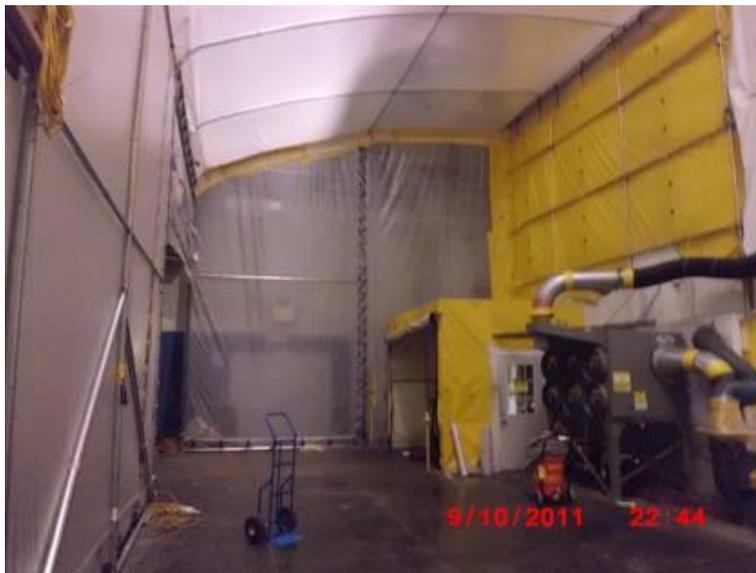
Photograph 15 – Extension of the CCE

The CCE was extended on its west side to enclose to operations associated with the removal of the biological shield. After the CCE extension was completed, the New Holland excavator was brought in to complete the removal of the concrete in the west biological shield wall to create the entrance into the biological shield cavity. Photograph 17 shows the New Holland excavator inside of the biological shield cavity demolishing the east wall concrete.

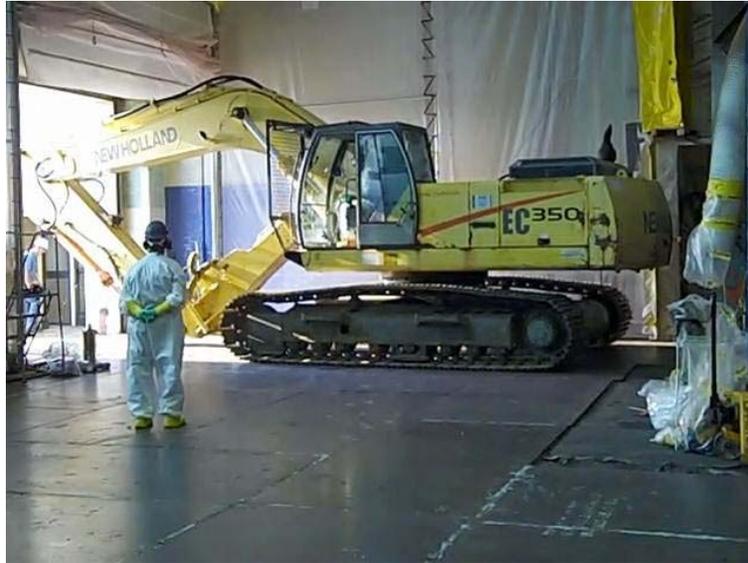
Photograph 16– New Holland Excavator Being Brought into CCE Extension Prior to Initial Use

A New Holland EC-350 track-mounted hydraulic excavator with a 10,000 psi class breaker hammer was received at BNL on August 13, 2011. On September 14, 2011 the machine was ready to be placed into service. Concurrent with the preparation work on the New Holland excavator, the project staff completed the facility modifications and completed the opening in the west biological shield wall. On September 16, 2011, the New Holland excavator was driven into the interior of the biological shield and commenced demolition of the remaining walls.

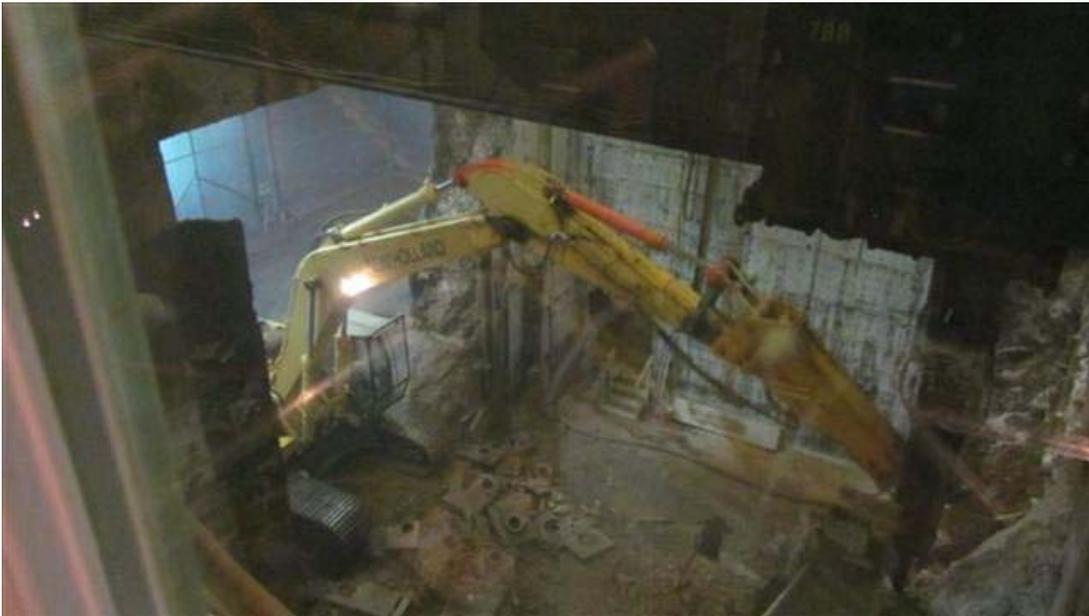
Photograph 17 – New Holland Excavator in Opening in West Wall Demolishing East Wall

After completion of the preparations to deploy the New Holland excavator, demolition of the biological shield continued at a faster rate. Work continued on schedule and without any issues until November 29, 2011 when a worker sustained serious injuries when he fell from a scissor-type aerial lift. This event is further discussed in Section 9.0.

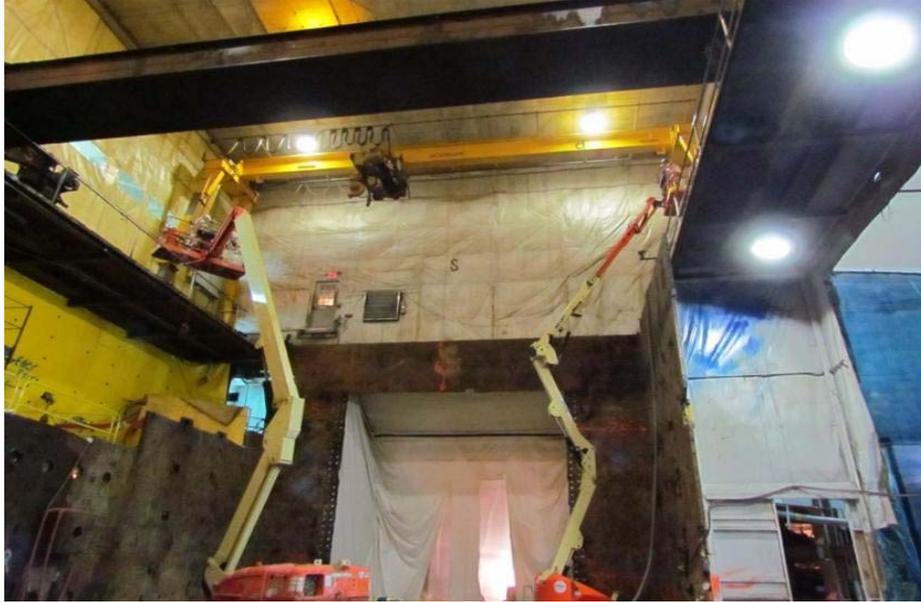
Photograph 18 – Stabilization and Radiological Surveys of CCE Prior To Dismantlement

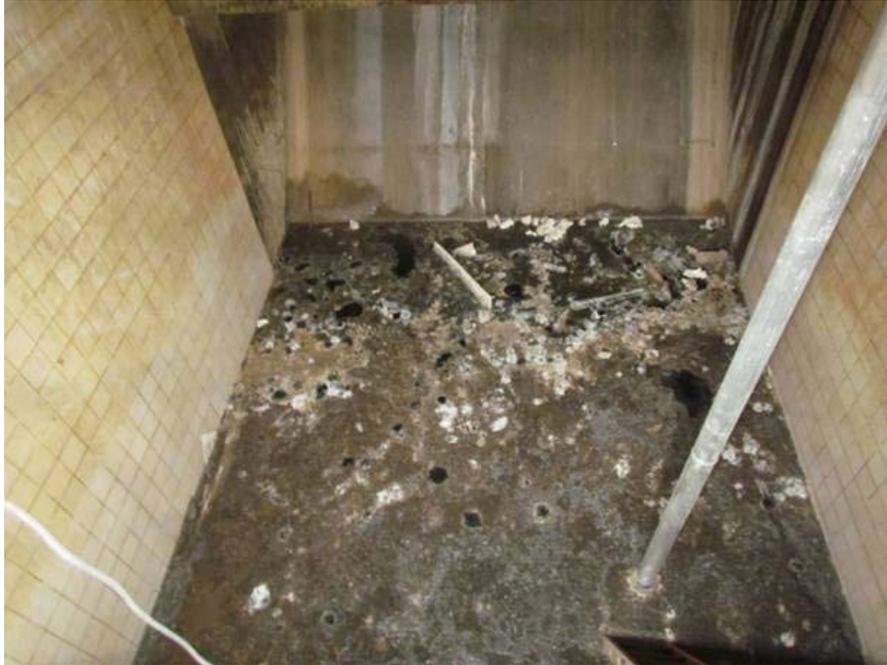
Photograph 19 – Deep Pit Prior to Removal of Water

Upon initial investigation on March 2, 2012, approximately 4,000 gallons of water was discovered in the Deep Pit. This water is suspected to have come from the water used for dust suppression during the demolition of the biological shield, entering the Deep Pit via the south reactor outlet air plenum. The water was pumped out, and solidified by the BNL EPD, Waste Management Group. Photographs 19 and 20 show the Deep Pit before and after removal of the water.

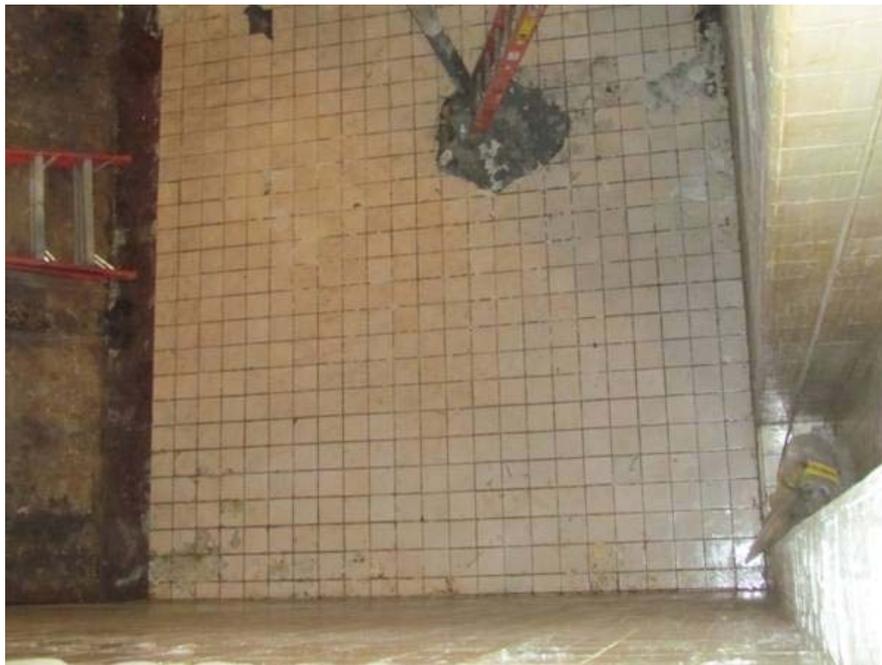
Photograph 20 – Deep Pit After Removal of Water

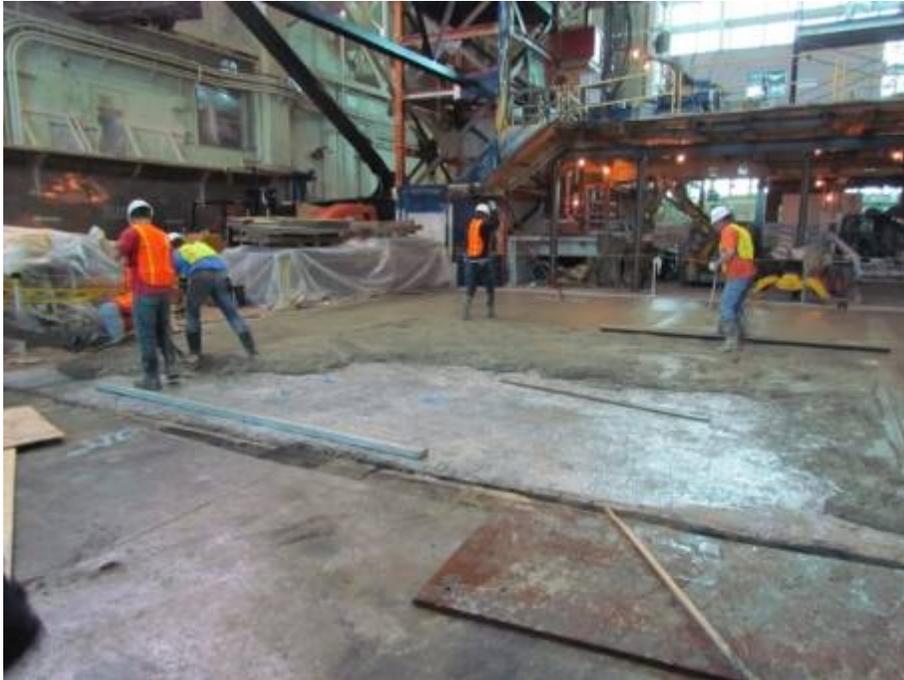
Photograph 21 – Placement of Final Concrete Cap on Elevation 110'-0"

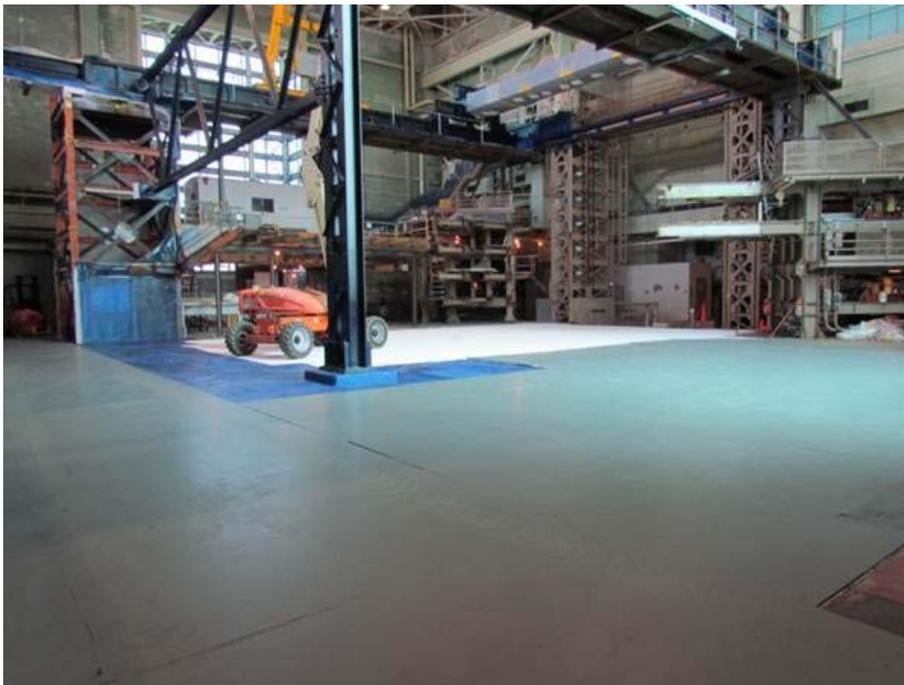
Photograph 22 – Completed Installation of Concrete Cap on Elevation 110'-0"

Upon completion of removal of loose contamination on the existing reinforced concrete floor within the biological shield footprint, a preliminary radiological survey was conducted to confirm that the final concrete cap, which would vary in thickness from 1.5-inches to 4-inches, would ensure that the general area radiological dose rate on the floor would be less than 0.1 mrem/hr. On March 28, 2012, the final concrete cap was placed to elevation 110'-0". Photograph 22 shows the final cap, which has a 28-day compressive strength of 5,200 psi.

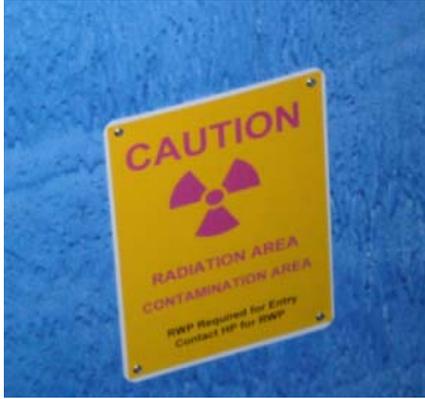
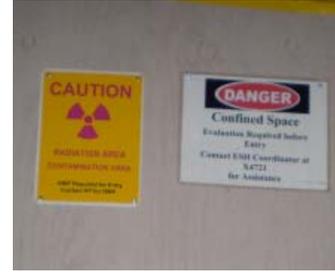
Photograph 23 - Posting of Deep Pit and Below Ground Ducts

Deep Pit Posting

South BGD Posting

ORISE performed a Type A independent verification of the BGRR as-left interior survey. ORISE determined that the appropriate level of effort and records were provided to document the as-left conditions. The independent verification is documented by *Project-Specific Type A Verification Letter Report for the Brookhaven Graphite Research Reactor, Brookhaven National Laboratory, Upton New York, DCN: 5098-LT-01-0*, (ORISE, 2012) (Appendix C). The report noted that information had not been provided for them to verify that the south below ground duct and the fuel canal and deep pit were posted and controlled as contamination areas. These areas are appropriately posted and controlled as contamination and radiation areas as required by BSA's Radiological Control Program. Photographs of the postings are presented in Photograph 23 below:
