Building 902 Ladder Injury

Building 1005R Ladder Injury

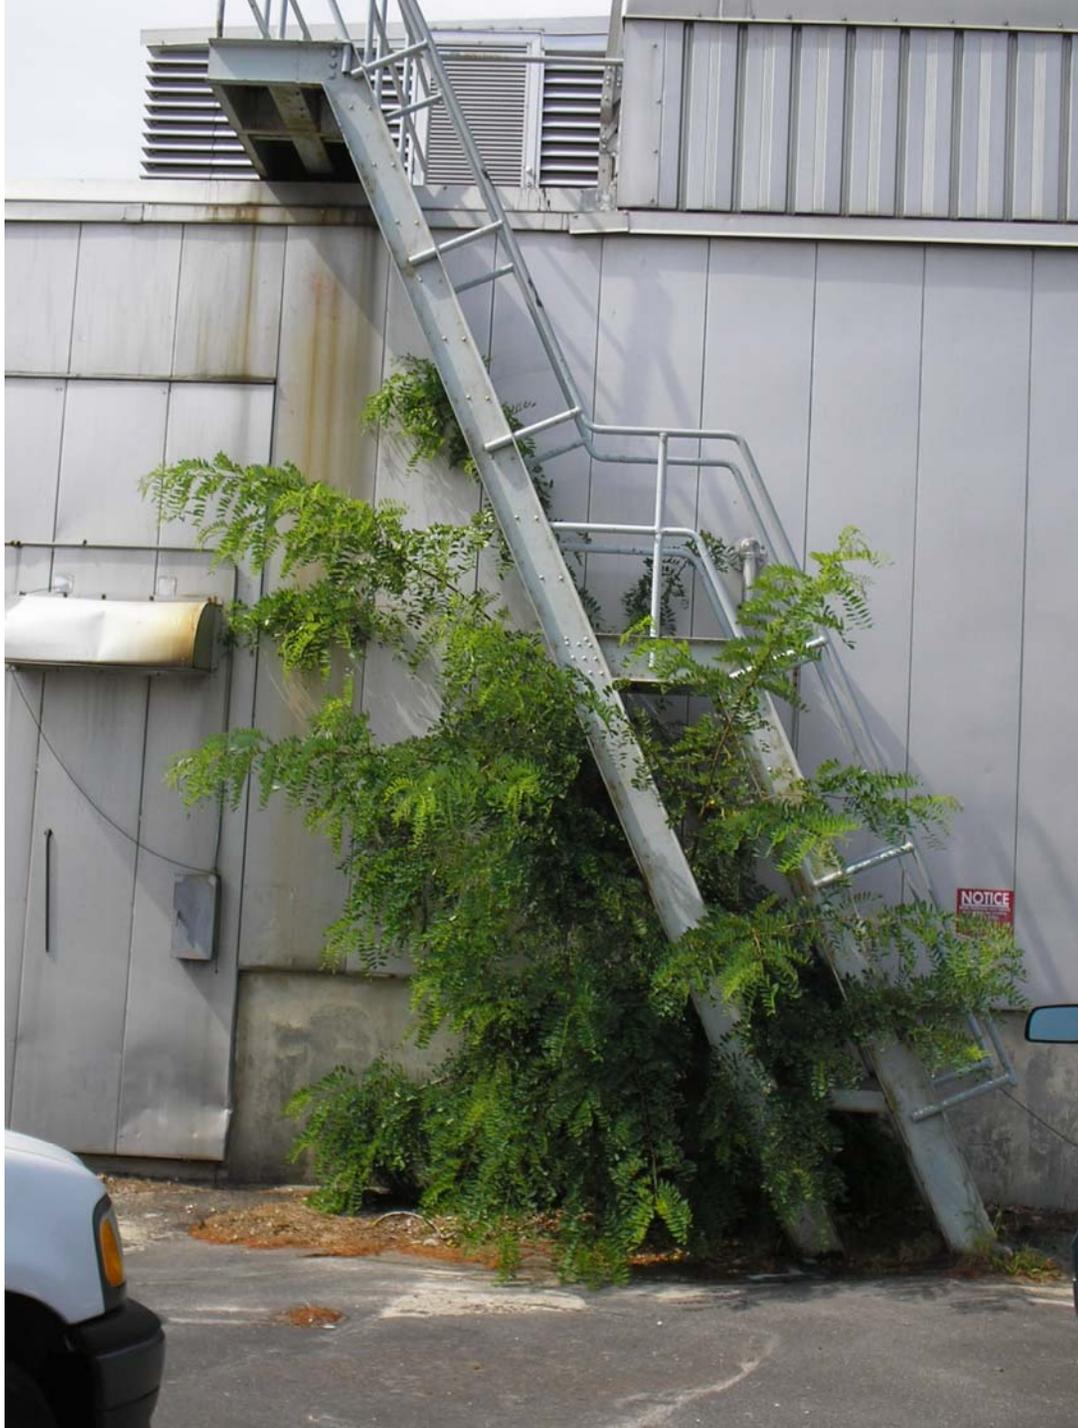
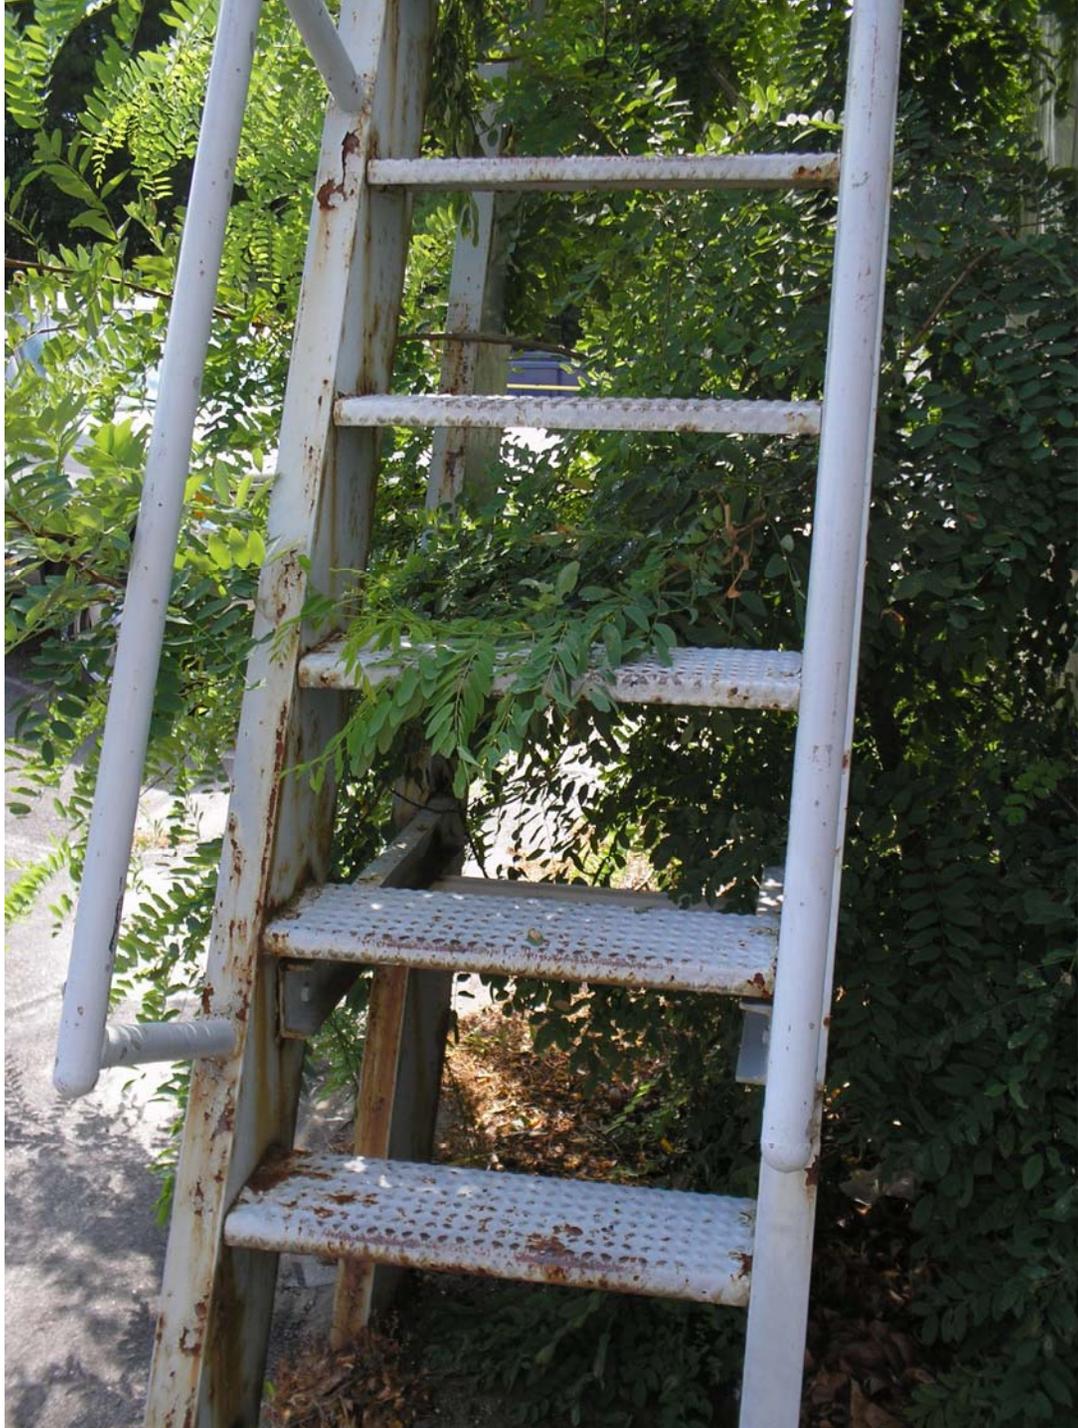
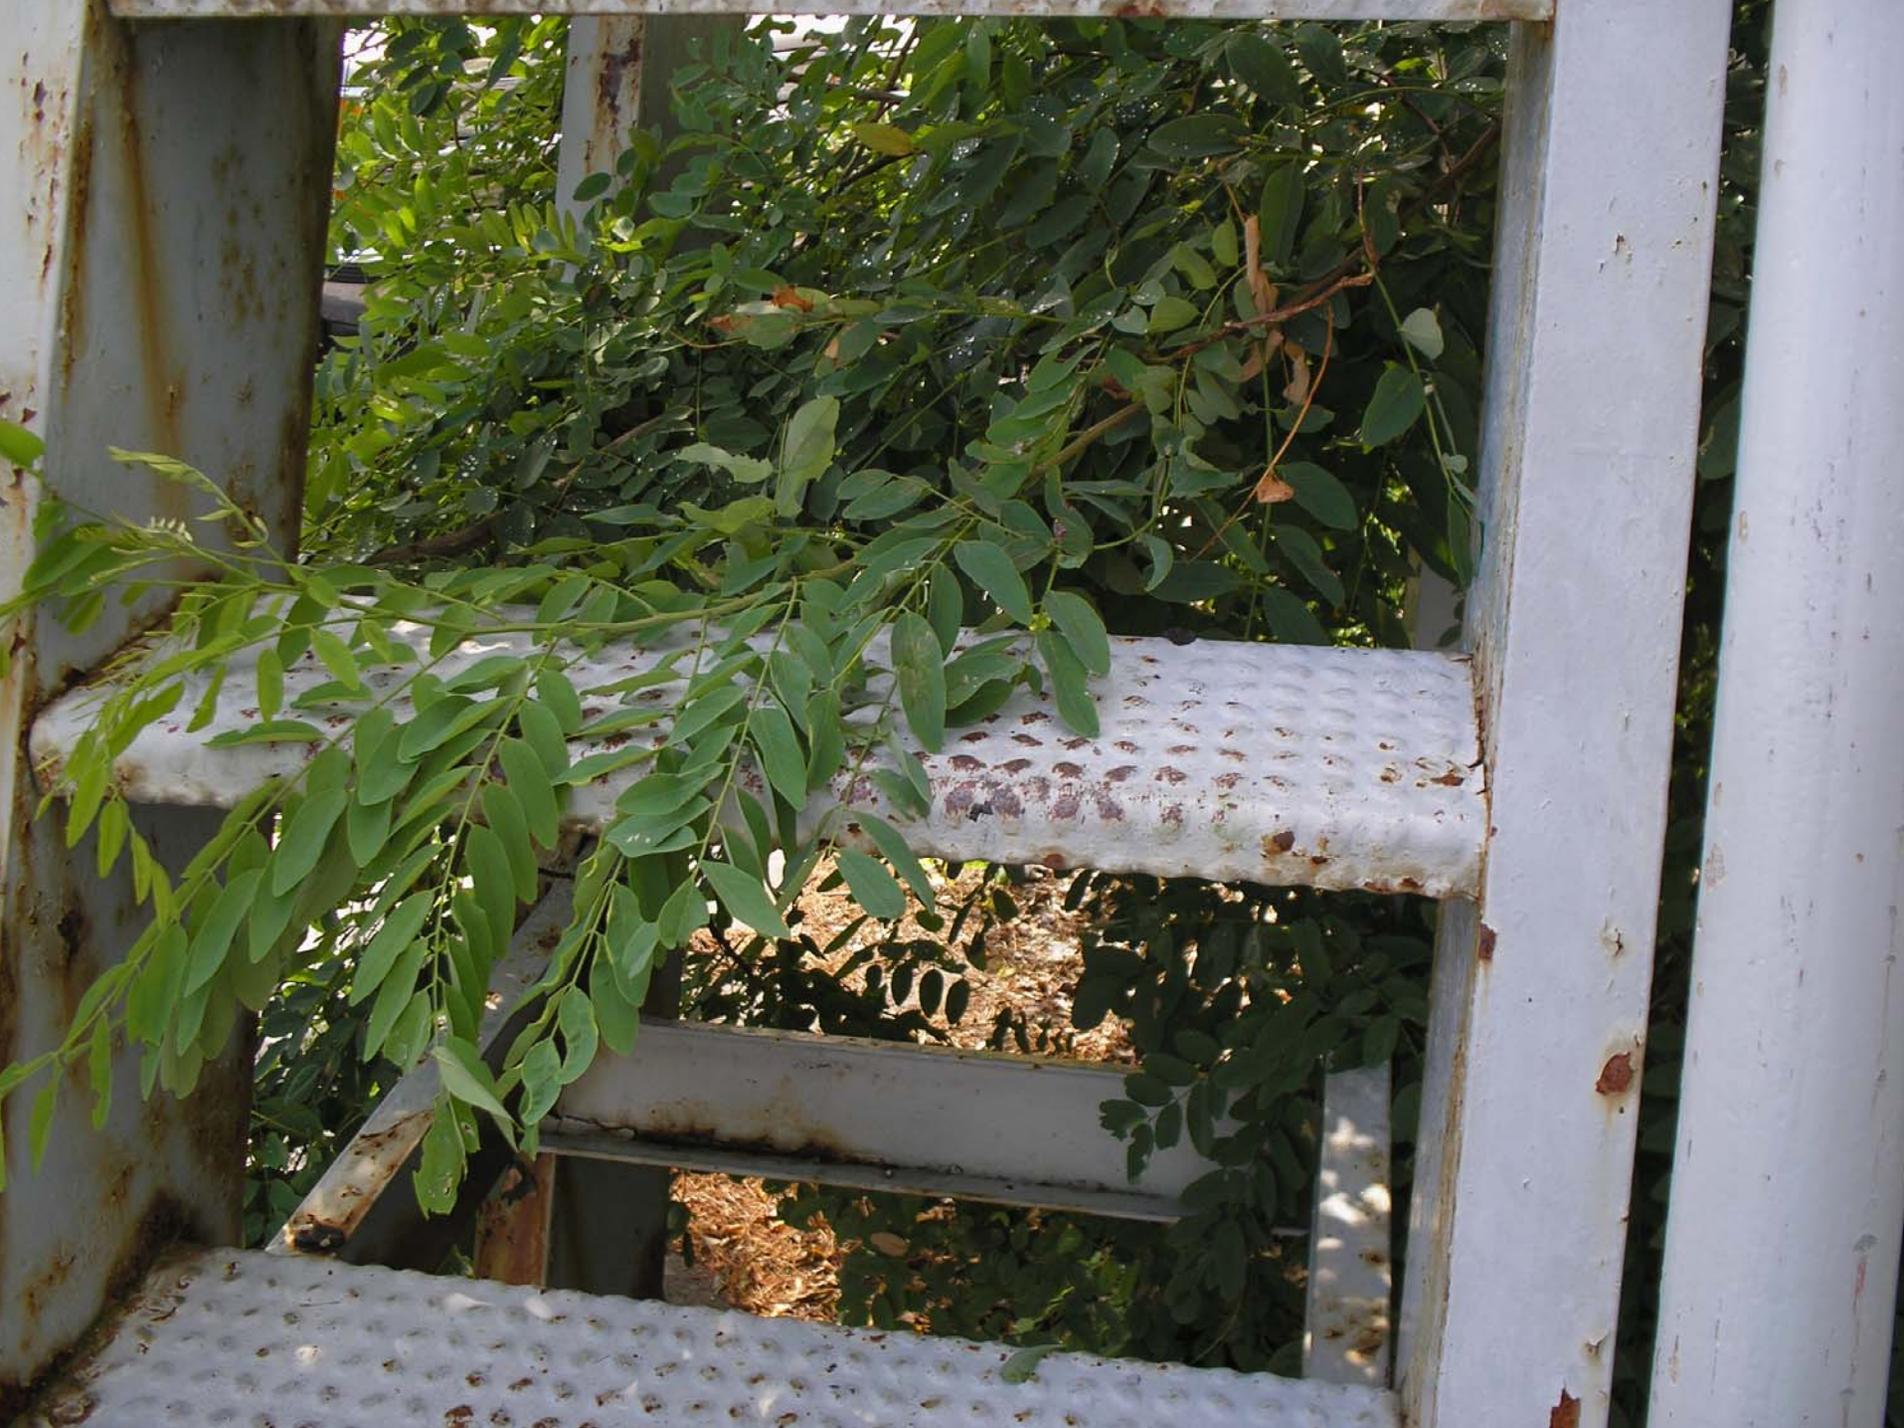
- August 14, 2006 – A Plant Engineering employee was descending an outdoor staircase and missed a step. His hand slid down the railing and hit a metal pole. The employee broke 2 bones in his hand. The injury required medical treatment and resulted in lost time.

- Similar stairs were identified on OSHA FY03 inspections
 - Identify non-compliant ladders and stairs
 - Throughout the Laboratory fixed vertical ladders are used.
 - The addition of handrails can enhance the safe use of these ladders under certain circumstances
- Need to identify and fix similar deficiencies that were found on OSHA inspection of FY03
- Walk outside of the buildings during Tier 1 inspections
 - Identify egress issues
 - Identify other hazards

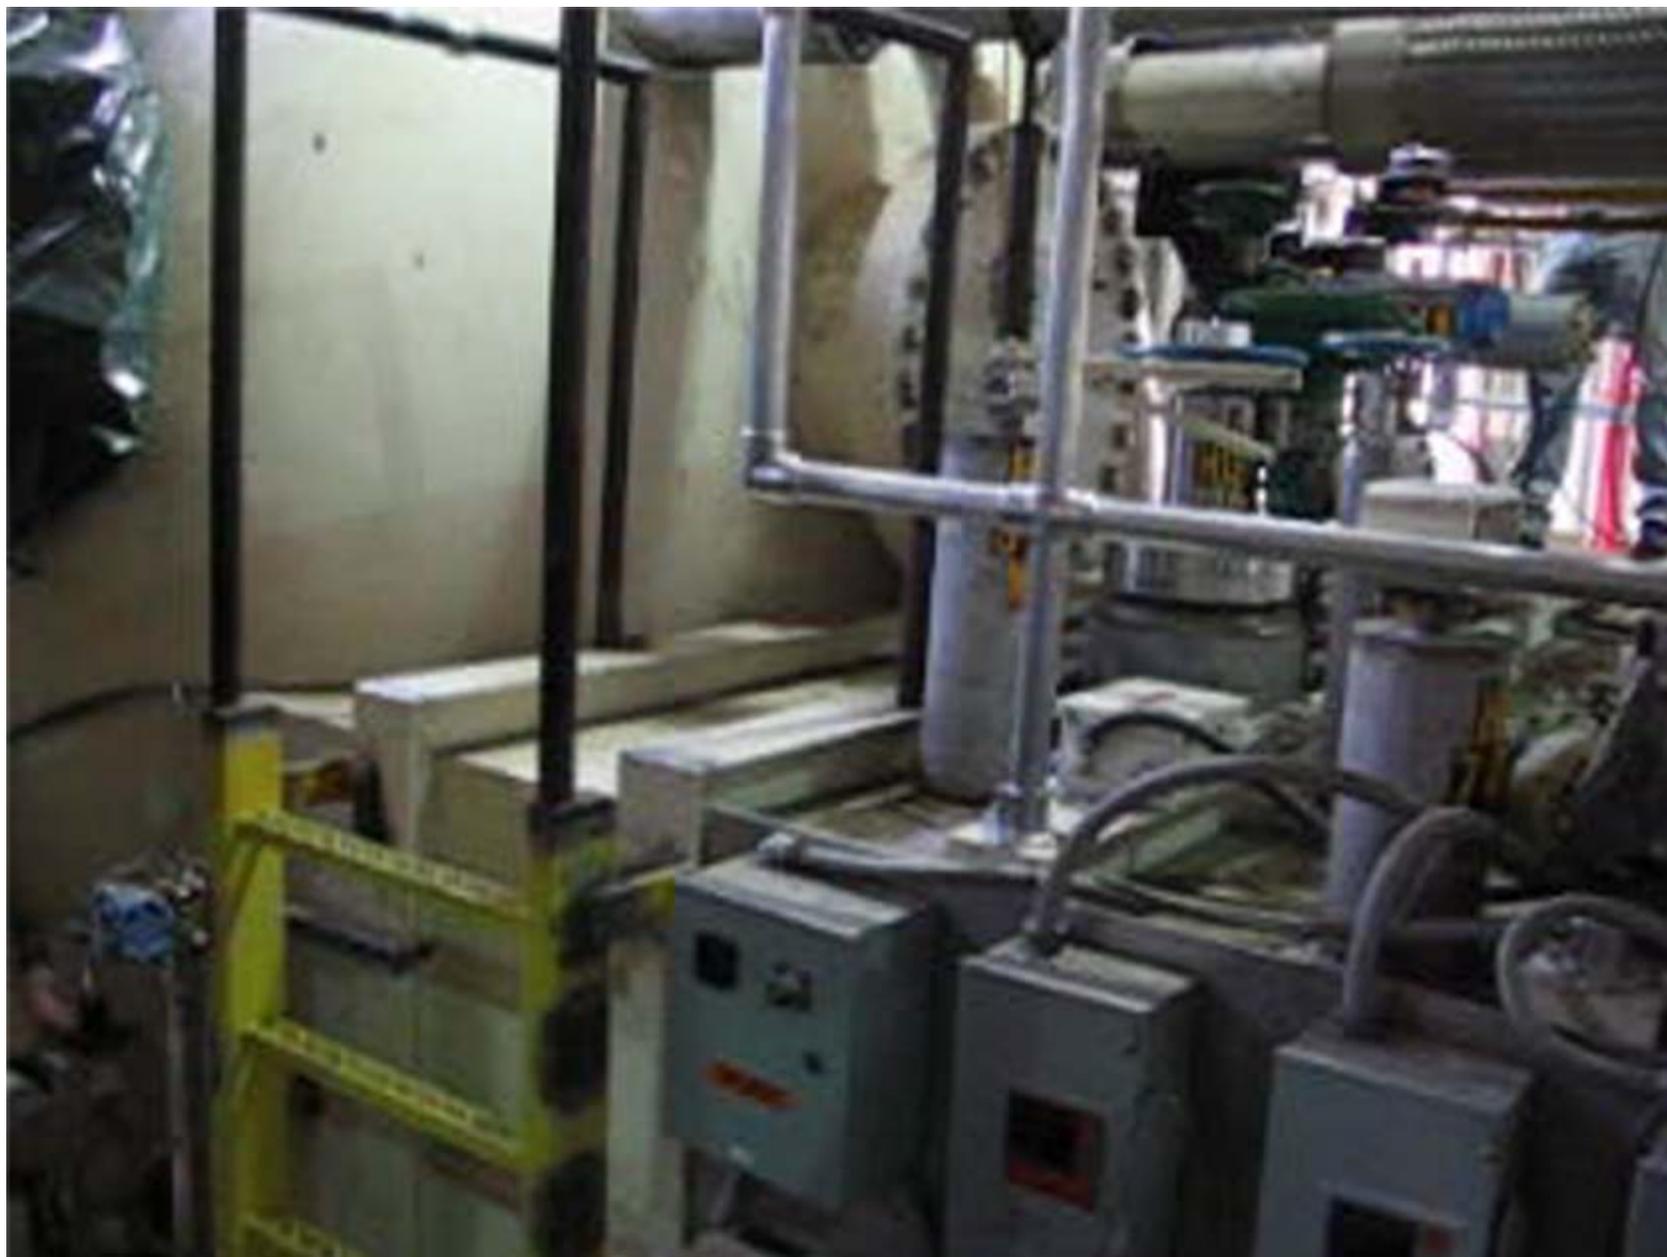
Non-standard railings at the top of the ladder onto the platform

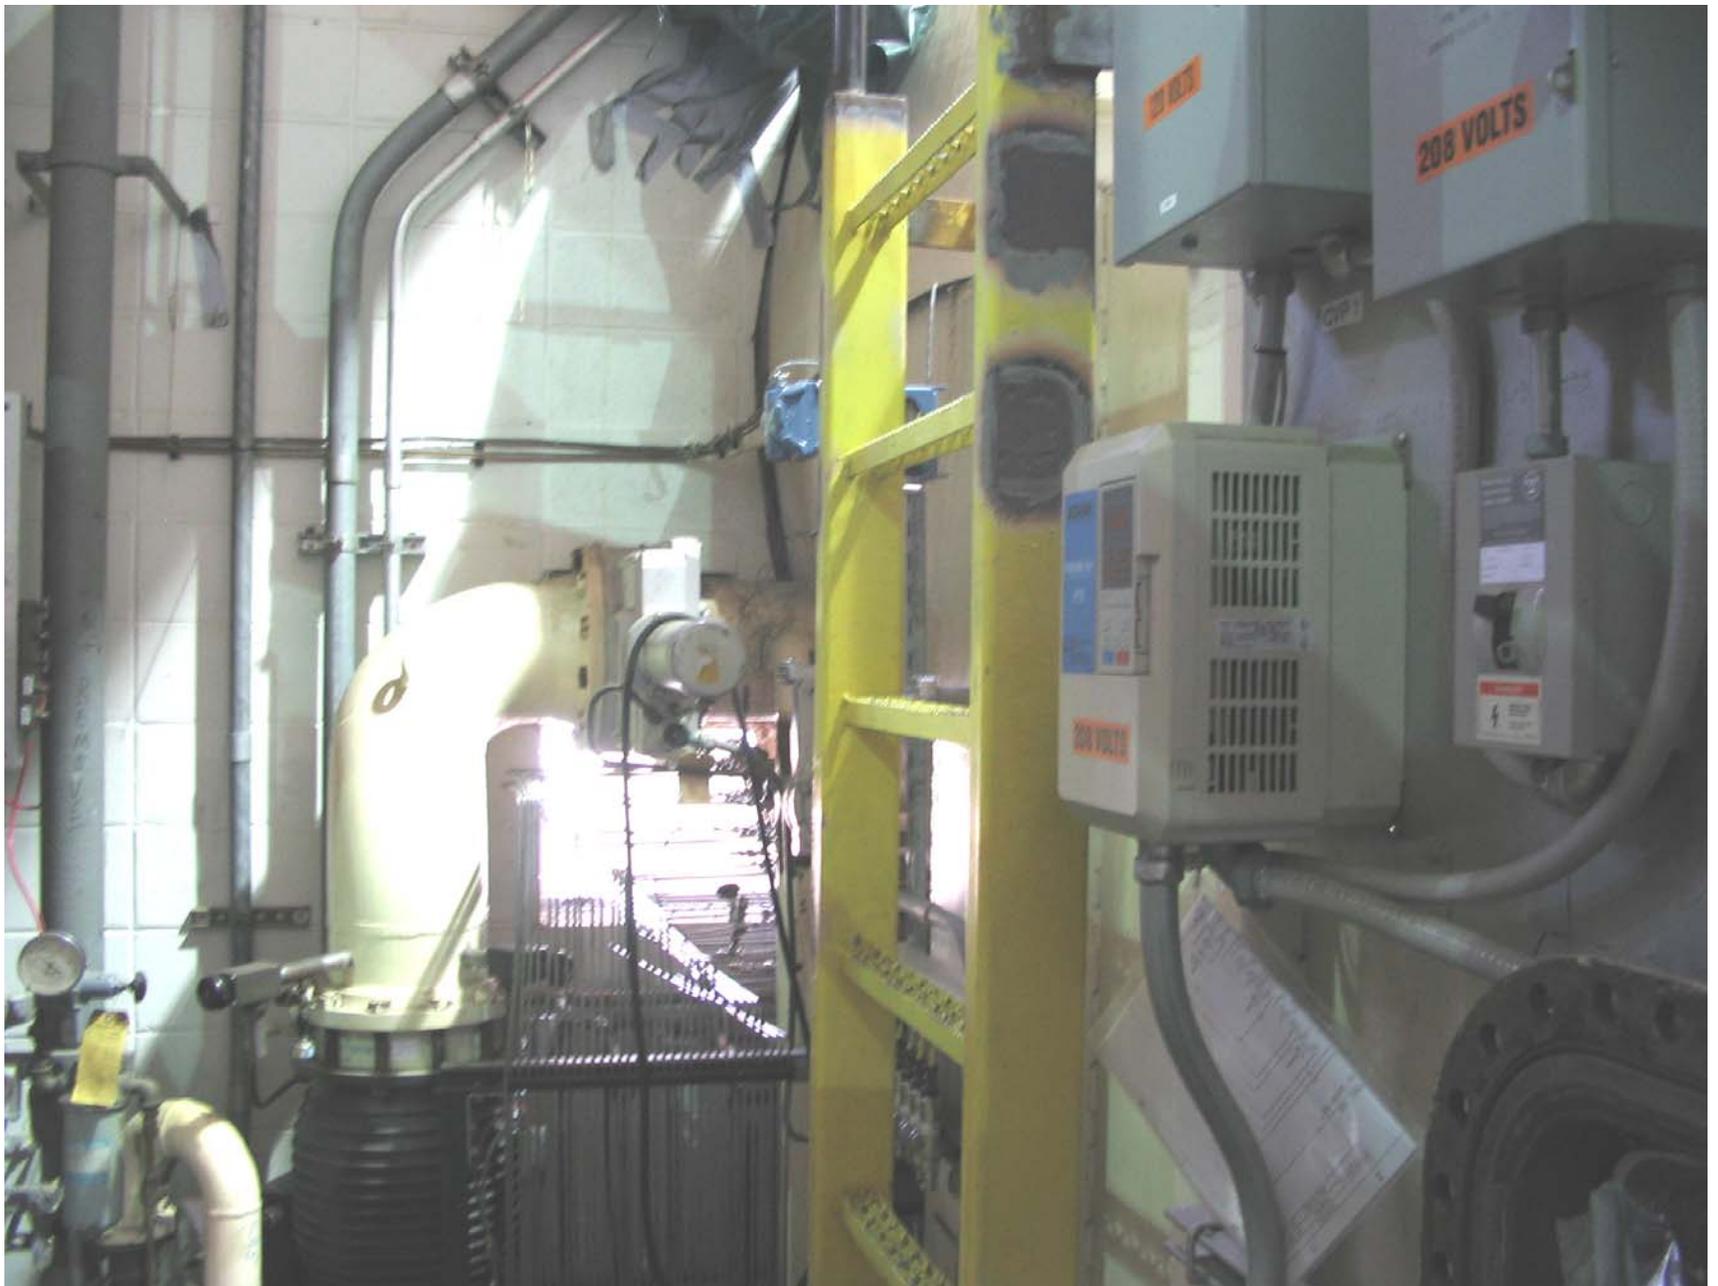
Fixed vertical ladder to access platform on cold box 5 (approx. 7 feet high)

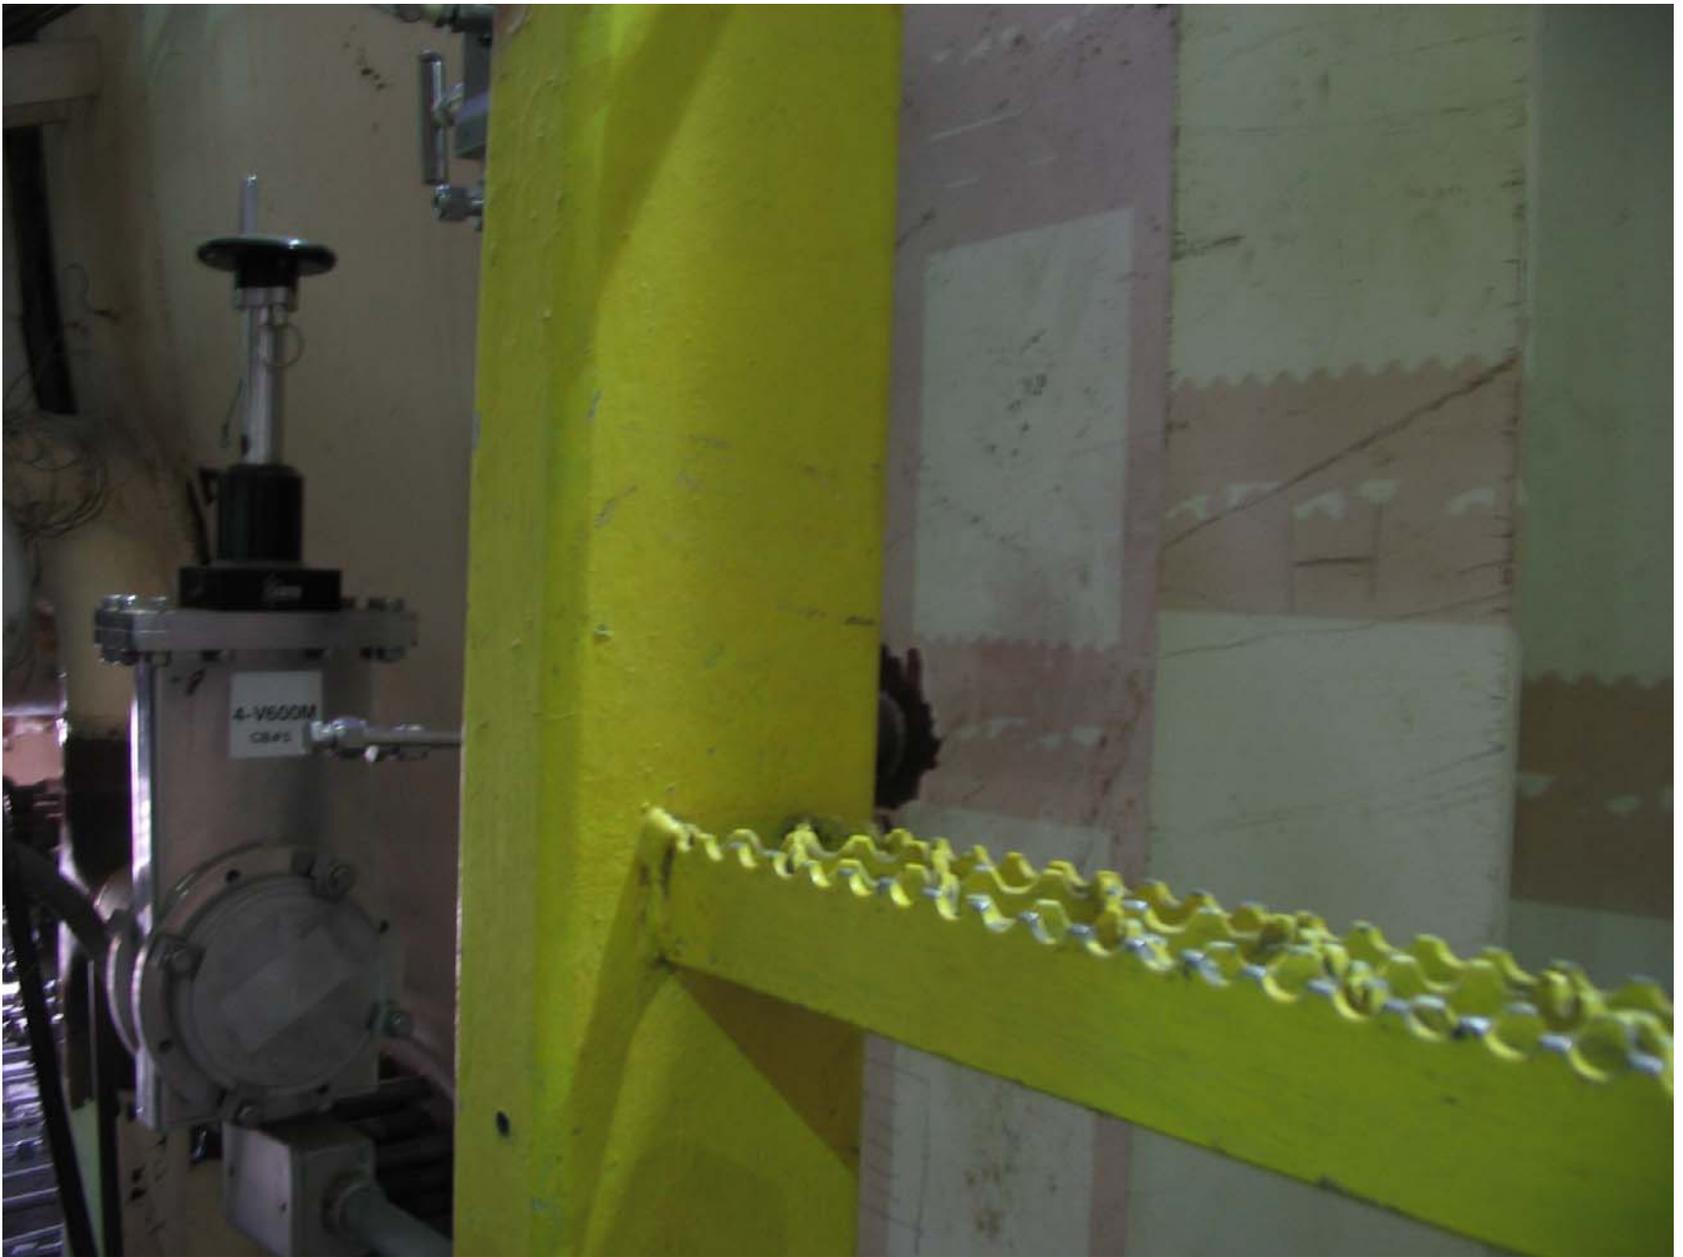
- August 21, 2006 - A CAD employee, while ascending a fixed vertical ladder attached to a platform on cold box 5 inside of Building 1005R, injured his shin on the rung of the ladder. The injury required medical treatment. The injury did not result in any worker restrictions or lost work time.

Rung of ladder
