Environmental Information Management System

Environmental Restoration Division

Operable Unit I

AOC 16

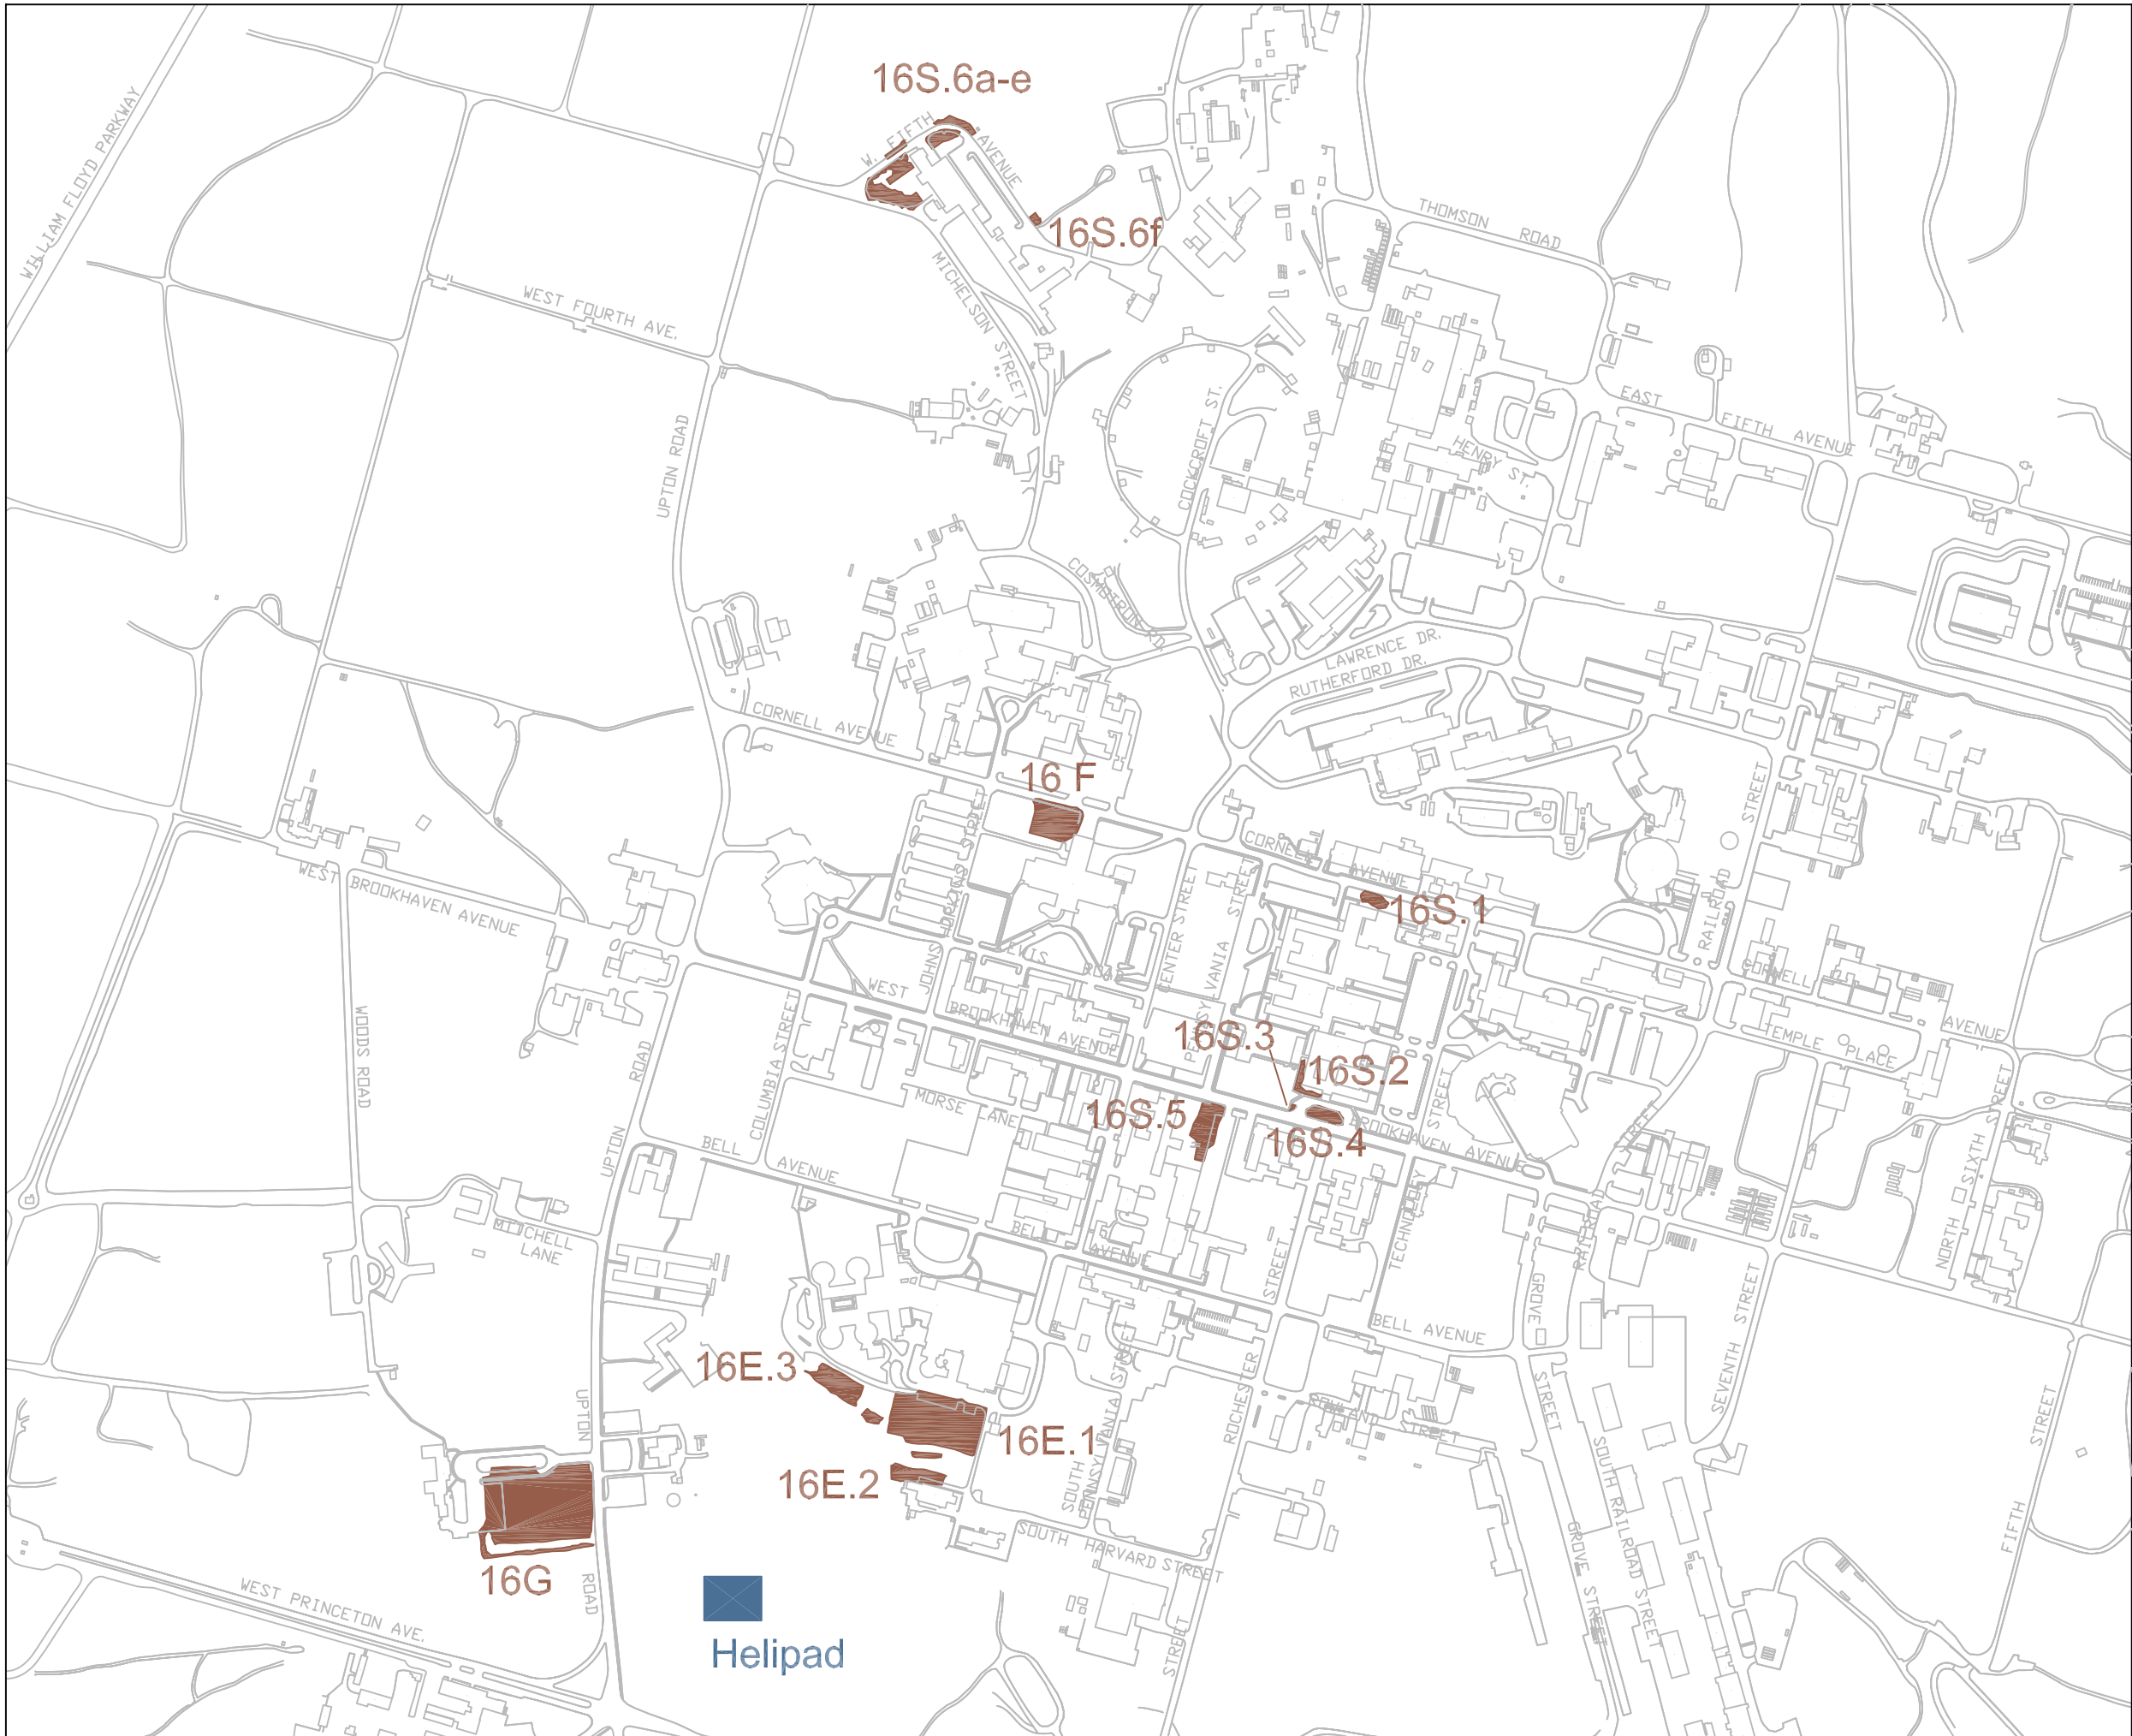
Figure 1

Locations of Radiologically Contaminated Landscape Soils At BNL

Areas of Radiologically Contaminated Landscape Soils

Background Sampling Area (Helipad)

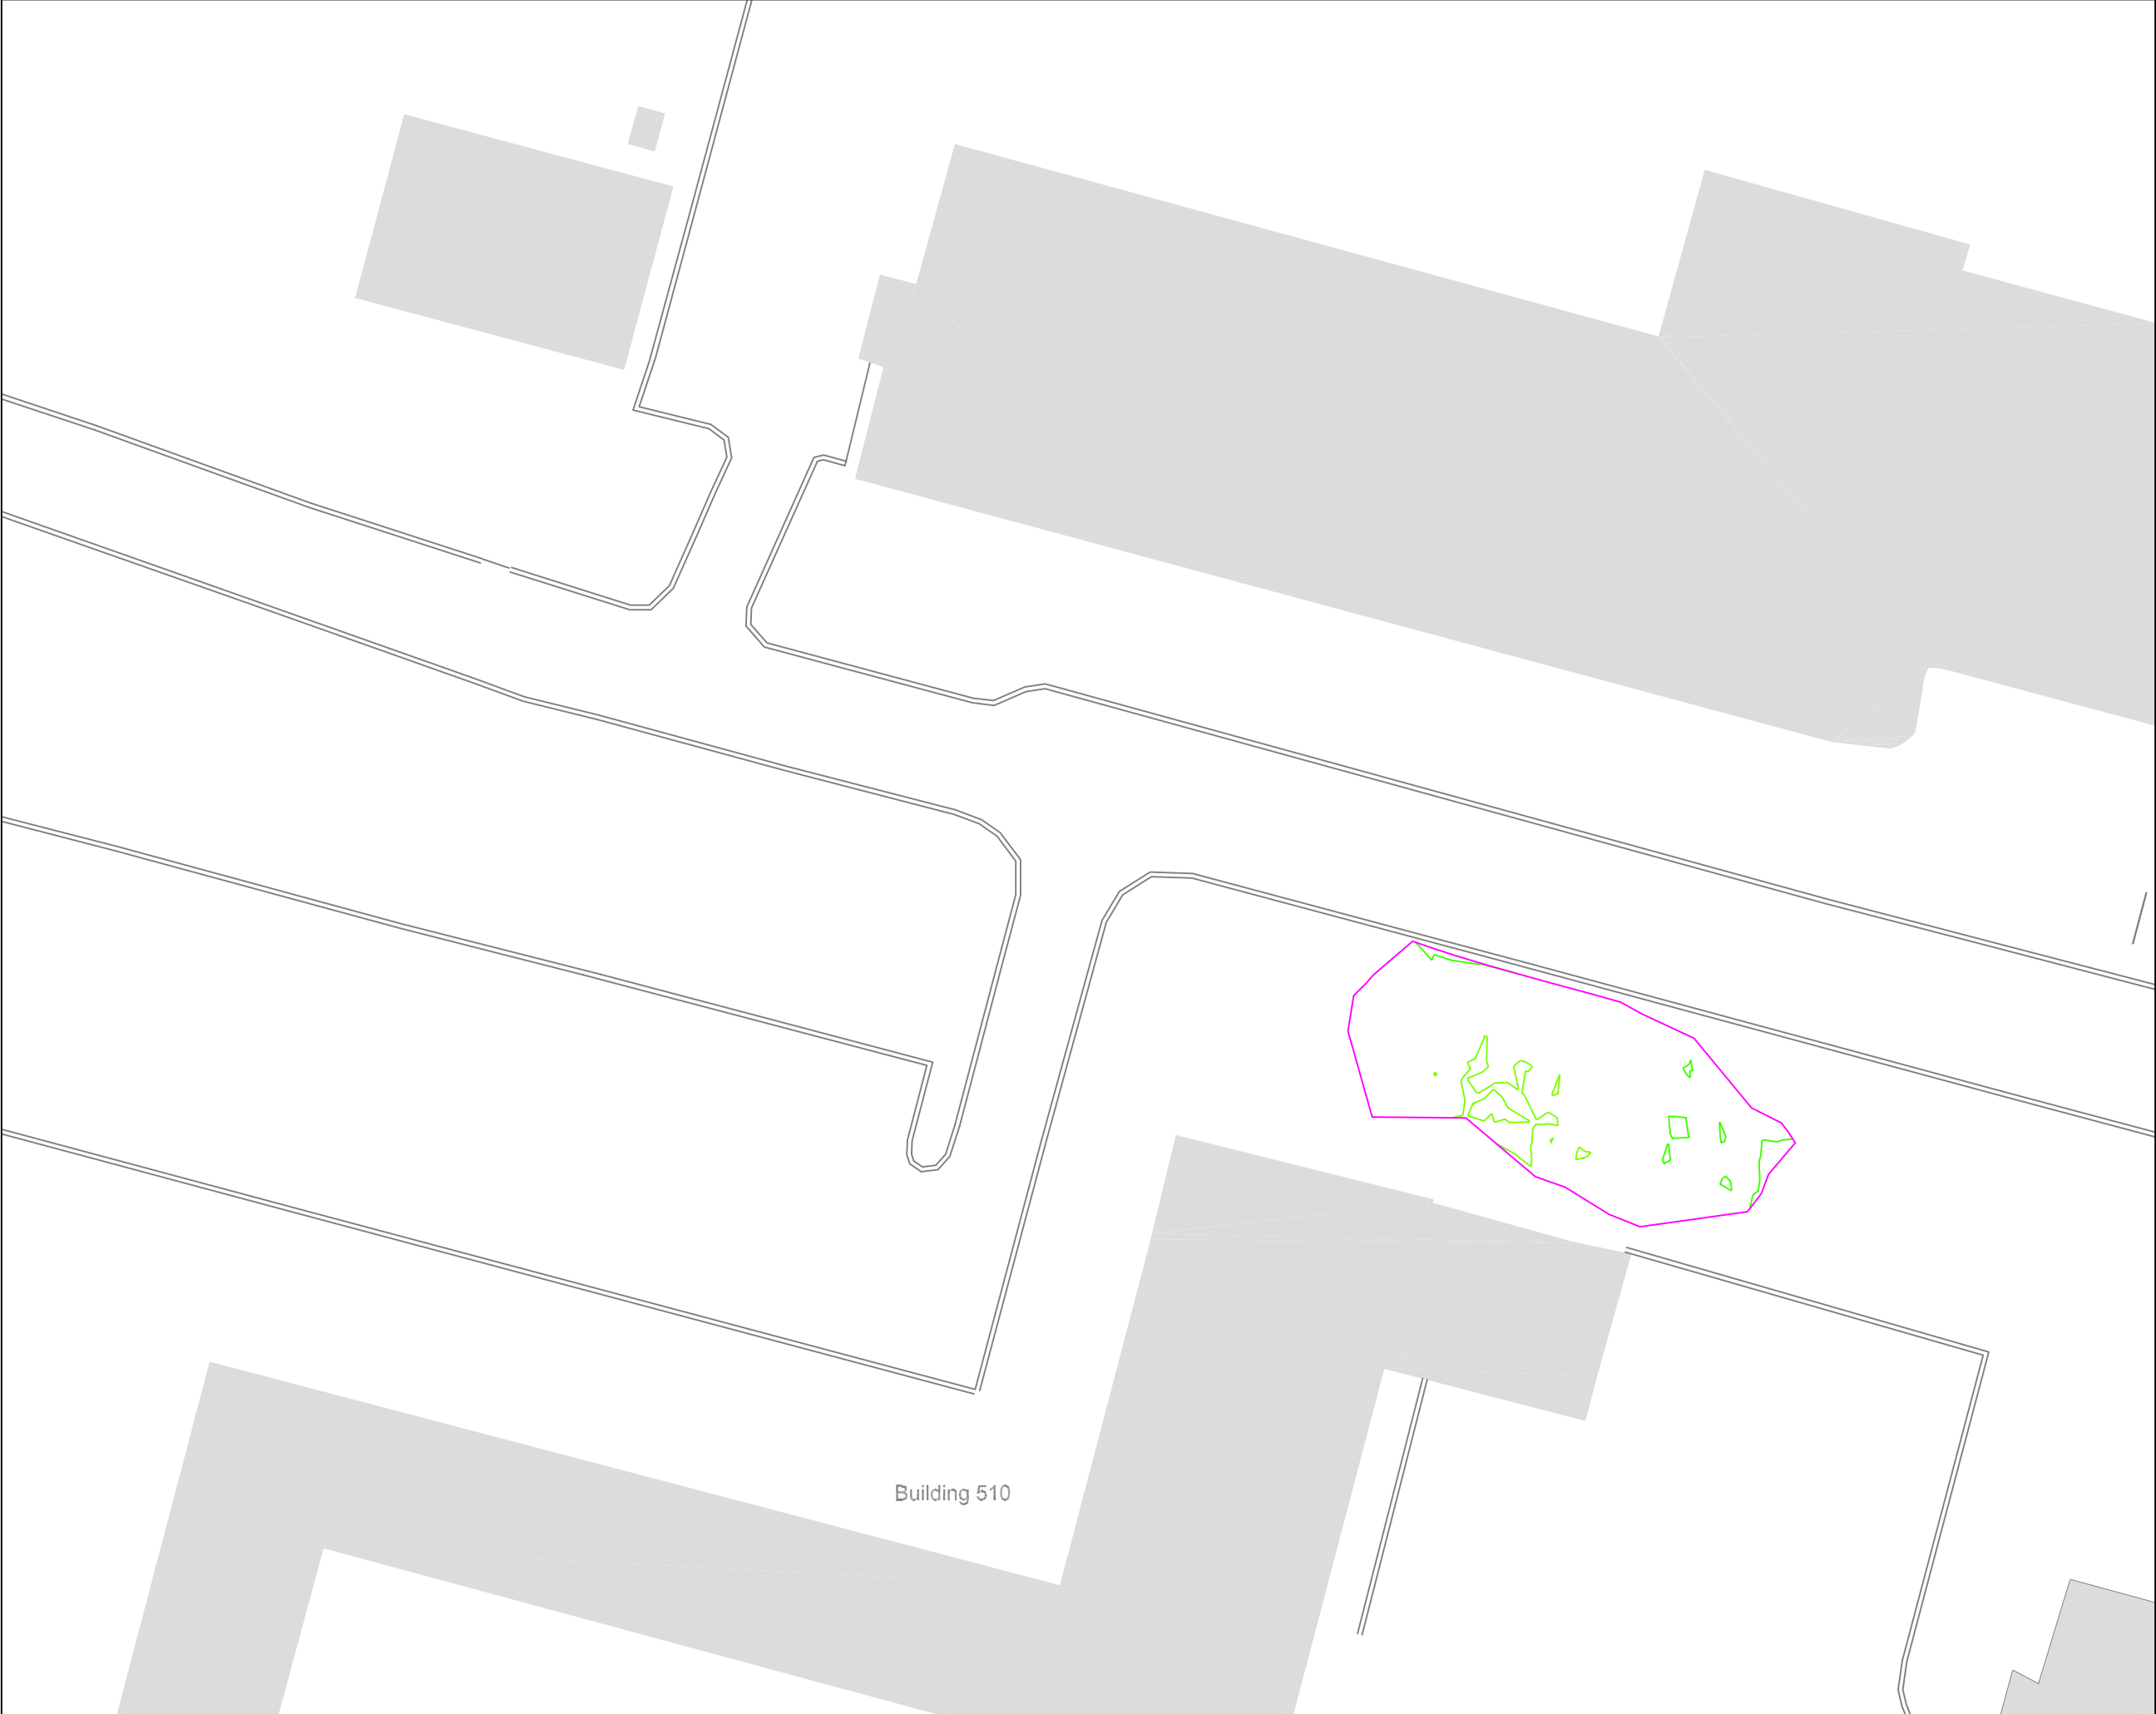
Figure 6  
Radiological Walkover  
Survey Results  
Sub-AOC 16S.1  
North of Building 510

- >= 80,000 CPM
- 70,000 CPM
- 60,000 CPM
- 50,000 CPM
- 40,000 CPM
- 30,000 CPM
- 20,000 CPM
- 10,000 CPM
- 7,000 CPM

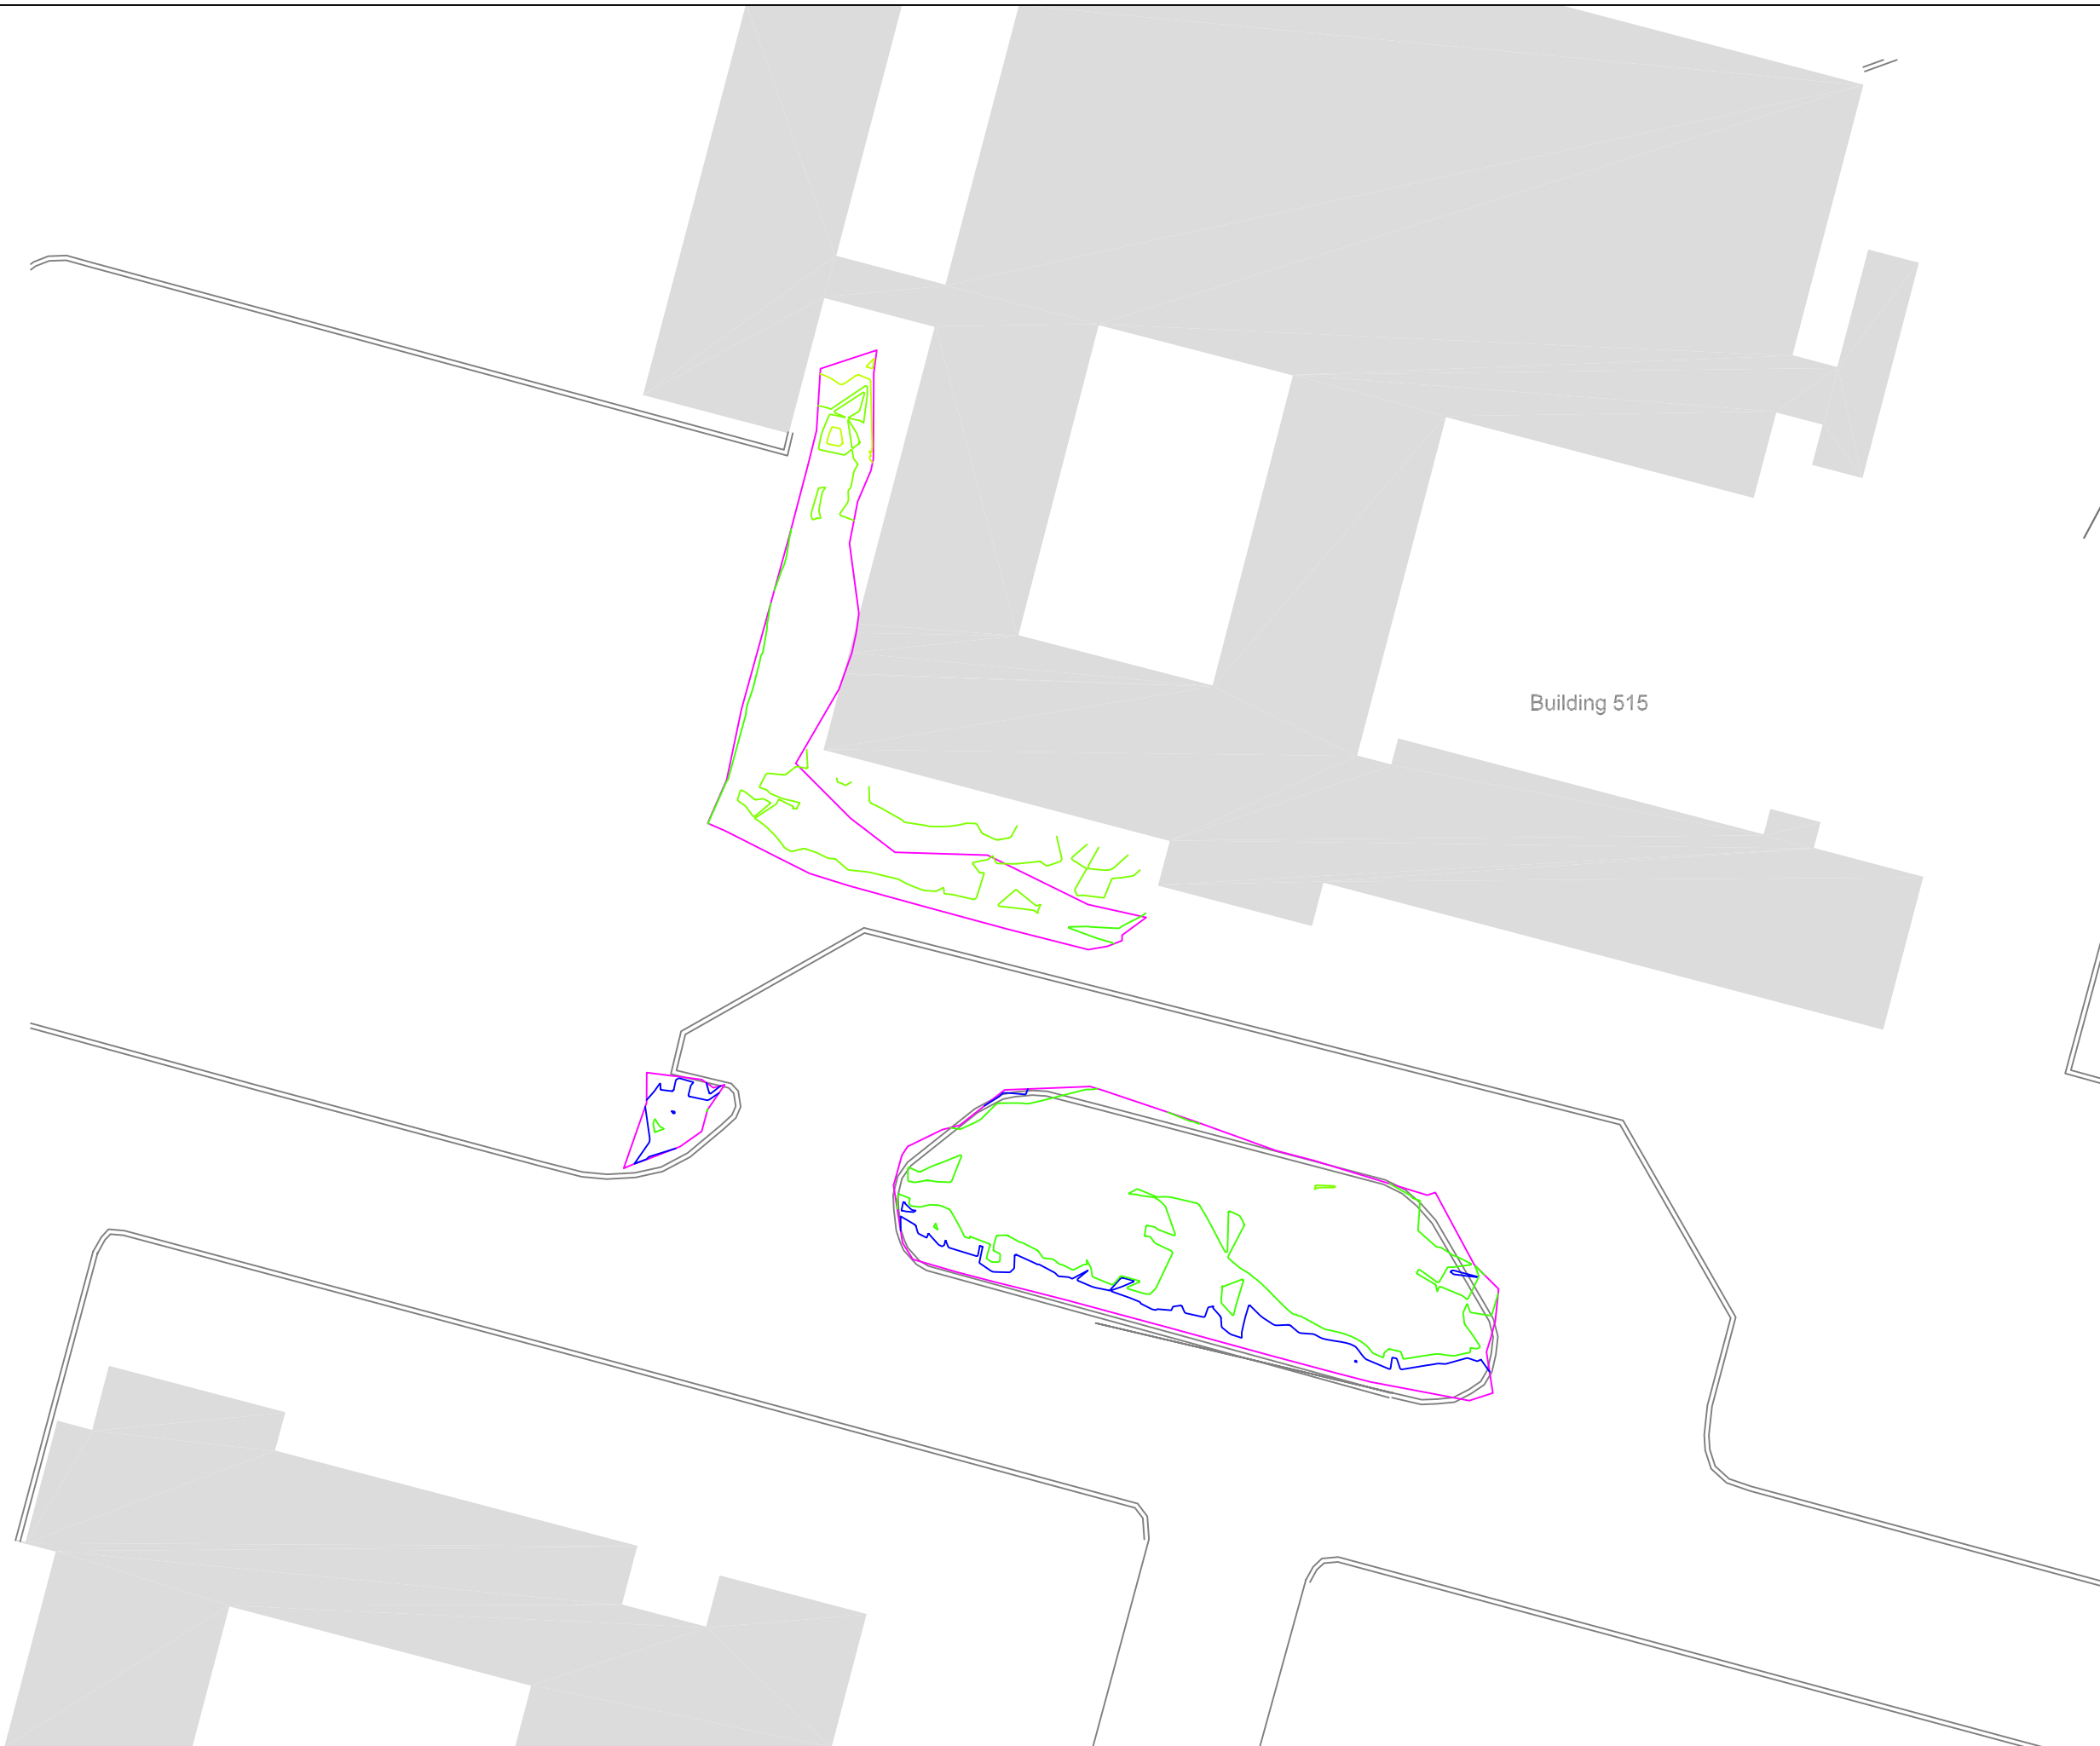
Figure 7

Pre-Excavation Radiological  
Walkover Survey Results

Sub-AOCs 16S.2, 16S.3 and 16S.4  
South and Southwest of building 515

- $\geq 80,000$  CPM
- 70,000 CPM
- 60,000 CPM
- 50,000 CPM
- 40,000 CPM
- 30,000 CPM
- 20,000 CPM
- 10,000 CPM
- 7,000 CPM

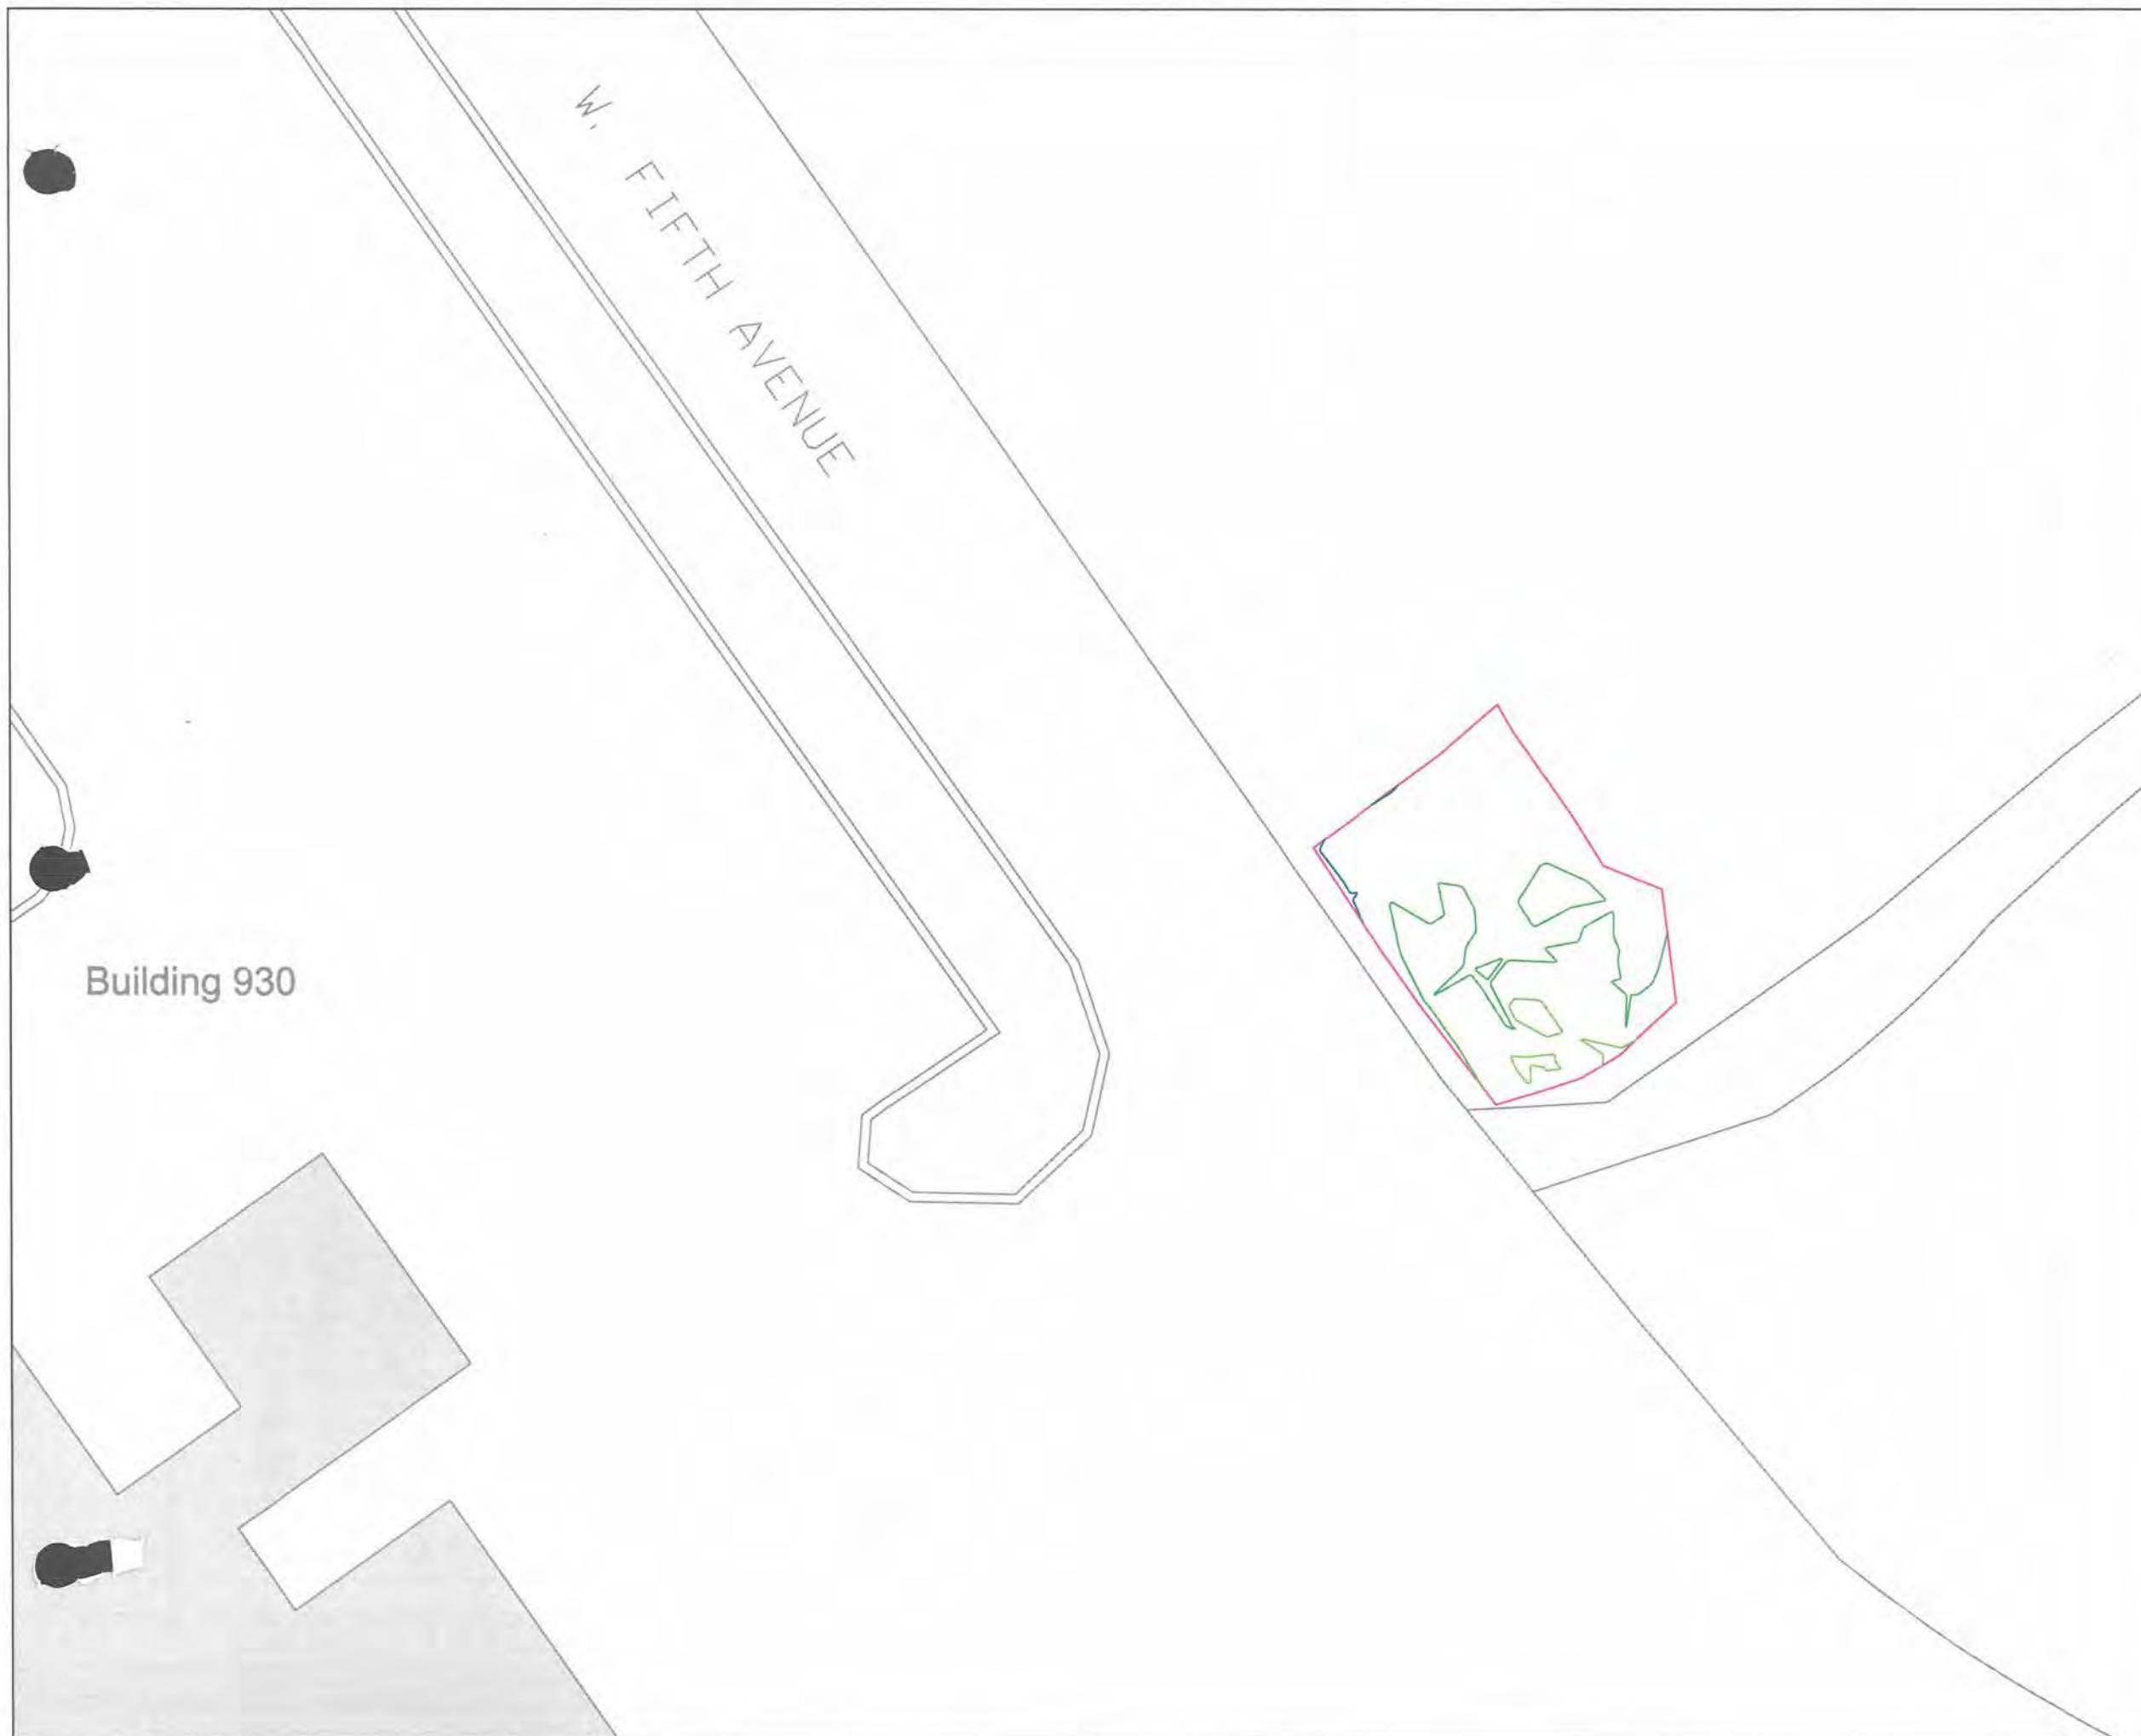
Figure 10

Radiological Walkover  
Survey Results

Sub-AOC 16S.6f  
Adjacent to Building 930

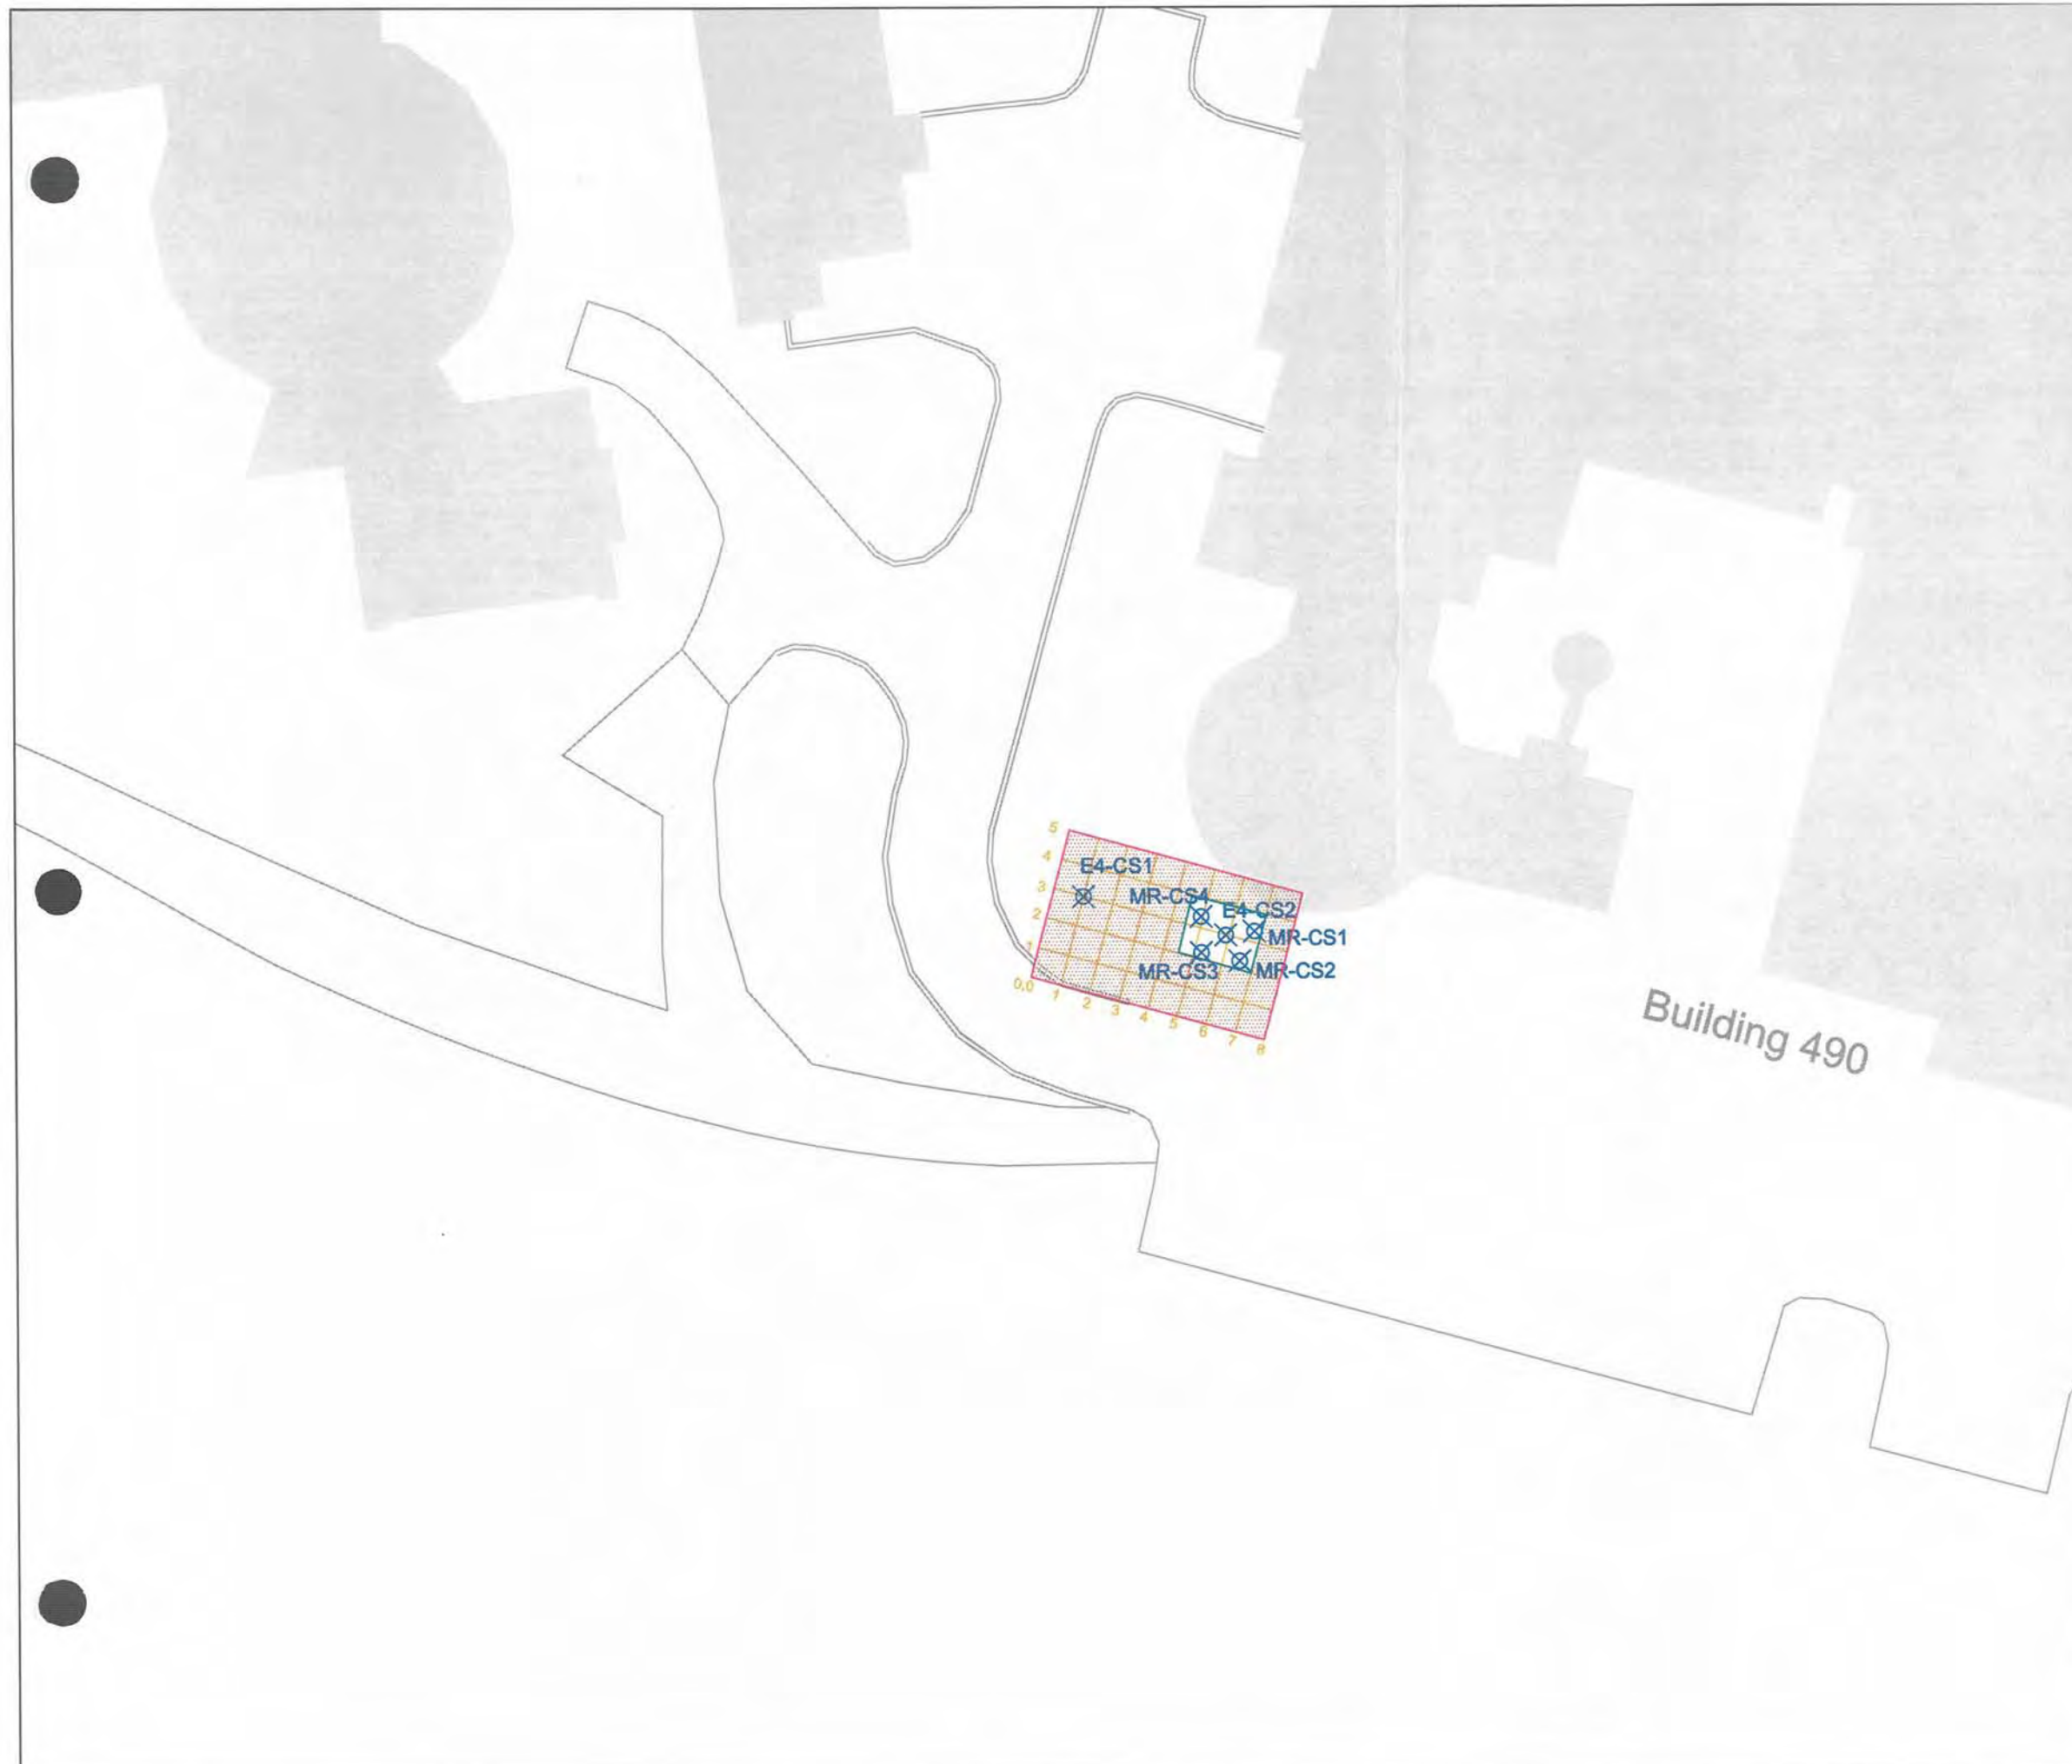
Figure 13

Post-Excavation  
Sampling Locations

AOC 16 - BMRR  
South of Building 490  
Medical Research Reactor

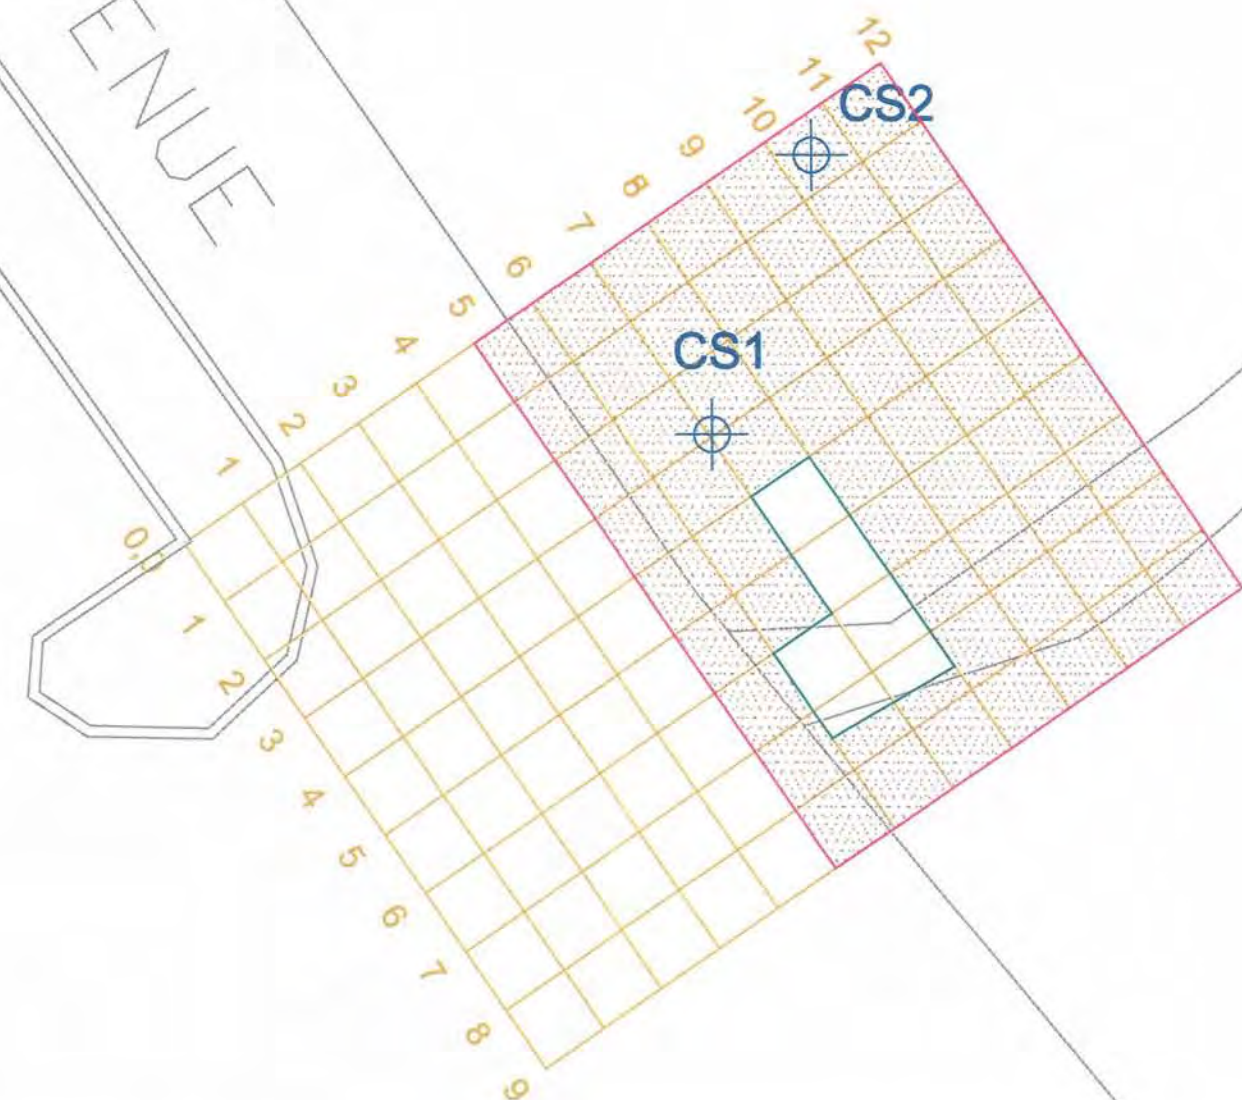
Figure 20

Post-Excavation  
Sampling Locations

Sub-AOCs 16S6.f  
Adjacent to Building 930

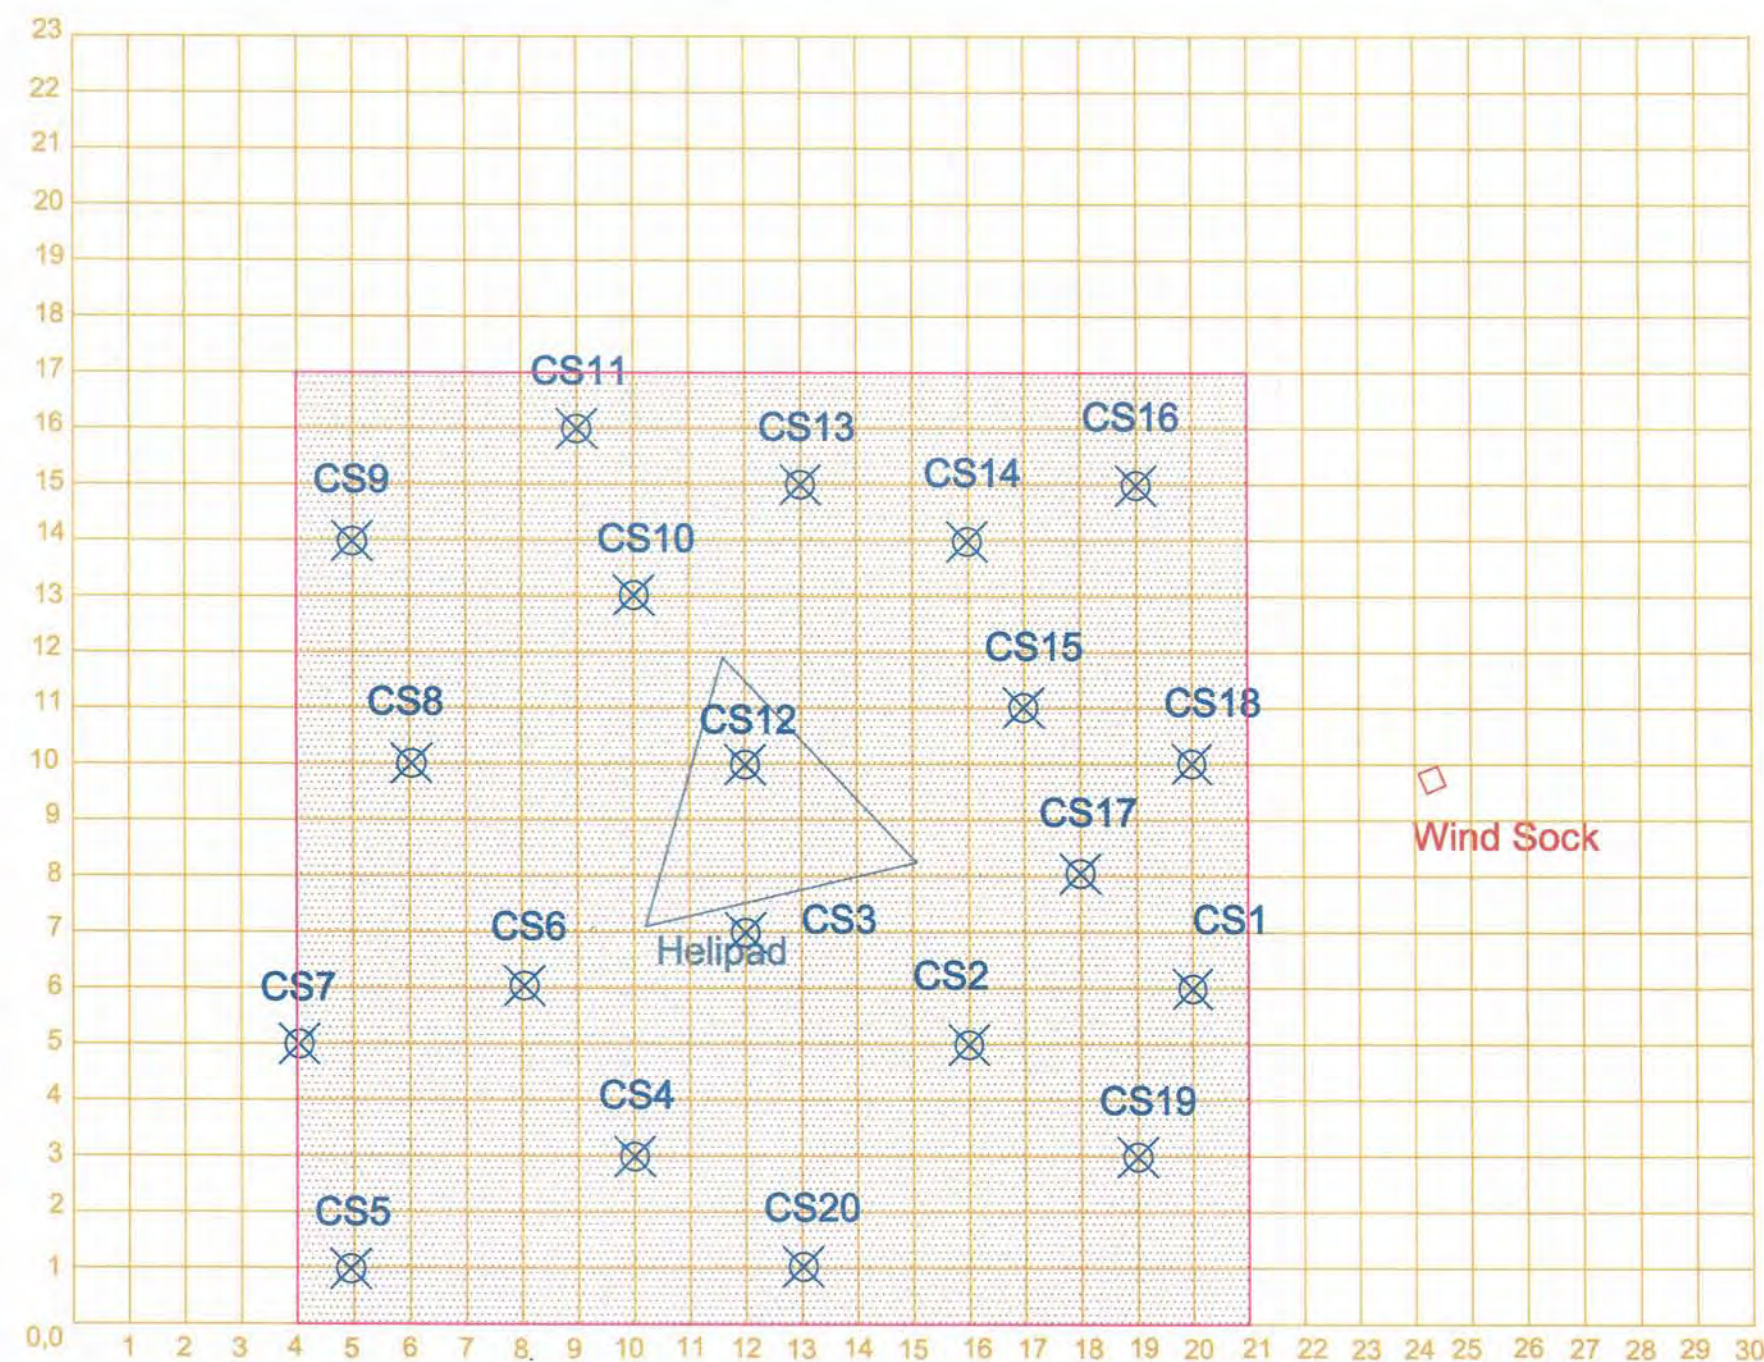
Figure 21

Post-Excavation

Sampling Locations

Background Sampling at Helipad

Field South of Building 50
