CLOSEOUT REPORT

Former Hazardous Waste Management Facility Soil Remediation Brookhaven National Laboratory Upton, New York

> Prepared By: Envirocon, Inc. 510 Heron Drive, Suite 208 Swedesboro, NJ 08085 Subcontract No. 88341

> > September 29, 2005

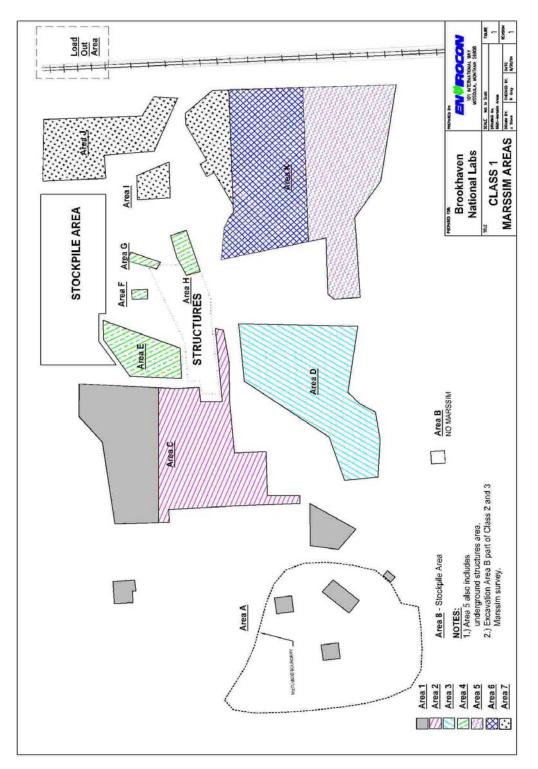
Figure 3-1. Nine (9) Planned MARSSIM Class 1 excavation areas.

above cleanup goals and sub-surface structures were designated as Class 1 survey units. The maximum suggested area for Class 1 soil area survey units is 2,000 square meters (m^2). Areas A and C-K were divided into nine (9) Class 1 survey units as shown on Figure 3-1. A site map showing the planned Class 1 and 2 survey units is presented as Figure 3-2. The *MARSSIM* classifications are discussed in further detail in Section 3.5.3.

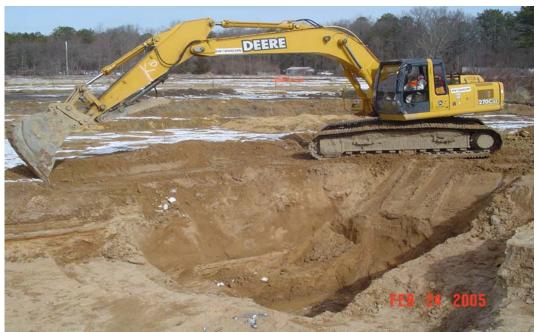
Photograph 1 – Soil removal at the former HWMF.

Soils contaminated above cleanup goals for Cs-137 and Sr-90 were excavated in one-foot lifts unless prescribed excavation depths were one foot or less. In these cases initial excavation lifts were slightly less than one foot. After each lift, excavations were surveyed with a collimated NaI gamma scintillation detector. Further excavations were guided by the radiological survey results.

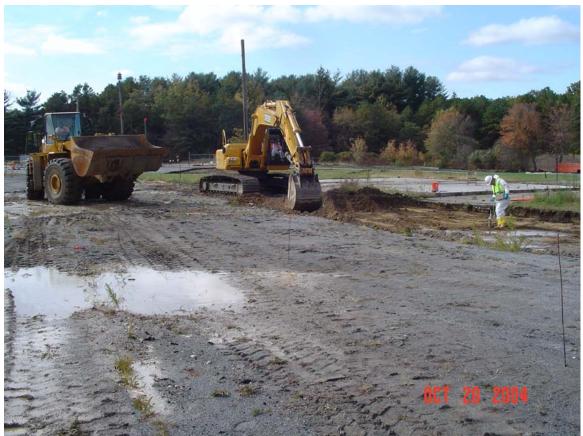
Photograph 2 – Excavating and surveying at the former HWMF.

Except in several isolated areas where Sr-90 concentrations exceeded those of Cs-137 (Refer to Section 3.5.3 for the discussion on those areas), Cs-137 was the primary radiological contaminant that drove the remediation of the site. As a result, gamma count rates using field instruments (NaI gamma scintillation detectors) were used to identify areas requiring excavation to meet the site cleanup goals. An excavation action level of approximately 20,000 counts per minutes (cpm), uncorrected for background gamma count rates, was established as the criterion for determining when excavations were complete. This criterion was determined using a correlation between data from field radiological surveys, onsite ISOCS analyses, and offsite gamma spectroscopy analyses at Severn Trent Laboratories (STL). Correlation curves for instrument response and measured soil activity are presented as Figures 3-4 and 3-5.

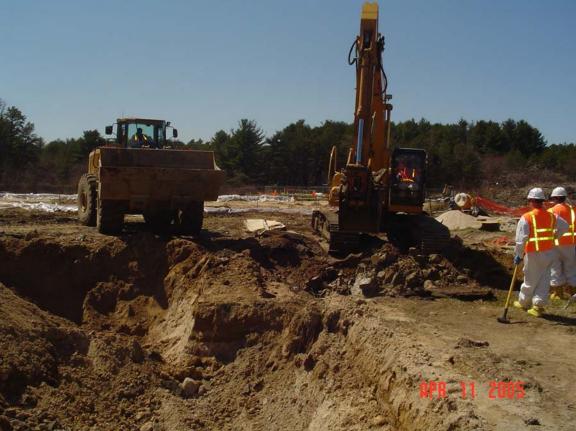
Photograph 3 – Uncovering trench at the former HWMF.

Nine trenches were removed during remedial activities at the former HWMF, designated as C1 through C9. The soil adjacent to each trench was excavated until the structure was fully exposed. Excavated soils were surveyed in accordance with project soil screening procedures. Approximately 570 CY of soil were shipped for disposal.

A concrete crusher was used to remove and dismantle each trench. In addition to concrete, several of the trenches were lined with a steel jacket. Trench debris, including steel and concrete, was segregated, surveyed, and size reduced with a shear prior to being loaded into railcars for shipment and final disposal at Envirocare. Approximately 200 CY of trench debris were shipped for disposal.

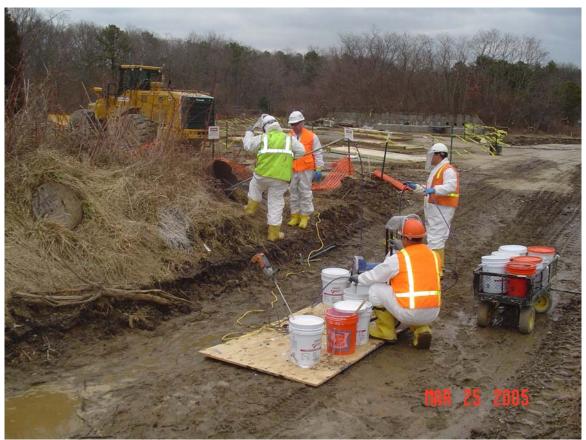
Photograph 4 – Applying fixative to slant-holes at the former HWMF.

either corrugated or steel pipe. The vertical holes consisted of either vitrified clay or concrete pipe. Prior to removal, a fixative spray was applied to the walls and bottoms of each structure, followed by an injection of a sand and cement grout to prevent the spreading of loose contamination. Overburden soils were excavated, surveyed, and segregated in accordance with project soil screening procedures. Soils contaminated above cleanup goals were either stockpiled or direct loaded in rail cars for disposal. Soils below cleanup goals were set aside and later used as backfill. Approximately 140 CY of soil were used as backfill and approximately 970 CY of soil were shipped for disposal.

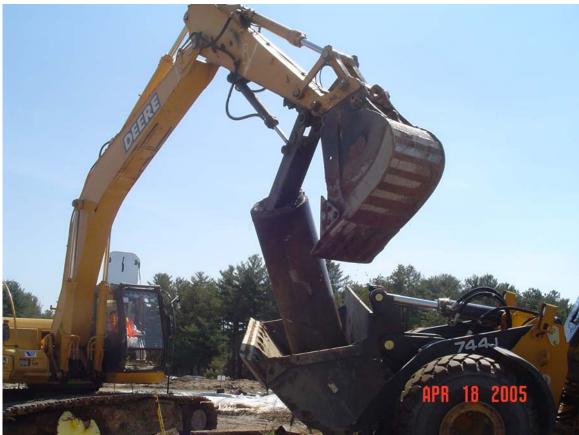
Photograph 5 – Removal of vertical hole at the former HWMF.

After each structure was exposed, it was removed with an excavator and size reduced. The waste debris, including corrugated pipe, concrete, steel, and vitrified clay was surveyed and segregated prior to being loaded into railcars for shipment and final disposal. Slant holes debris was placed in supersacks for contamination control purposes due to the presence of removable alpha activity (discussed below) prior to loading the material into railcars. Approximately 20 CY of slant holes debris and 20 CY of vertical holes debris were shipped for disposal.

Elevated gamma dose rates of 1000 mrem/hr at contact were observed at the bottom of vertical hole B-4. The source was later determined to be two small Sr-90 needles. Upon the establishment of the proper radiological controls, the two Sr-90 needles were removed from the excavation area. As a result of BNL's activity estimate for Sr-90 of 180 micro curies, it was determined the objects did not meet Envirocare's WAC. The Sr-90 needles were transferred to the BNL Waste Management Division for disposition, and later transported to Los Alamos National Laboratory for final disposal.

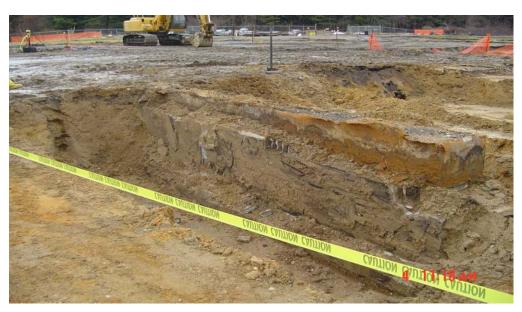
Photograph 6 – Discovered sub-surface structure as the former HWMF.

Three additional sub-surface structures were encountered during remedial activities in Excavation Areas C and D, as shown on Figure 1-4. Each structure consisted of a steel trench approximately 22 feet (ft) long, 2 ft wide and 3 ft deep. The tops of the structures were at or just below grade. A four-course concrete block wall surrounded the sub-surface portions of the structures. The structures were filled to grade with soil.

The soils inside and adjacent to each structure were excavated until the four walls were fully exposed. Excavated soils were surveyed and in accordance with project soil screening procedures. Approximately 160 CY of soil adjacent to the structures were shipped for disposal.

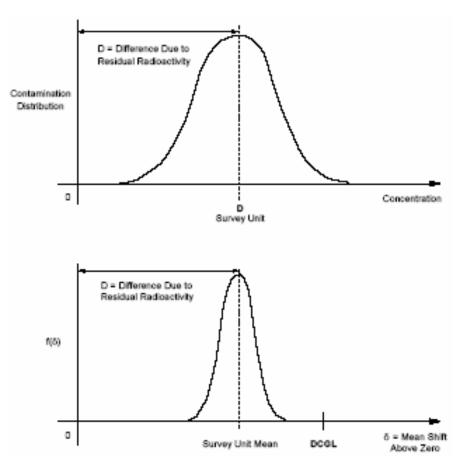
Figure 3-8. Decision Rule Graph.

Error! Reference source not found.3-8 (from *MARSSIM* Figure D.3) illustrates the decision rule, except that the value 1 substitutes for the DCGL in the figure. The measurement distribution of D, $f(\delta)$, is centered at D, the true value of the application of the unity rule. This distribution is shown in the lower graph of Figure 3-8.

As stated in *MARSSIM* Appendix D, "If $f(\delta)$ lies far to the left (or to the right) of [D = 1] [see *MARSSIM* Figure 5-1], a decision of whether or not the survey unit demonstrates compliance can be easily made. However, if $f(\delta)$ overlaps [D = 1], statistical decision rules are used to assist the decision maker."

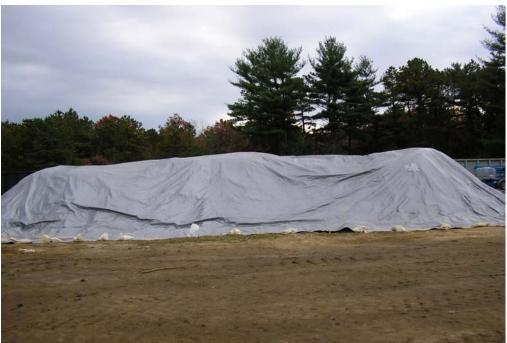
Photograph 7 – Stockpiled waste soils at the former HWMF.

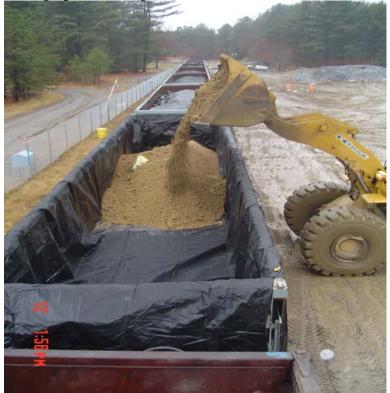
Photograph 8 – Loading railcars with waste soil at the former HWMF.

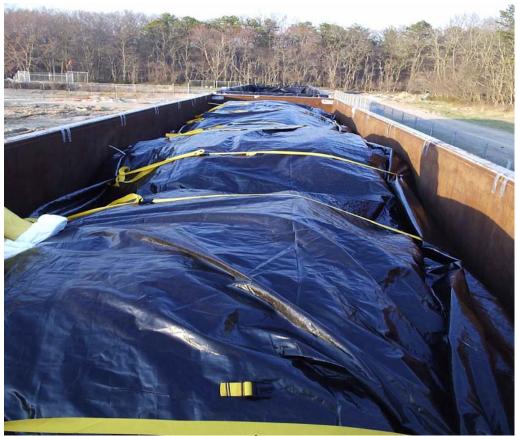
Photograph 9 – Sealed Black Stallion[®] liner in railcar at the former HWMF.

MHF, Incorporated; ECDC Logistics, LLC; and Cavanagh Services Group, LLC provided railcars for transportation of the waste soil and debris to Envirocare. After the railcars arrived on site, they were inspected and released for loading. The bottom of the inside of each railcar was covered with a geotextile liner and a Black Stallion[®] railcar liner was placed within each railcar prior to loading. Approximately 95-100 tons of waste was placed into each rail car. The weights of the soil and debris were determined utilizing a bucket scale on the front-end loader. After the waste was loaded into the railcar, the liner was closed/secured using tie wraps and bungee hooks for transport and secured into position. In addition, either a hard or soft tarp cover was secured over each railcar for shipment.

- For railcars loaded with substantial amounts of debris, a non-woven geotextile was placed under the liner and above the Black Stallion® railcar liner. In addition, a second liner, fabricated of non-woven geotextile, was placed inside the liner package. Prior to loading the car with debris, a soil layer was placed in the railcar. The debris was topped off with another soil layer. These measures were effective in preventing damage to the liner package from the debris.
