Leak Rate for the Old LN2 Heat Exchanger in HEUB

2/11/04 K. C.

Leak Rate of the Old HEUB - LN₂ HX

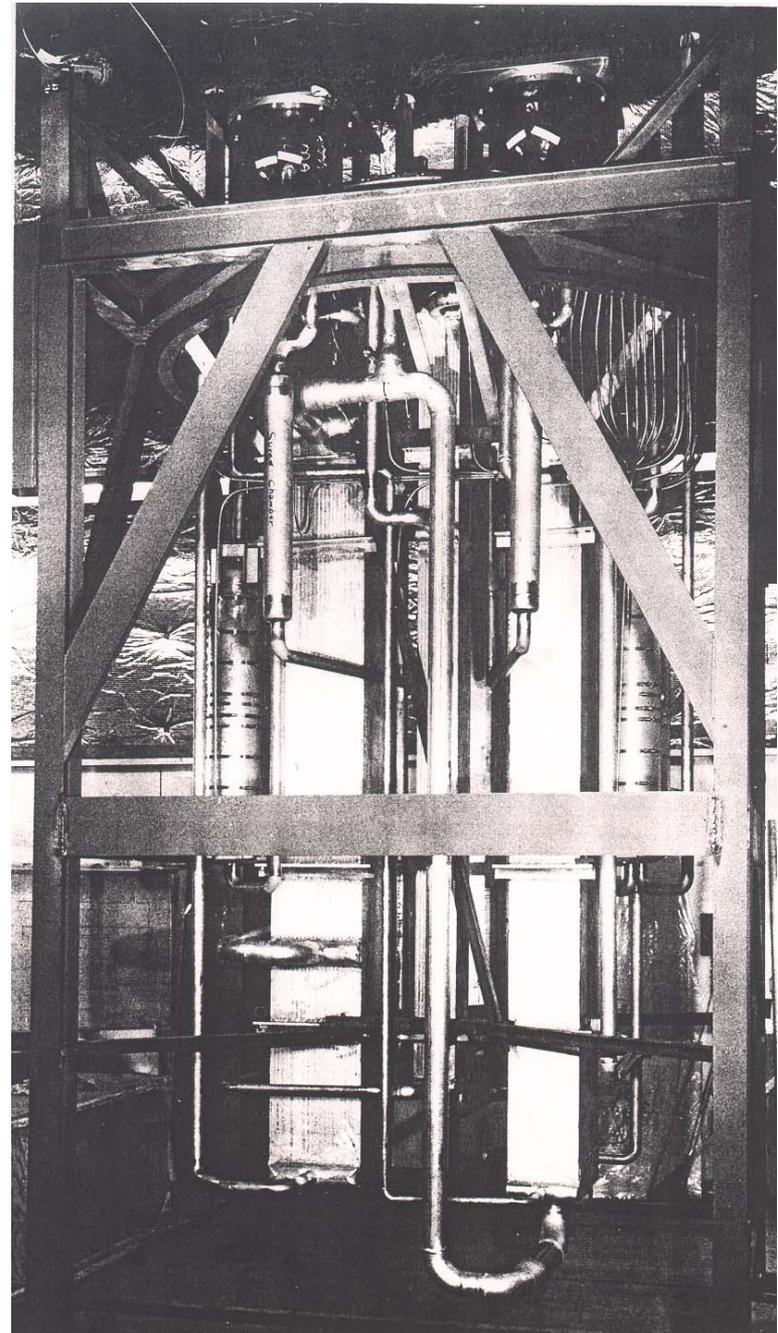
Front view of HEUB
cold box, LN₂ HX is
on the exchanger on
the right

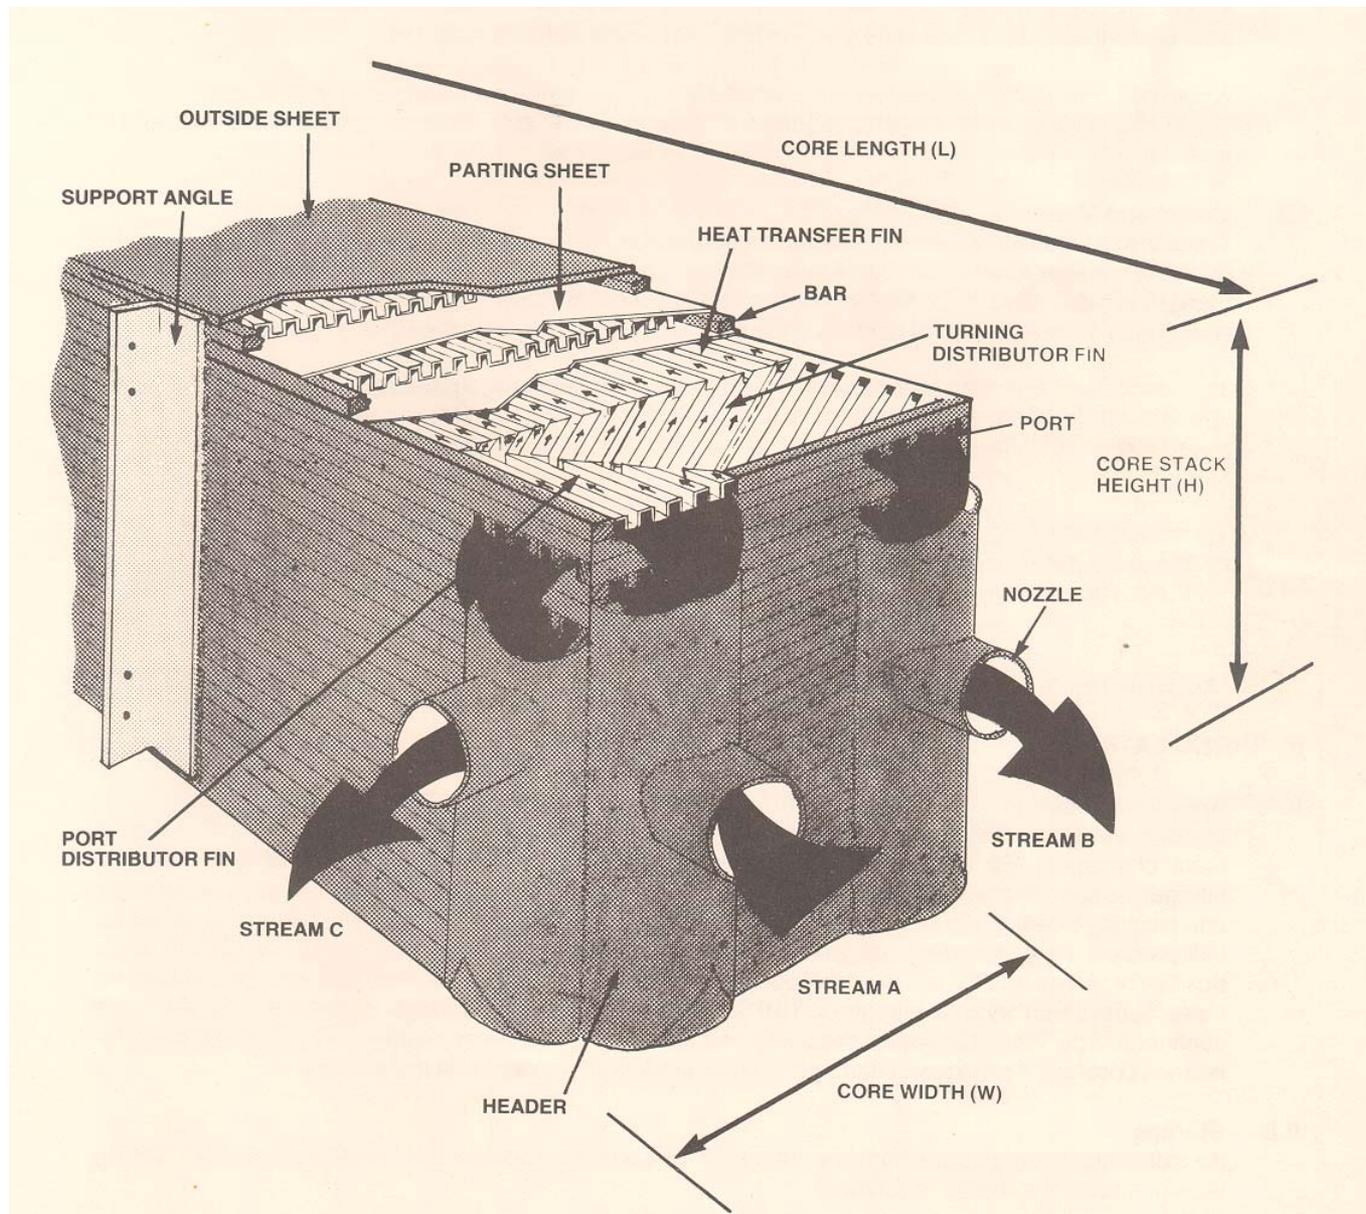
Basic Components of a Brazed Aluminum HX (Cutaway)

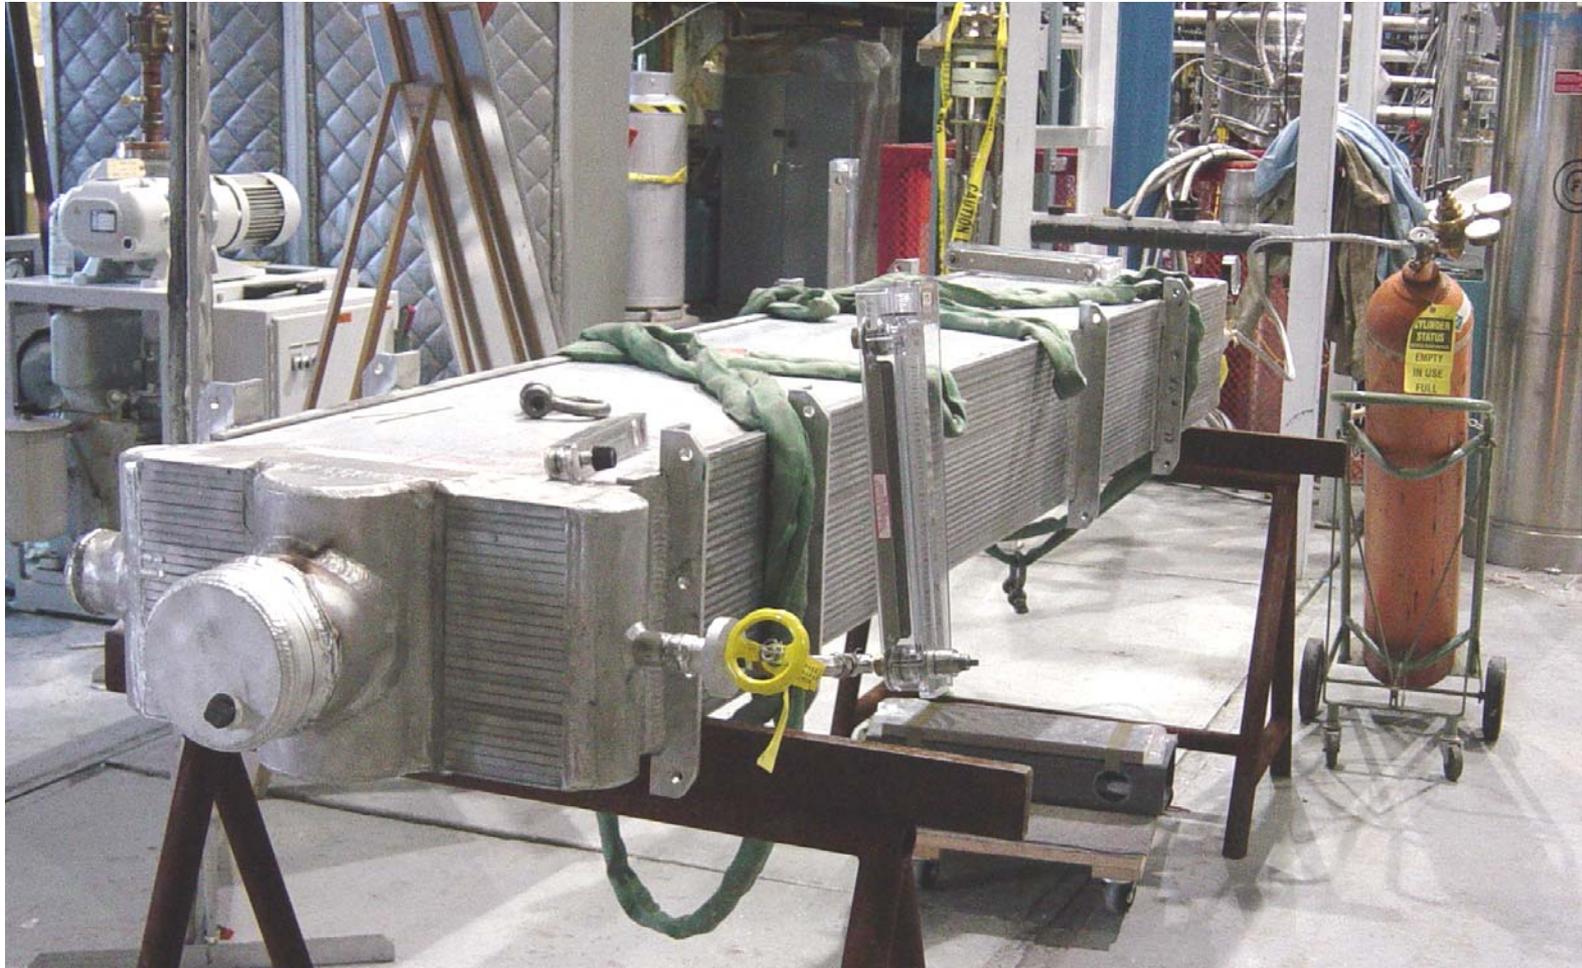
Old LN₂ HX on the Bench for Measuring Leak Rates
The HX is mounted vertically in the refrigerator with warm end, left in the figure, mounted in top.

- The old HX is laid on test bench for leak measurement.
- H.P. stream is pressurized using both N₂ and Helium gas, flow from the N₂ and L.P. sides are measured.
- It turns out leak occurs not only from H.P. to the nitrogen side, but also from H.P. to L.P.
- Dwyer flowmeter were used to measure the flow.
- We found that leak from H.P. to L.P. is about 2.5 times that from H.P. to N₂.
- Description of the HX and leak rates are given below.

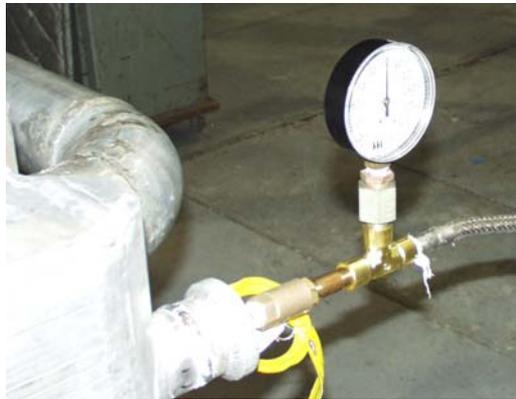
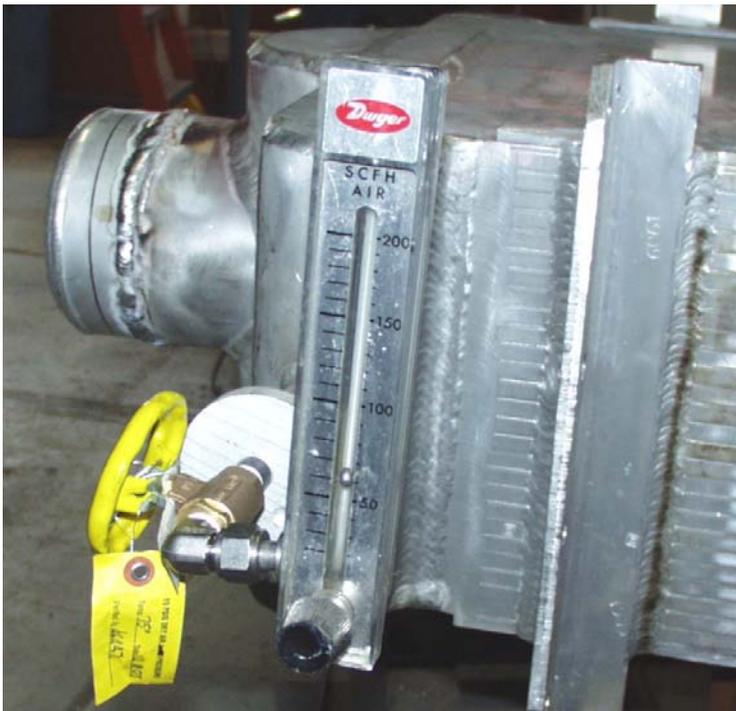
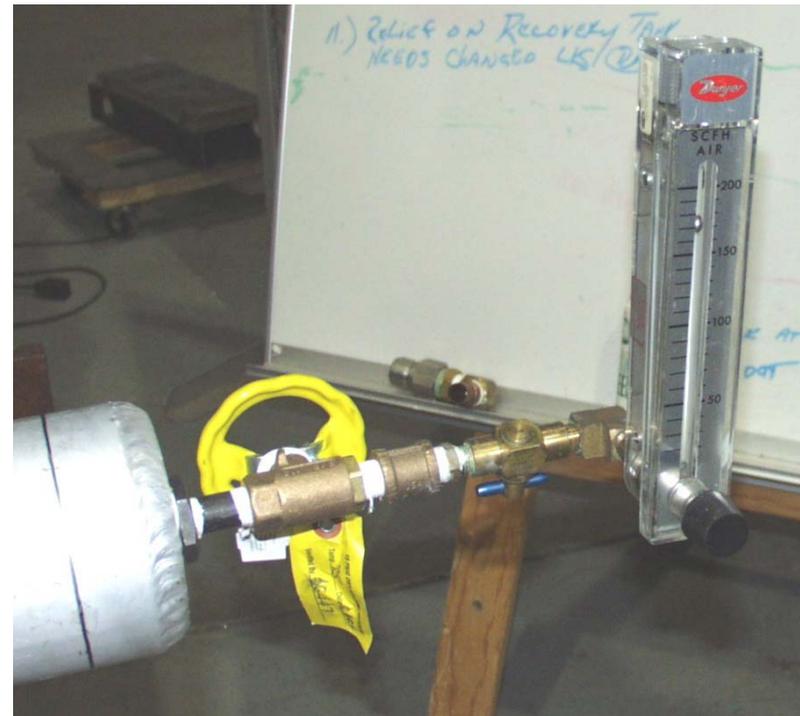
Leak Test of Old LN2 HX at 150 psi

Pressurize H.P. side and measure flow from N2 side and L.P. side.

Left: Pressure on H.P. side – He at 150 psi

Lower right: Leak to L.P. – 170 SCFH]air

Lower left: Leak to N2 side – 65 SCFH]air

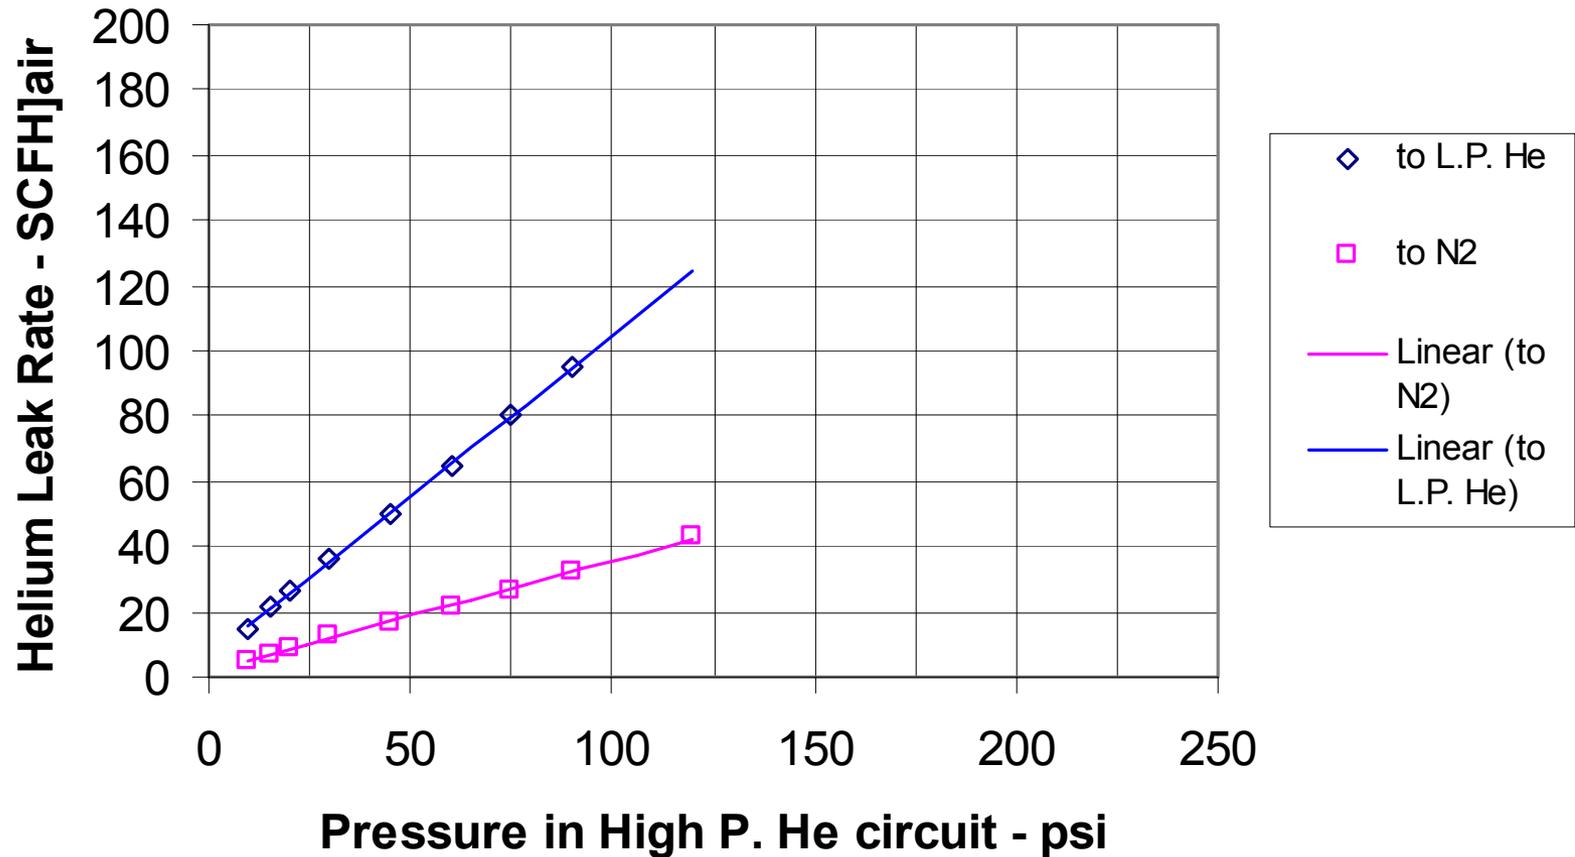
Leak Rate of HEUB LN2 HX from H.P. Helium Side Using Helium Gas through Dwyer Flowmeters – 1/27/04

- Operating pressure for the H.P. stream of HEUB is 16 atm (235 psia or 220 psi).
- Since the leak rate increases linearly with pressure, the flow from H.P. to N₂ side will be 79 SCFH_{air} at 220 psi as extrapolated from 43 SCFH_{air} at 120 psi.
- To get actual flow for helium, correction factor of 2.7 [square root of (29.2/4)] should be applied on the Dwyer flowmeter.
- Thus the helium leak equals to ~ 213 SCFH
- At 213 SCFH, the amount of helium loss equals 153,000 St. cubic foot per month – ~ 2.8 tube trailers per month.
- In terms of mass flow, the helium flows are 0.27 and 0.81 g/s for leak from H.P. stream to N₂ and to L.P. respectively.

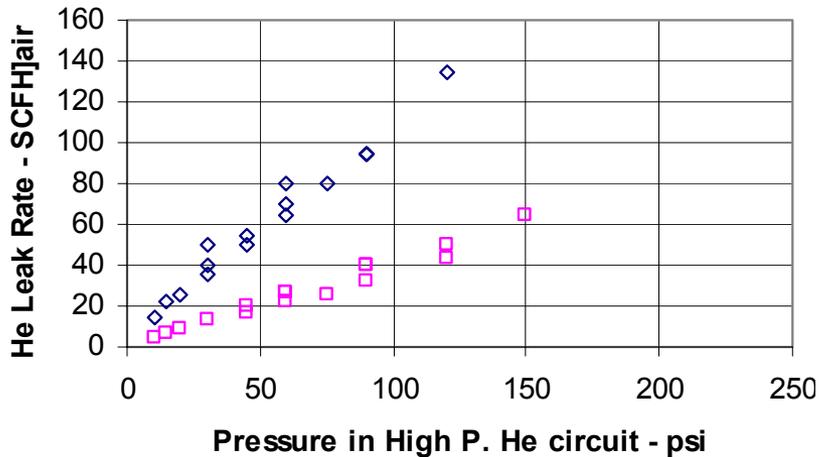
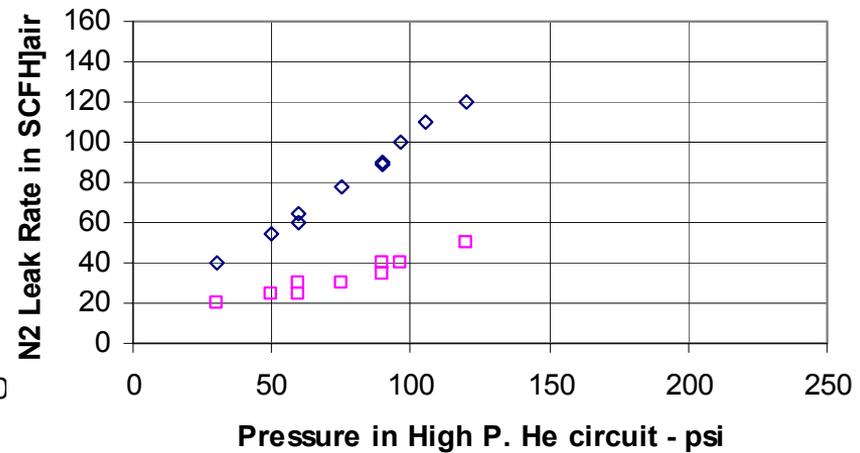
Leak Rate from H.P. Helium Side to N₂ and L.P.
Using Helium (left figure) and N₂ (right figure)
Reading from Dwyer flowmeters are basically the same
as expected

Using Helium Gas - 1/27/04

Using N₂ - 1/26/04

◇ to L.P. He
□ to N₂

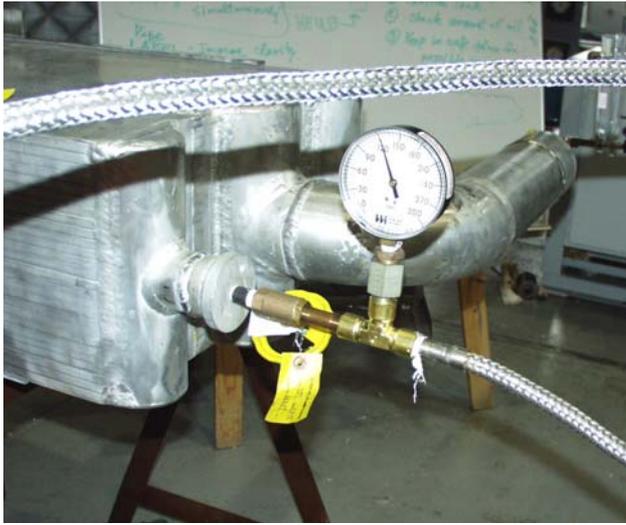
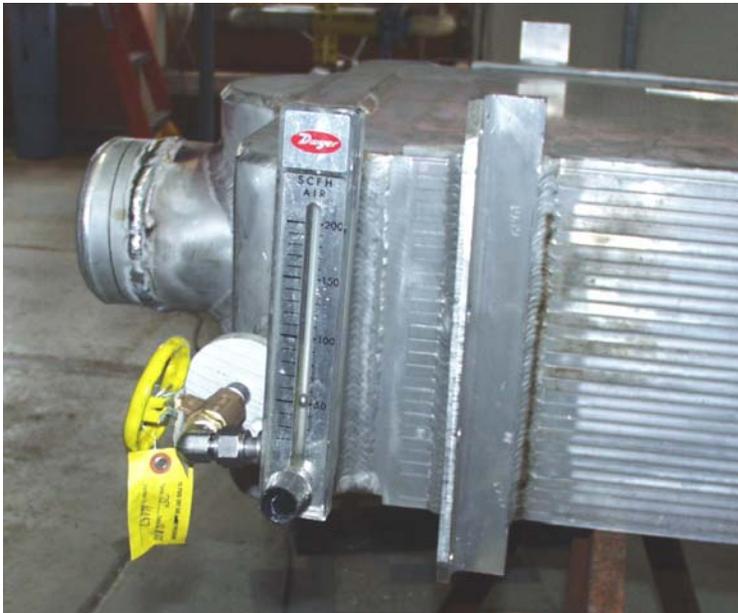
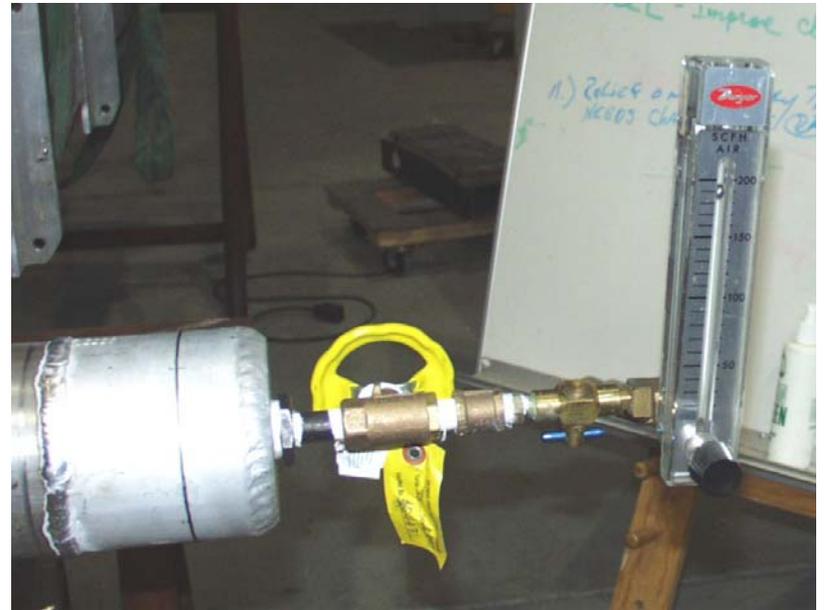
Leak Test of Old LN2 HX at 120 psi

Left, H.P. – He at 120 psi

Lower right, Leak to L.P. – goes up to 190 SCFH]air mysteriously

Lower left, Leak to N2 line – 50 SCFH]air

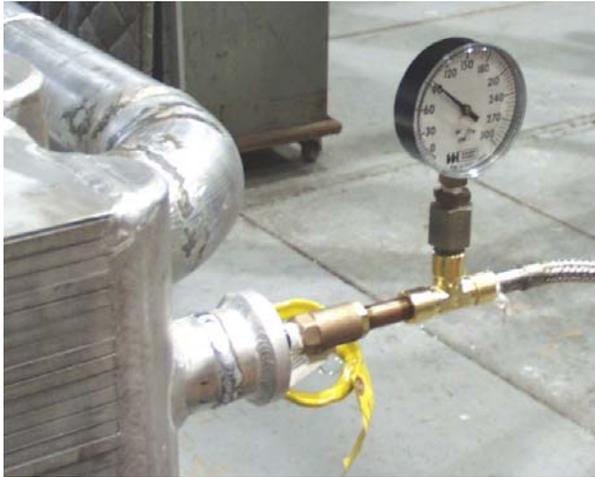
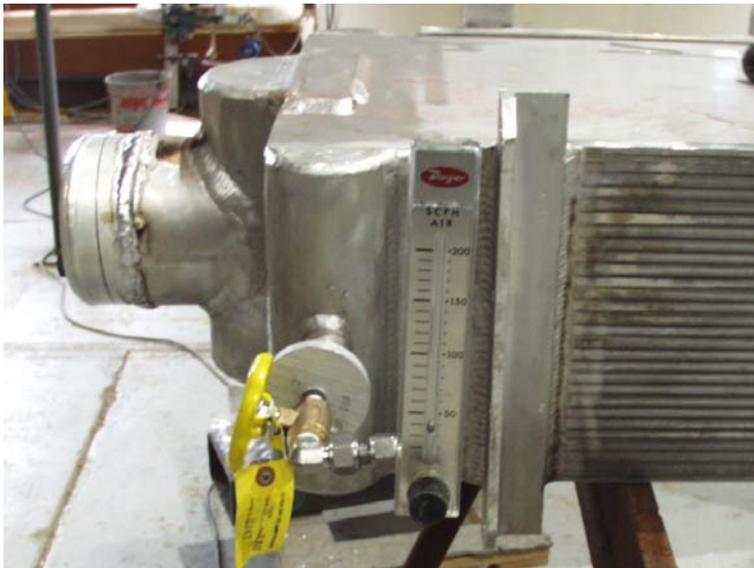
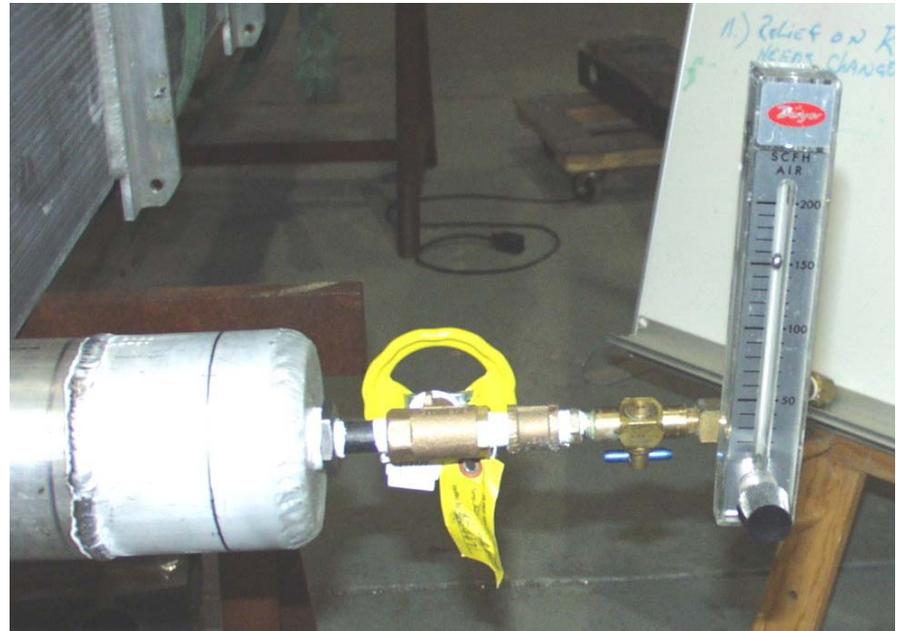
Leak Test of Old LN2 HX at 90 psi

Left, H.P. – He at 90 psi

Lower right, Leak to L.P. – goes up to 150 SCFH]air mysteriously

Lower left, Leak to N2 line – 40 SCFH]air

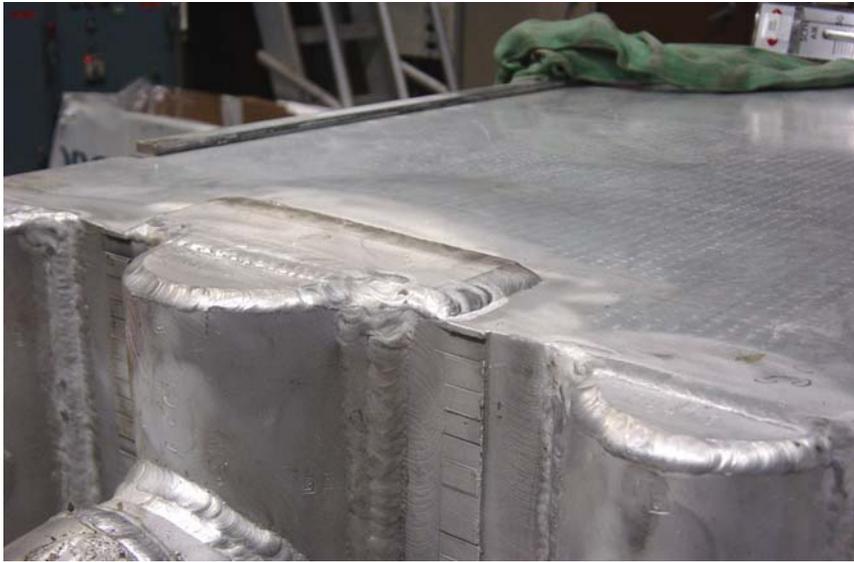
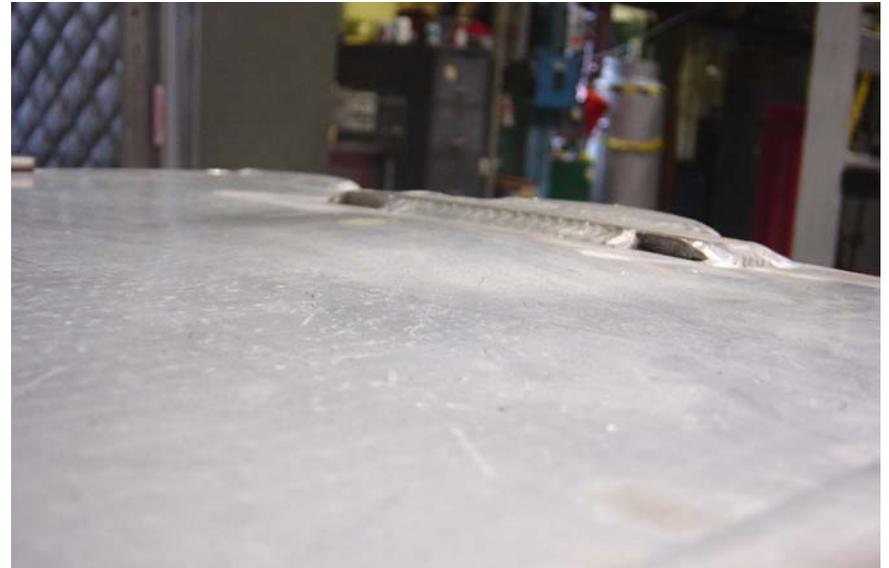
Deformation on the outer shell in the cold end, the Old LN2 HX may not be repairable.

- Flow measurements confirm large helium leaks in the old LN2 HX in HEUB refrigerator
- Leak occurred from H.P. stream to both L.P. and LN2 sides
- Leak from H.P. to LN2 contributes to loss of helium gas
- Measurement for leak rate of ~ 2.8 tube trailer may not be accurate.
- With the new LN2 HX installed, we hope to see saving of 2 tube trailer per month in the future.
- From the deformation of the old HX, we suspect the Old HX is not repairable.
