Electrical Safety

In the Research Community

2005 NSLS User Meeting Electrical Safety Workshop

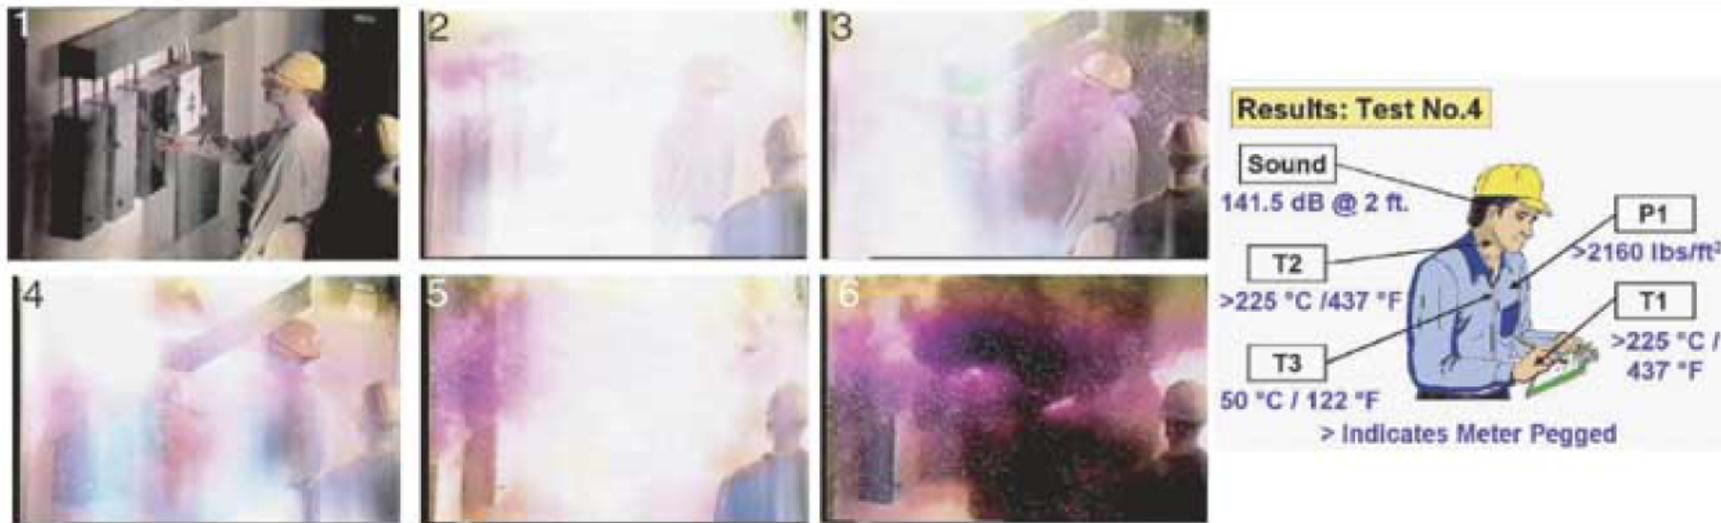
Figure 3. Test 4 - 22,600 - A rms, 480-V, fault initiated on line lug of size 1 starter, feeder protected by a 640-A noncurrent-limiting overcurrent protective device, and fault was cleared in 6 cycles.

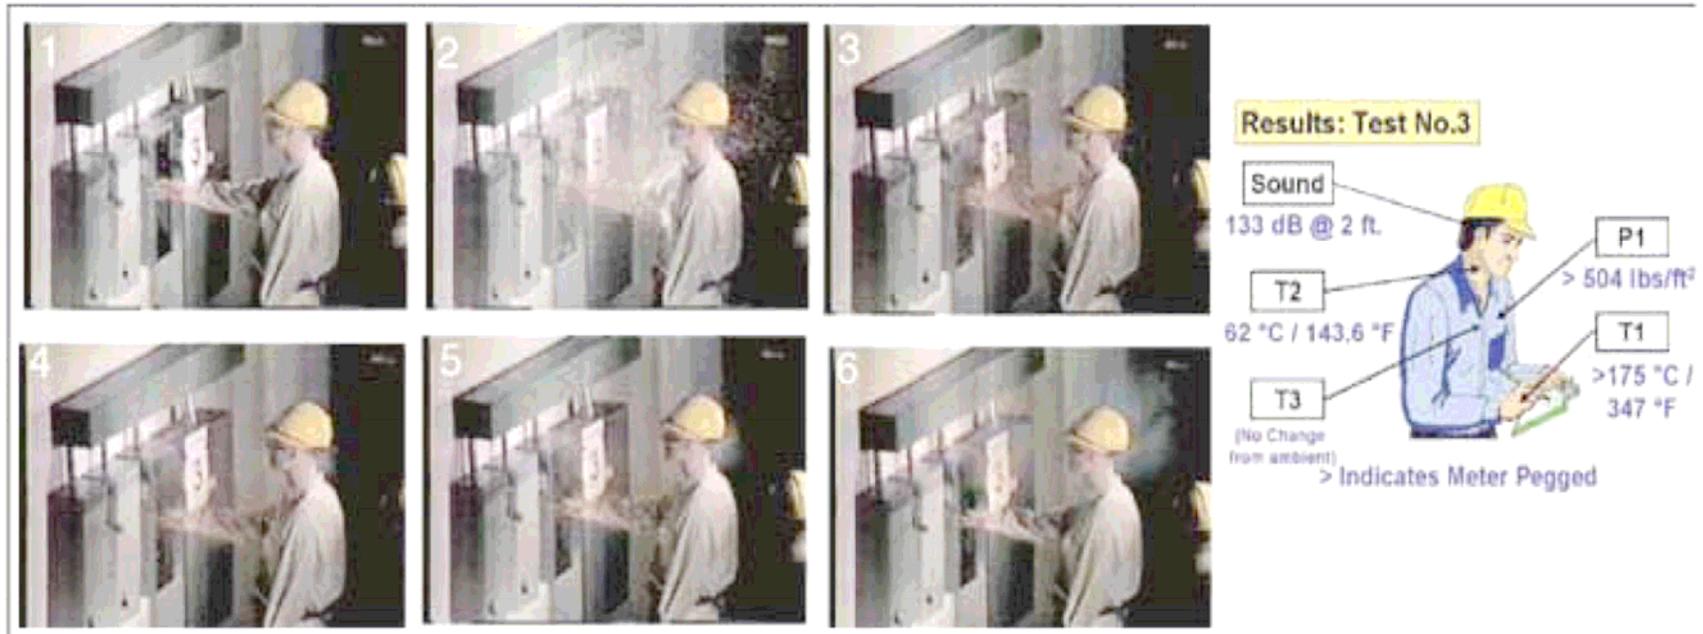
Figure 4. Test 3 - 22,600-A rms, 480-V, fault initiated on line lug of size 1 starter, feeder protected by a 601-A current-limiting device and fault was cleared in 1/2 cycle.

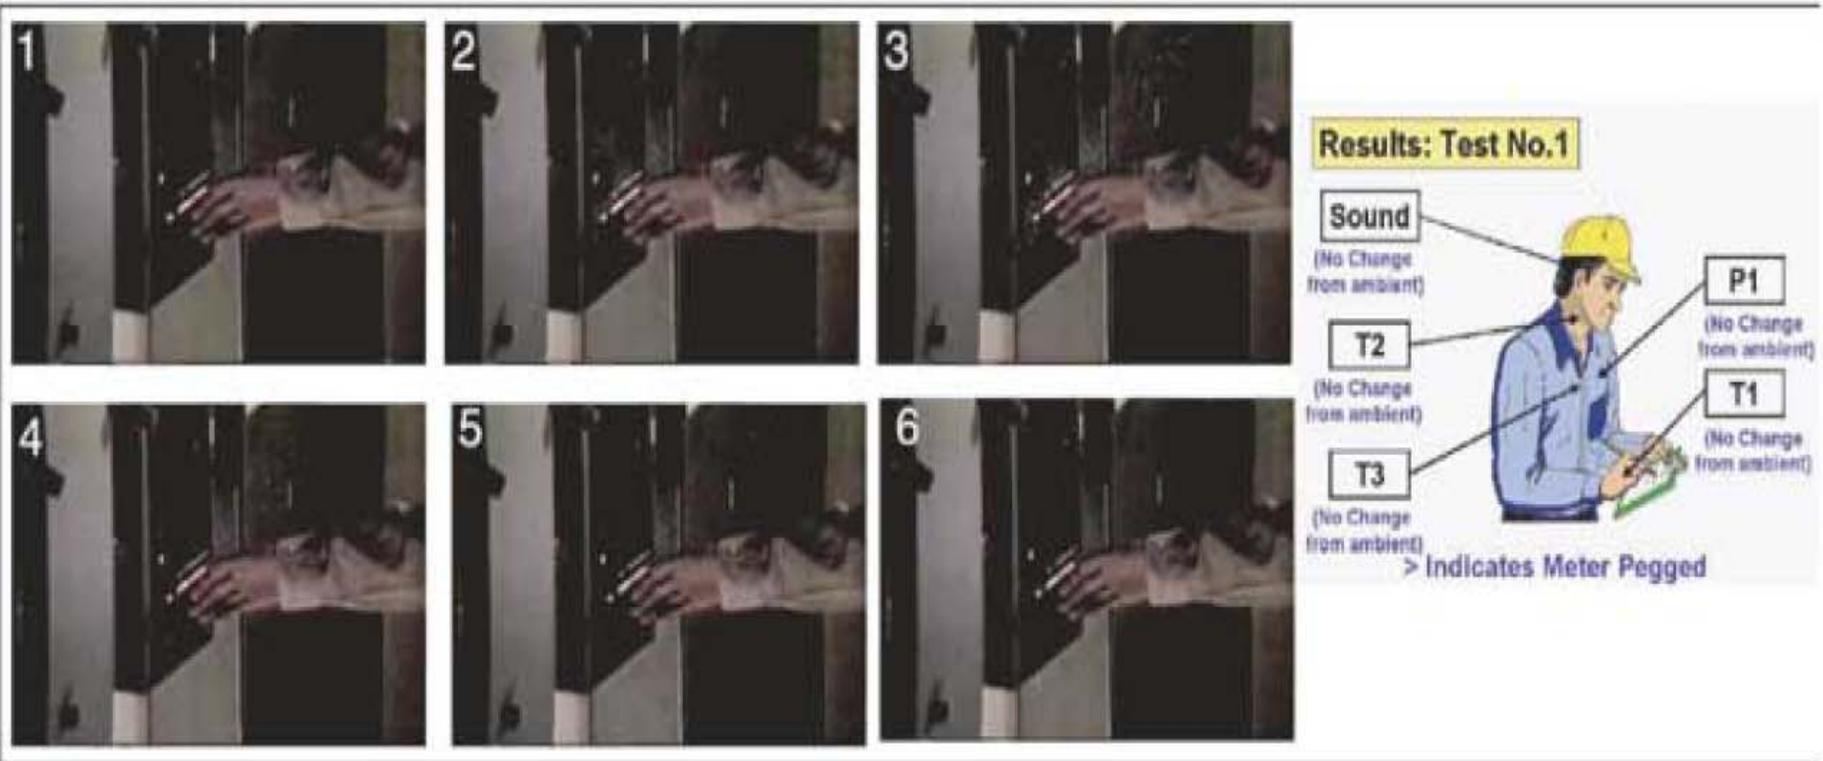
Figure 5. Test 1 - 22,600-A rms, 480-V, fault initiated on load side of a 30-amp current-limiting device in the size 1 starter, and fault was cleared in less than 1/4 cycle.

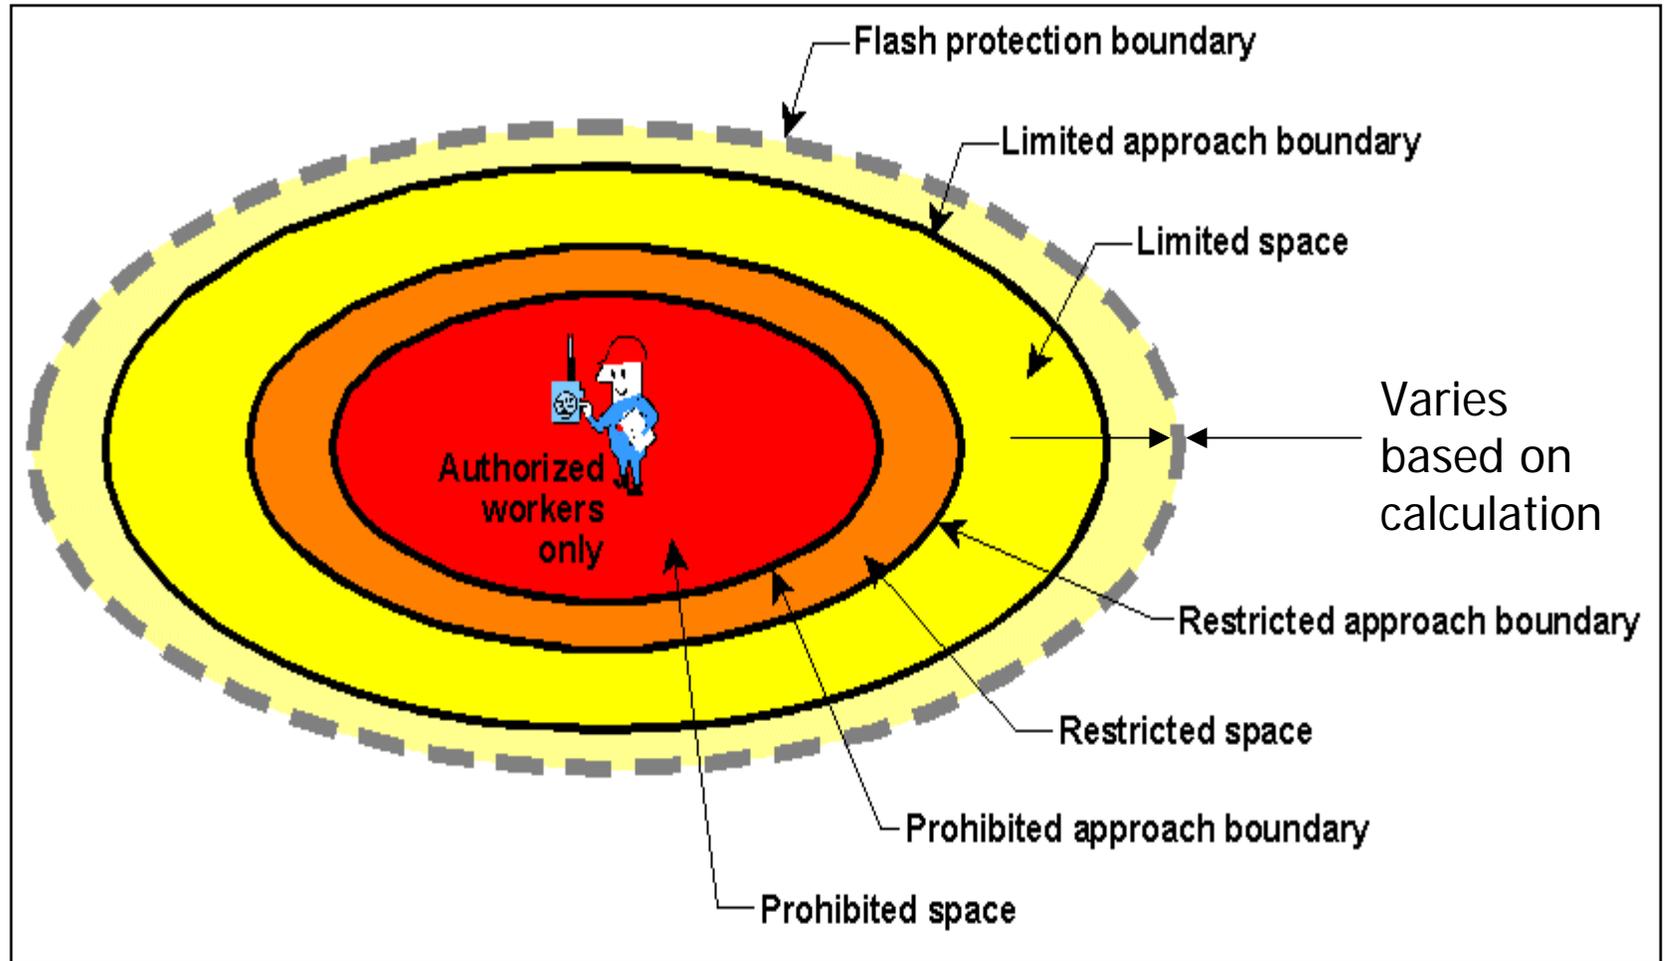
Control Zones for Energized Conductors With Barriers Removed

- Limited Approach Boundary
 - Range B is 3' 6"
 - Working “near” energized conductors
 - Qualified personnel authorized by supervisor or escorted
- Restricted Approach Boundary
 - Range B is 1"
 - Still working “near” energized conductors
 - Only qualified personnel authorized by supervisor
- Prohibited Approach Boundary
 - Range B is Avoid Contact
 - Working “on” energized conductors
 - Only qualified personnel authorized by supervisor
- Distances for these various zones are defined in ESH Standard 1.5.0.

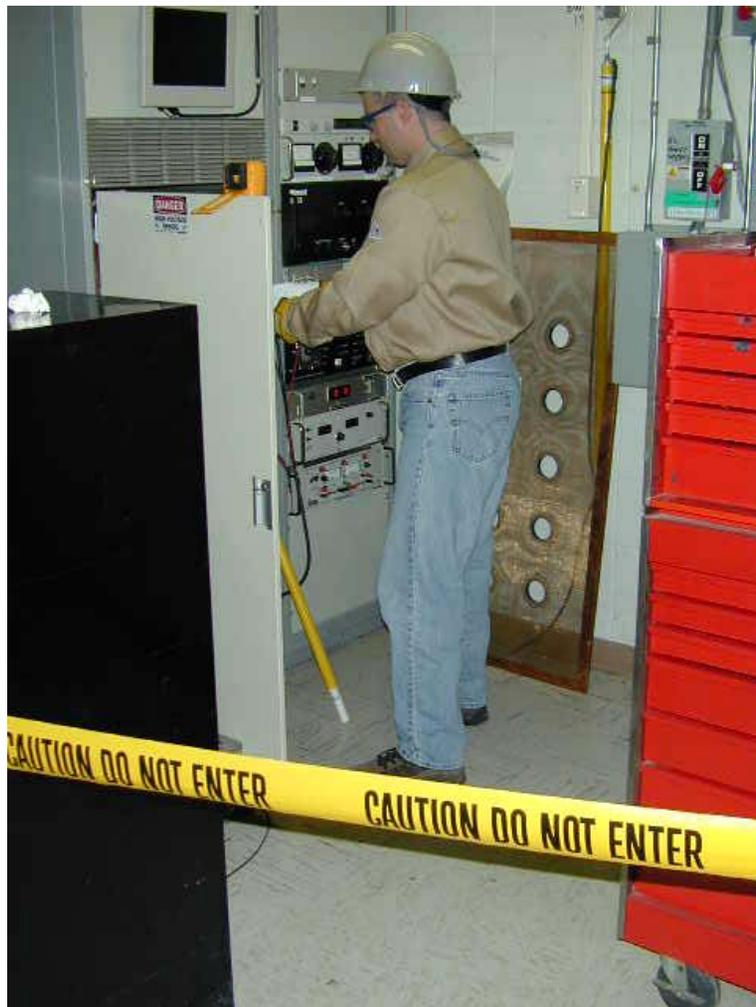
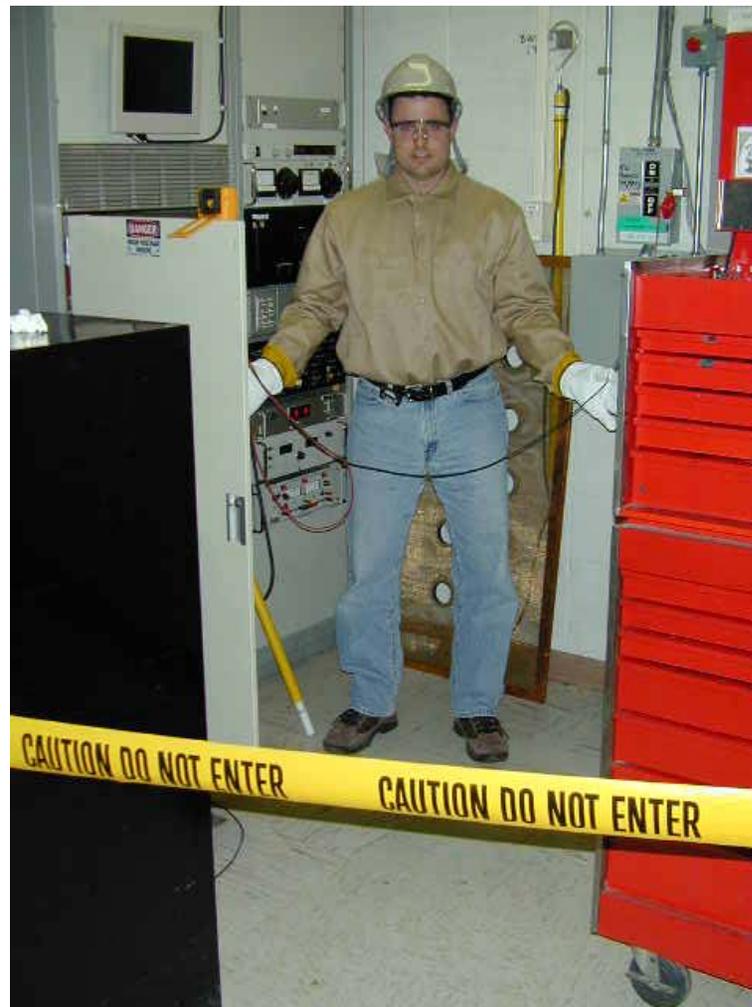
“Range B” Voltage Testing / LOTO Verification PPE

- Voltage Rated Gloves & Leather Glove Protectors (500 Vac/750 Vdc)
- Denim Cotton Jeans
- Flame Resistant Long Sleeve Shirt (≥ 4 cal/cm²)
- Natural Fiber Undergarments
- Hard Hat
- Safety Glasses (non-conductive)
- Training
- Category III or IV Multimeter
- Energized Work Permit

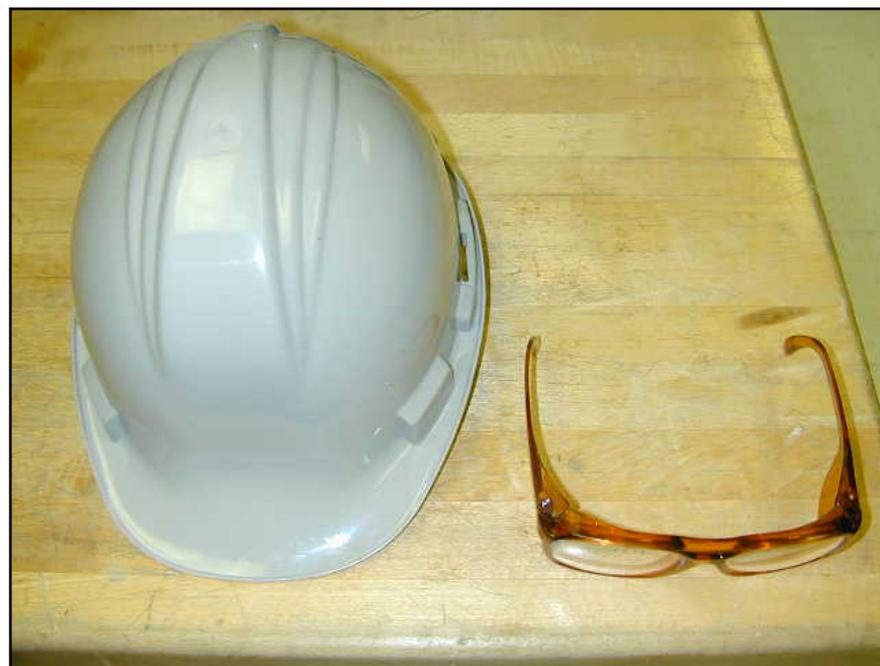
Hard Hat & Safety Glasses

- ANSI Z89.1 Hard Hat
- ANSI Z87.1 Safety Glasses

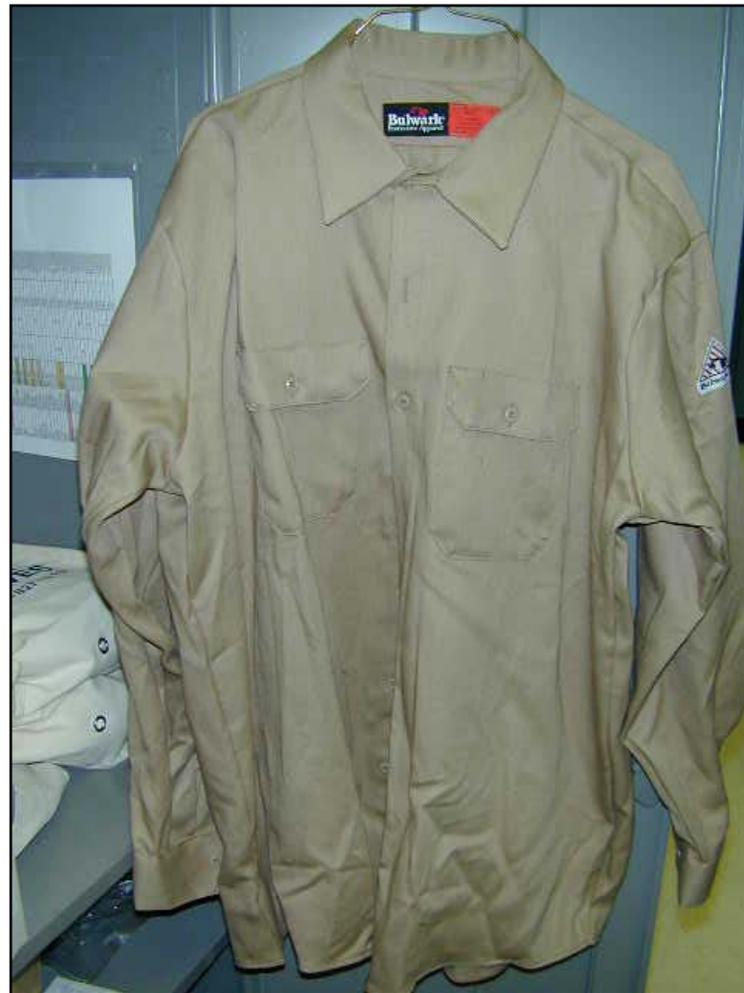
Flame Resistant Shirt for “Range B”

- No bleach
- No products containing hydrogen peroxide
- No starch or fabric softener
- Dry clean or machine wash
- Tumble dry

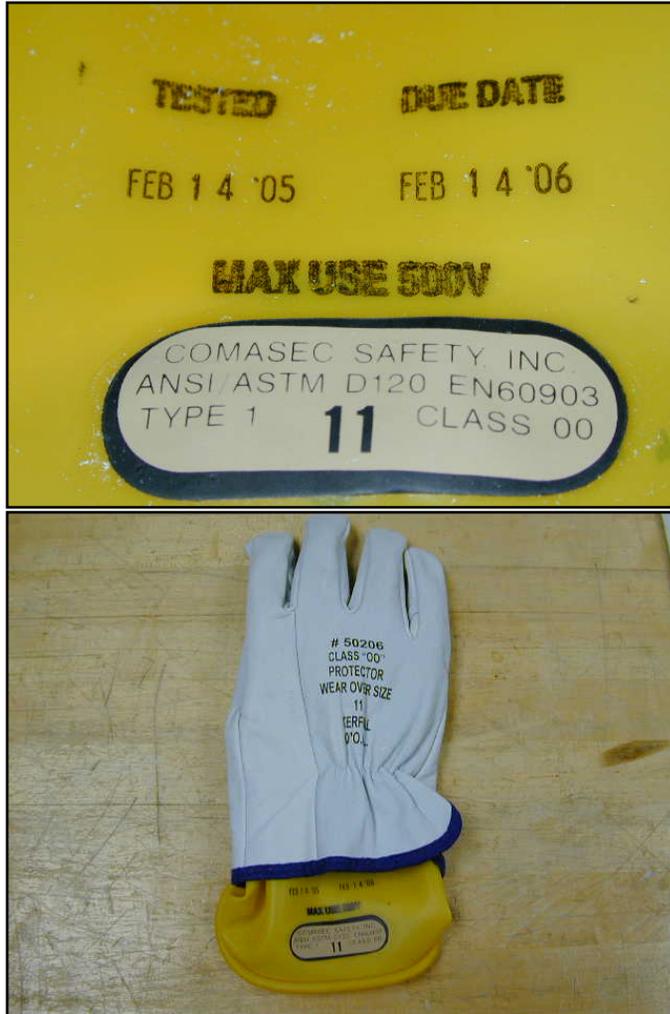
Voltage Rated & Leather Protector Gloves for “Range B” Class 00

- 500 Vac/750 Vdc
- Shelf life one year (stamped)
- 6 Month retesting & cleaning period (controlled by Al Boerner)
- Inspect before each use
- Must wear leather protectors over v-rated gloves

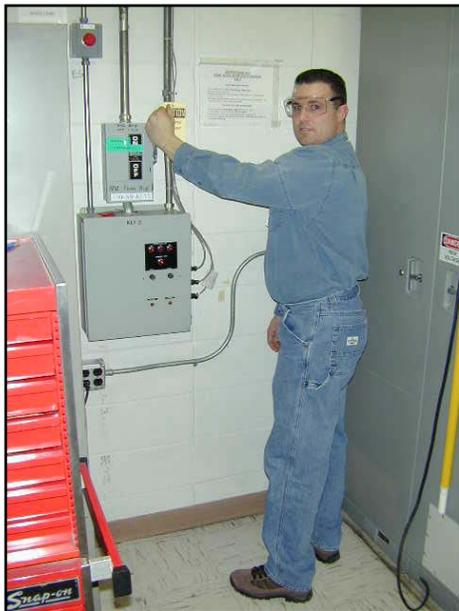
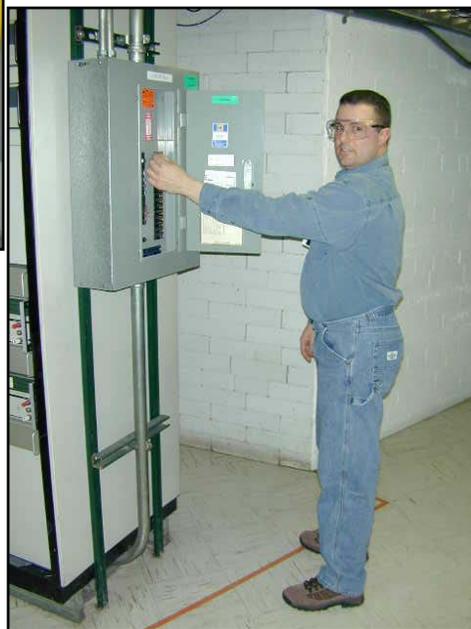
Circuit Breaker and Fused Switch (Disconnect) Operation With Covers on ($\leq 600V$ ac rms)

- Safety Glasses
- Natural Fiber Long Sleeve Shirt
- Natural Fiber Long Pants
- Look Away & Stand to the Side of Device if Possible

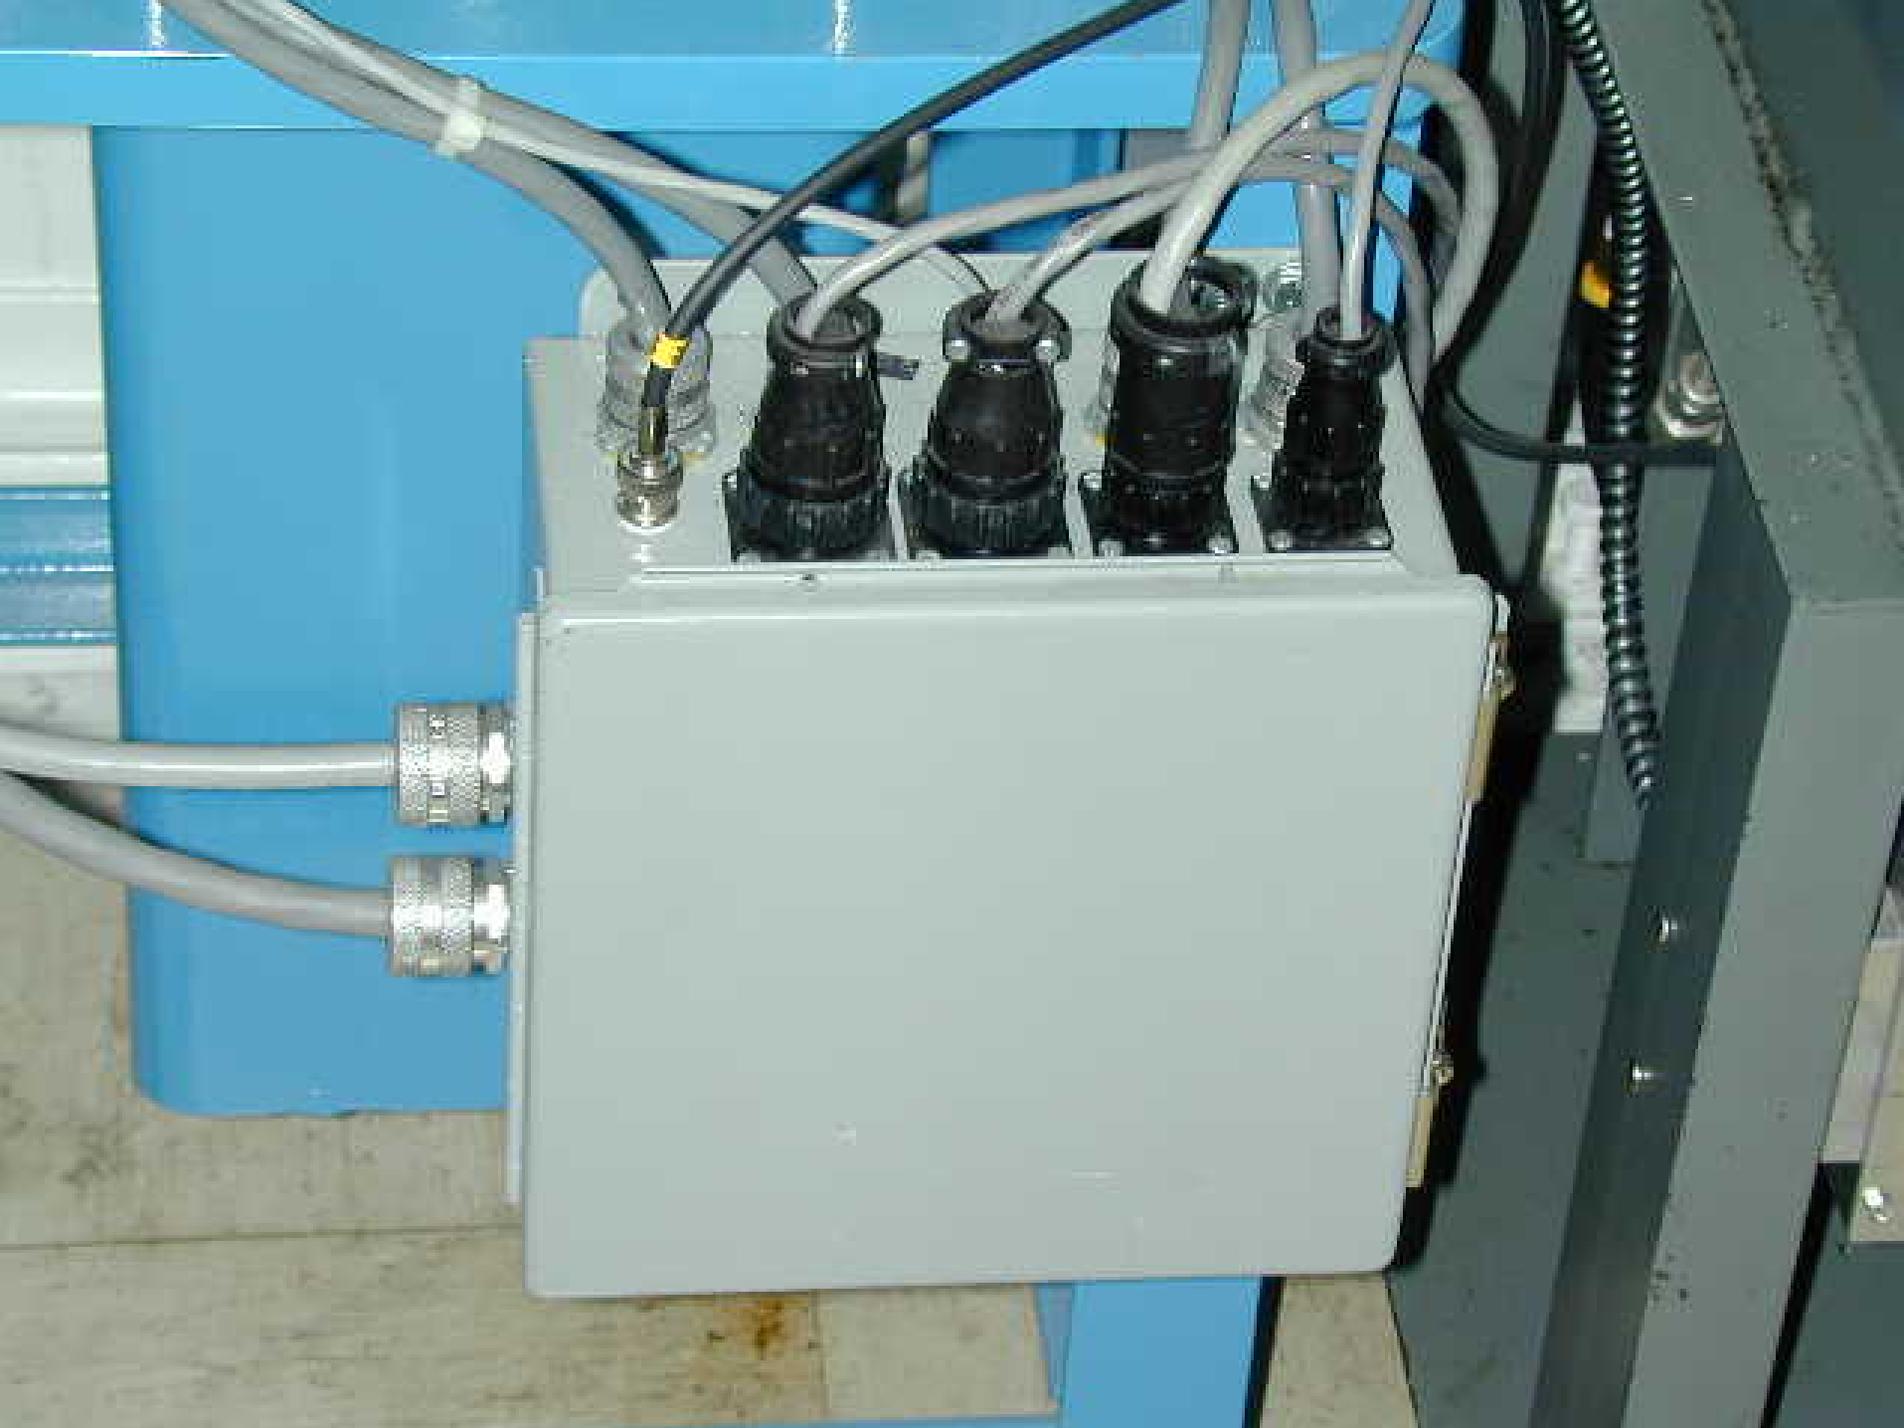
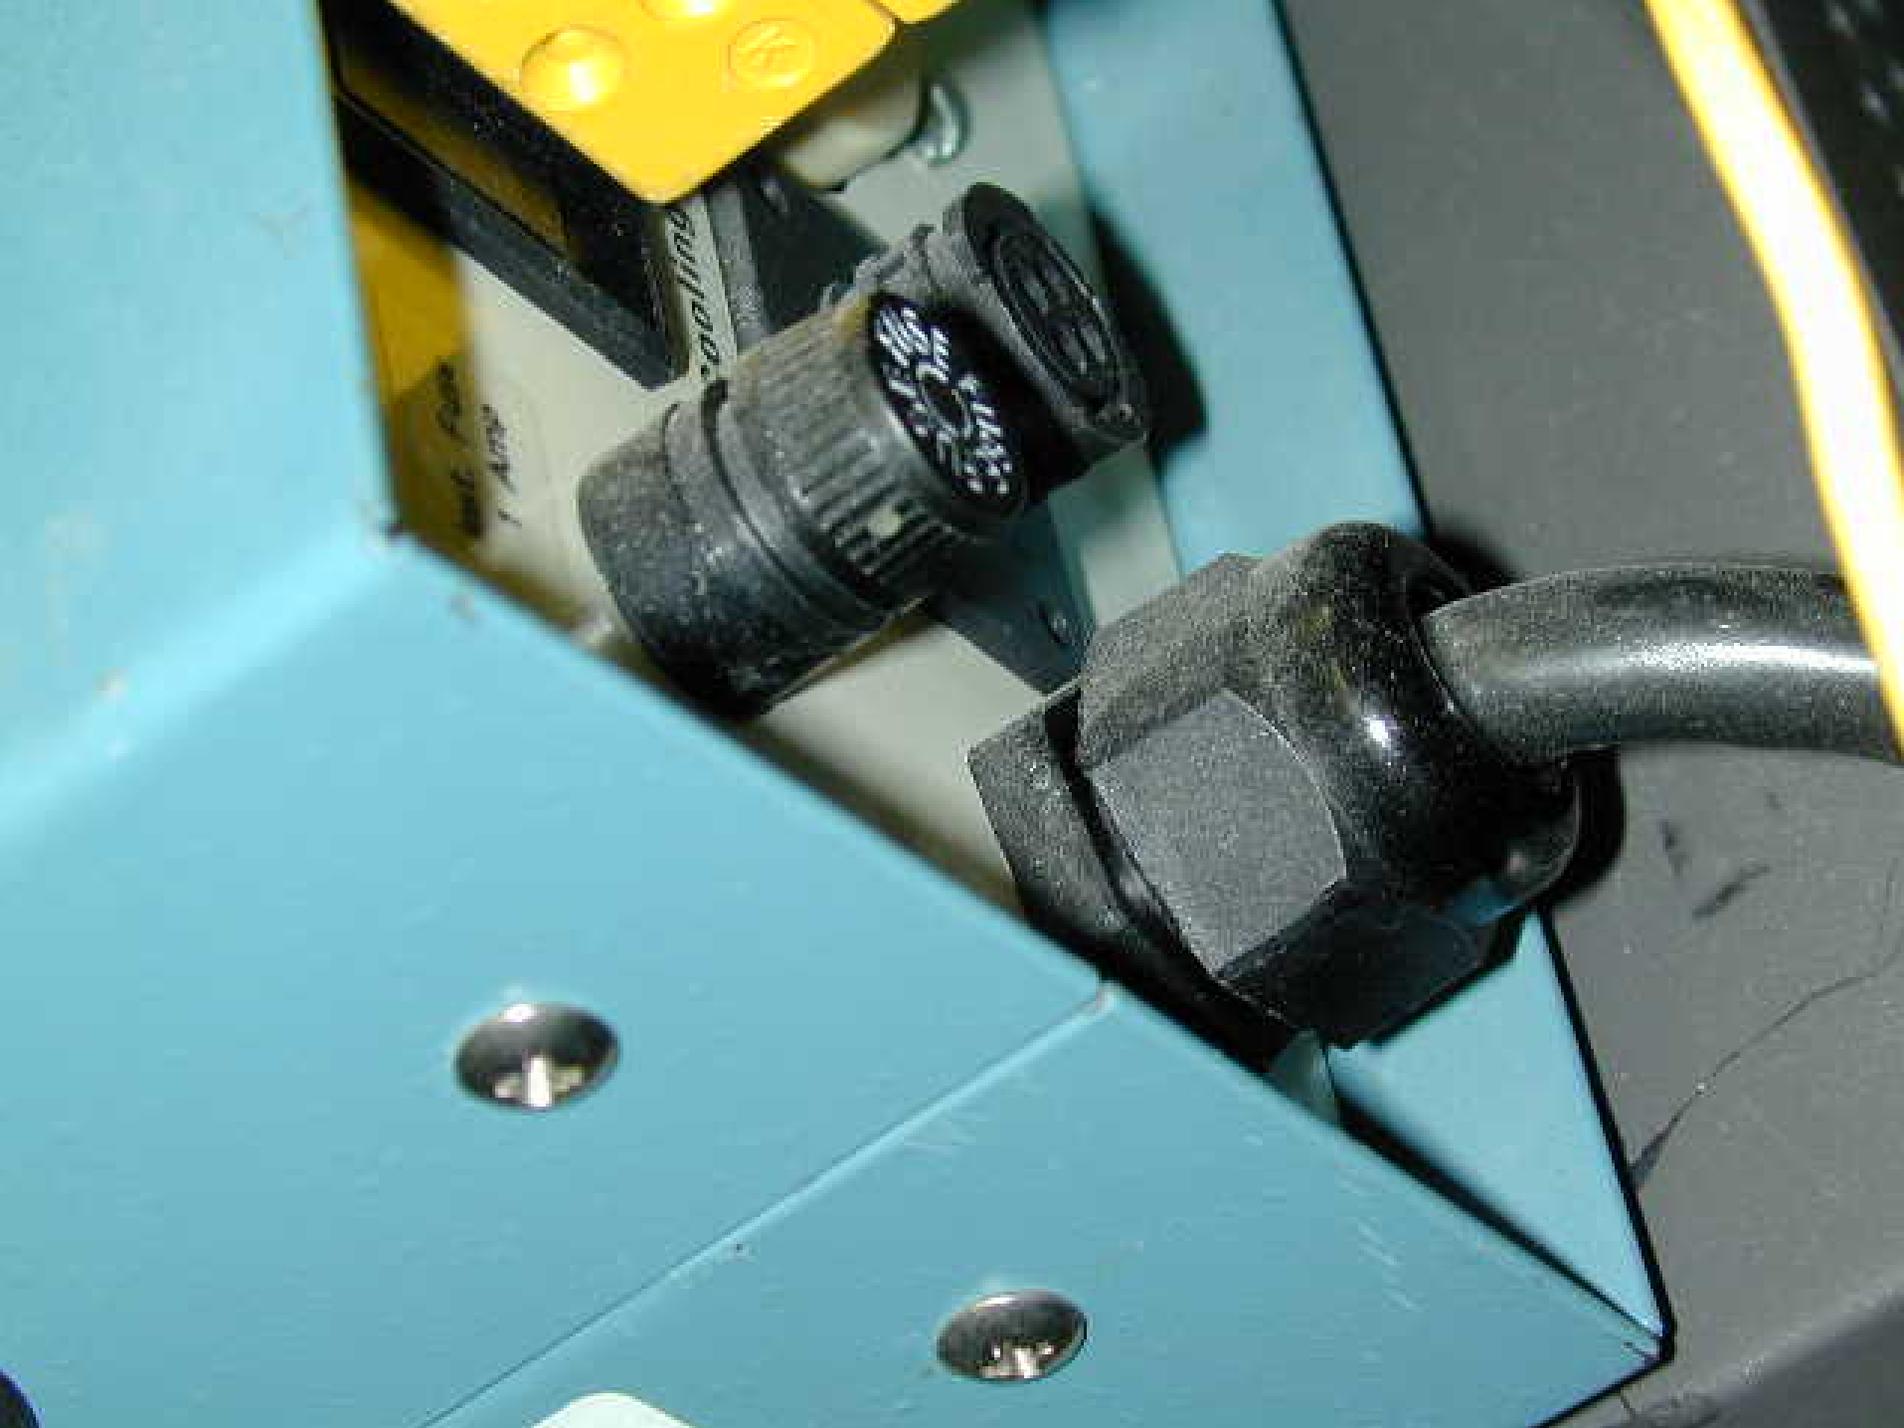
- Scientists assemble needed components
 - Assembled from available parts
 - Assembled to function not to code
 - Limited experience with accepted practice and design
- Typical mistakes
 - Poor/inappropriate connections
 - Poor grounding
 - Undersized conductors
 - Improperly insulated conductors (double insulated power)
 - Poor feed through / strain relief
 - Inadequate enclosure / exposed conductors
 - No fusing

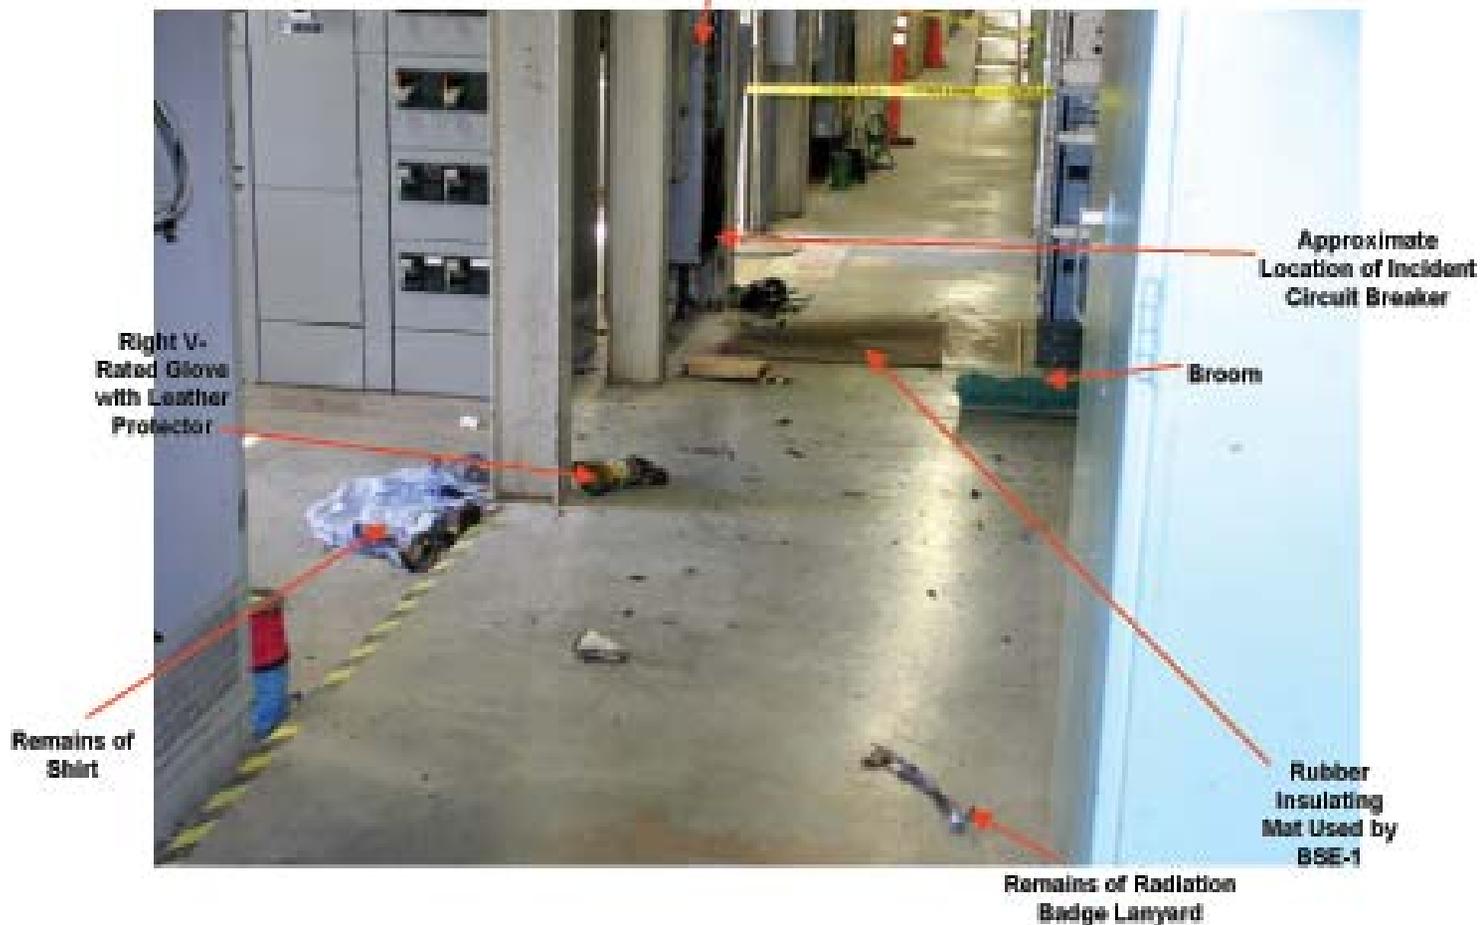
Figure 2-1. Scene immediately after the accident

- SLAC Supervisor directs subcontractor electrician to install breaker in live 480-volt dist. panel
- Supervisor did not obtain required working “Hot” permit
- The electrician wore a short-sleeved cotton/polyester shirt, leather gloves over Voltage (V)-rated gloves, safety glasses, and a hardhat
- When the accident occurred, the electrician had connected phases B and C and was in the process of connecting phase A

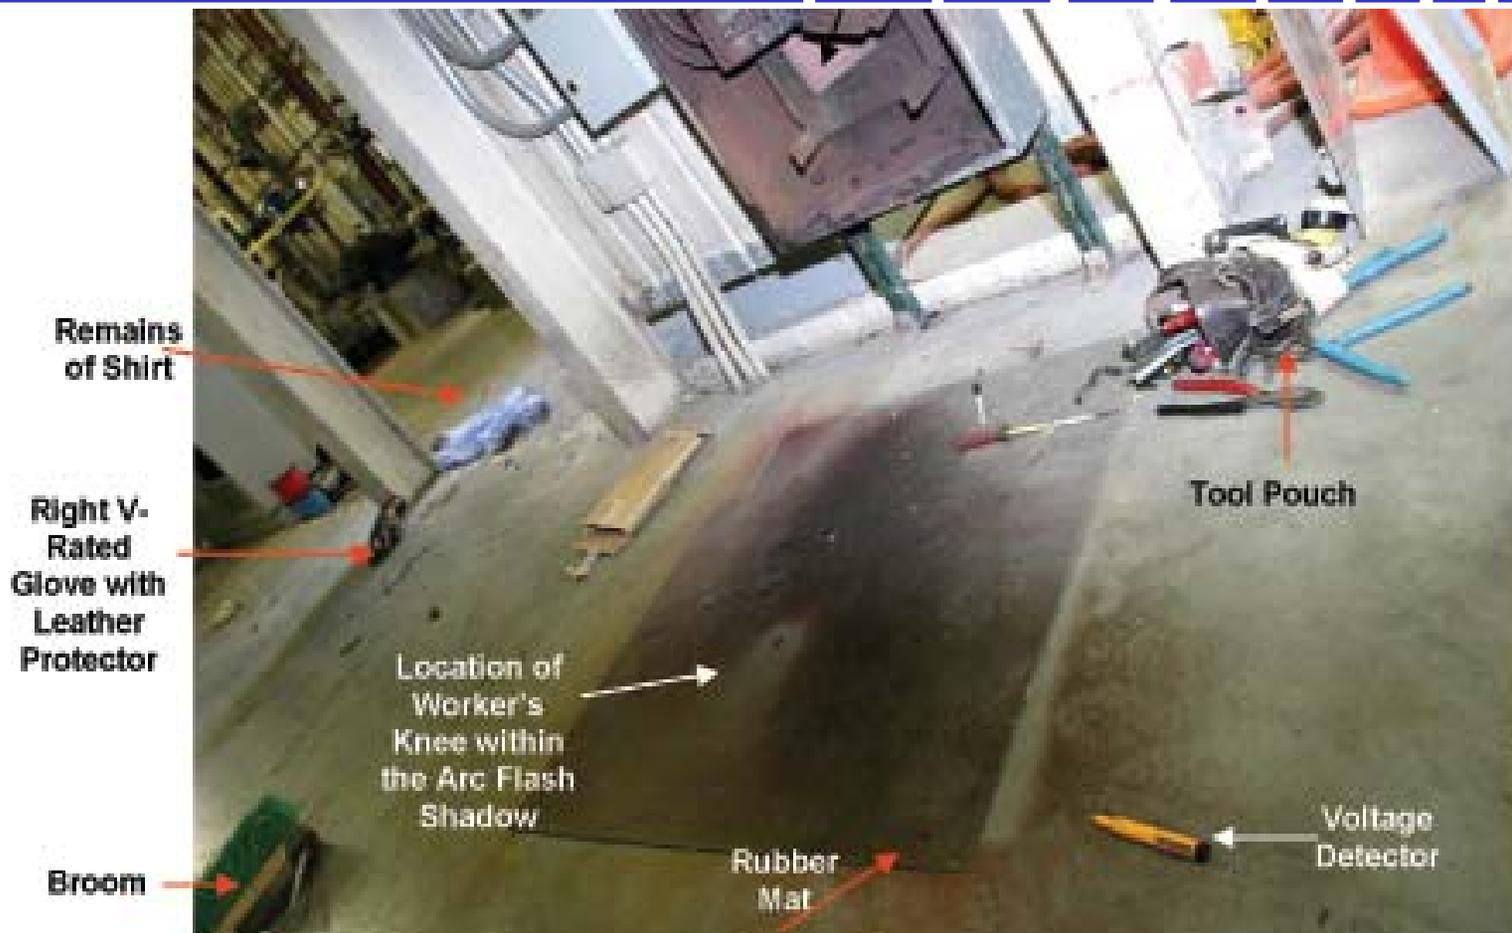
Figure 2-3. The insulating mat with the outline of BSE-1's knee in the arc flash shadow

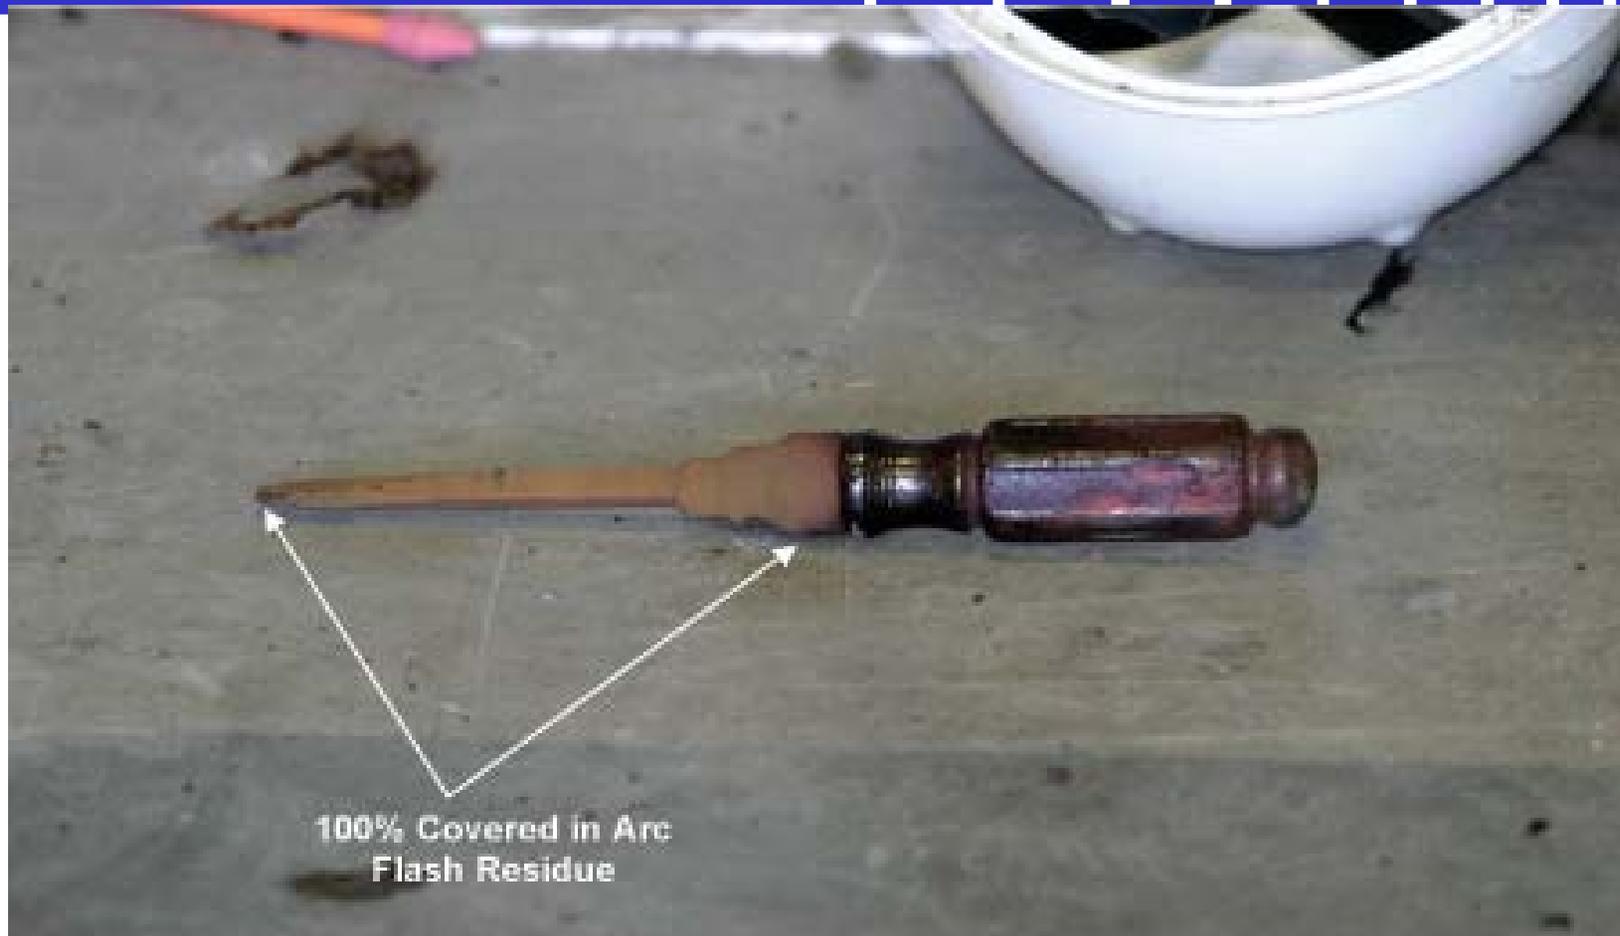
Figure 2-9. Closeup of the screwdriver the Board believes BSE-1 was using when the arc flash occurred

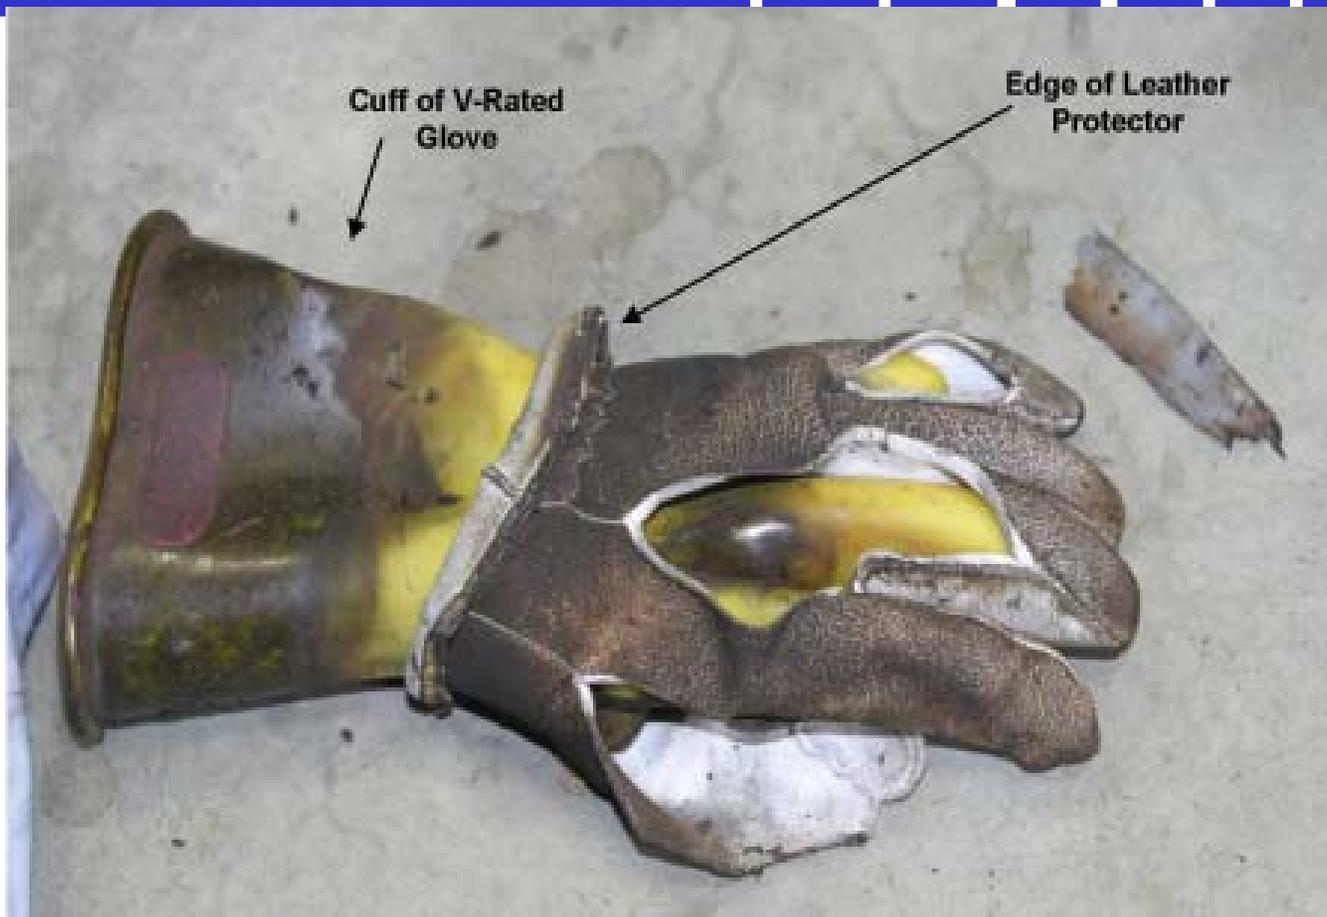
Figure 2-8. Closeup of one of BSE-1's burned gloves

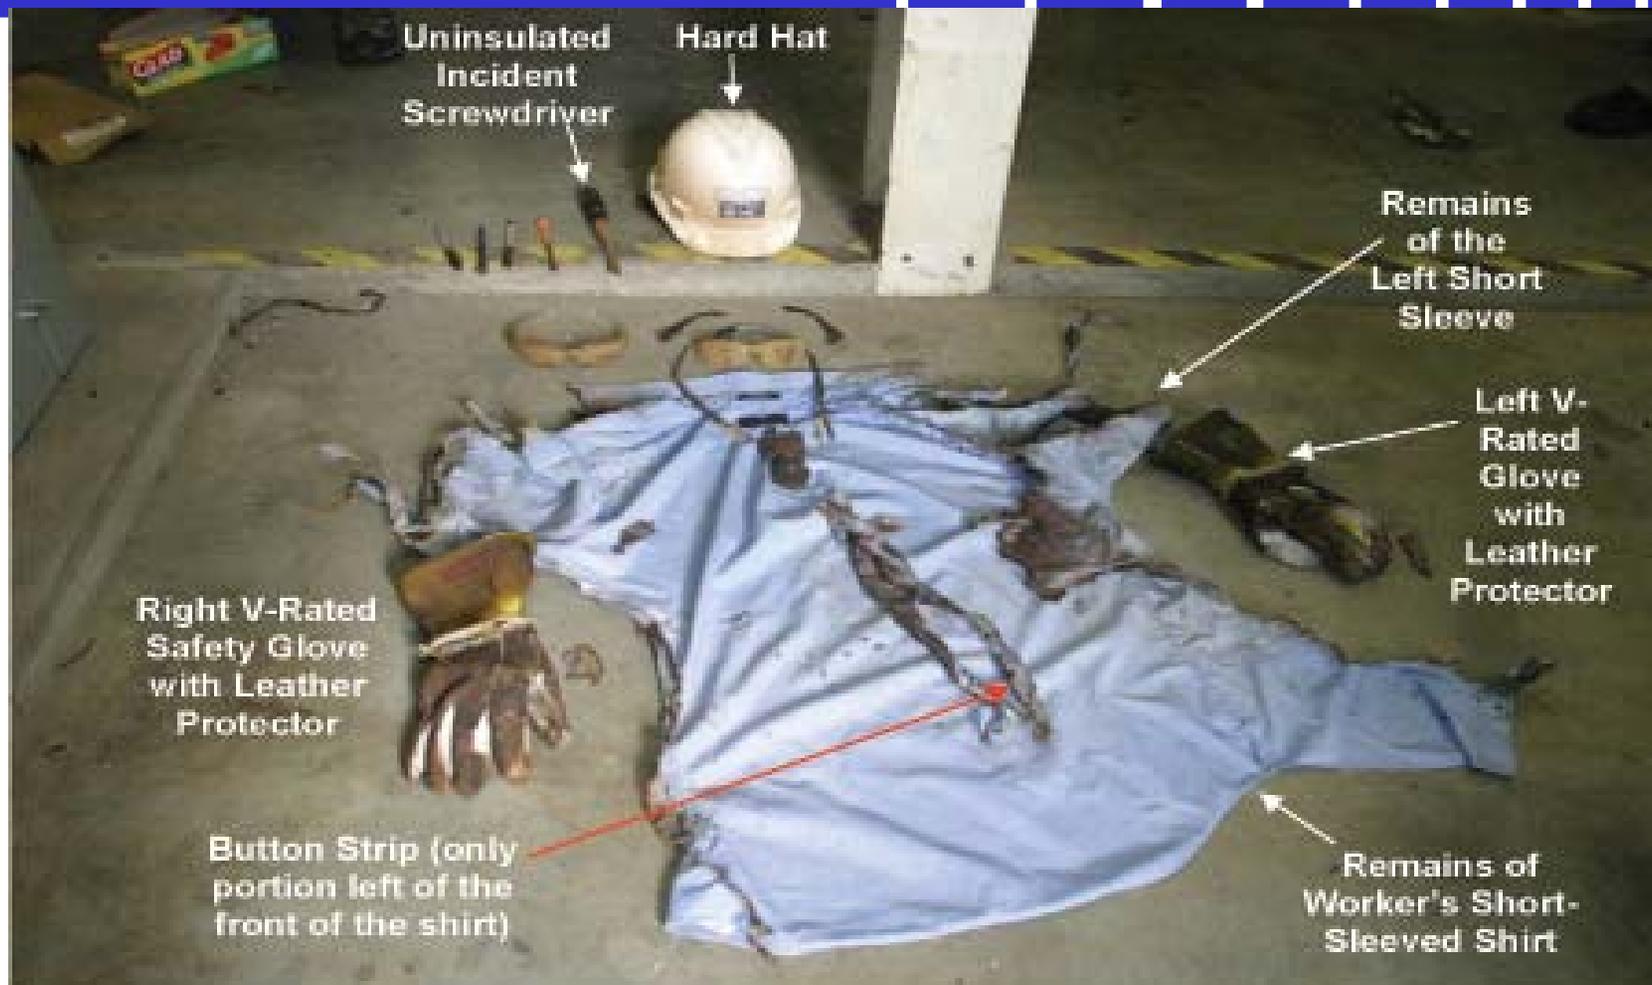
Figure 2-6. BSE-1's burned shirt and his flash-damaged PPE and tools

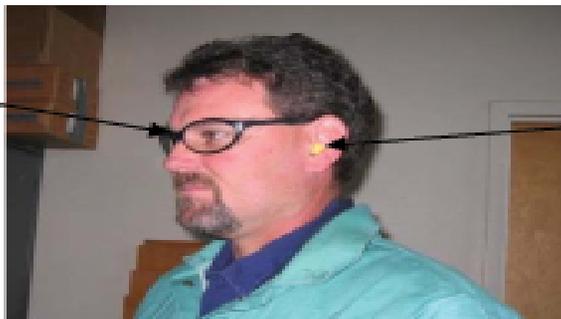
Safety Glasses

Hearing Protection

Figure 3-5. Worker wearing the eye and hearing protection to be worn under the double-layer switching hood

Figure 3-5. Worker wearing the eye and hearing protection to be worn under the double-layer switching hood
