Electrical Safety

In the Research Community

2005 NSLS User Meeting Electrical Safety Workshop

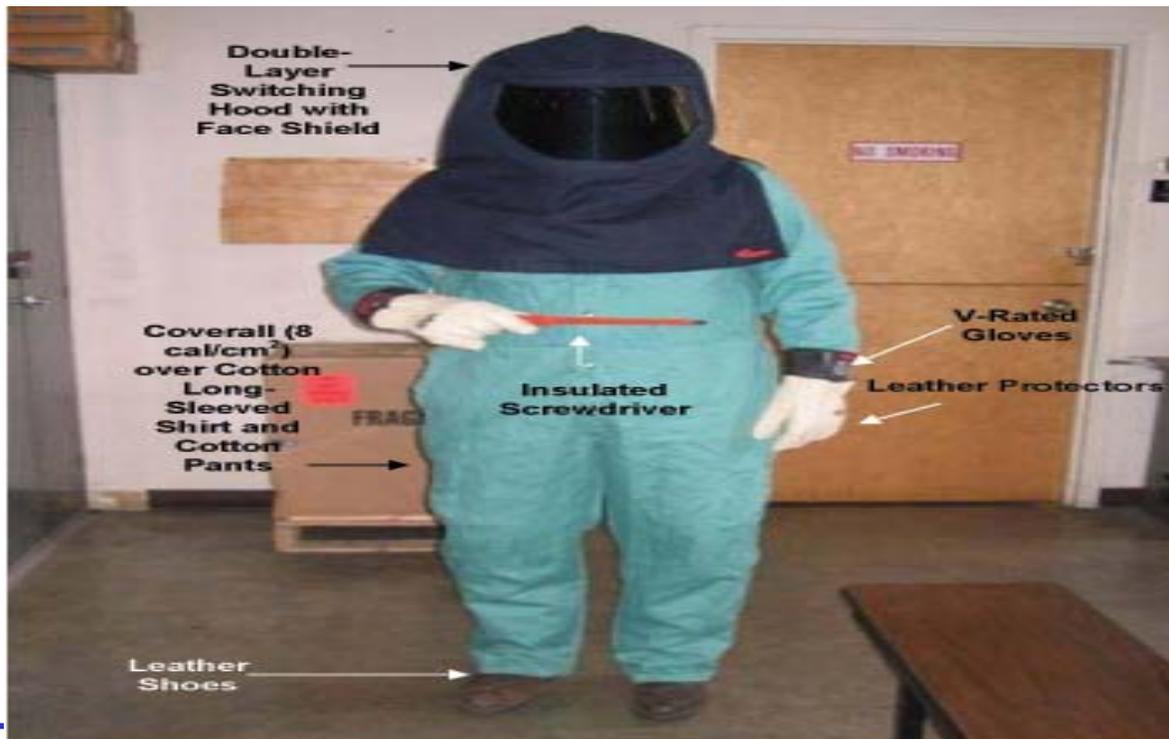
Double-Layer Switching Hood with Face Shield

Coverall (8 cal/cm²) over Cotton Long-Sleeved Shirt and Cotton Pants

Figure 3-4. Worker wearing the correct protective clothing and PPE

Figure 3-4. Worker wearing the correct protective clothing and PPE

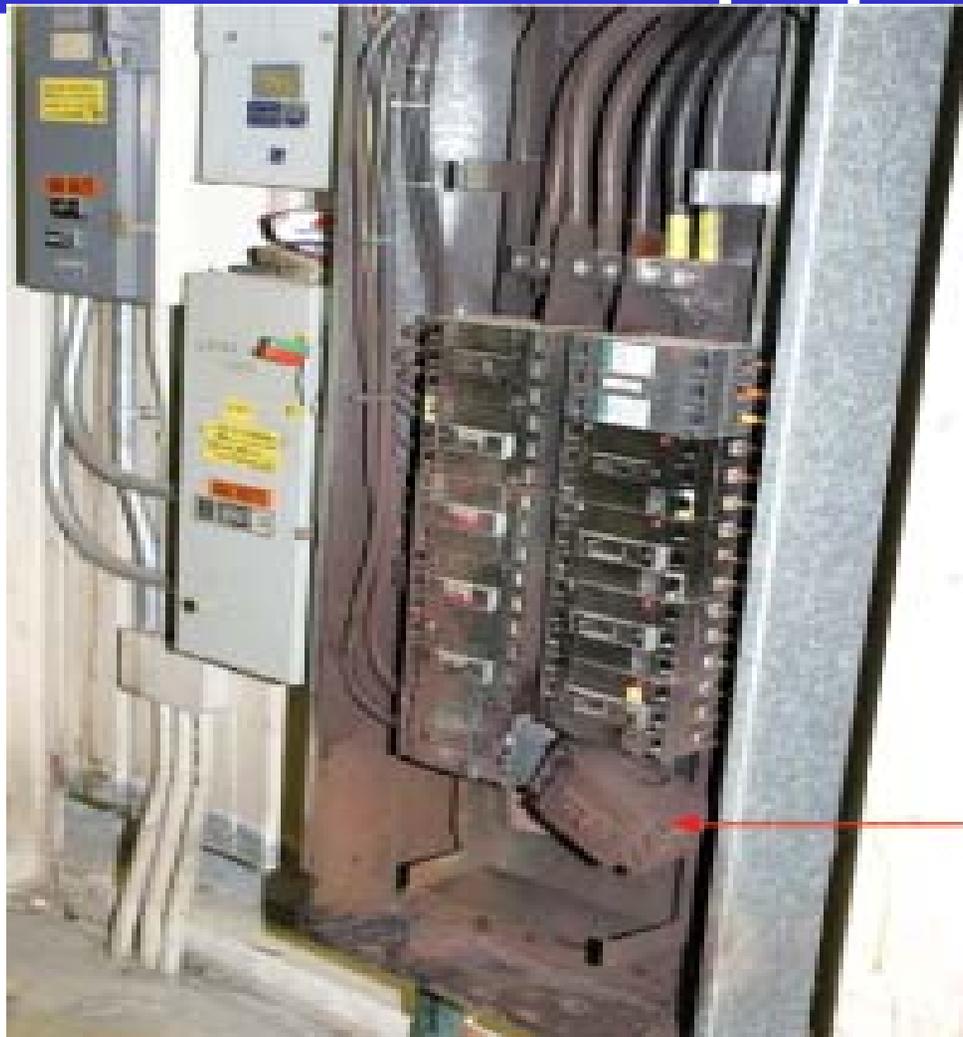
Circuit Breaker Panel

**Incident Circuit
Breaker Supported
Only by Phase C
Connection**

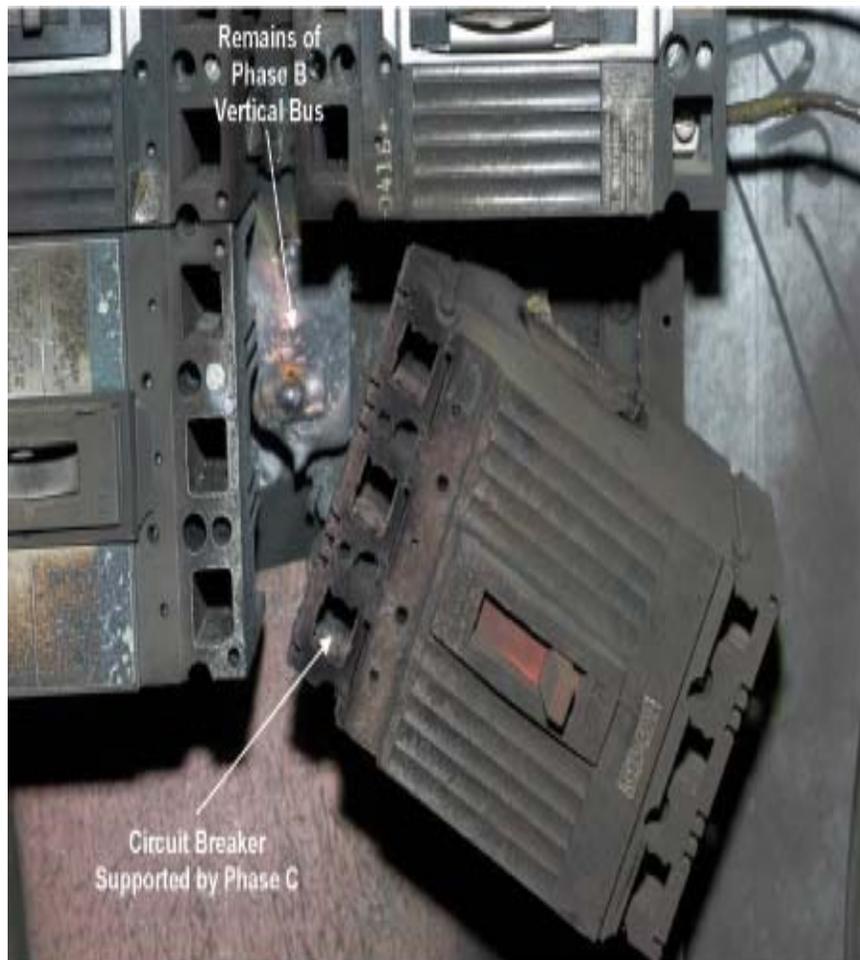
Figure 2-10. Closeup 1 of the damaged circuit breaker panel

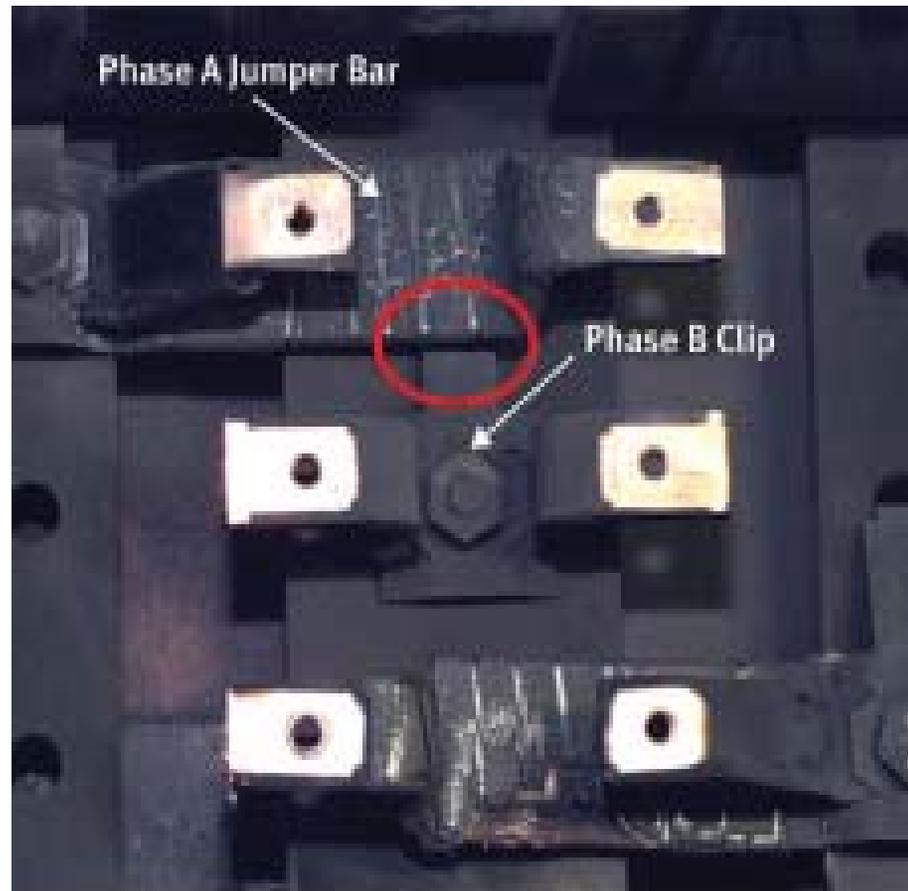
Figure 3-3. Close up of jumper bar and clip with the believed location of the fault circled in red

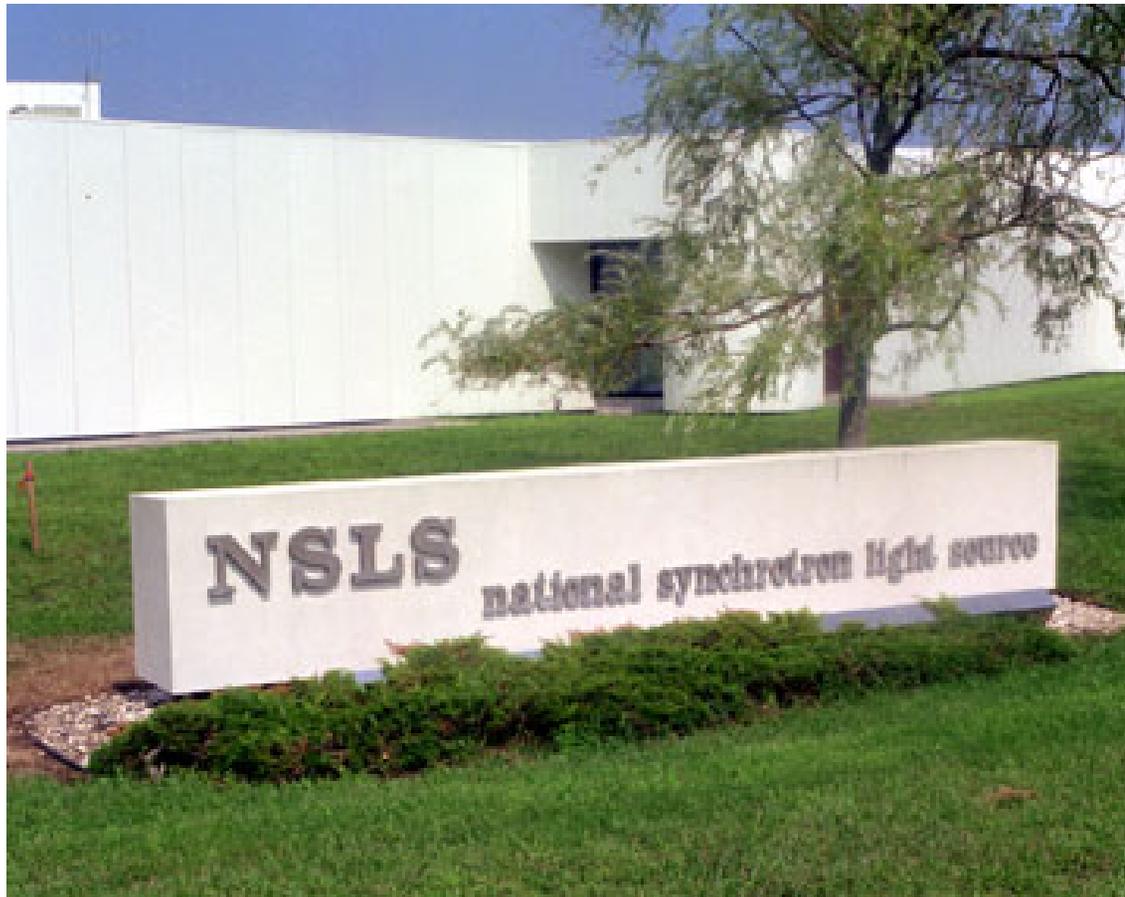
Incident 1 -May 2002

User modifies electrical connections to address an operational issue and accidentally energizes BNC connector to 1000 V DC - he experiences electrical shock.

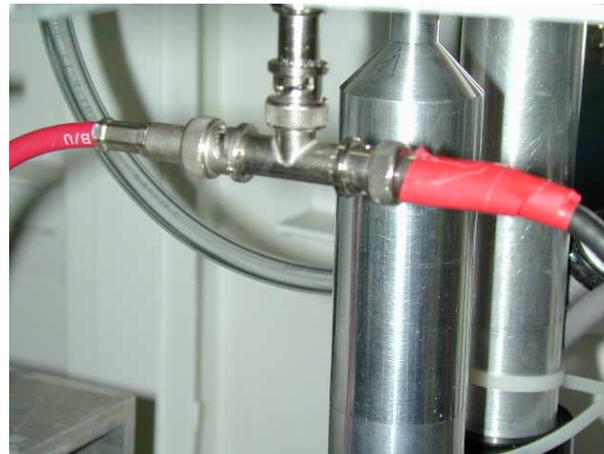
Incident # 2 - May 2004

In an effort to change polarity, two users reverse electrical connections of cable at 1000 V DC power supply and accidentally energize outer shell of SHV connectors. Unsafe condition exists for ~ 5 days and carries on to 2 subsequent experiments.

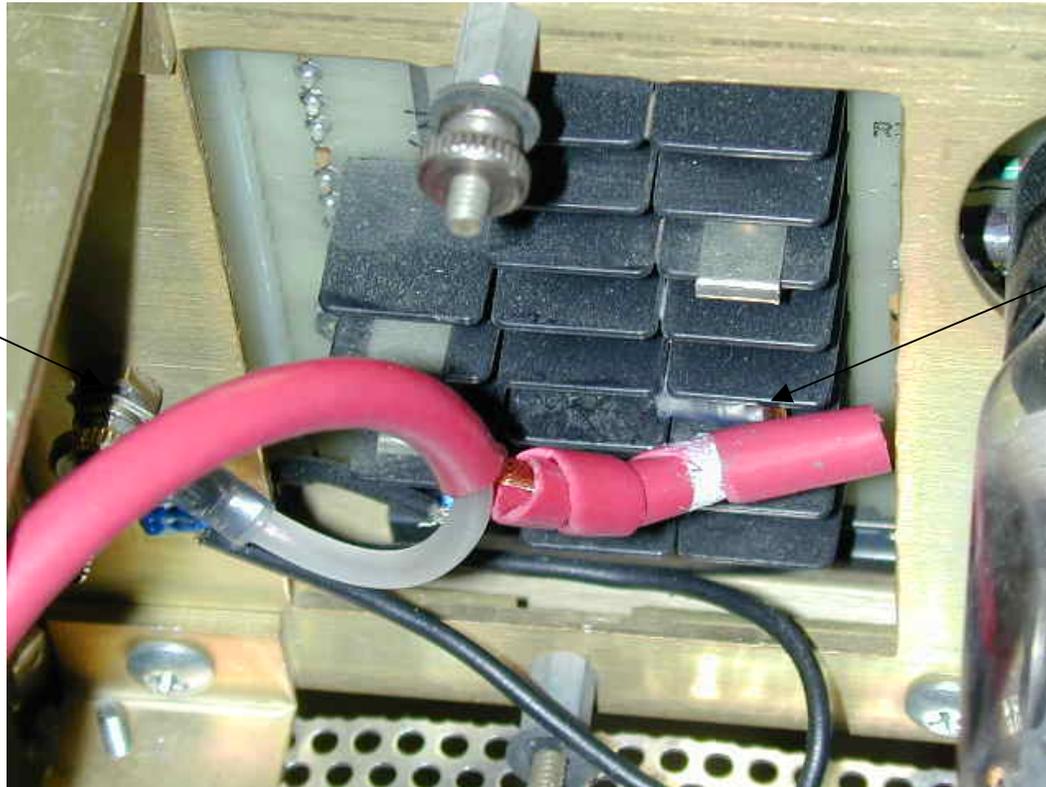
Modified High Voltage Power Supply Resulting in 1 kV on Ground Shielding

Center conductor connected to ground

1 kV on outer shield and connector

- Identify high voltage power supplies with banana jack outputs and terminal blocks that lend themselves to be easily reconfigured.
- Excess or retrofit these supplies with SHV bulkheads.

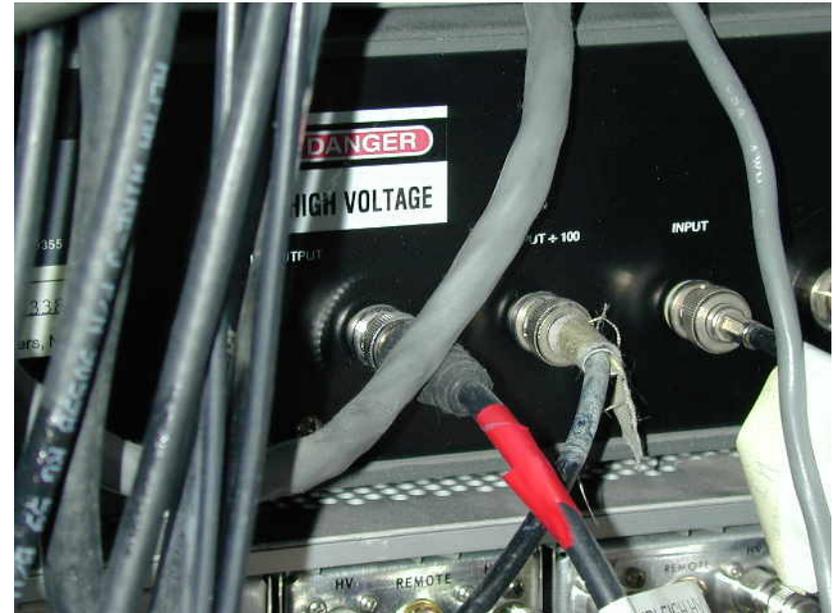
International Label for Equipment With Potentially Lethal Voltages $>50\text{ V}$ and $\leq 600\text{ V}$

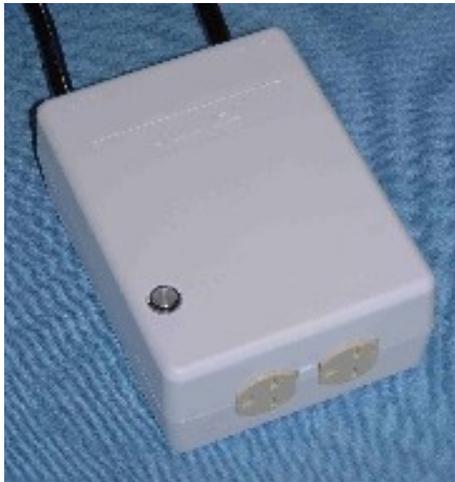
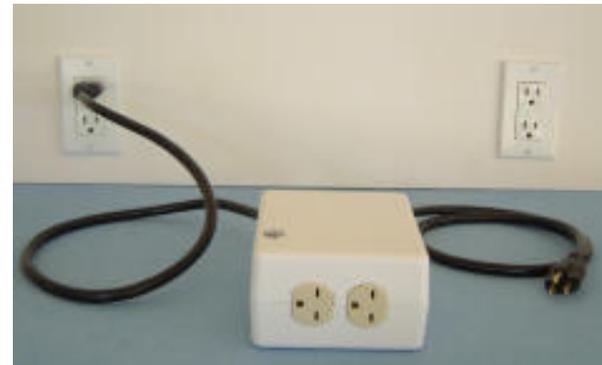
NRTL Approved Voltage Converter
(Quick 220® Power Tap adapter by Diamond H.
Company, LLC)

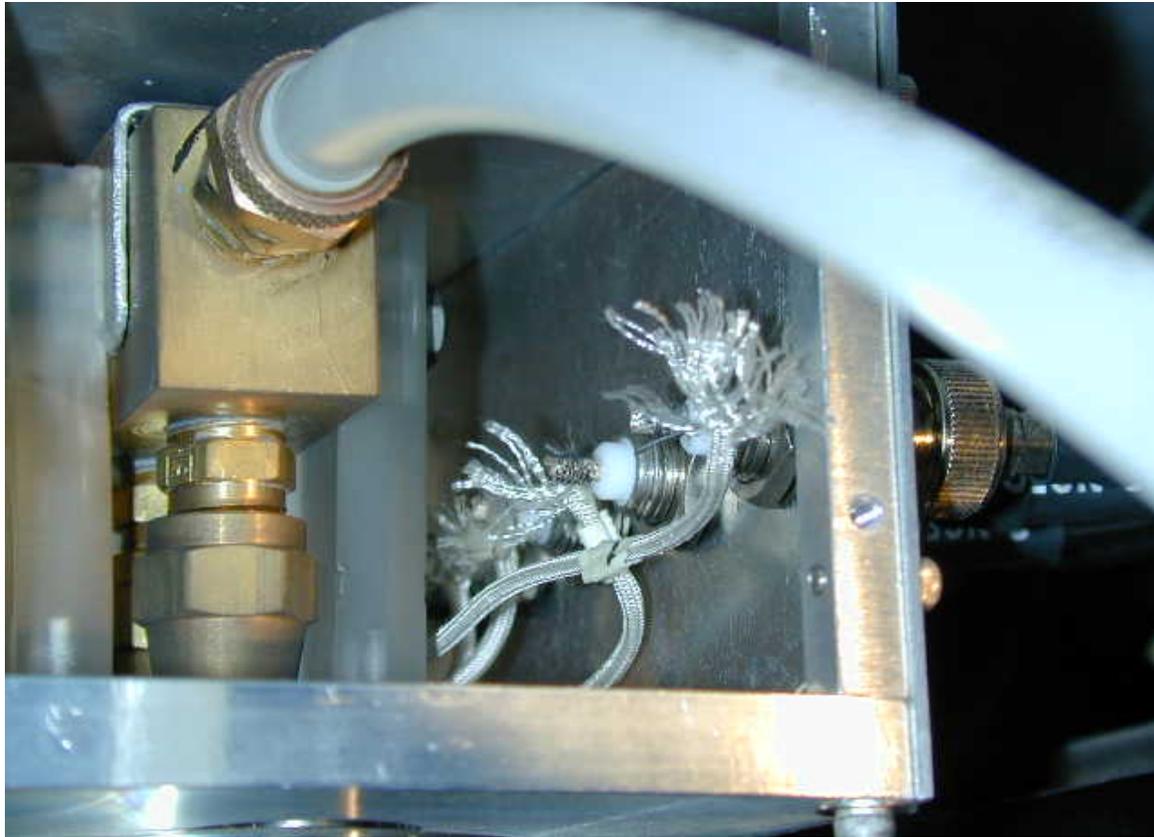
Interior of beam position monitor

A member of a PRT and a NSLS tech remove the front plate to a beam line component for maintenance. Neither is aware of energized surfaces within box and tech receives 300 V DC (20 mA) electrical shock when he begins work.

Ensure that all beam line and facility equipment with significant hazards has clear ownership and a responsible person. It is important that all hazardous equipment has someone designated to maintain safe configuration, including appropriate warning signs, and to act as a contact for questions concerning hazards, operation, maintenance, and troubleshooting.
