APPENDIX A.  
EQUIPMENT MODIFICATION DESIGN STUDY SUMMARY  
AND  
IMPLEMENTATION OF EQUIPMENT MODIFICATIONS

## **EQUIPMENT MODIFICATION DESIGN STUDY SUMMARY AND IMPLEMENTATION OF EQUIPMENT MODIFICATIONS**

This appendix section summarizes 1) equipment modification design study and 2) implementation of equipment modifications to the Cement-Lock demo plant sediment-modifier feeding system and the slag discharging system for the Phase II work.

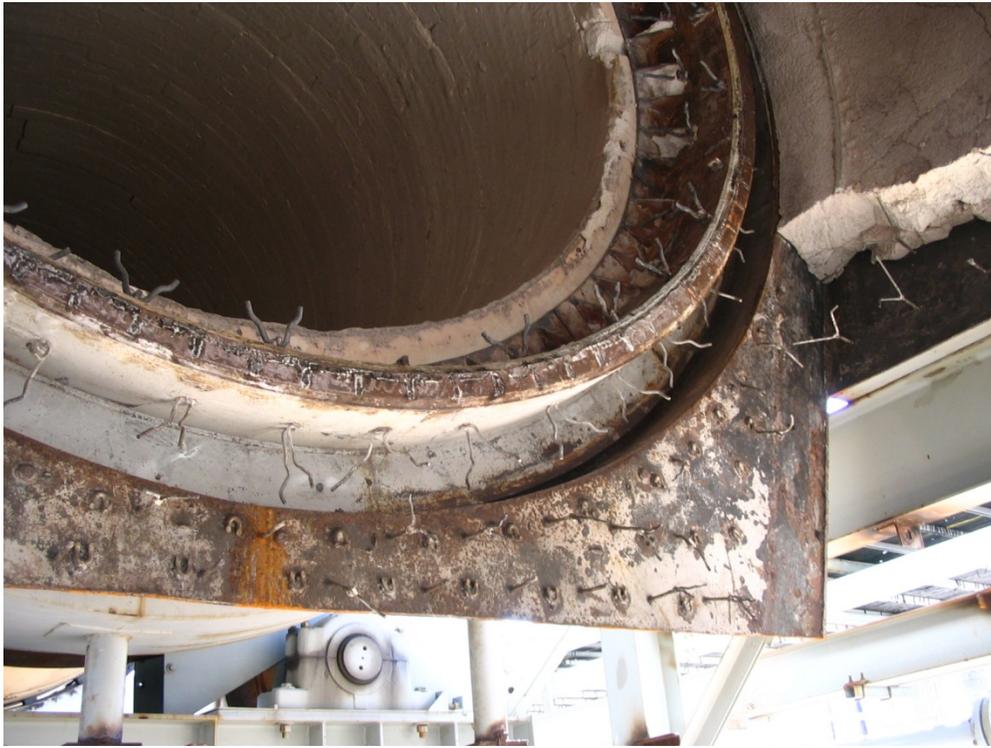
Next, FMW completed cutting the lower part of the drop-out box away. The nose ring gussets and nose ring shelf metal were also cut away. The kiln was rotated slowly to bring the parts to be cut away into reach. Figure A-2 shows the kiln nose after the cracked refractory was removed. Also the lower part of the drop-out box has been cut away in this view.

Figure A-2. Lower Part of Drop-Out Box Cut Away. Old Refractory Anchors Visible in the Nose Ring and Drop-Out Box Wall

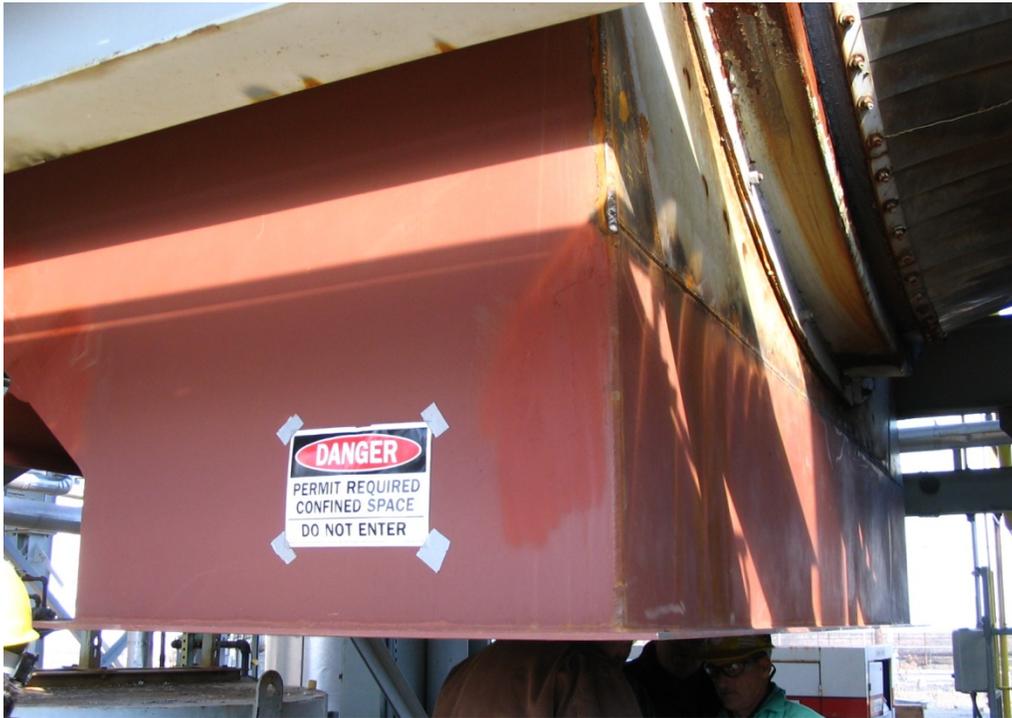
FMW installed the main drop-out box section and welded the existing upper and new lower sections together (Figure A-3). The upper discharge chute (without refractory) and the stainless steel lower discharge chute are also shown in Figures A-4 and A-5 awaiting installation.

Figure A-3. New Drop-Out Box Installed and Welded in Place

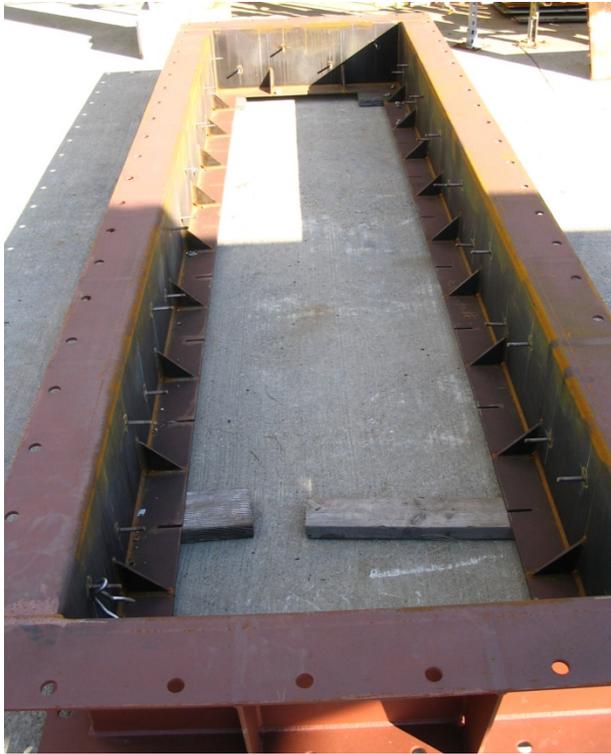
Figure A-4. Upper Discharge Chute  
(without refractory)

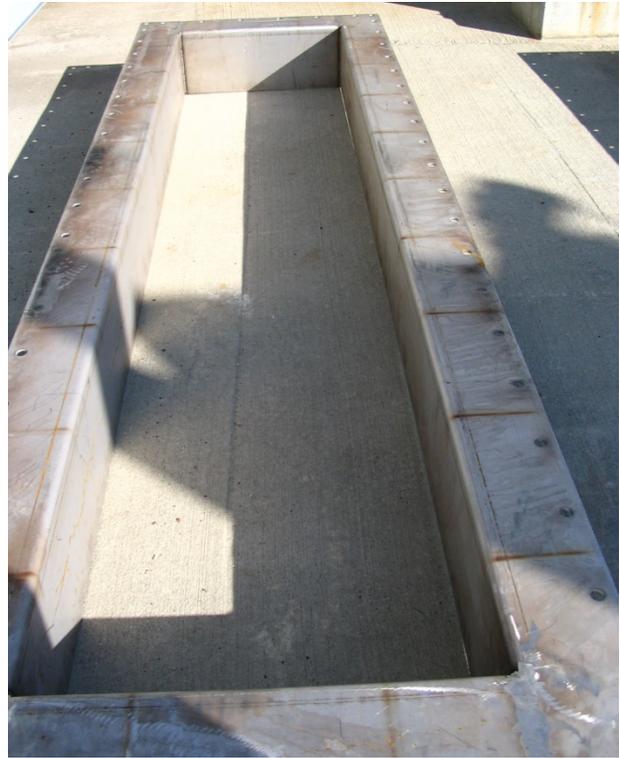
Figure A-5. Stainless Steel Lower  
Discharge Chute

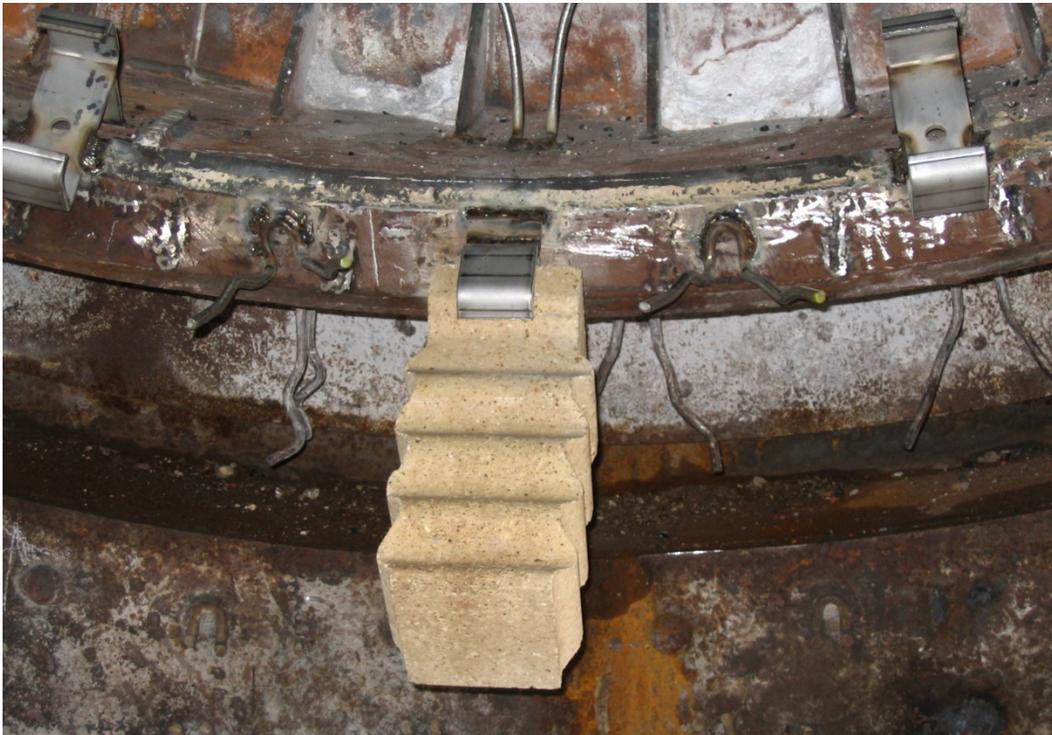
The anchors needed to support the wire anchors as well as the ceramic anchors around the nose of the kiln were also installed. The refractory anchors are positioned around the kiln nose ring alternating 45° up and 45° down. A ceramic refractory anchor is shown in place in the nose ring (Figure A-6).

Figure A-6. Ceramic Refractory Anchor in Place on the Nose Ring.  
Wire Anchors Shown Welded in Place

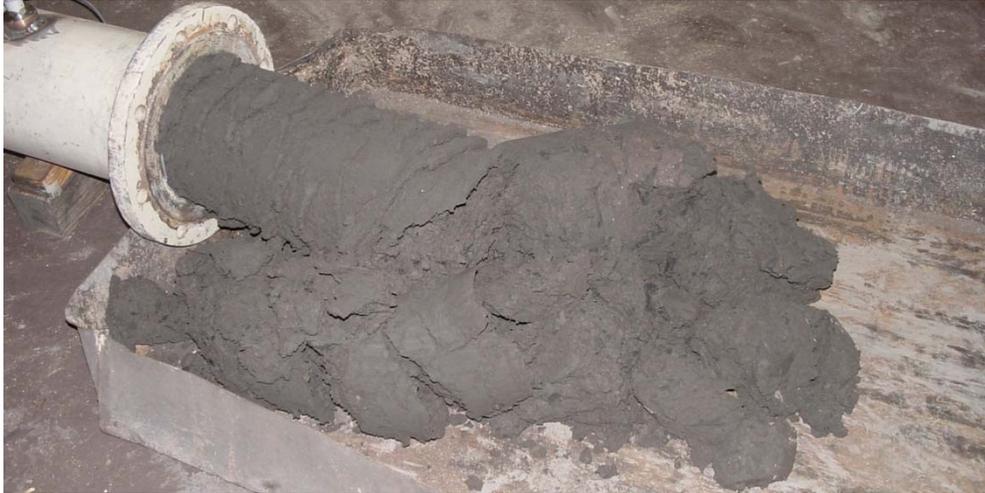
The first test of the V-Ram pump was with as-shipped Passaic River sediment. The sediment was shoveled into the flowable hopper and the pump was activated at a rate of about 18 strokes per minute. The V-Ram readily pumped the material through the pipe (Figure A-8).

Figure A-8. Passaic River Sediment Being Discharged through Straight 8-inch Diameter Pipe from V-Ram 11-inch Pump

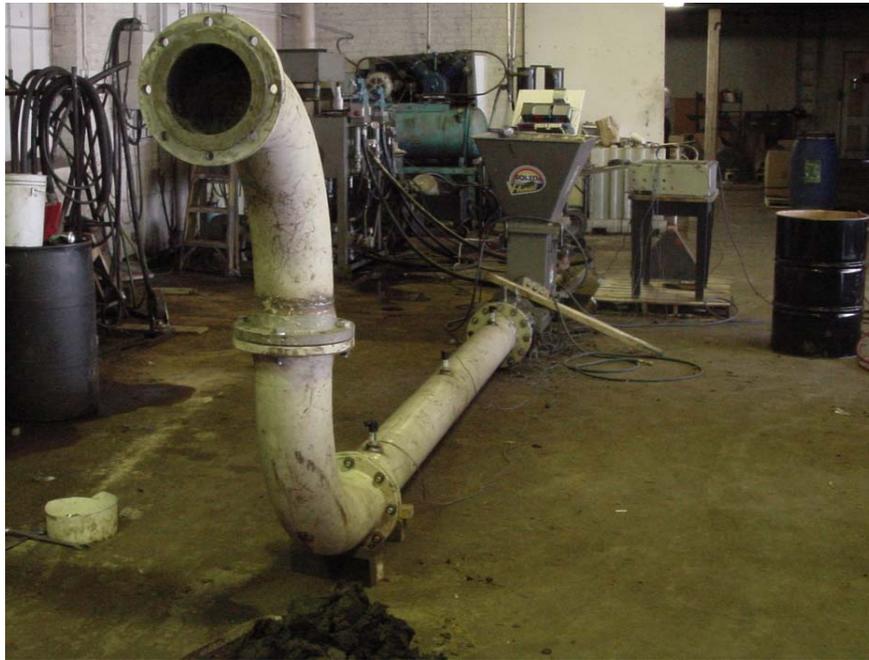
The second test of the system was with Passaic River sediment blended with about 20 wt % dry fine silica sand. For this test, two 90° bends were also included in the piping (Figure A-9). The addition of sand was to simulate the addition of modifiers to the sediment. The sand and sediment were loaded into a mixer for blending and then into the feed hopper for the test. The V-Ram also readily pumped this mixture. The tests were recorded using a digital video camera. The data collected during the tests was recorded and transmitted to ECH on a CD.

Figure A-9. Test Configuration for V-Ram Test with Passaic River Sediment Blended with Sand

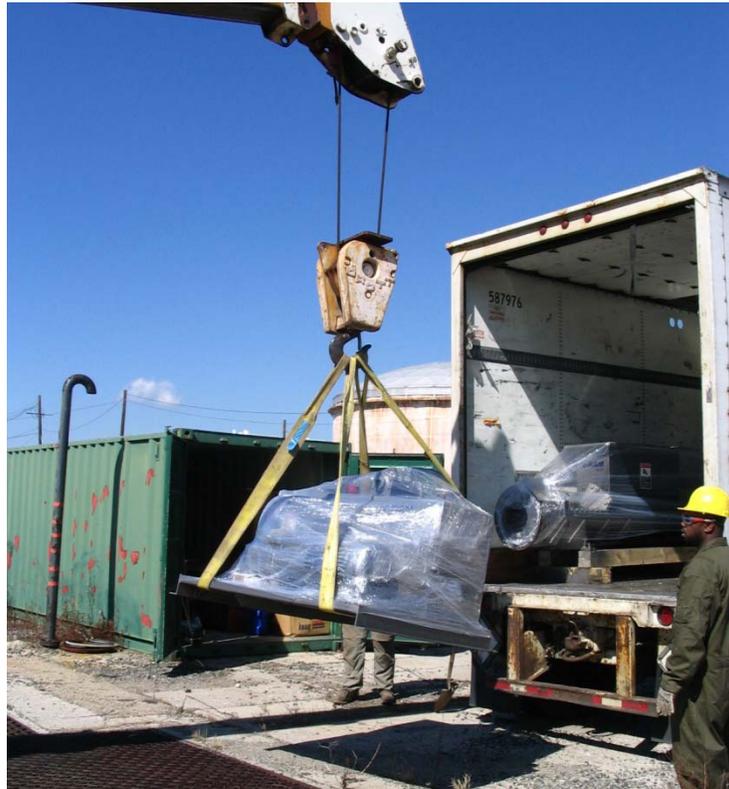
Figure A-10. V-Ram Hydraulic Module Being Off-Loaded at the Cement-Lock Demo Plant Site (September 26, 2006)

ECH evaluated the proposals and selected the 16-inch carbon steel system with non-flowable hopper. The purchase order was prepared and submitted to V-Ram in early August 2006. The complete V-Ram feeder system including control panel and hydraulic unit were delivered to the plant site on September 26, 2006 (Figure A-10). It was subsequently mechanically installed at the charging deck by FMW. SM Electric made the electrical connections. An end view of the V-Ram feeder installed is shown in Figure A-11. The high-pressure hydraulic lines are shown at lower right.

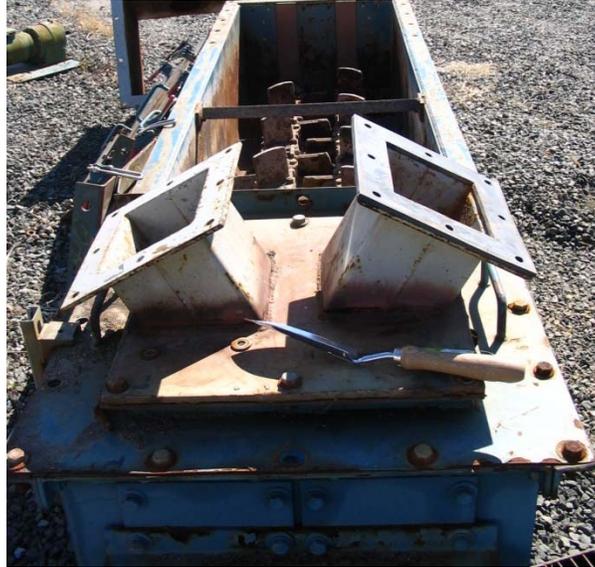
The existing pug mill (M-131, Figure A-12) was relocated and positioned just below the discharge of the inclined belt conveyor (Figure A-13).

Figure A-12. Pug Mill (M-131) to be Installed Above the V-Ram Feeder

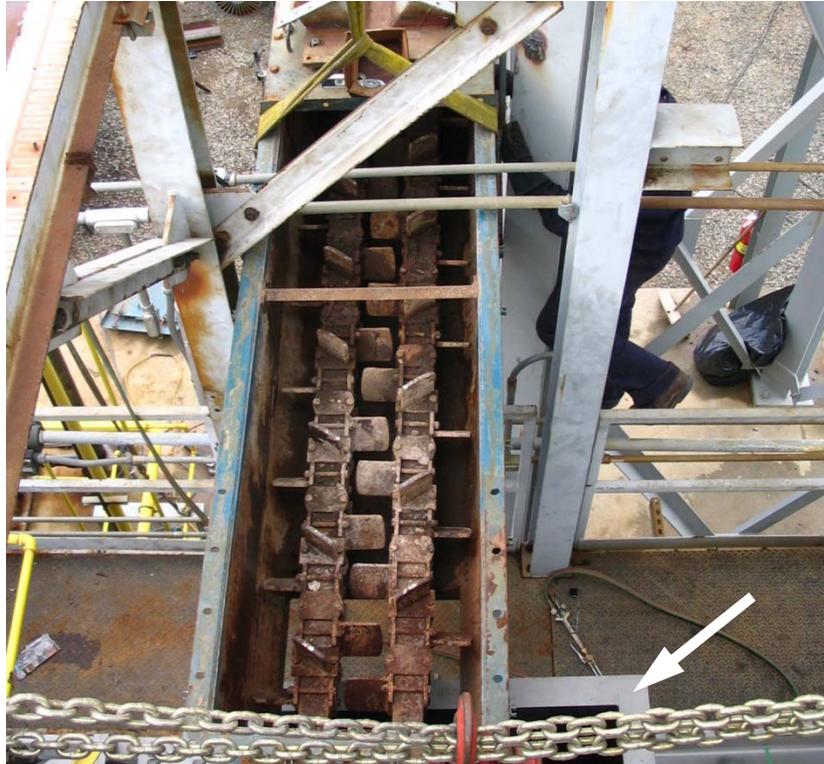
Figure A-13. Pug Mill (M-131) Relocated to the Charging Deck Above the V-Ram Feeder (V-Ram hopper shown at bottom)

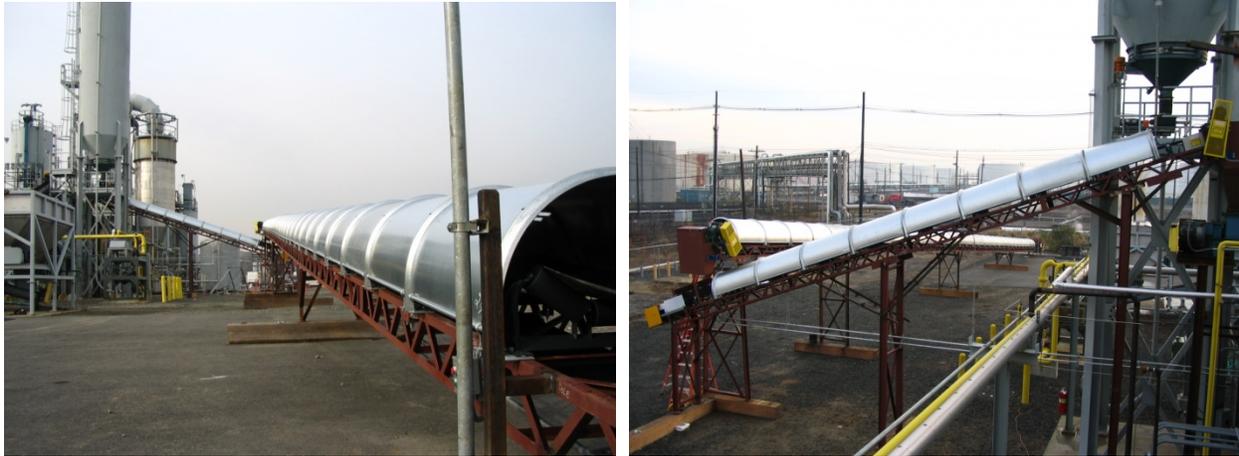
lifted them up onto the stanchions. SM Electric Company connected power to the two conveyor motors and ran conduit and wire so that the long conveyor could be started or stopped at the inlet at the sediment storage area. The two-section belt conveyor system is shown in Figure A-14.

Figure A-14. Covered Belt Conveyors Running from the Sediment Storage Area to the Charging Deck (left: looking west from the sediment storage area; right: looking east from the SCC platform)

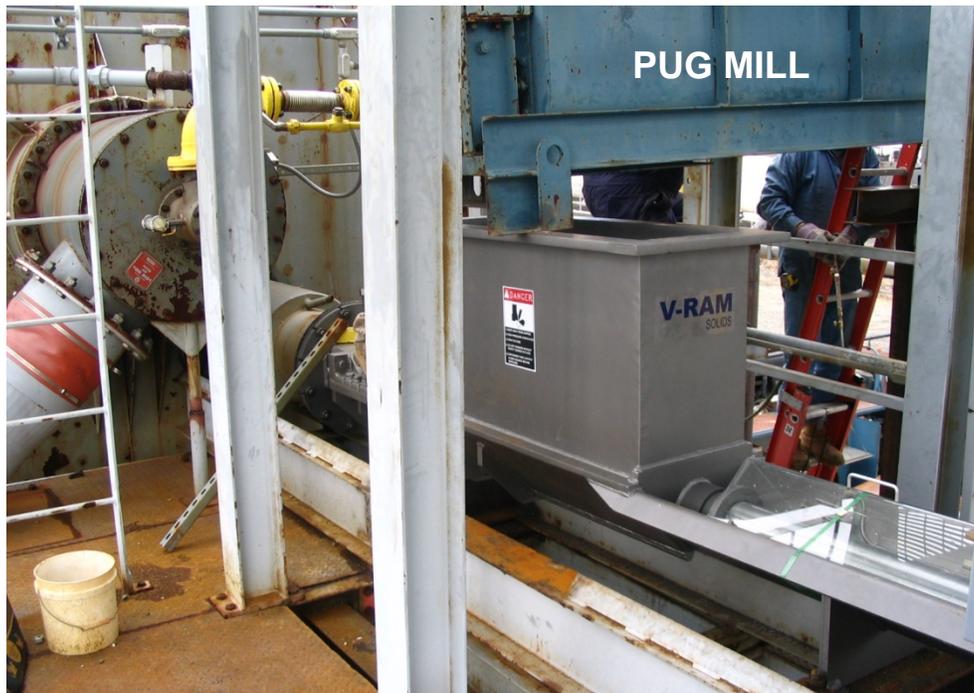
Once the V-Ram feeder was installed, the pug mill (M-131) was relocated and positioned above the V-Ram hopper (Figure A-15). The hydraulic connections between the V-Ram feeder and the hydraulic unit (at ground level) were connected.

Figure A-15. V-Ram Feeder Pump Installed at the Charging Deck. The Water-Cooled Screw Auger (C-151) Removed. Relocated Pug Mill (M-131) Above.

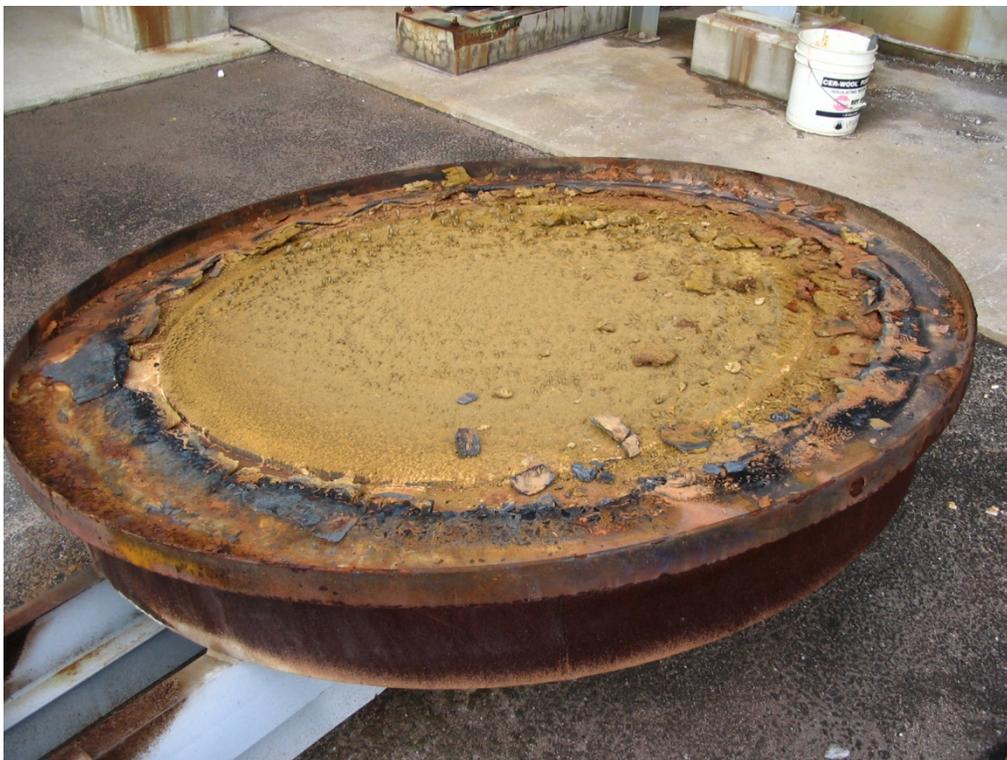
**Stack Cap:** The stack cap was removed from its position on top of the emergency stack and placed on the ground (Figure A-18) in an inverted position. During previous tests, the overheated steel had warped the stack cap such that the cap did not close completely. Steel that had been damaged due to overheating was removed. The burned metal was removed from the stack cap. According to DCI, the refractory appeared to be sound. The stack cap was reinstalled and tested for proper function.

Figure A-18. Stack Cap (Removed From Emergency Stack) Showing Overheated Metal
