**FINAL  
CLOSEOUT REPORT**

**Brookhaven Graphite Research Reactor  
Graphite Pile Removal  
Area of Concern 9  
Brookhaven National Laboratory  
Upton, New York**

**October 2010**

**Brookhaven Science Associates  
Environmental Restoration Projects**

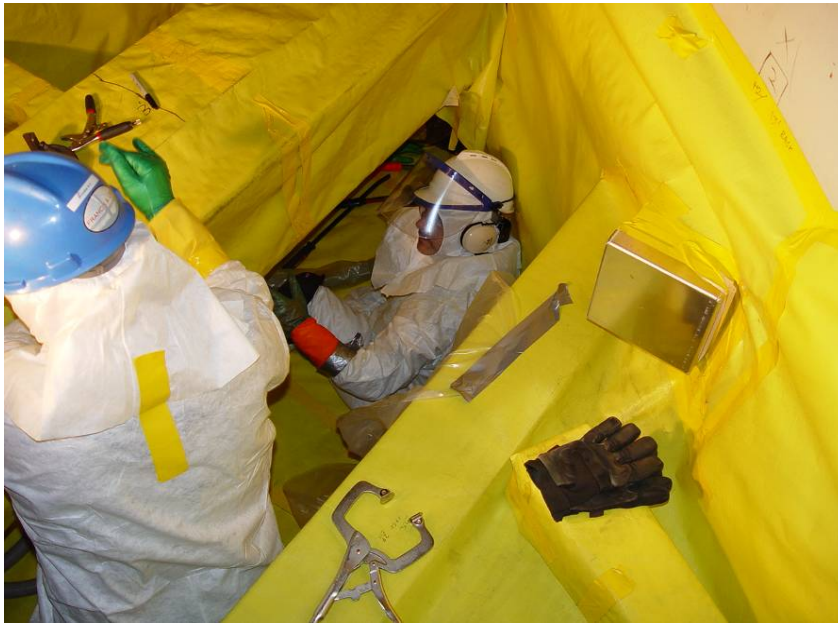
Photo 1  
Control Rod Cutting and  
Removal

The BGRR had 16 boron steel control rods. Each control rod assembly consisted of approximately 10 ft of rack and 26 ft of rod. Each rod penetrated the reactor horizontally in directions parallel to the diagonals of the reactor's base. Two of the control rods were used to control reactor power during operations. All 16 rods were used during the process of reactor shut down. A bank of eight rods penetrated the reactor from the southeast corner and the other bank of eight penetrated the reactor from the southwest corner.

Control rod removals began in early December 2009 and were completed by late December. The southwest bank of control rods were removed first because they were estimated to be less radioactive than the southeast bank of control rods. This allowed the work crew to develop proficiency in cutting and handling methods before working on the more radioactive rods. Each control rod was slowly pulled from the reactor, mechanically cut into five-foot sections, and loaded into one waste box for disposal. The control rods were not radioactive enough to require the waste box to be shielded. The waste box was shipped February 2010 to Energy Solutions (ES), Utah for disposal.

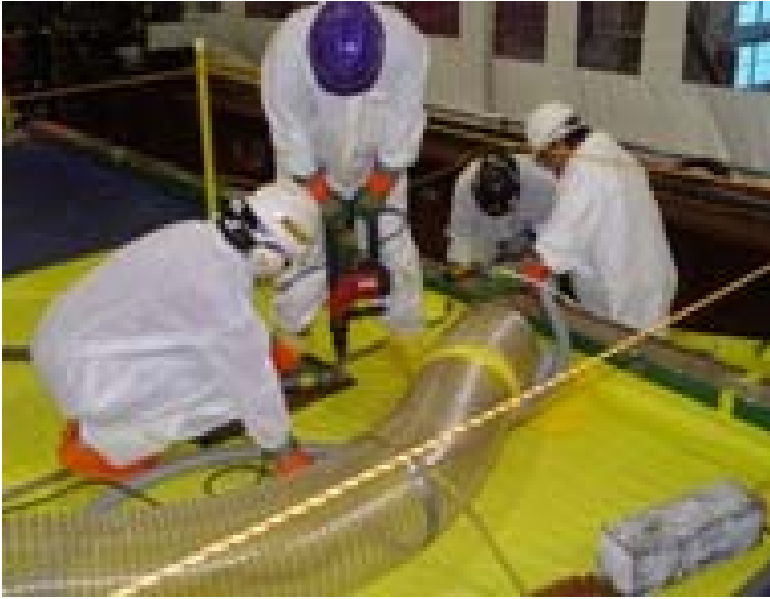
Photo 2  
Boron Shot Removal

Boron shot well system was provided to shut down the reactor in the event of an emergency in which the control rod shutdown system was prevented from operating properly. The system shut down the reactor by gravity feeding a sufficient quantity of neutron poison in the form of cadmium-coated boron steel shot into boron shot wells in the reactor. There were two vertical boron shot wells in the graphite and two diagonal boron shot wells in the reactor gap. Approximately 1,050 pounds of 5/16-inch-diameter boron steel balls were used in the reservoirs. They were made from hot-drawn boron steel wire and had the same composition as the boron steel used in the control rods. The balls were cadmium-plated to minimize rust.

Boron shot removal commenced in early January 2010, just before the concrete roof plugs were rigged out and disposed of, and was completed within one week. The shot was vacuumed out of each well with a portable HEPA vacuum by connecting the vacuum head to a long pole and lowering the pole into each of the shot wells. The vacuum exhaust was directed via portable tubing to a HEPA-filtered 55-gallon drum where the shot was initially collected. After all shot was collected in the drum the contents were transferred to a B-6 steel box for disposal.

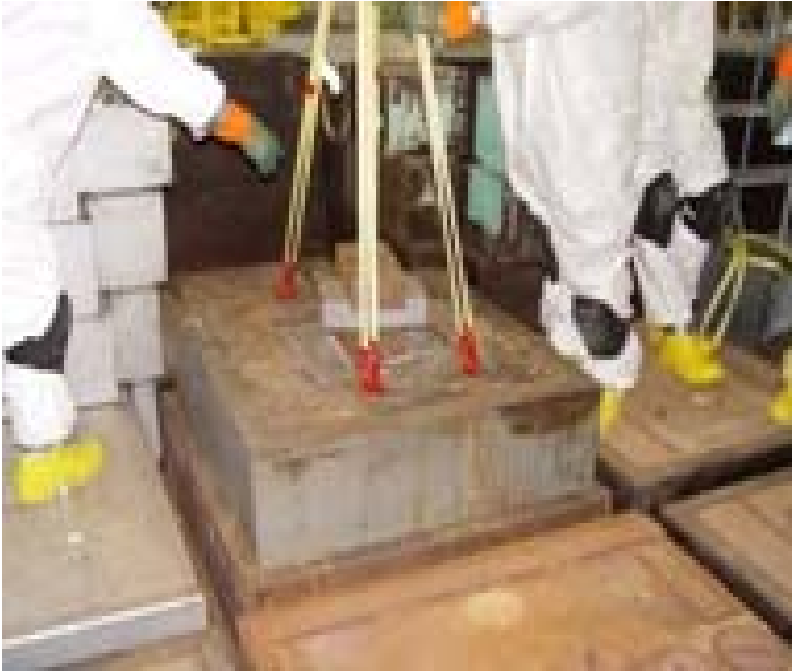
Photo 3 Roof Plug Removal

The reactor top contained two layers (upper and lower) of concrete roof (shield) plugs. The roof plugs had several different shapes and sizes (e.g., square, wedge, etc.) and were designed to minimize dose rates on the reactor top during operations such that workers could have access to the area. Roof plug weights varied between 1,100 and 10,800 pounds. There were a total of 151 plugs.

Plug removal began in mid-January 2010 and was completed by early February. Each of the roof plugs were individually rigged out using a 10-ton gantry crane and lowered into connex containers staged on the north side of the reactor within the Contamination Control Enclosure (CCE), a large tent used to confine dispersible radioactivity. The upper layer of plugs was not radiologically contaminated, but the lower layer of plugs contained small amounts of contamination. Several of the plugs did have higher dose rates than expected (i.e., factors of two or three). This was attributed primarily to the higher neutron dose rates that existed at the reactor gap where there was less shielding. Bracing was added to each container to ensure the concrete plugs did not shift during transport.

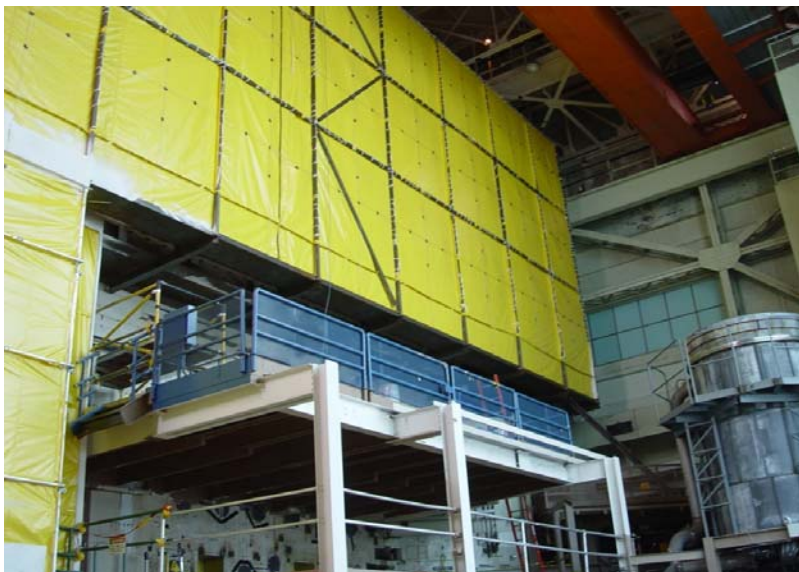
Photo 4 Exterior of CCE

A CCE and High Efficiency Particulate Air (HEPA)-filtered ventilation system was constructed by the subcontractor and utilized during the removal of the Boron Shot, concrete plugs and graphite pile. The CCE surrounded the upper level of the biological shield and extended down to elevation 110 ft on the north side of the biological shield. It was designed to contain airborne radioactivity that was generated during graphite removal operations, provide an air flow path from areas of lesser contamination to areas of higher contamination, and to prevent its escape to non-contaminated portions of the building. During operation it was maintained at a negative pressure with respect to Building 701. The CCE enclosed the excavator manipulator and 10-ton gantry crane.

The CCE was constructed of metal framing, and the design was approved by a licensed New York State Professional Engineer. The framing supported thin panels of yellow, fire-retardant plastic which were sealed together with double over-lapping Velcro. The design included two airlocks for movement of equipment into and out of the CCE and one airlock for personnel entry. The equipment airlock doors were curtain roll-up style, zipper operated, and sealed with Velcro. Air flowed into the CCE through barometrically-controlled damper valves which closed at low differential pressure between the CCE and the building high bay to guard against backflow of contaminated air into the high bay. The CCE was initially certified and then inspected each shift to verify its operability as an engineering control prior to graphite removal operations.

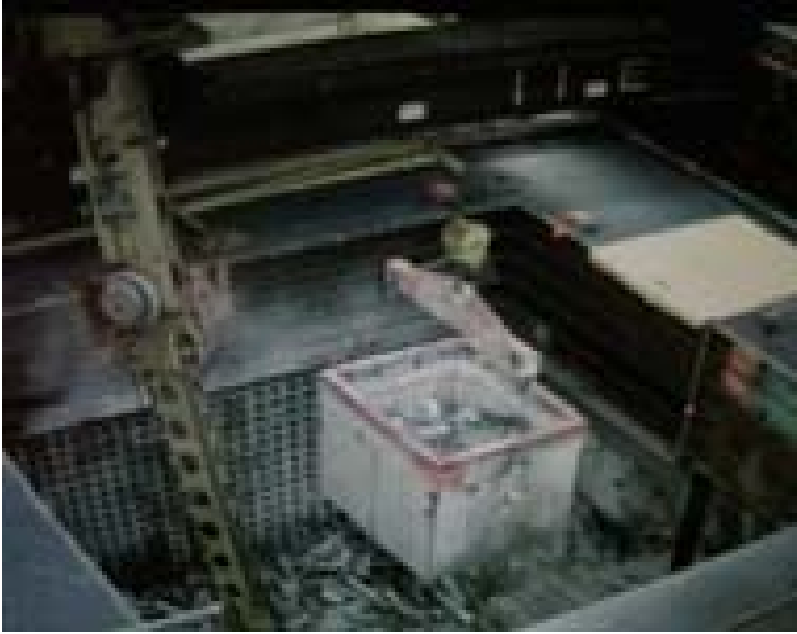
Photo 5  
Excavator Loading Lift Fixture and Super Sack

The hydraulically operated excavator was the primary tool for graphite block removal. The process of filling a super sack with graphite blocks started with pouring an 18-pound bag of vermiculite into the bottom of the super sack to absorb any hydraulic fluid from the excavator that may have leaked during the loading process. This would ensure that there was no free-standing liquid in the waste stream. The super sack then was rigged up from the 110' level to the reactor top and into the reactor pit using the gantry crane. Utilizing a clamshell bucket fitted with a specialized blade, graphite blocks were dislodged layer by layer with the excavator and loaded into the super sack. A hydraulic hammer attachment was also utilized to break up graphite layers. After the sack was filled it was rigged out of the reactor pit and held stationary over two fixed, remote-reading dose rate instruments to ensure the external super sack dose rate was within acceptable limits for offsite transportation. Following this measurement the super sack was lowered back down to the 110' level and rigged into an industrial package (IP)-1 waste container. The IP-1 container lid was then secured into place; the container was surveyed and then moved out of the CCE pending transportation to the BNL Waste Management Division (WMD) for final processing and offsite disposal at the DOE Nevada Test Site.

The excavator was fitted with a spray system to apply a fixative agent for graphite dust suppression. A latex paint and water mixture was applied to the graphite material during removal, for dust control. The interior of the loaded super sack was also coated with this mixture.
