## HYSPEC Status, March 29, 2012

A month ago, on February 28, we provided a status report on the HYSPEC instrument; this is a quick follow-up report on each of these issues.

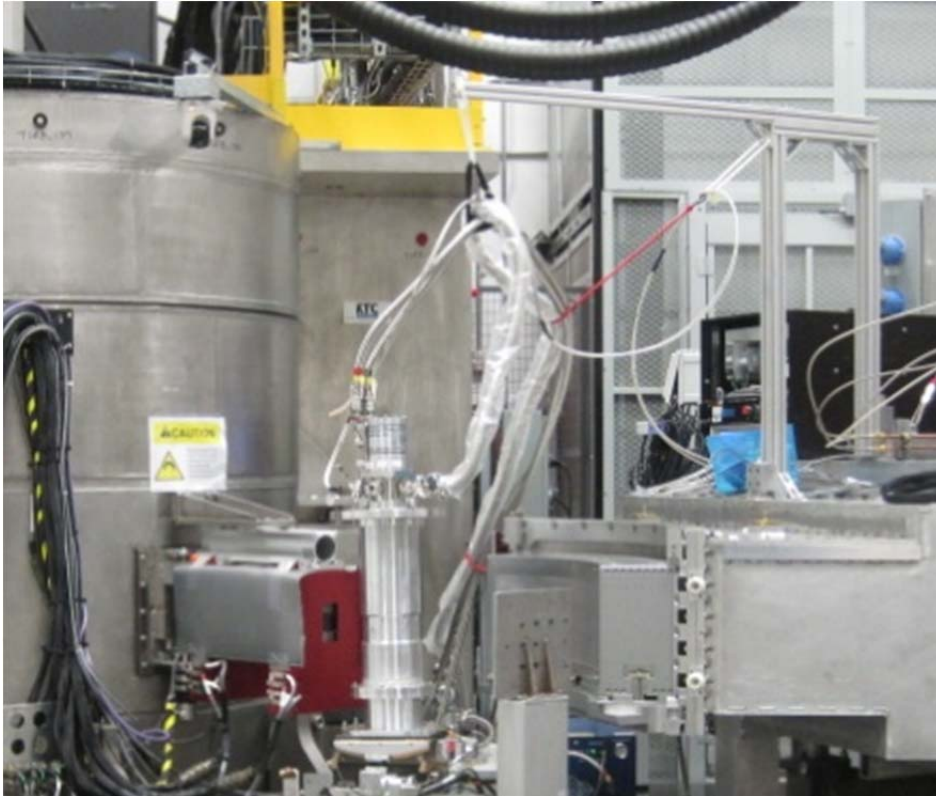
The CCR-10 system has been mounted at our sample table, and has been cooled to 5 K. Control for temperature is via a Lakeshore 336, which is connected to our control computers and has been operated and scanned using PYDAS. With the sample rotation cable management problem solved, the only constraint on rotation is the normal hose management limitation one experiences on triple axis spectrometers. Below is a photo showing this system.

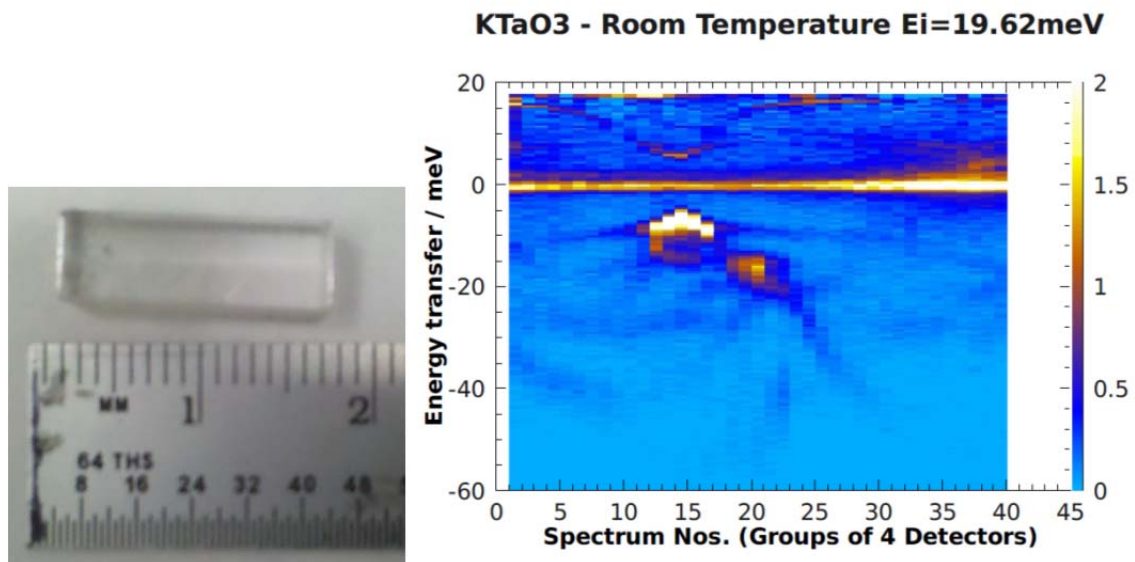
The following are some plots of phonon data taken on a single crystal of  $\text{KTaO}_3$  (photo below). Its

dimensions are 5 mm x 5 mm x 15 mm. At the moment we run like a triple axis, vertically focused with the crystals we then integrate vertically on the LPSD's and group 4 detectors together. This gives us resolution akin to HB3.

The following is raw data, not normalized to Vanadium, at room temperature, in CCR-10 and in vacuum.
