2020 Site Environmental Report: An Overview

Community Advisory Council Meeting

October 14, 2021

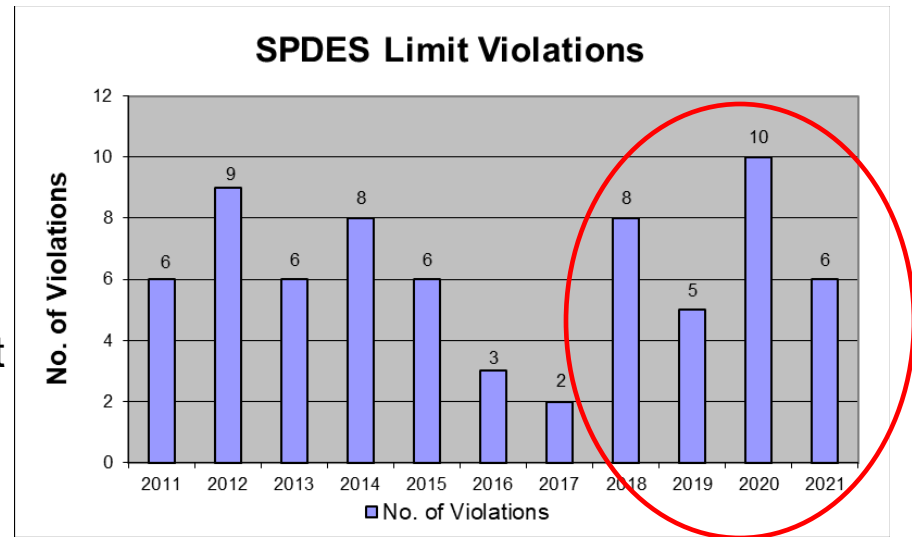
- 10 permit excursions (nine at Sewage Treatment Plant [STP] and one at Outfall 002 [HN])
 - All due to Tolyltriazole (TTA)
- Investigation into cause(s) of these exceedances and corrective actions has been on-going since TTA was first detected at STP in January 2018

- NYSDOH Legionella Disease prevention regulations enforced in 2015.
- Much lower flow conditions at the STP (especially during COVID-19).
- Sheer number of cooling towers and chilled water systems (no alternative corrosion inhibitor products for copper systems).

- Continued a pilot study using a new chemical that does not contain TTA
- Decreased the amount of TTA used in cooling tower systems
- Continued installation of automated chemical control systems
- Initiated hydrogen peroxide treatments at targeted cooling towers to help alleviate Legionella issues

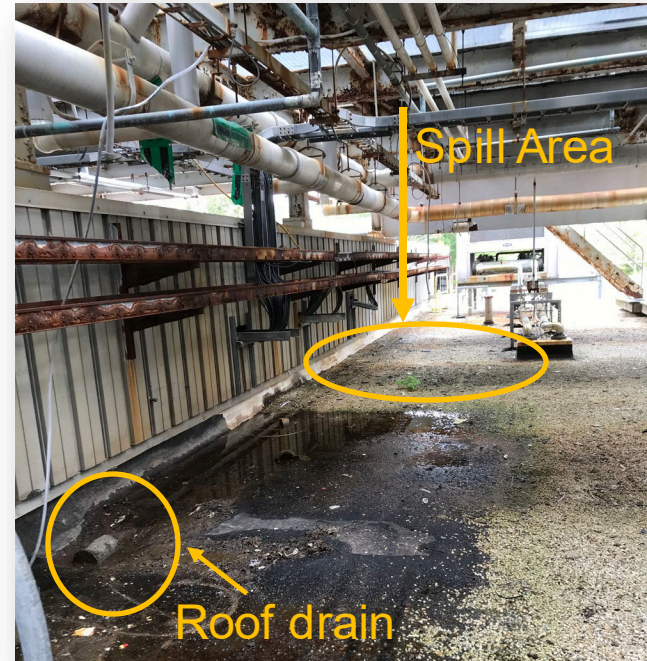
Building 911 Evaporative Cooler Release of Tritium

- On July 28, 2020, an evaporative cooler on the roof of Building 911, used for the AGS main magnet cooling, leaked approximately 100 gallons of tritiated water when a coupling failed.

- The evaporative cooler automatically shut down from the water loss.
- Last sample collected of the water in the system was on 8/15/19 and Tritium concentration was 29,900 pCi/L.

- An investigation team was formed and performed fact finding, causal analysis, and development of corrective actions.
- During the time of the investigation a second, similar event occurred on September 10, 2020.
- The investigation into these two events resulted in the following corrective actions that were completed for the exterior Main Magnet Cooling System piping:
 - Replaced all couplings
 - Re-insulated all valves, couplings, and other clamps above the platform
 - Developed inspection plan involving random sampling of coupling/clamps

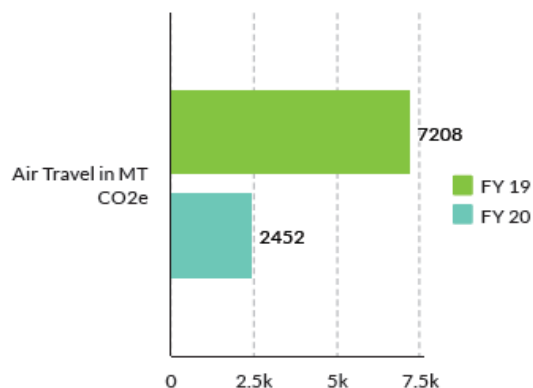
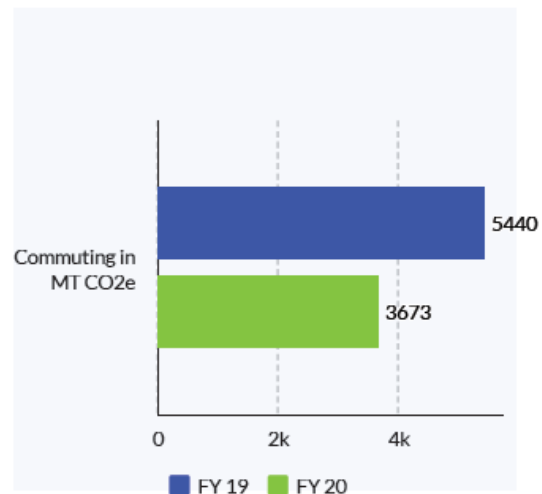
Figure 4-4: BNL Scope 3 Greenhouse Gases – Federal Impact of COVID-19

Brookhaven National Lab mirrored the federal and state governments and saw significant reductions in greenhouse gas emissions

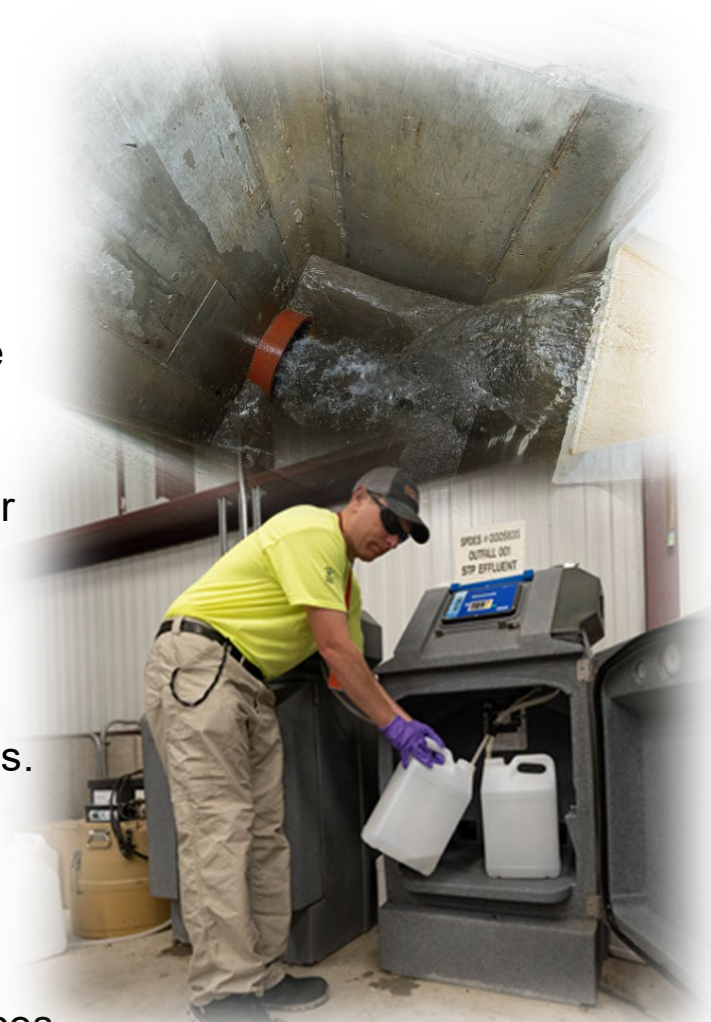
Sampling STP Effluents

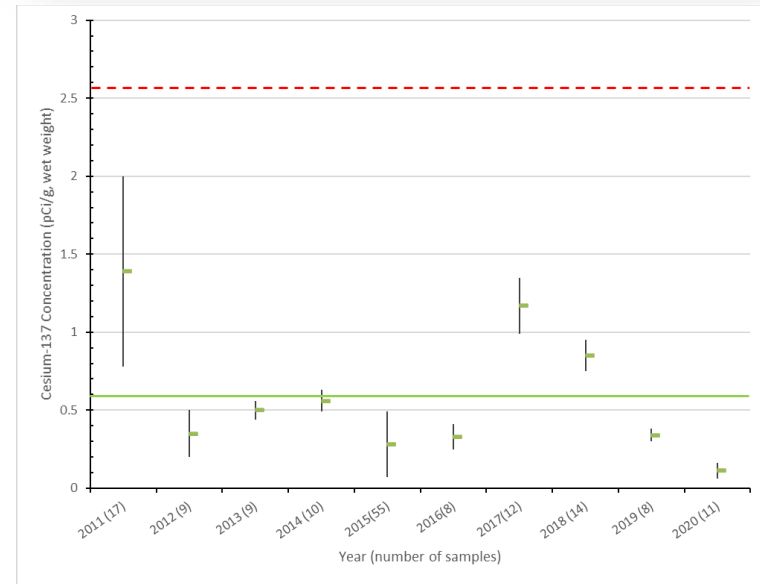
Ten-Year Trend of Cs-137 Concentrations in Deer Meat, dashed line is pre-cleanup avg., solid line is 10-year avg. 0.59 pCi/g wet weight.

- Ten-year trend of Cs-137 in deer meat shows decline; 2020 on-site average in meat was 0.06 pCi/g, wet weight, with ten-year on-site average being 0.59 pCi/g, wet weight
- No fish monitoring – Peconic River had low water levels throughout the year
- Grassy vegetation and soil sampling results consistent with past years
- Low level mercury continues to be detected – highest value 8.37 ng/L

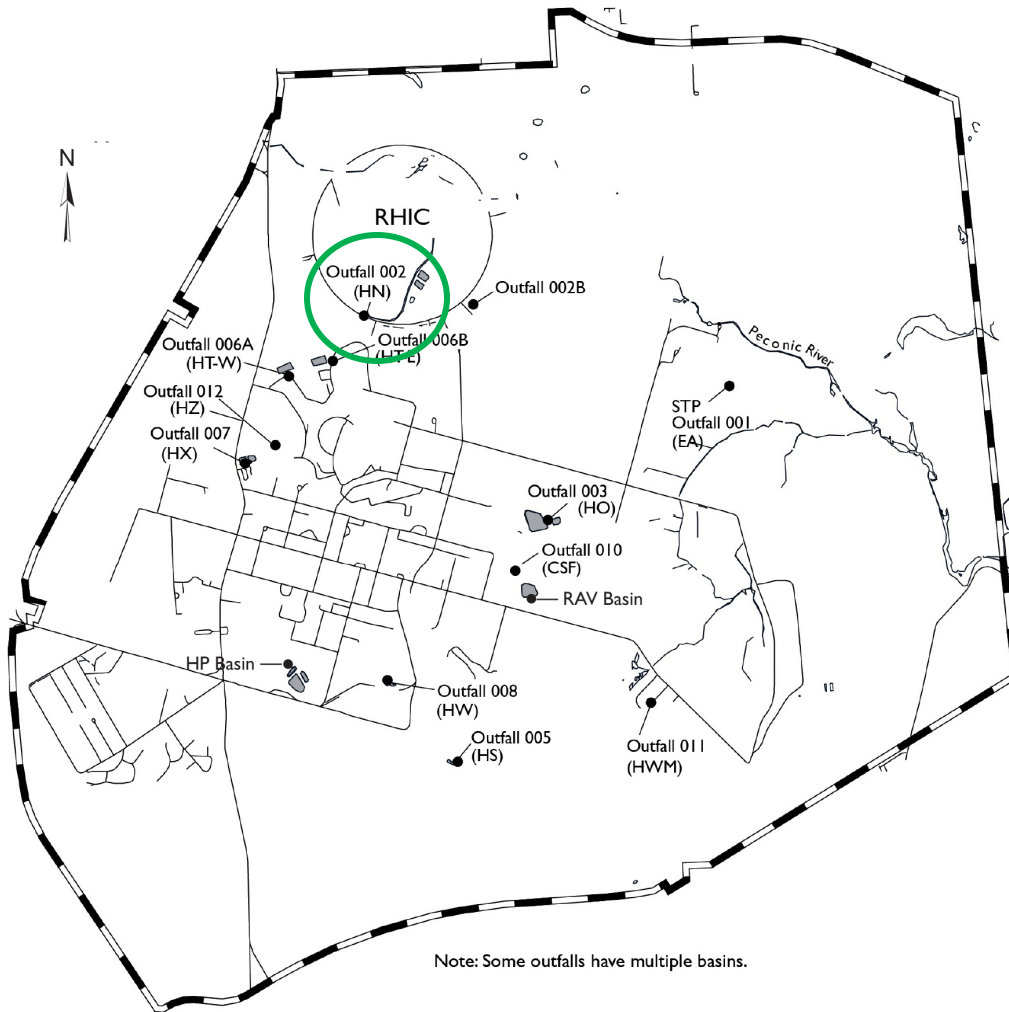
Table 5-2. Radiological Analysis of Samples From On-Site Recharge Basins

Note: Some outfalls have multiple basins.
