Results of Tritiated Water Events Common Cause Analysis CAC Meeting

Sharon Kohler, Associate Lab Director, ESH

October 10, 2024

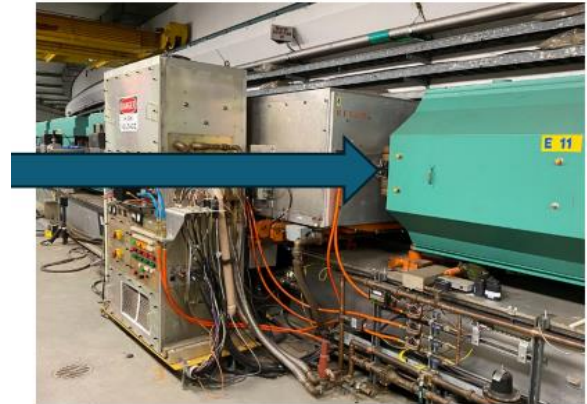
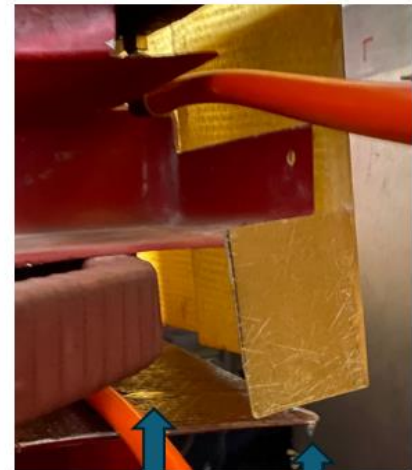
Two leaks found inside the AGS tunnel, Sept 2024

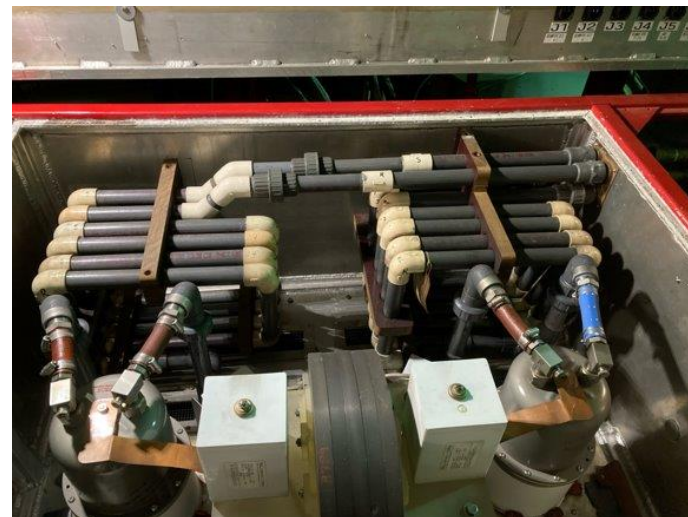
Booster Main Magnet Cooling System piping –
before replacement

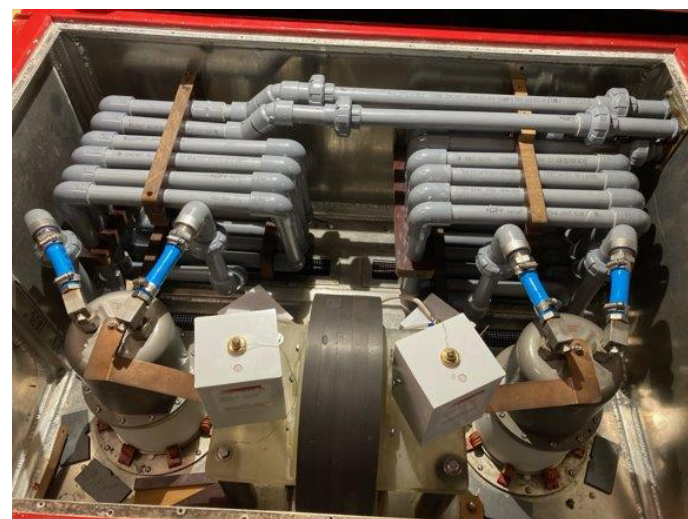
Booster Main Magnet Cooling System piping –
after replacement
