# Dismantlement & Disposal of High Flux Beam Reactor Building 705 (The Stack)

Brookhaven National Laboratory  
Community Advisory Council  
March 11, 2021

# Scope of Work

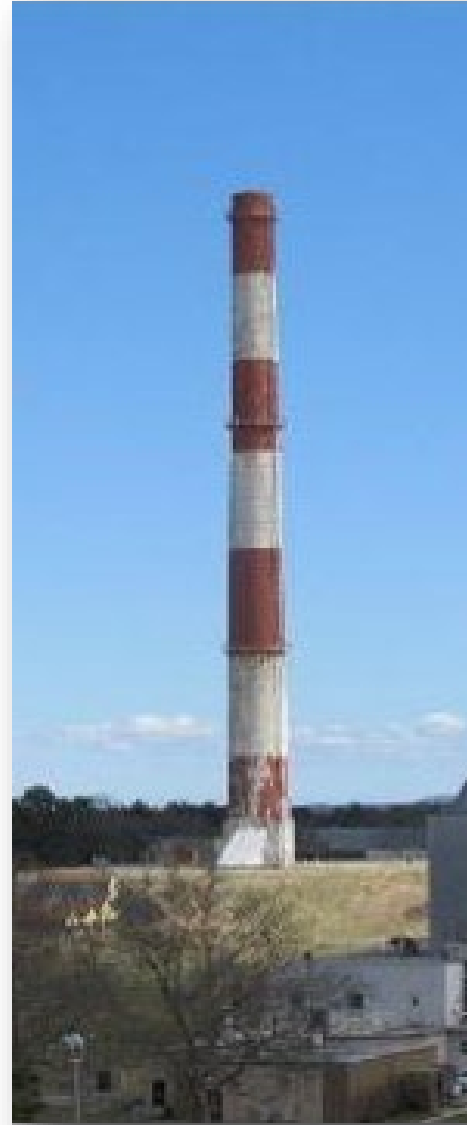
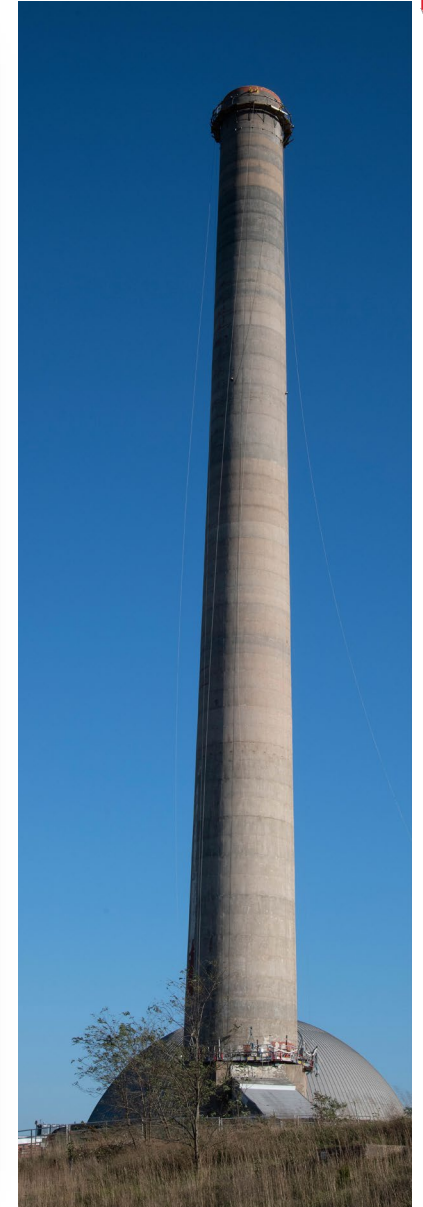
- Exterior coating and water pumped to a vacuum box lined with an asbestos-approved bladder bag.
- During abatement, wastewater ran to a holding tank. Holding tank water was then treated through a series of filters.
- Water tested after filtration to verify process performed as expected and currently being prepared for transport to an approved off-site disposal facility.
- Air monitoring done throughout entire abatement process.

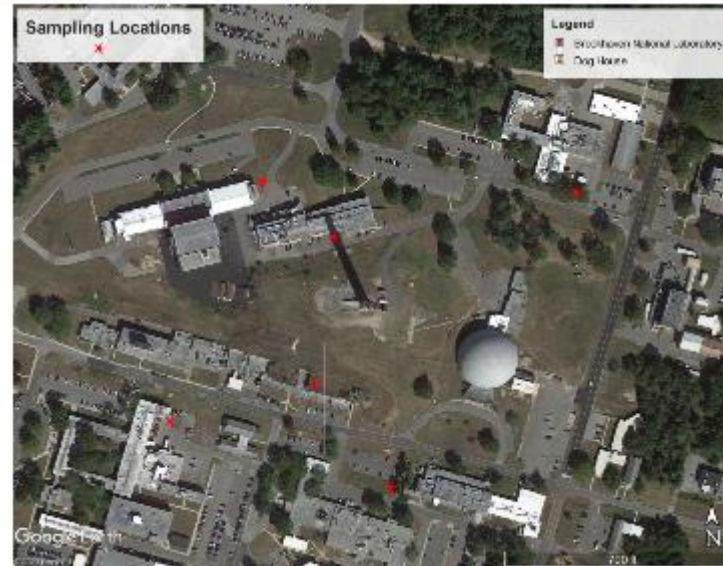
Exterior Building 703  
Exterior Building 815  
Exterior Building 480  
Exterior Building 510  
Exterior Building 801  
Exterior Building 901

- The sampling locations and frequency of sampling were selected by evaluating wind directions and proximity of personnel in nearby buildings. Sampling during abatement activities occurred at the six (6) exterior locations approximately twice a week.
- Due to the mitigation techniques utilized by USACE as well as the fact that the lead and asbestos were bound within the paint matrix, it was determined to be unlikely that results for airborne lead and asbestos would exceed the OSHA and American Conference of Governmental Industrial Hygienists (ACGIH) limits.

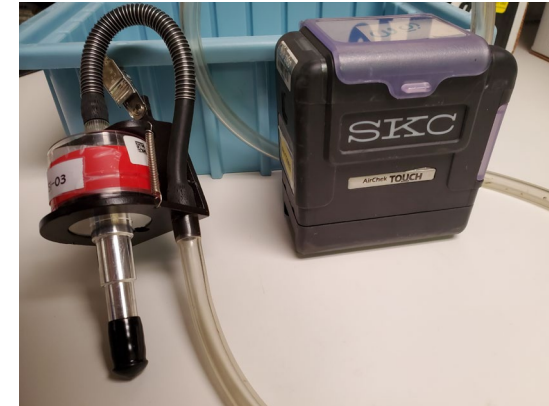
Monitoring Pump

- All airborne lead results obtained at the six (6) locations were below the detectable limit with an 8-hr TWA value < 0.21 ug/m<sup>3</sup>.
- Airborne fiber results collected ranged from below the detection limit to a calculated 8-hr TWA of .0078 f/cc, significantly below the OSHA and ACGIH limit of 0.1 f/cc.

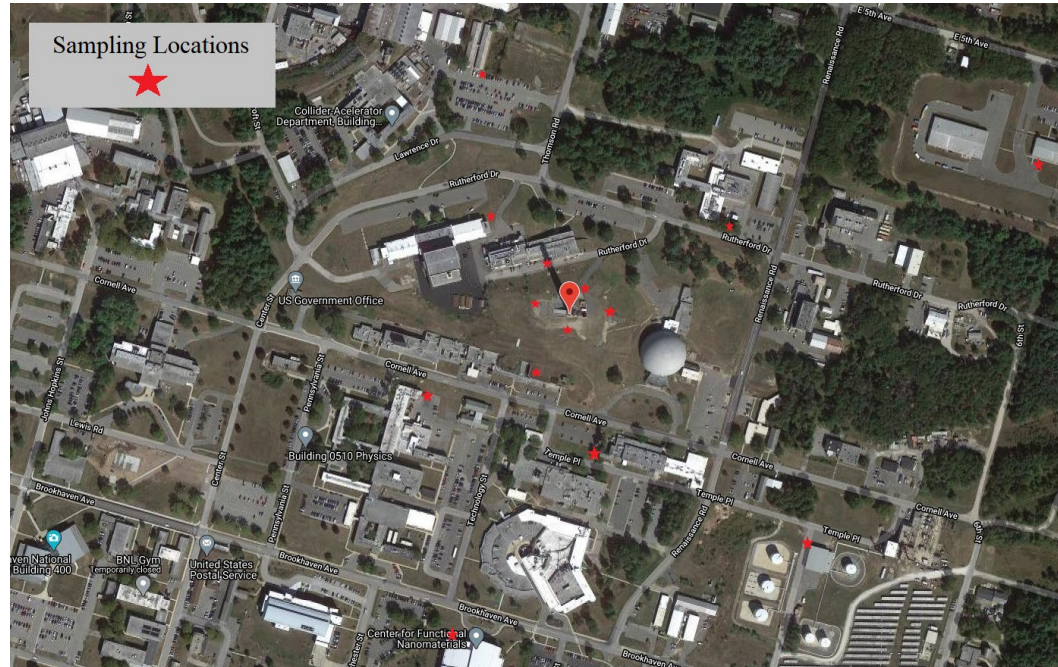
Exterior Building 703  
Exterior Building 815  
Exterior Building 480  
Exterior Building 510  
Exterior Building 801  
Exterior Building 901  
Exterior Building 860 'WM'  
Exterior Building 923  
Exterior Building 735 'CFN'  
Exterior Building 639 'Birdhouse'  
Exterior Fence line – North Direction  
Exterior Fence line – East Direction  
Exterior Fence line – South Direction  
Exterior Fence line – West Direction

- Sampling locations were selected to provide a range of distances to assess the environment for airborne silica and dust. Other factors considered included wind patterns for this time of year and potential impact to personnel. Sampling during demolition activities occurred ~daily during demolition activities.
- Due to the mitigation techniques utilized by the USACE, it is expected that any measurable quantities of silica and dust would not exceed the OSHA and ACGIH limits.

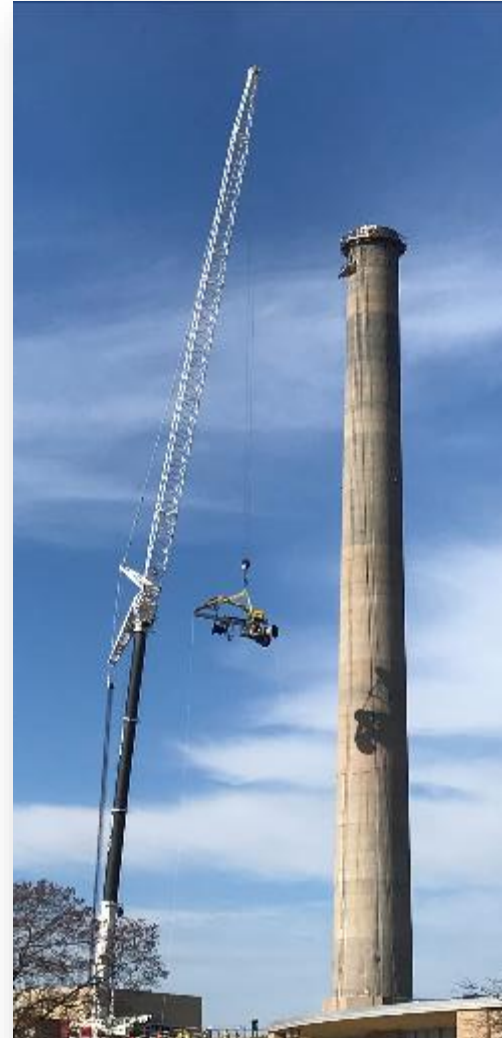
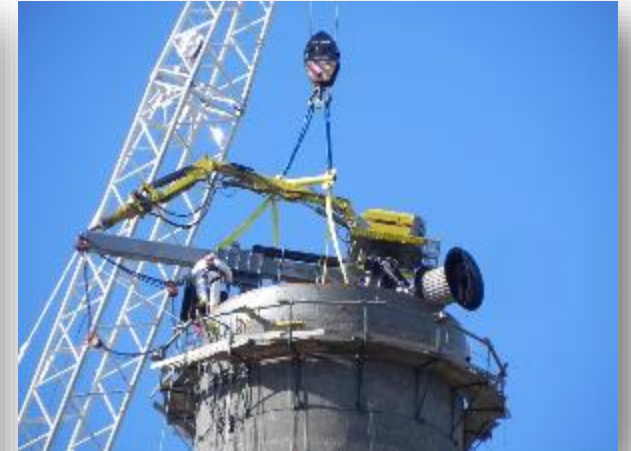
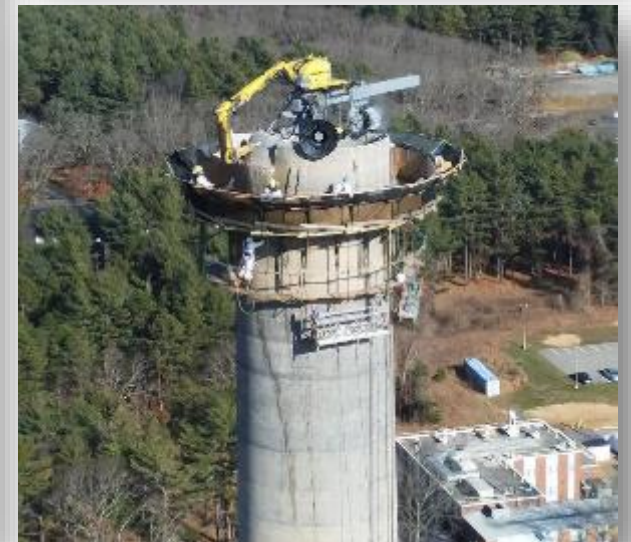
- Only requires a crane for the installation & removal of the equipment and is supported by the stack itself during demolition operations.
- Debris is controlled by using the MANTIS to direct the debris' center of gravity to the inside of the stack, away from the personnel access platform.
- Demolition methodology utilizes the stack itself as a debris control system, as the demolished concrete is contained within the stack at all times and collected at grade.

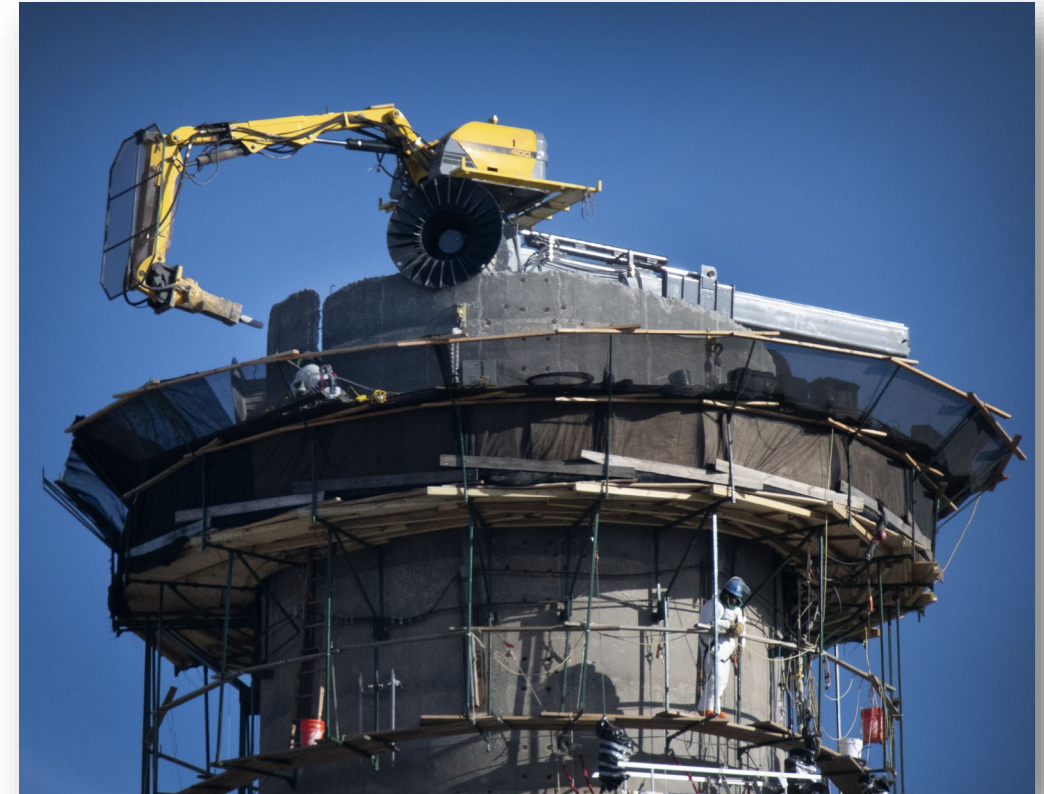
- The K-Bracket personnel access platform design incorporates a “sealed” deck that contains all material and small debris by utilizing a rubber belt around the circumference of the stack, in conjunction with plywood decking and outer vertical guard, and heavy debris netting that extends outward at the top of the handrail.
- The MANTIS is run by electric and controlled by remote, which removes hazards associated with using fuel and allows the operator to remain on the working deck at all times.

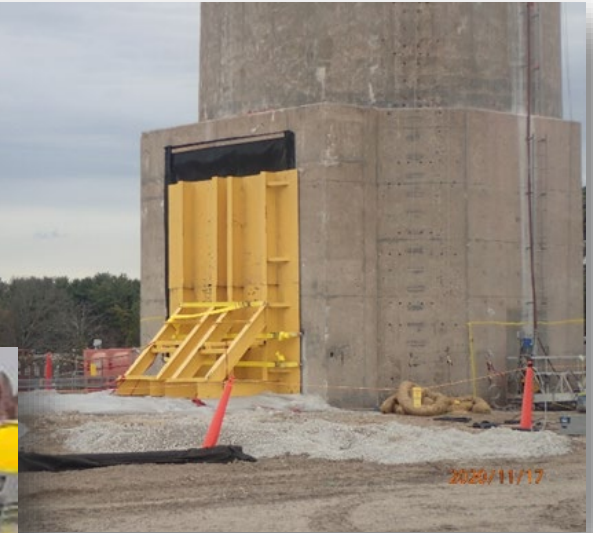
Water nozzles on MANTIS and at hammer impact point

- The primary radiological hazards were the residuals from past emissions that absorbed/adhered to the interior of the concrete chimney and associated components and could become dislodged during demolition with the MANTIS or other surface-destructive tools.
- The Contractor relied on sound work practices and safe demo techniques using remote equipment, striking non-radiological exterior surfaces with the MANTIS, and the natural design of the now-disconnected stack (a bottom-sealed chimney) to control the spread of dropped debris or associated radionuclides. **When the Shield Door is installed, the Stack is only open at the top and there is no mechanical airflow.**
- The Contractor also judiciously used misting dust suppression under a graded approach to address the potential for emissions from the highest risk activities.

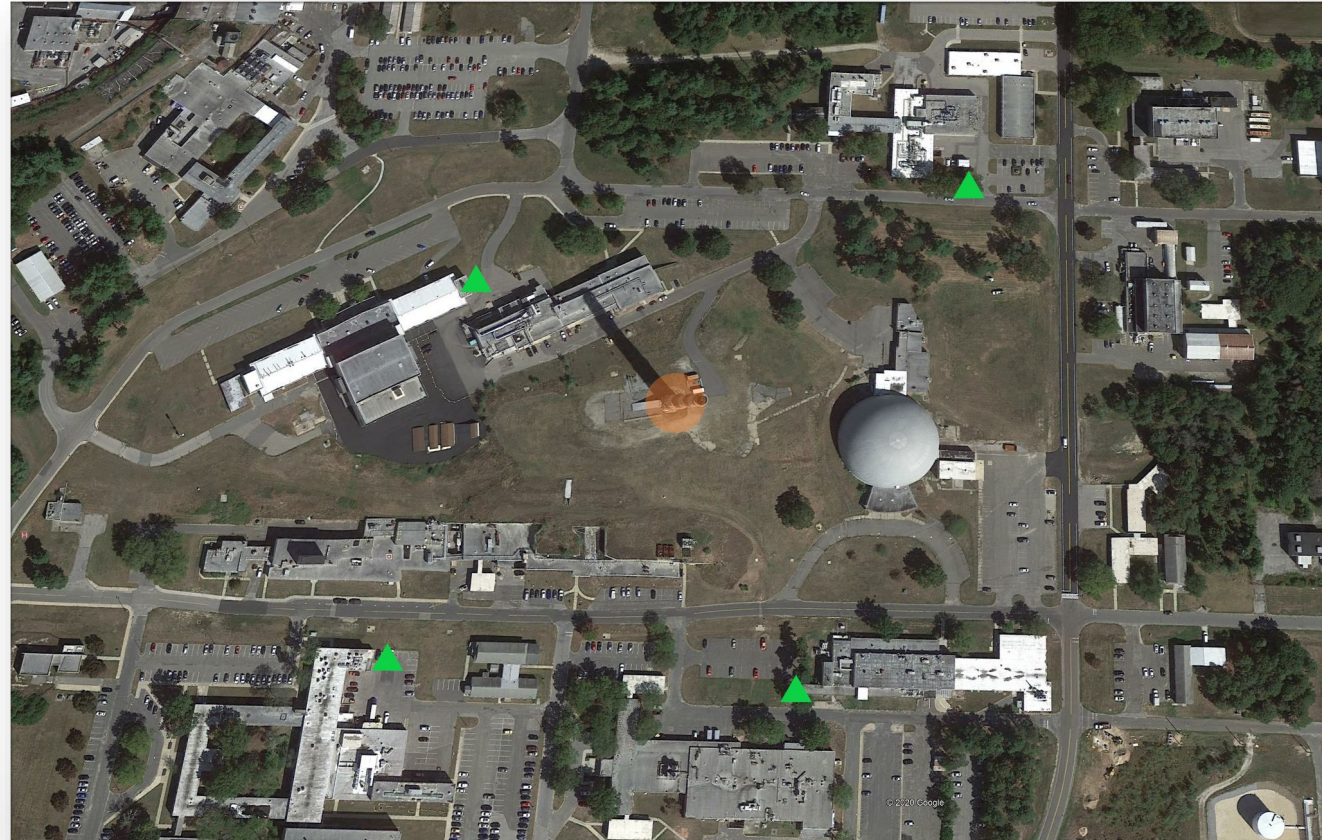
## Project periphery particulate monitors

- Air sampling initiated one month prior to demolition to establish background levels.
- Locations determined with consideration of:
  - Wind Rose
  - Available power taps
  - ~90 degree separation.

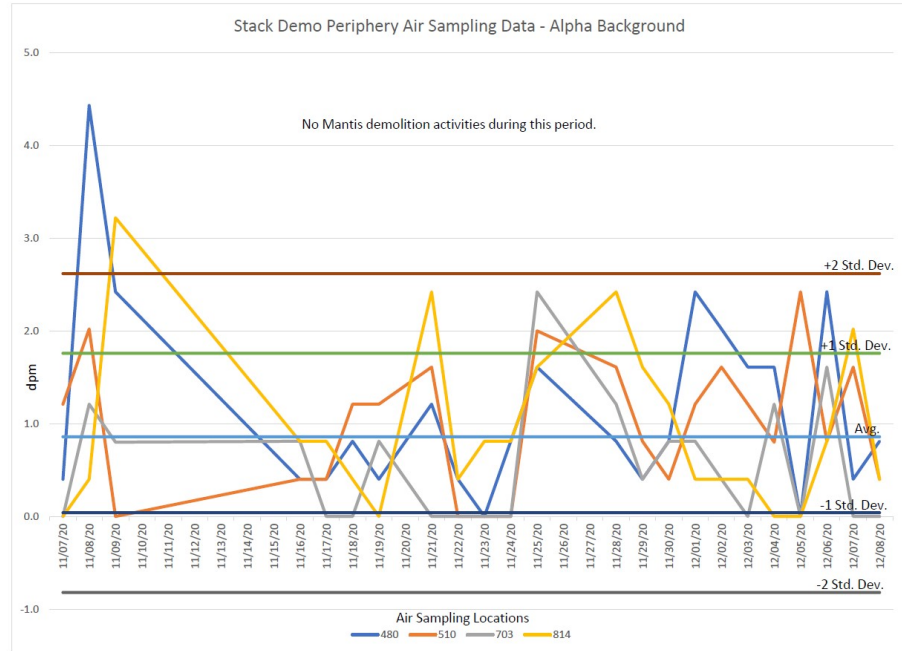
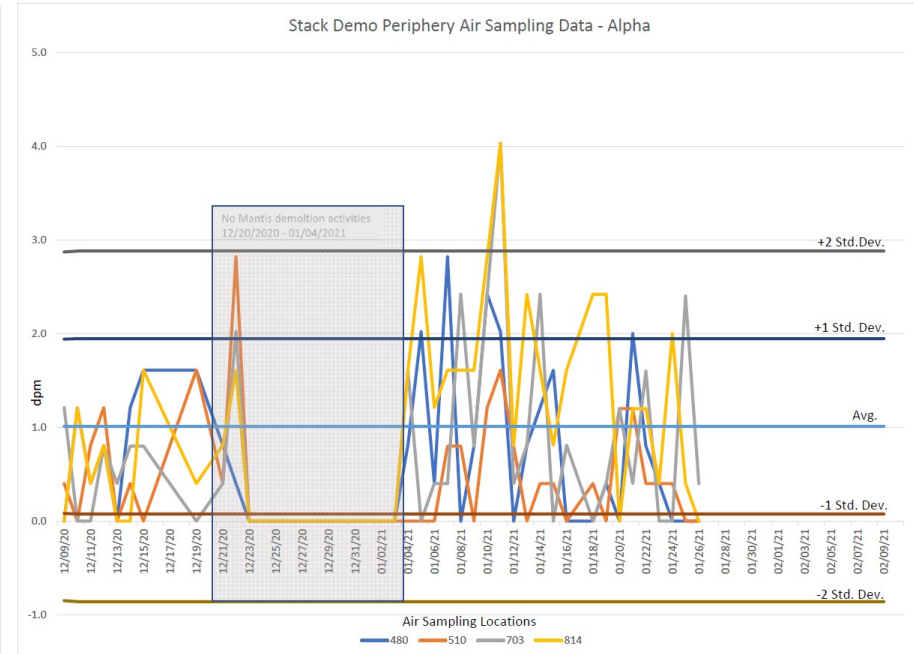
Alpha	Pre-Demo	During Demo
(pCi/m <sup>3</sup> )	0.012	0.013

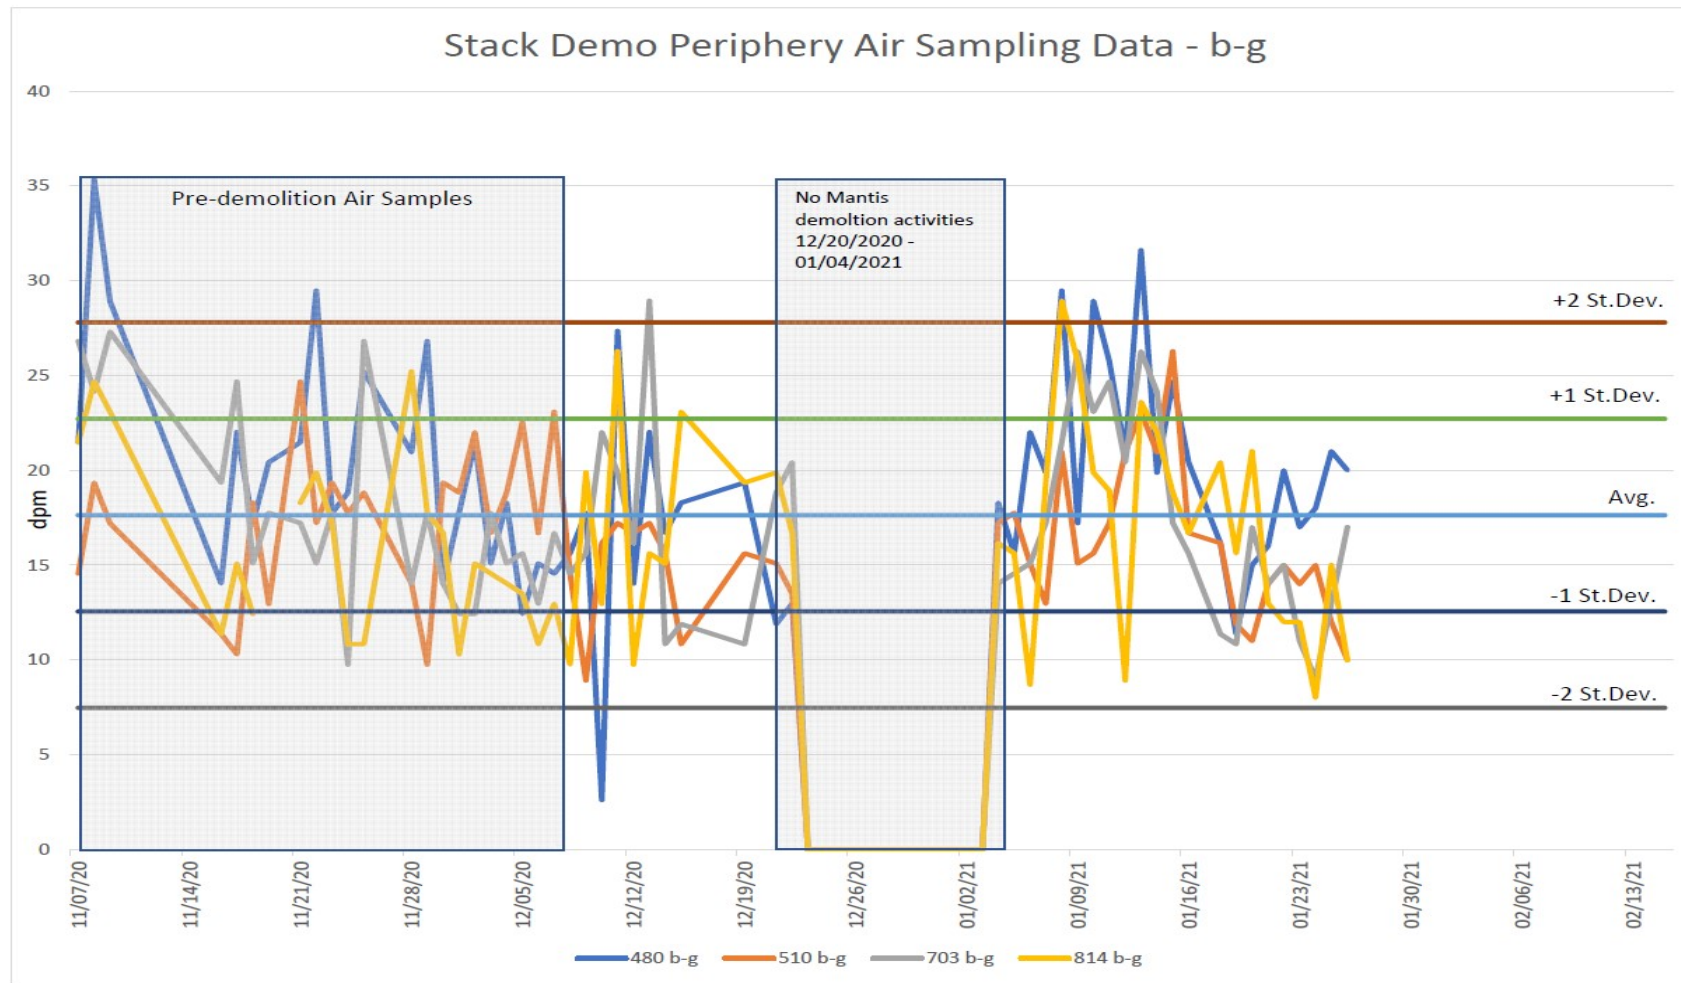
Beta-Gamma	Pre-Demo	During Demo
(pCi/m <sup>3</sup> )	0.24	0.24

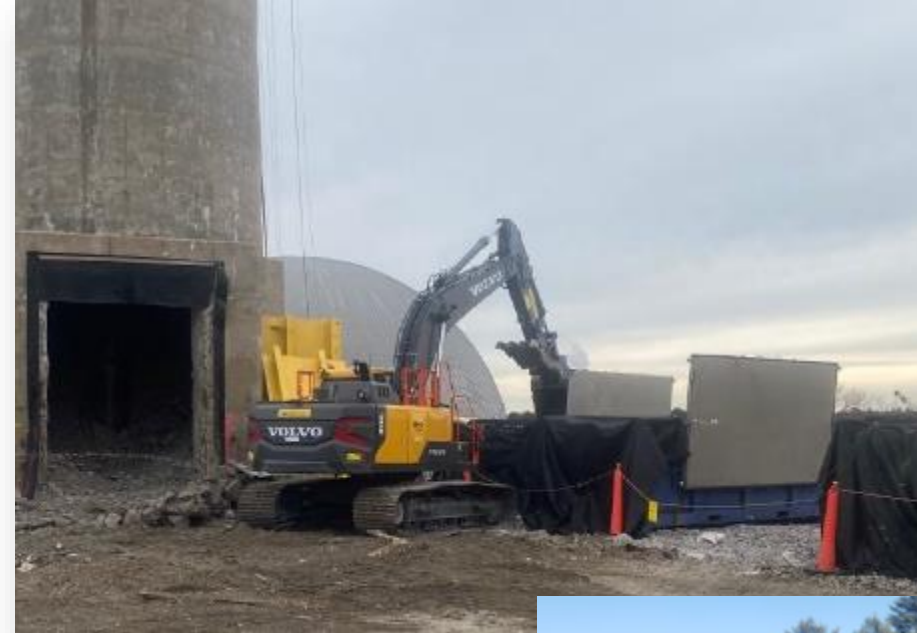
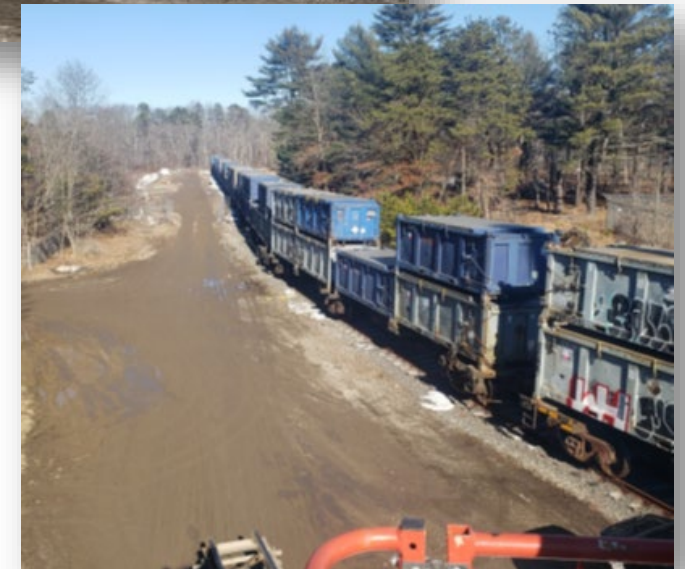
- Stack debris handled in Inter Modal Containers (IMCs)
- Materials are direct-loaded into IMCs and then returned to rail spur staging area
- IMCs loaded onto railcars and shipped for disposal
- Stack debris, soil, and paint abatement waste will be transported to Waste Control Specialists (WCS) in Texas for disposal

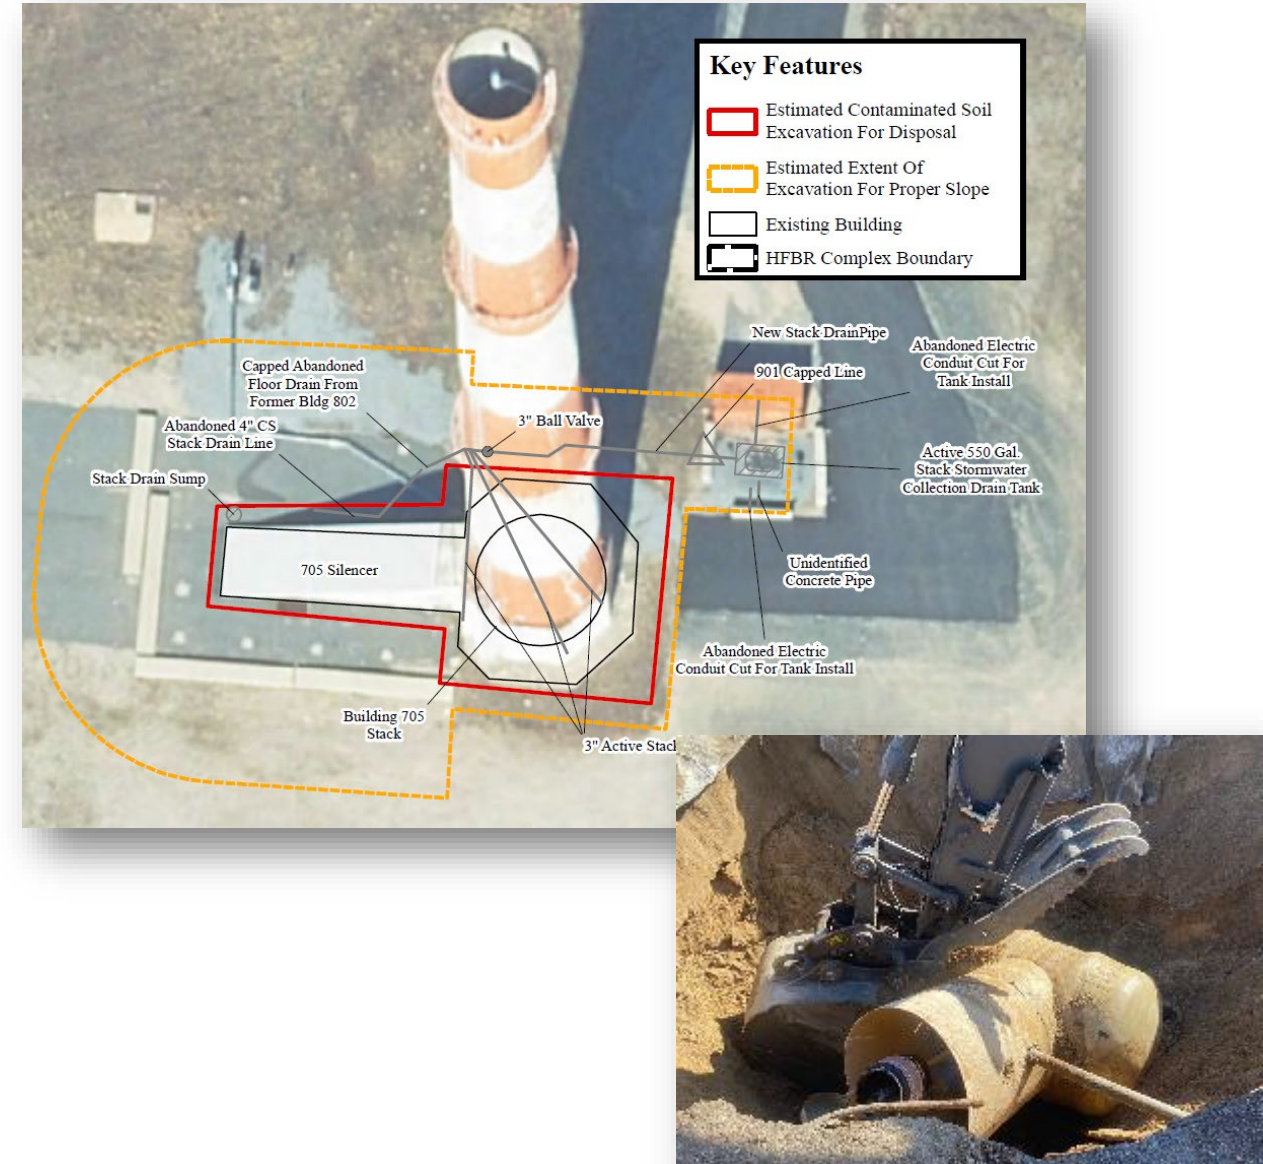
Delineation-and-excavation method to assure removal of contaminated soil and minimizes removal of uncontaminated soil

- Conducted after stack demolition in areas around the pedestal and silencer
- Excavate to depth based on sample results
- Post-excavation confirmation sampling
- Continued excavation until cleanup levels achieved
- Unaffected soil stockpiled for potential re-use as fill at site
- Water truck for dust suppression
- Final Status Surveys and ORISE independent verification surveys to be utilized
