# Building 650 Demolition Project Update

Community Advisory Council  
April 8, 2021

**BROOKHAVEN**  
NATIONAL LABORATORY

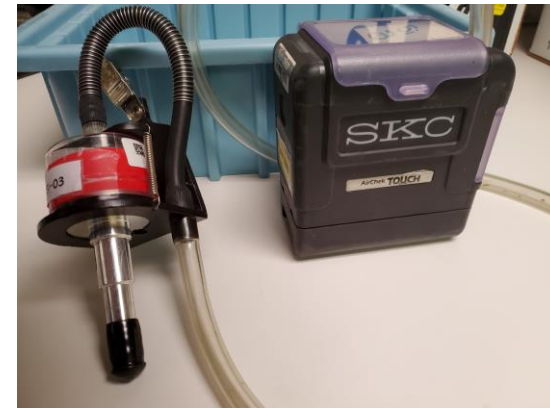
Monitoring Pump

- 4 Silica area samples collected at the perimeter of work zone
- Individuals working within work zone sampled for Silica, Lead & Cadmium (daily)
  - Individuals equipped with respirators

- All Silica (Worker & Perimeter) Results were below the detectable limit
  - Highest Si result using worst case (equipment detection limit) =  $<.864 \text{ ug/m}^3$
- All Cadmium Results were below the detectable limit
  - Highest result using worst case (equipment detection limit) =  $<.004 \text{ ug/m}^3$
- Lead Results ranged from non-detectable to a max. value of =  $0.133 \text{ ug/m}^3$

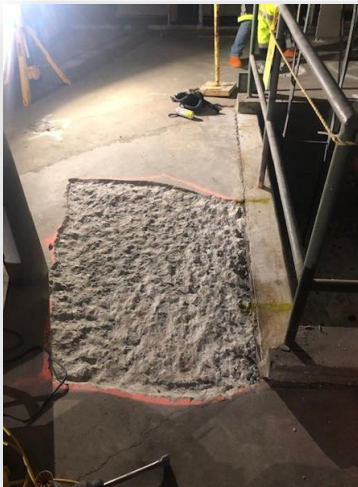
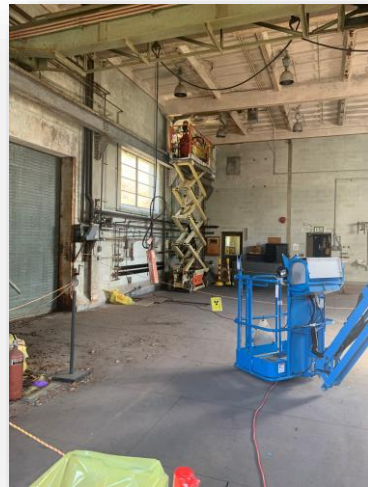
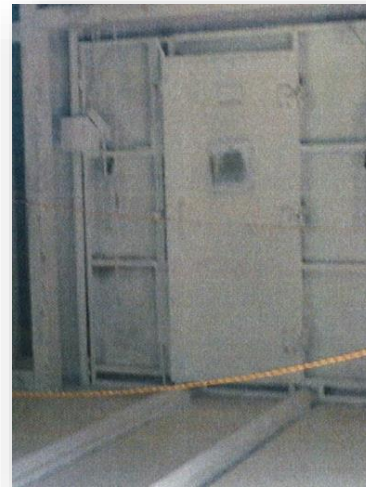
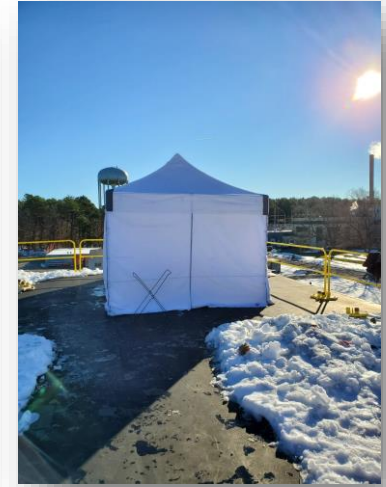
### Concrete Scabbling, Duct Removal, & Fixative

- Scabbling contaminated concrete
- Removing contaminated systems
- Applying fixative to contain contamination

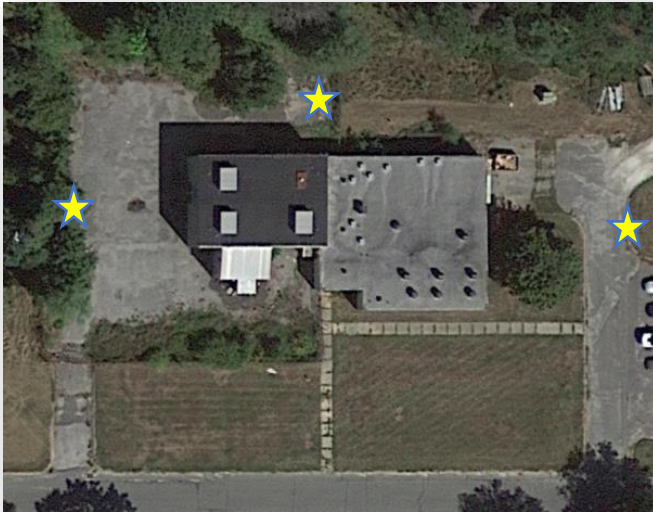
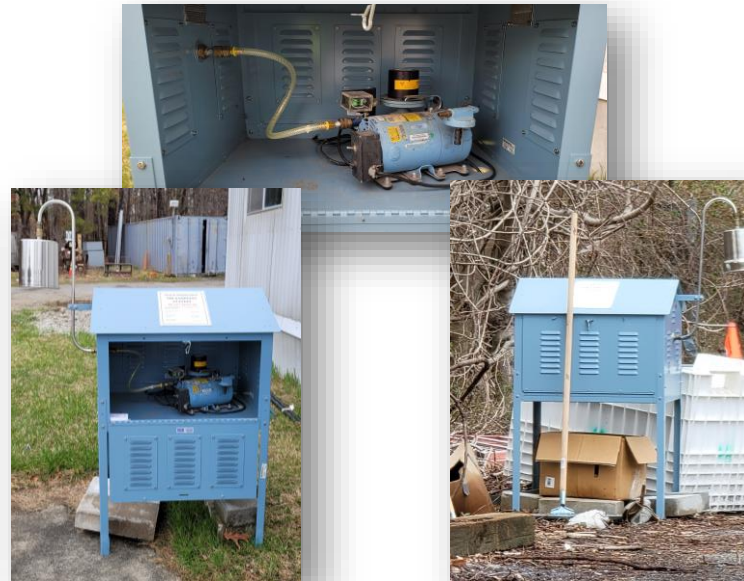
### Air Monitoring Equipment & Placement (Radeco AVS-28)

- 3 High Volume Air Samplers were positioned at the perimeter of work zone

- Consistent with pre-demo background measurements
