BROOKHAVEN NATIONAL LABORATORY

Sealed Source Contamination Incident

October 13, 2011

Cesium (Cs-137) Source Failure

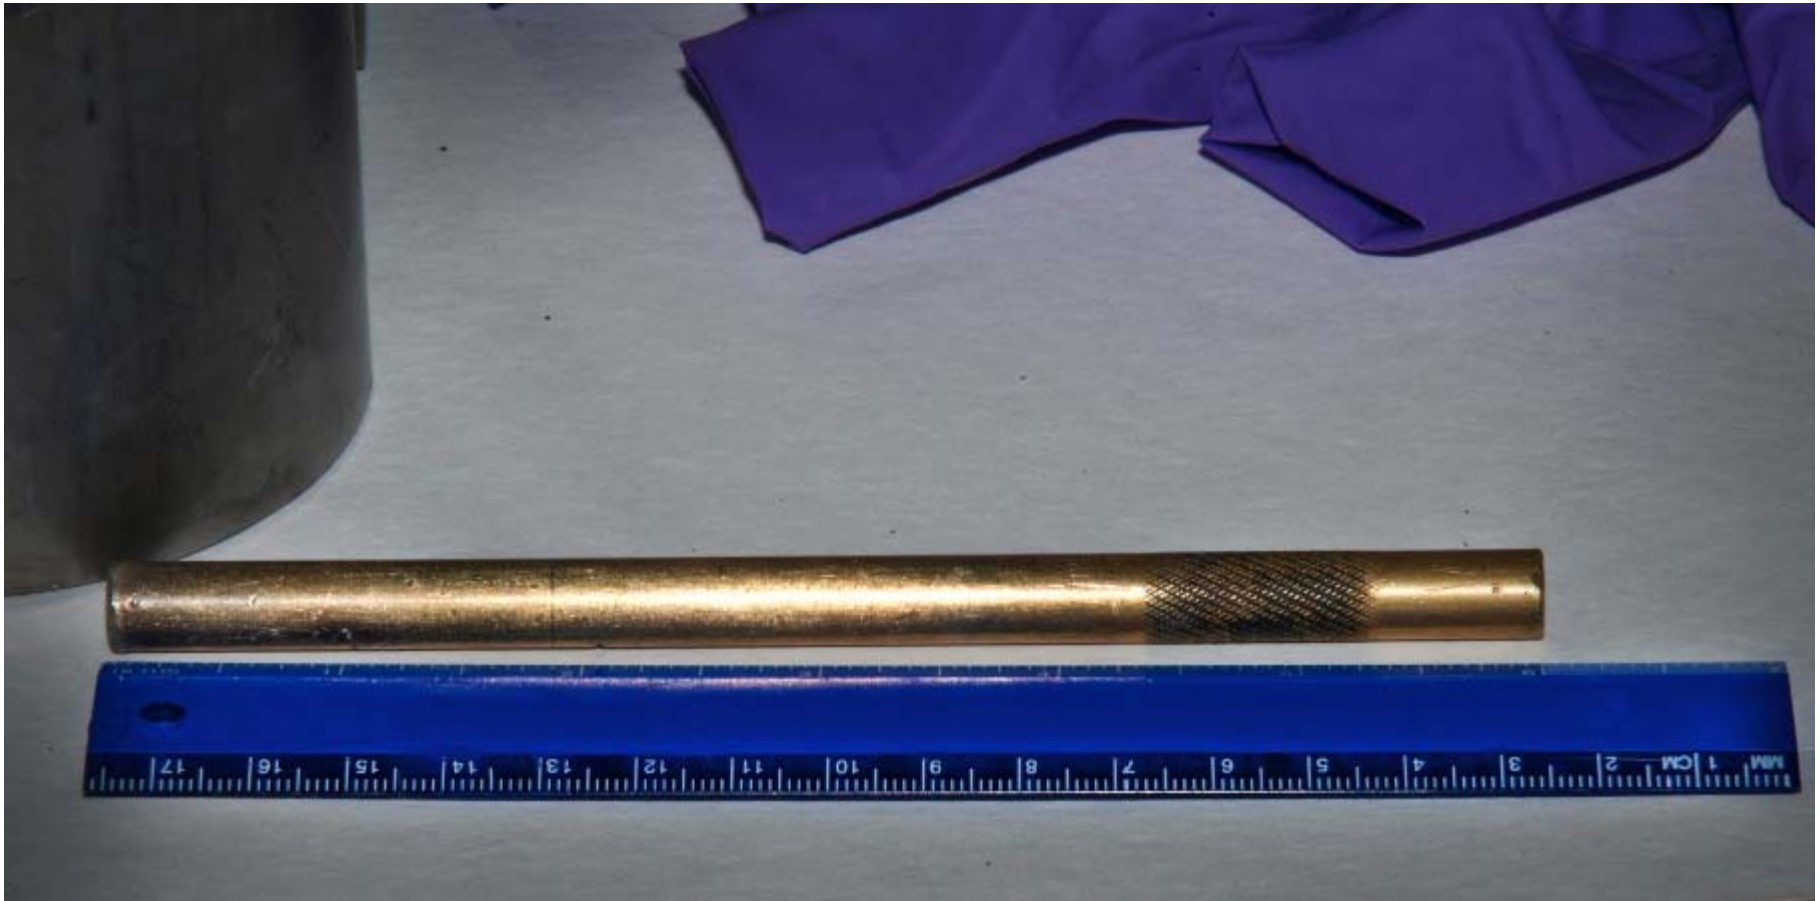
Cs-137 Source

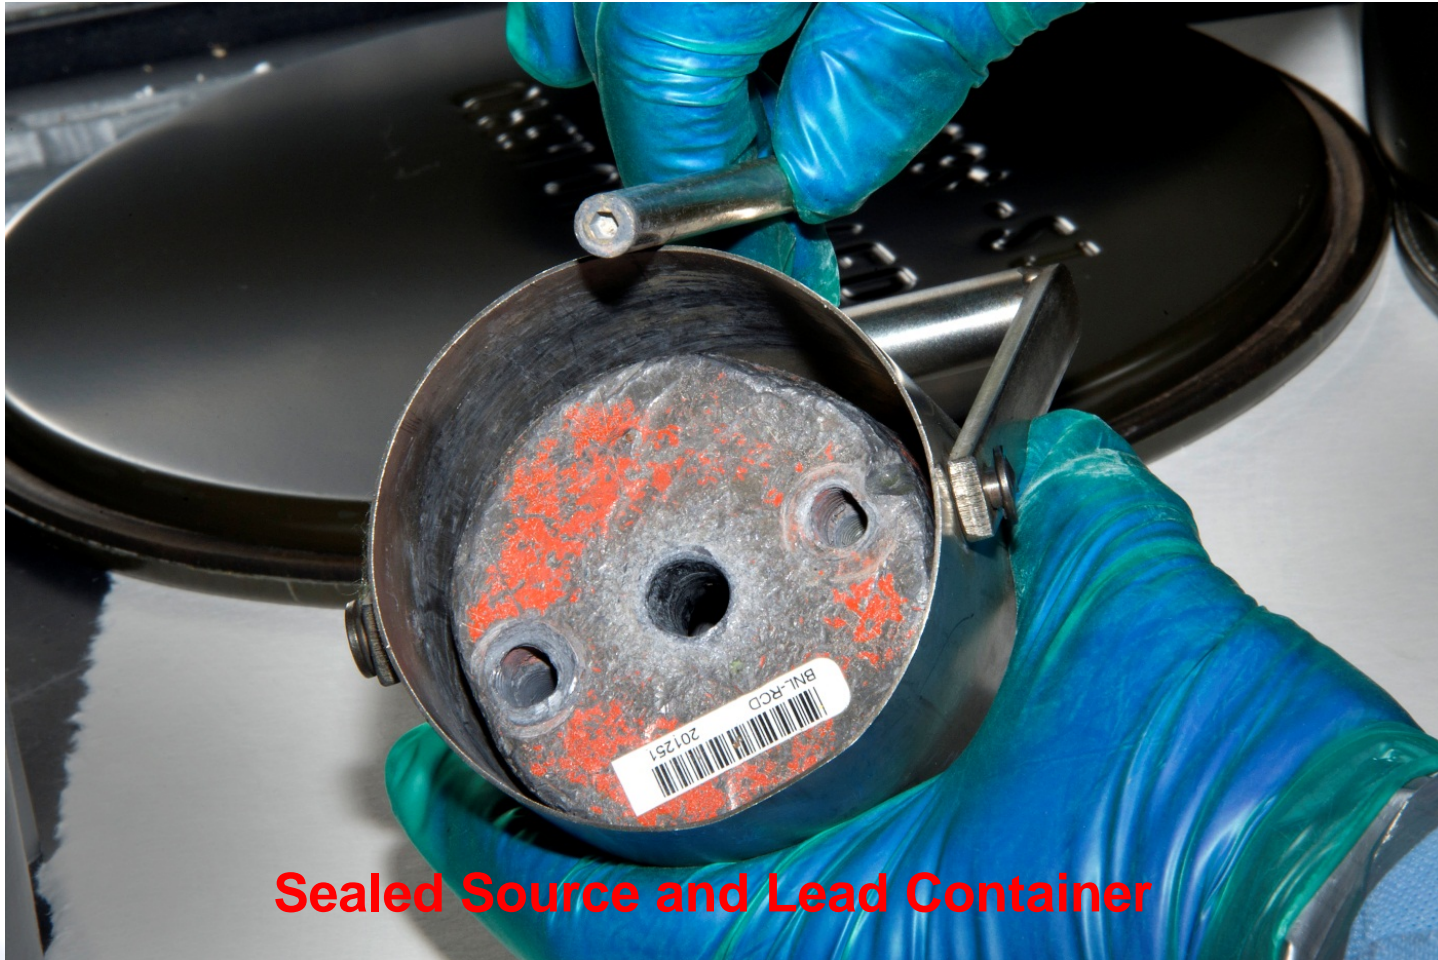
Cs-137 Sealed Source and Lead Pig

Sealed Source and Lead Container

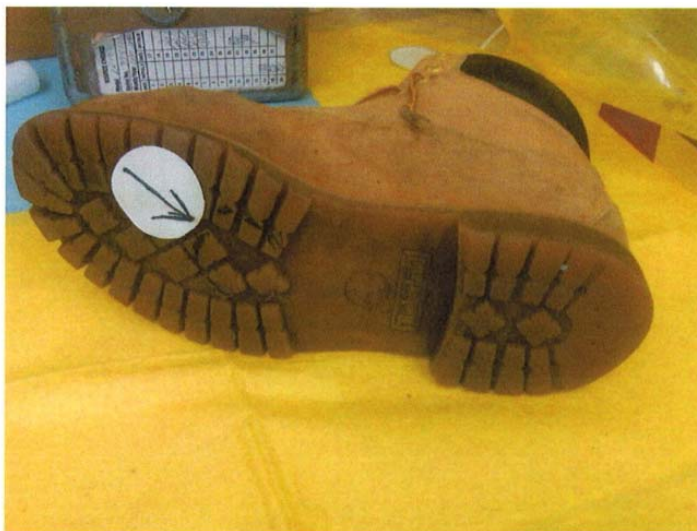
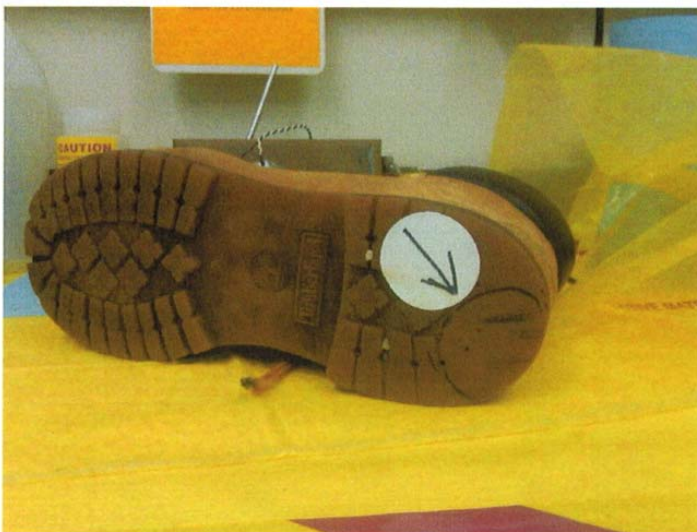
RCT 1 Shoes

- Radiological Control Technician (RCT) #1 – Contamination found on his hands, shirt and shoes. The individual was decontaminated and clothing dispositioned
- RCT #2 – left shoe only, decontaminated
