Sample Ladder Information Form

Ladder ID: 801-003		Ladder Location: B801 Upper Roof Transition

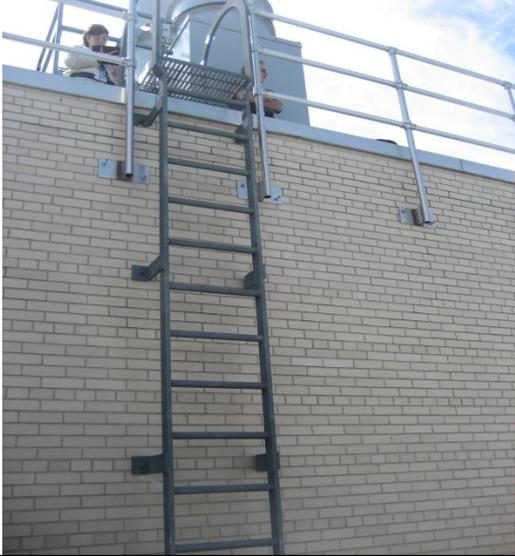
Identified Hazard / Deficiencies:		Mitigation / Controls:	
1e	1) Side rails do not have good "grip ability"	1) Wear gloves while climbing ladder, do not use side rails, use ladder rungs for handhold.	
4f	2) The step across distance from the nearest edge of the ladder to the nearest edge of the structure is less than 2.5 inches	2) Situational Awareness, exercise caution when grasping the top rung, if present	
6a	3) The ladder way floor opening or platform is not protected by standard railings on all exposed sides	3) Situational Awareness – there may not be adequate fall protection once on platform	
6b	4) The passage through the railing is not protected with a swing gate or offset	4) Situational Awareness - be cognizant of where you are in relation to opening when working on the roof.	
6i	5) For ladders, the top of the step or rung is not level with the top of the access/egress level or landing platform served by the ladder	5) Situational Awareness – ensure footing is secure before moving onto or off of the platform.
