BROOKHAVEN LINAC ISOTOPE PRODUCER (BLIP)

**CLOSEOUT REPORT
REMOVAL ACTION
AREA OF CONCERN 16K**

November 14, 2001

FINAL COMPLETION REPORT:
VISCIOUS LIQUID BARRIER
DEPLOYMENT AT BROOKHAVEN
NATIONAL LABORATORY

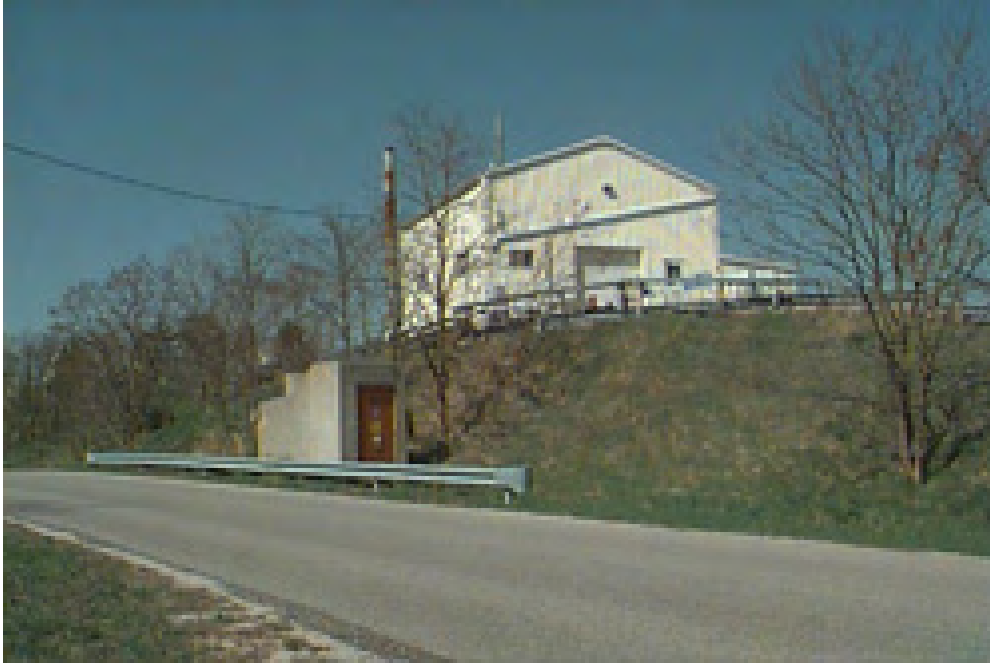
The radiological equipment and target handling area for the BLIP are contained in Building 931B. The BLIP is built on an artificial hill that rises to just over 100 feet above mean sea level (MSL) (**Figure 2**). The hill is asymmetrical, with the surrounding land to the north, east and west at 85 to 90 feet and to the south at 70 feet above MSL.

Figure 2. The BLIP facility.

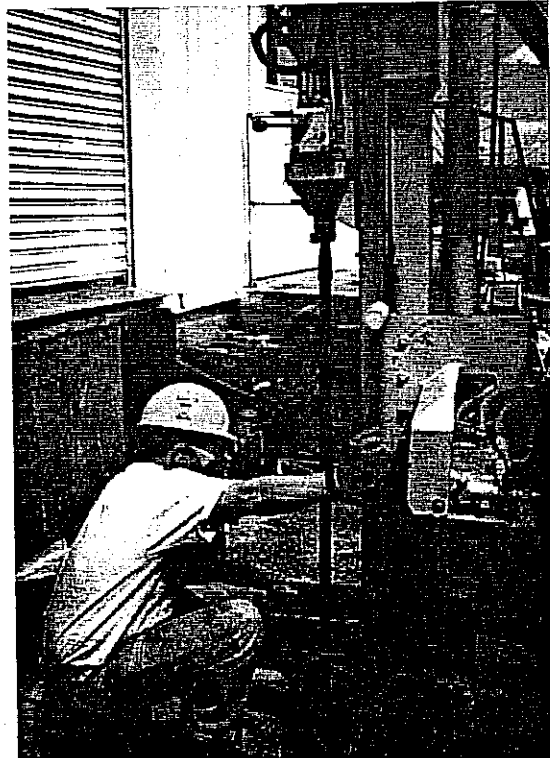
Figure 2-3 shows the collection of a sample using the Geoprobe.

Figure 2-3. Sample collection with Geoprobe.

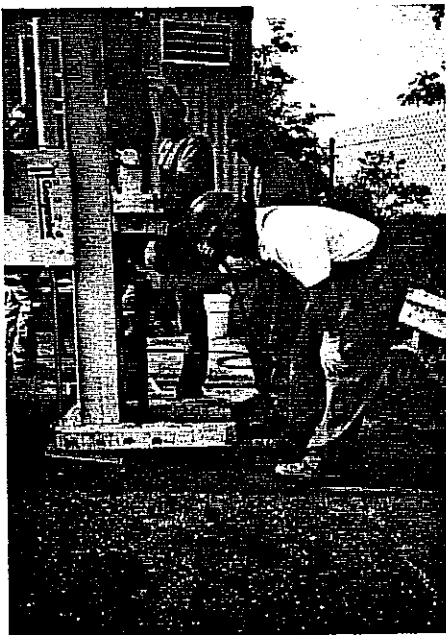
Grout injection began at TP-1 where a pilot hole was pushed to 5 feet into the ground using the Geoprobe rig. Figure 5-3 shows grout injection of the test panel. The pilot rod, with an oversize drive point, created a slightly oversized hole in which the injection rod could be placed. The purpose of the pilot hole was to create a near-perfect vertical starter hole for the injection rod, allowing grout flow to be established without flowing to the surface. The verticality of the pilot rod was measured using a bubble level and a calibrated 24-inch digital level. The rod was driven down to 5 feet bgs while checking plumbness periodically and making adjustments to the Geoprobe drive head as necessary. The pilot rod was then pulled from the ground and the injection rod placed down the hole.

Figure 5-3. Test panel injection.
