**BROOKHAVEN NATIONAL LABORATORY
2019 ENVIRONMENTAL MONITORING
REPORT
CURRENT AND FORMER LANDFILL AREAS**

Prepared by
**Brookhaven National Laboratory
Environmental Protection Division
Upton, New York**

February 28, 2020

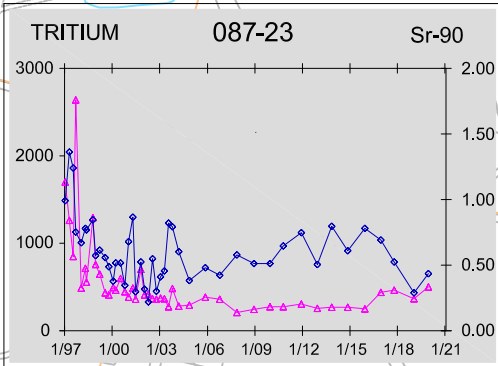
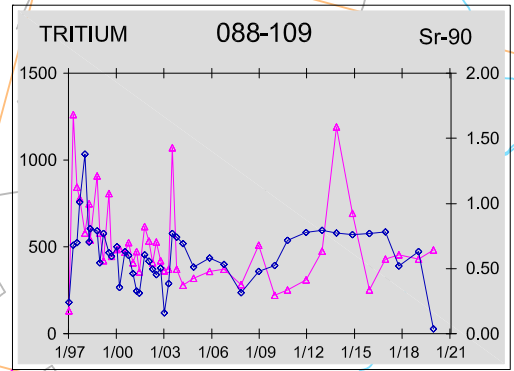
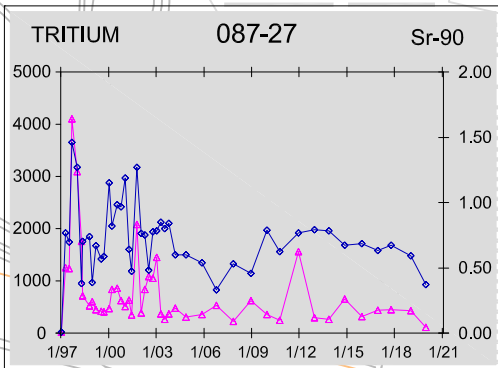
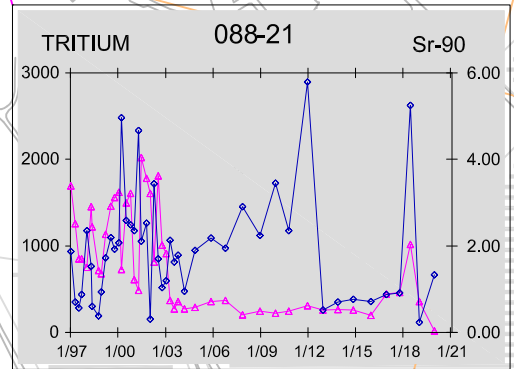
DWN: AJZ	VT:HZ.: -	DATE: 02/05/20	PROJECT NO.: -
CHKD: JM	APPD: RFH	REV.: -	NOTES: -
FIGURE NO.:			8

TITLE:
CURRENT LANDFILL TRITIUM AND STRONTIUM-90 TREND PLOTS
2019 ENVIRONMENTAL MONITORING REPORT
CURRENT AND FORMER LANDFILL AREAS
