**Brookhaven National Laboratory
High Flux Beam Reactor (HFBR)**

Characterization Summary Report

**Revision No. 1
February 2007**

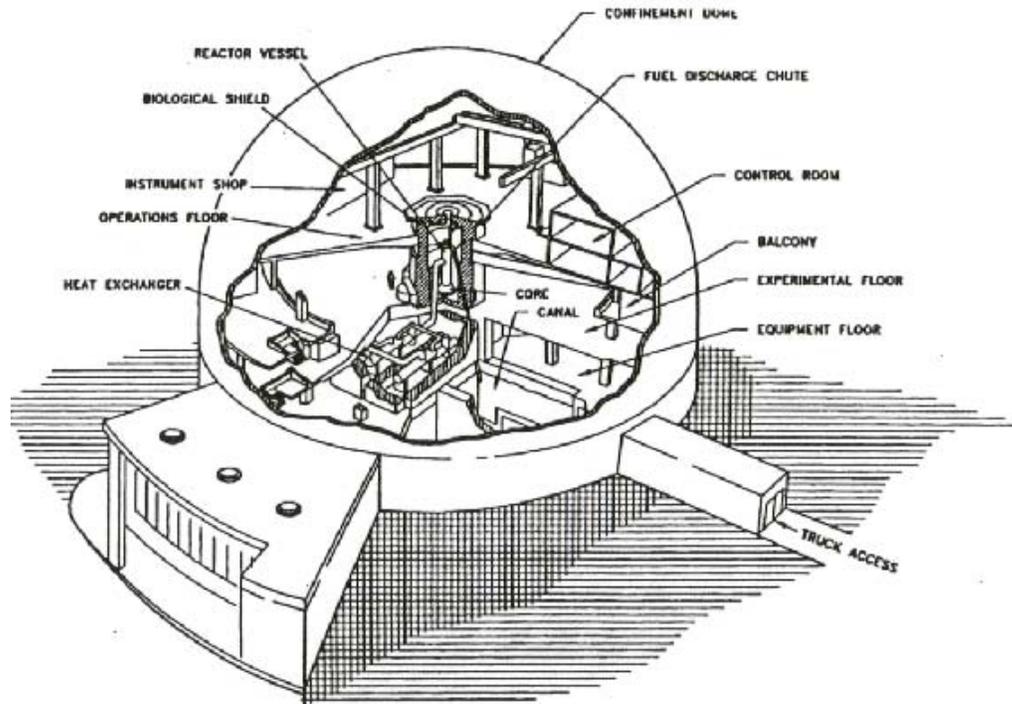
Figure 0-1. Cutaway View of the HFBR, Building 750

The most recognizable feature of the High Flux Beam Reactor is its steel dome structure in the shape of a hemisphere resting on a cylindrical base. This structure is formed of welded steel plates supported upon an integral I-beam framework. The inside diameter of the hemisphere at its base is 176 ft-8 in. The cylindrical base (22 ft-4 in. high) rests upon a bedplate that is bolted to the reinforced concrete foundation ring. The hemispherical portion of the dome is insulated on the outside, and the insulation is covered with aluminum sheets. The steel plates in the hemispherical section are 0.250 in. thick, and those in the cylindrical base are 0.375 in. thick. The foundation of the reactor building is a reinforced concrete mat bearing on the soil beneath the building. The confinement building consists of four levels: the Equipment Level, Experimental Level, Balcony Level, and Operations Level. The descriptions of the systems, structures, and components are taken from the “HFBR Plant Description Manual.” (BNL, 1996)

The HFBR core was formed of 28 fuel elements in a close-packed array. The fuel material was fully enriched (93%) uranium oxide-aluminum, clad with aluminum and shaped into curved plates. Heavy water (D_2O) served as the moderator/reflector and primary water coolant. The reactor vessel is fabricated from a 6061-T6 aluminum alloy

and contained the active core, reflector and control rods and provided space and access for 16 experimental facilities, which utilized the high neutron flux in the core region. The vessel consists of an 82-in inside diameter spherical section welded via a transition piece to a 46-inch inside diameter cylinder. Including the closure flange, the over-all height of the vessel assembly is 24.75 ft. The nine horizontal beam reentry tubes are integral (welded) parts of the vessel's spherical section.

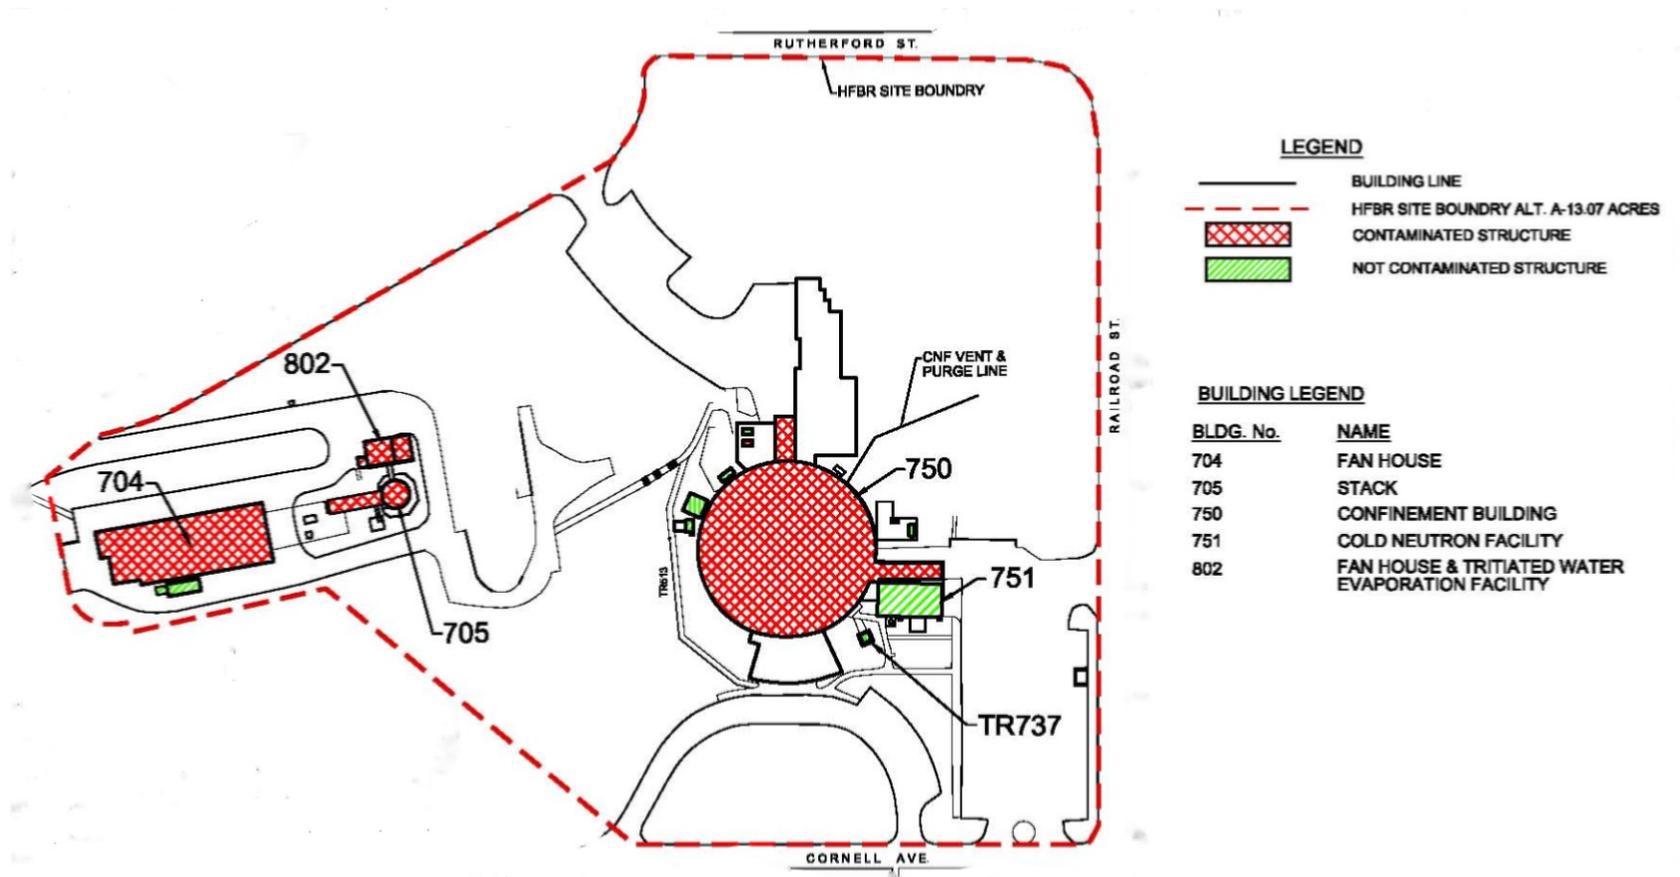
Figure 0-2. HFBR Site Plan

Figure 0-2 is a site plan showing the location of the HFBR ancillary/support facilities, and Table 0-1 shows the dimensions of these facilities.

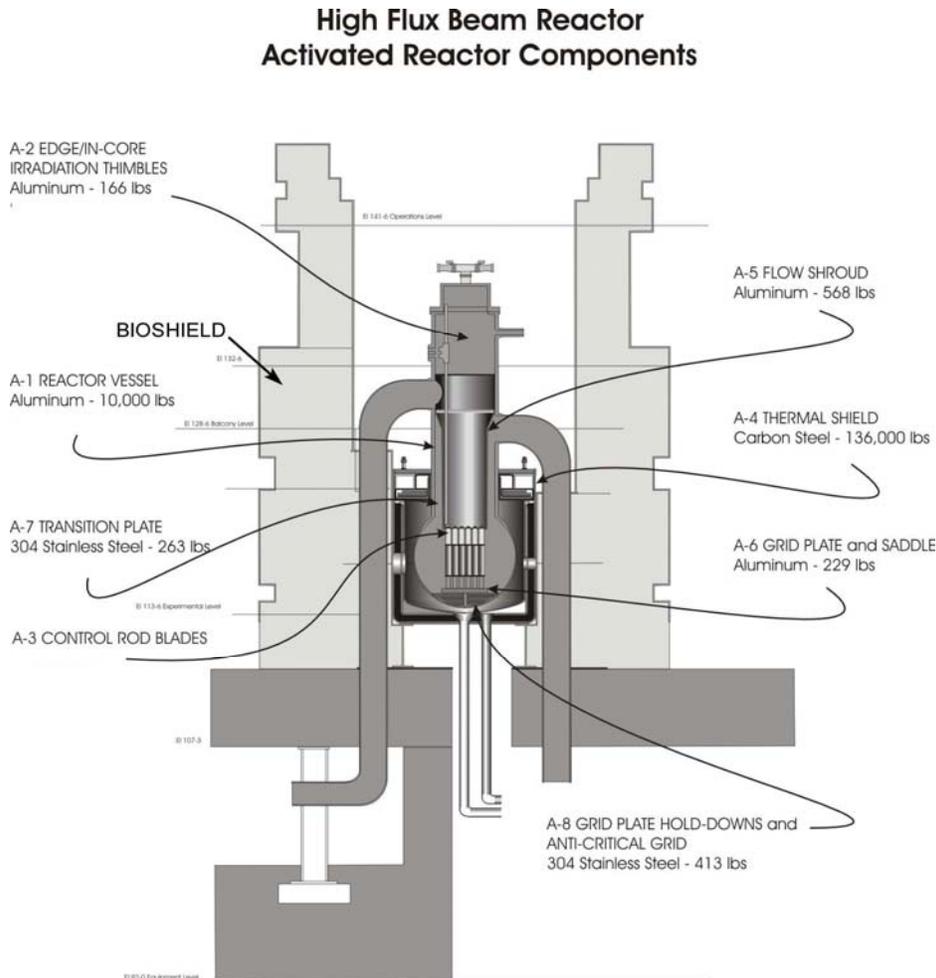
Figure 1-1. High Flux Beam Reactor Activated Components

The activated components of the HFBR considered here include the reactor vessel, reactor vessel internals, control rod blades, thermal shield and the biological shield (bioshield). The beam plugs are discussed only for information, as the current plans call for the beam plugs to be removed from the HFBR and are stored in a shielded area outside of the bioshield area on the experimental level of the HFBR. The activities of the activated components were determined based on WMG, Inc. calculations (WMG 2007a, WMG 2000b and WMG 2007c), and the beam plugs and collimators activities were determined based on an earlier calculation (Tichler 1995). Figure 1-1 shows the general configuration of the reactor vessel, the thermal shield, and the reactor internals, including the control rod blades.

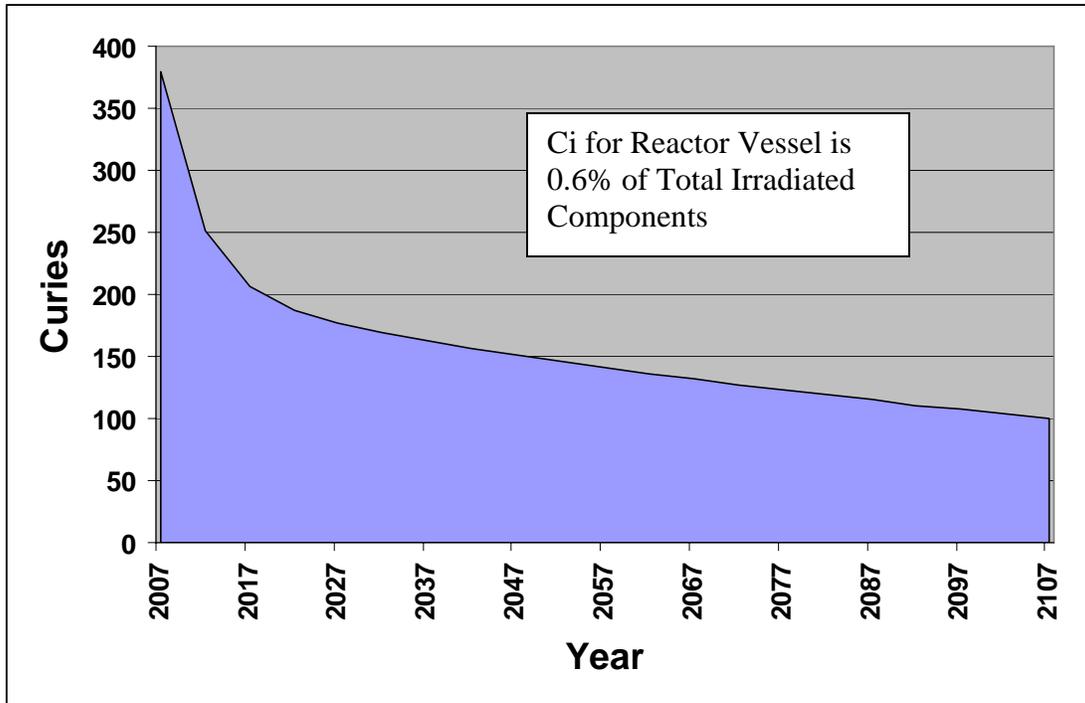
Figure 1-2. Reactor Vessel Total Curies 2007-2107

The following tables and figures are presented to show the radioactivity contents for the reactor vessel and other components, and they present the results of radioactive decay over the next 100 years. Half-lives of radionuclides were taken from "Nuclides and Isotopes, Chart of the Nuclides (KAPL 2002). The term "Co-60 Equivalent" represents the number of curies of Co-60 that would provide approximately the same gamma radiation hazard as the total curies of the mix of radionuclides.

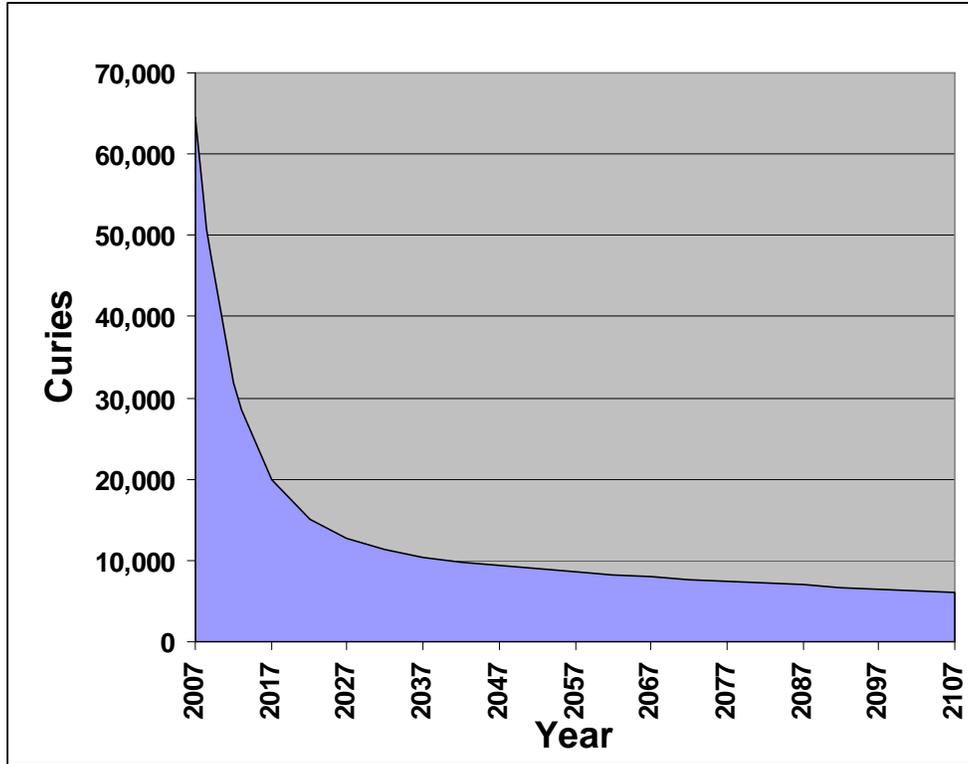
Figure 1-14. HFBR Total Irradiated Components- Curies 2007-2107

The activated components contain the vast majority (>99% in 2007) of the total radioactivity remaining at the HFBR. The physical form of these activated components (activated metal) makes the hazard primarily a direct exposure risk and not a contamination risk. The reactor vessel, internals, and the activated portion of the biological shield are well shielded in the HFBR's current condition, and there are no significant radiological hazards from those materials until they are disturbed during decommissioning. The beam plugs and collimators have been removed from the biological shield area and are in storage in a shielded condition.

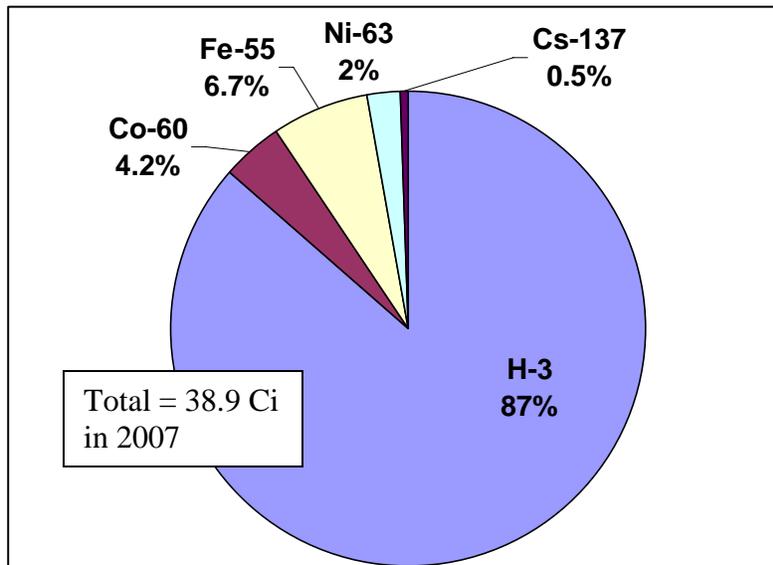
Figure 2-1. HFBR Systems: Radionuclide Percent of Out-of-Core Activity- 2007

The majority of the radioactivity remaining in the systems is from tritium, due to small amounts of residual D₂O left over from system drain down, Figure 2-1 “HFBR Systems: Radionuclide Percent of Out-of-Core Activity – 2007” shows the relative amounts of the system radionuclides. Figure 2-2 shows the decay of these radionuclides over time. Both Figure 2-1 and 2-2 represent out-of-core activity, since the irradiated materials in and near the reactor core, vessel, and biological shield are much higher in radioactivity content.

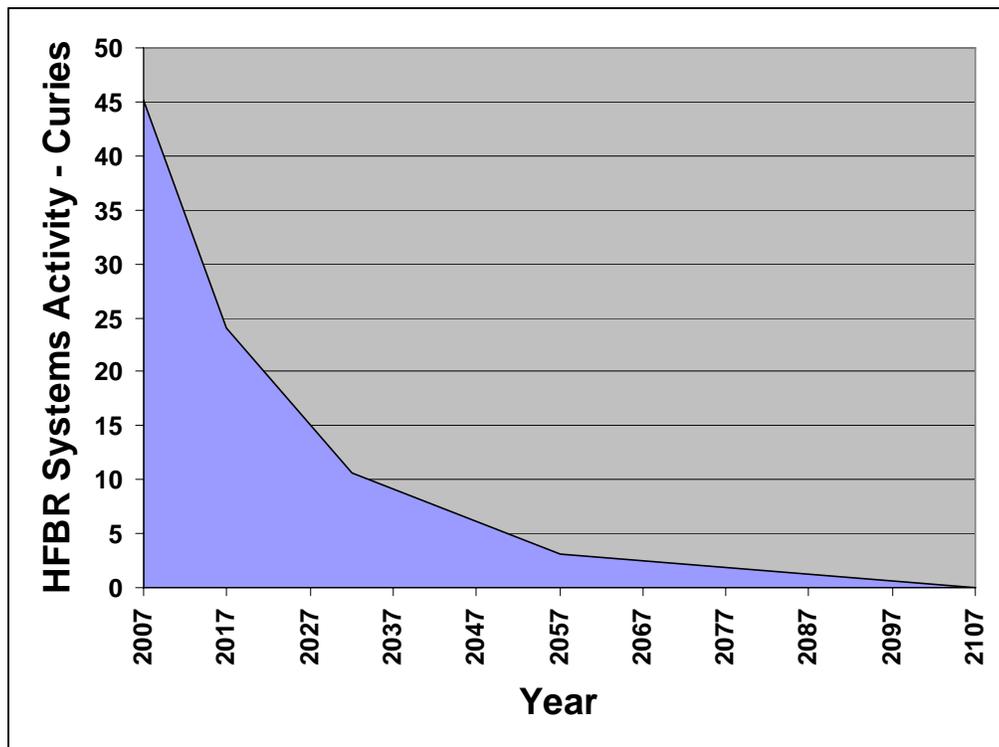
Figure 2-2. HFBR Systems: Total Out-of-Core Activity- 100 year Decay

The results of the radioactivity estimates for HFBR systems are summarized in Table 2-4, “HFBR System Radioactivity Calculation Summary.” The total activity in all systems, exclusive of the reactor vessel and internals, control rod blades, thermal shield, biological shield, and beam plugs/collimators is less than 0.1 percent of the activated materials associated with the reactor. While the activated components contain the vast majority of the total radioactivity remaining at the HFBR, the physical form of these activated components (activated metal) makes the hazard primarily a direct exposure risk, and not a contamination risk. The systems and components are much lower activity, and while it is unlikely to have an event that will release radioactivity, the probability of releases from the systems to the environment is more likely than a release from activated components.

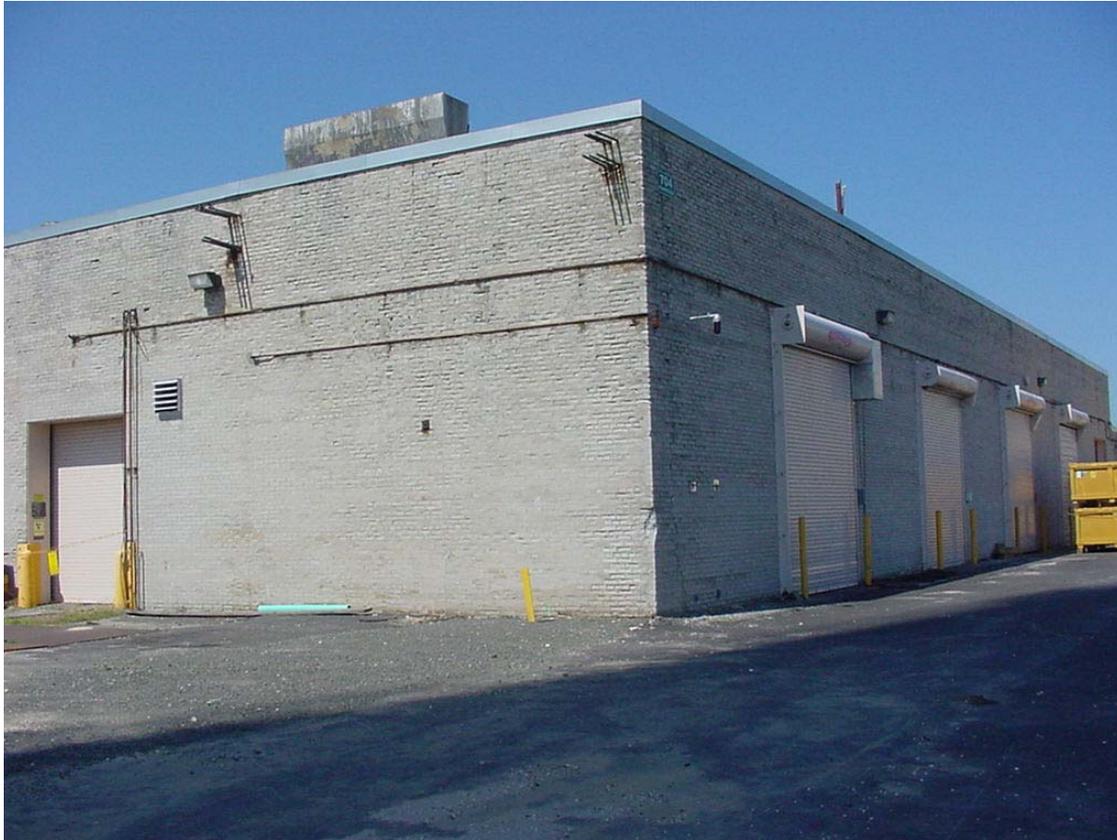
Figure 3-1. Building 704 Fan House

The Fan House was constructed in 1950 and was originally designed to support operations at the Brookhaven Graphite Research Reactor (BGRR). Following shutdown of the BGRR, the Fan House was designated as an HFBR Balance of Plant System since it housed electrical switchgear for AC and DC power to the HFBR, as well as for Buildings 701 and 703. The building housed five primary fans and a secondary fan, which took suction through ducts that penetrated the roof and connected to the above ground duct bottom. These fans discharged into a below grade exhaust duct directly below the fan compartments. Presently, the below grade duct is still intact, running under and along the northern portion of the building in the basement. As a result of past operations, the Fan House is a radiological controlled area.

this sample location indicated elevated levels of cesium-137 and strontium-90. Contamination at this location was likely the result of water leaking through the floor seams of the fan cell above. Results from the 4.5 to 5.0 foot sample depth met cleanup criteria. It was recommended that limited soil remediation at this location be performed, with endpoint sample collection.

Fixed radioactive contamination levels above release criteria exist in some areas (east area near filter bypass facility), up to 75,000 dpm/100cm². Dose rates are generally at 5-10 uR/hr, near background level, except near the underground plenum area, where levels up to 200 uR/hr are found.

Hazardous materials: Hazardous materials include lead, batteries, applied lead paint, asbestos wiring, insulation, and roof under the tar, oils and petrochemicals, PCBs, and mercury. Direct readings for lead paint show positive results on the door of the battery room. Sampling for mercury revealed negative results, however, mercury is suspected in the ballasts, capacitors, light ballasts, gear boxes, and in limit torque valve control oils.

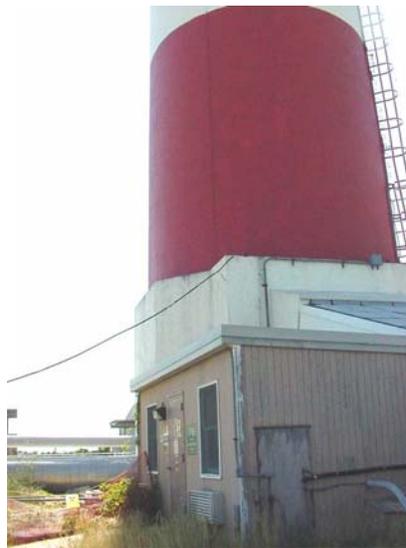
Figure 3-3. Building 715 – Stack Monitoring Facility

Surveys of radiation and radiological contamination within the building indicate background levels. There had been indications of contaminated soil based on previous characterization; therefore, additional soil samples were taken in 2004 to determine if remediation was necessary. Three samples were taken in November and December of 2004 at depths of 0-2 feet and 2-4 feet. Samples were analyzed for gross alpha, gross beta, Sr-90, tritium, and gamma spectroscopy. All samples were consistent with background radioactivity, and no reactor related radionuclides were detected (BNL, 2005a).

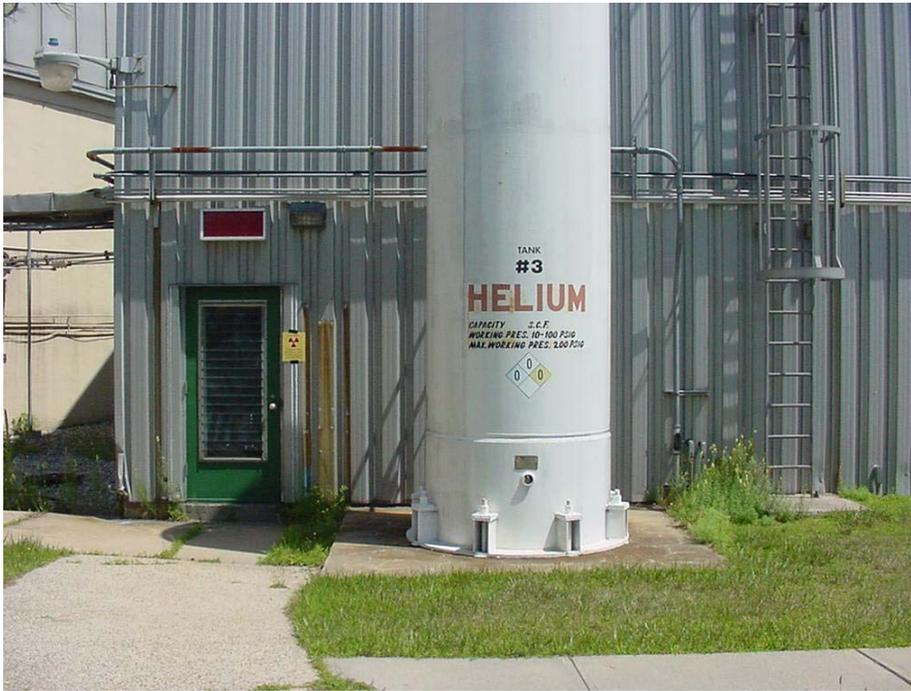
Figure 3-4. Building 751 – Cold Neutron Facility

Hazardous materials include solvents, degreasers, lubricants, oils and petrochemicals, and lead shielding. The hazardous materials are associated with equipment, such as motors and compressors with contained fluid. When this equipment is removed, the source of the hazardous materials will be removed (Cabrera, 2001b).

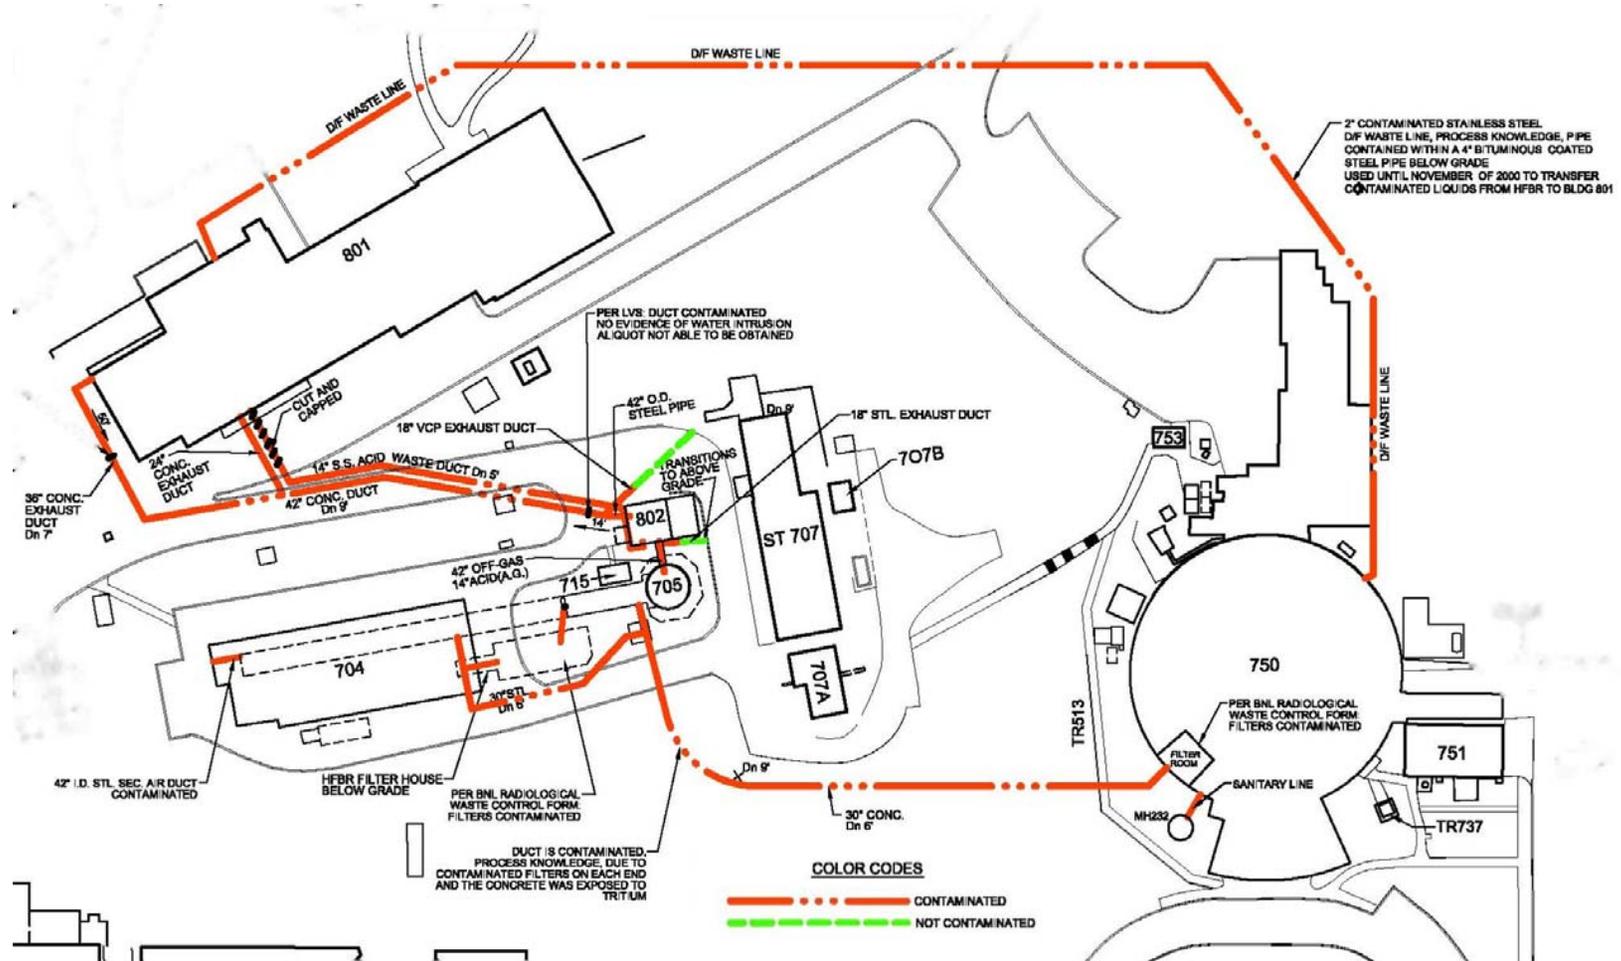
Figure 3-5. HFBR Site Plan, showing location of D/F-Waste Line

The liquid waste system provided a means of storage and disposal of potentially contaminated liquid wastes, including spilled heavy water. "D" wastes were pumped from the D/F Storage tank on the equipment level of the HFBR to the BNL waste treatment area where it was distilled with the distillate being solidified in waste disposal vaults. The portion of the D/F-Waste Line under consideration in this section that outside the HFBR confinement, and the line consists of about 1,117 feet of double-walled (2" within 4") carbon steel pipe that runs between Buildings 750 and 801. Figure 3-5 shows the general location of the pipe as it leaves the HFBR.
