# **SITE CLOSEOUT REPORT (REV 2)**

**HIGH FLUX BEAM REACTOR STACK (BLDG 705)  
DECOMMISSIONING AND DEMOLITION (D&D)  
BROOKHAVEN NATIONAL LABORATORY  
UPTON, NY  
CERCLIS NUMBER NY 789008975**

**March 2022**

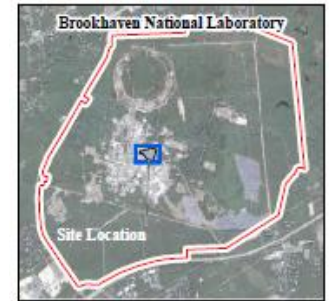
Stack Tank and Stormwater  
Collection System

SUBGRADE EABFF CONCRETE SLAB (18' BGS; Left in place from the Fan House (Bldg 704 & 802) Removal Project)

- TANK DRAIN SYSTEM COMPONENTS
- SUBGRADE STRUCTURE

A series of three drains existed beneath the Stack to collect precipitation that entered the Stack (**Figure 1-5**). These drains transected the pedestal and were composed of 3-inch stainless steel pipe. All three drain lines started at or slightly above the pedestal surface on the south and east sides of the Stack, descend through the top two concrete slabs, and exited the northwest side of the pedestal approximately 3 feet 10 inches below ground surface (bgs) and connected with the stormwater collection system. The first drain line was a trough drain spanning the area where the silencer duct connected to the base of the Stack along the west side of the pedestal. The second drain line started outside the Stack on the southeast side, connected with a 3-foot diameter by 2-foot deep drain in the center of the pedestal inside the Stack, and continued to the northwest side of the pedestal. The third drain line started on the east side of the pedestal outside the Stack and continued beneath the Stack to the northwest side of the pedestal and was installed to drain water collecting between the Stack wall and a proposed brick liner that was never actually installed.

A small area adjacent to the pedestal was excavated to remove the pipe connections to the pedestal. The drain lines within the pedestal were flushed with water to remove any loose sediments that may have entered the drains during demolition and removal activities.

The drains were stainless steel and steeply pitched, which maintained smooth inner surfaces with only a small amount of debris buildup to make them amenable to flushing. After the drains were flushed the ends of the drain were sealed to prevent any additional material from entering the pipes in accordance with the FSP (OFJV, 2020l). All water generated during flushing was collected and processed as described in the UFP-QAPP and the Waste Management Plan (OFJV, 2020d). The overall process involved periodically transferring the wastewater as needed from the Stack drain tank into totes, and adding a solidification agent so that the waste could be disposed as solids along with other demolition wastes at WCS.

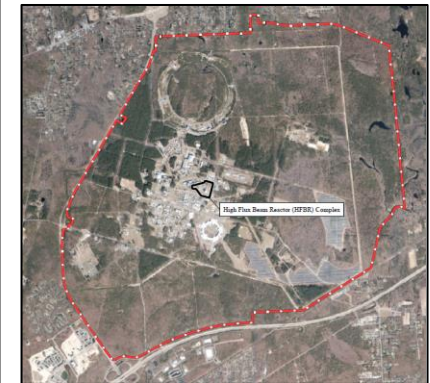
10/2021 PROJECT No. R5-0022.01 FIGURE 3-5

**3.5.5**); SU-7B, the silencer excavation (**Section 3.5.4**); SU-7C, the Stack stormwater collection system (**Section 3.5.3**); and SU-7D, the surrounding work area. The Survey Units are shown on **Figure 3-5**.

SU	Description
7A	Former Building 705 Pedestal
7B	Former Silencer Excavation
7C	Former Stack Drain and Collection Tank
7D	HFBR Stack Demolition Radiation Control Area
