BGRR Project Update

March 2012

Diane Rocco, Director
Environmental Restoration Projects

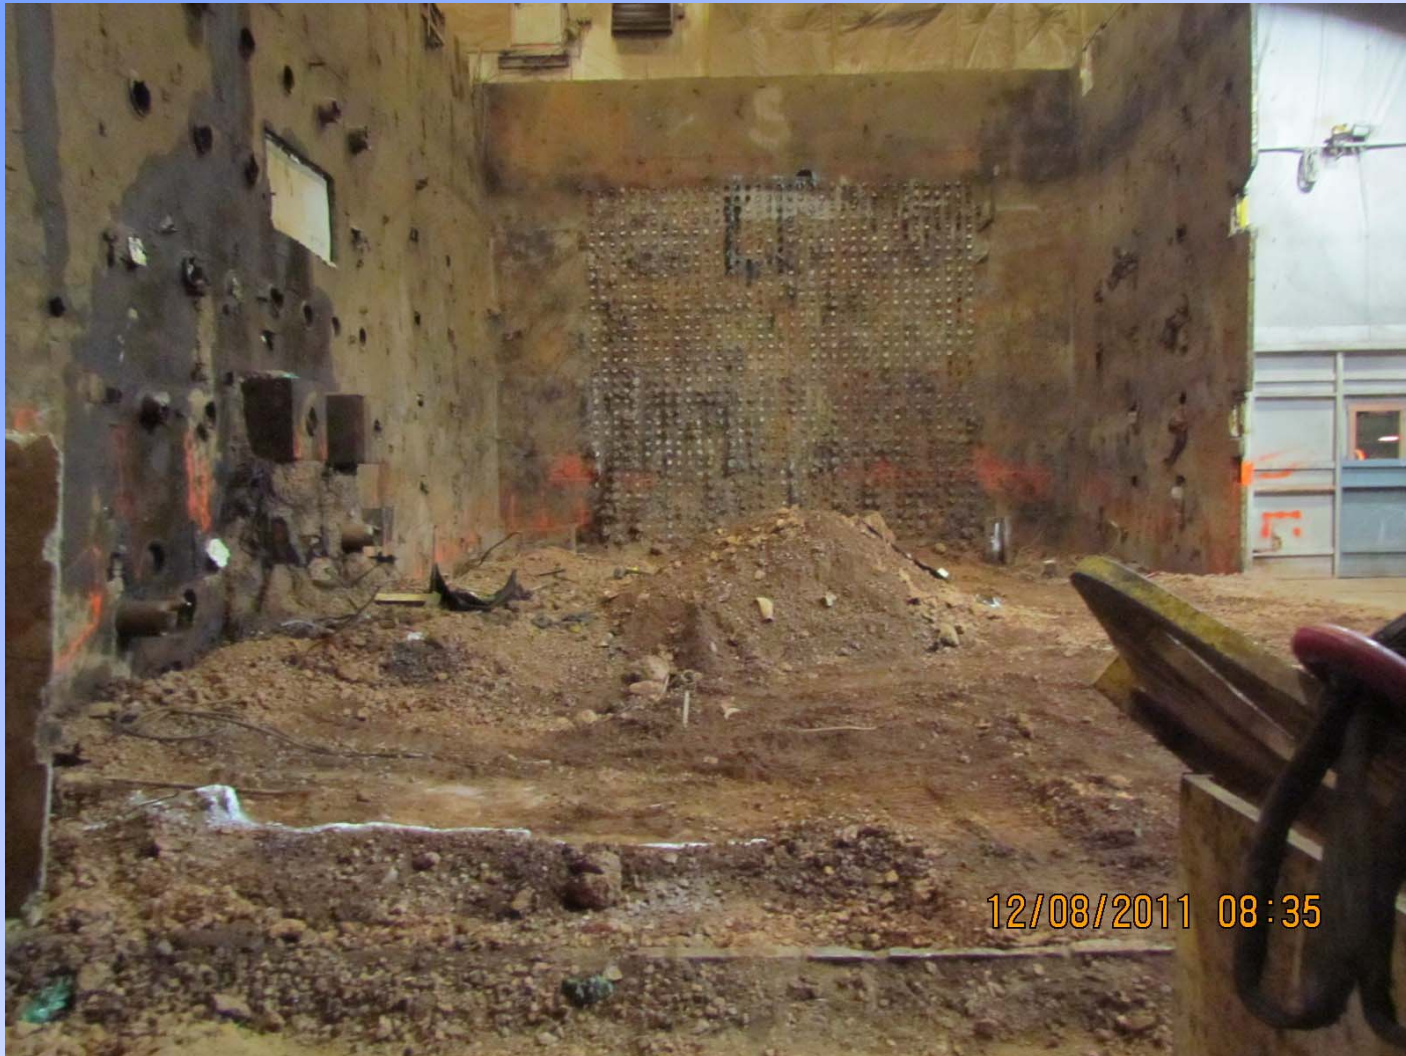
Biological Shield Demolition – 12/7

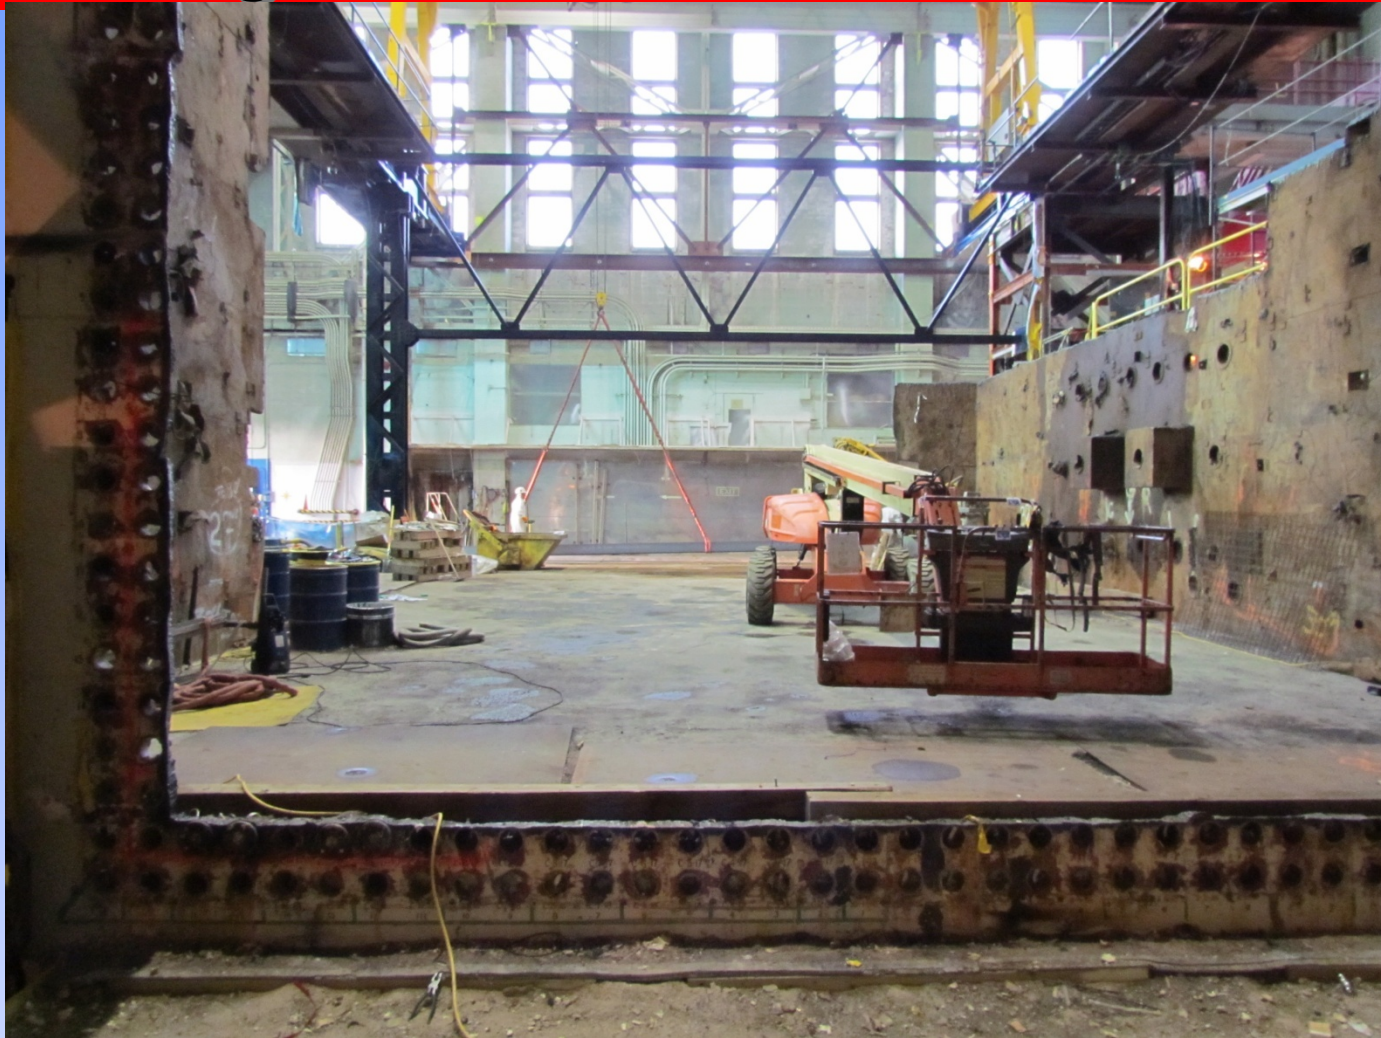
Biological Shield w/o CCE – 3/6
