# 2019

BROOKHAVEN NATIONAL LABORATORY

# Water Quality

CONSUMER CONFIDENCE REPORT

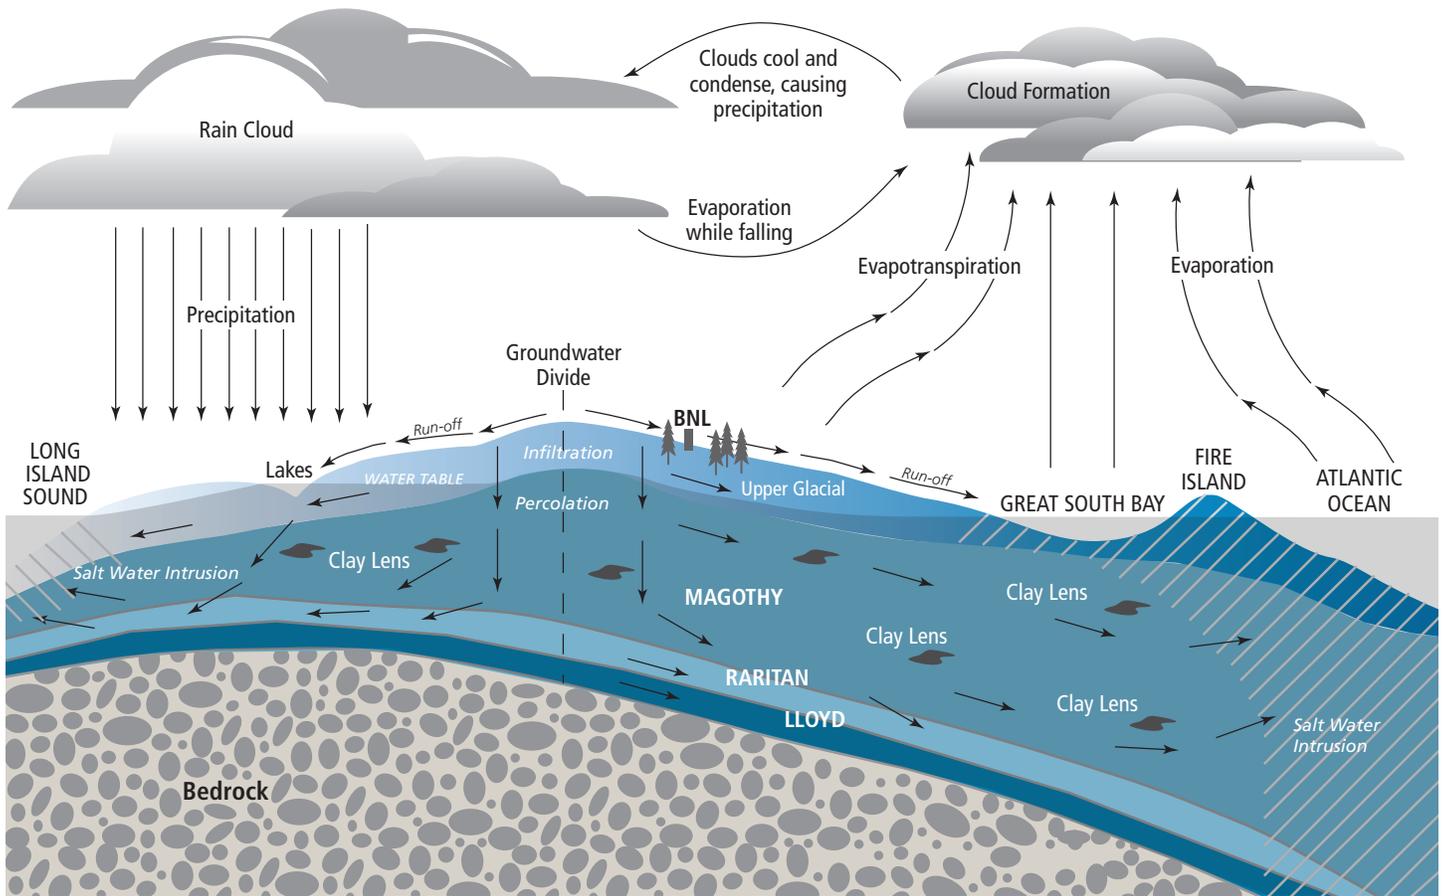
Long Island Aquifer System

The Long-Island aquifer system is made up of three primary formations. From the surface to approximately 150 feet below is the Upper Glacial aquifer, from 150 to 1,000 feet below is the Magothy aquifer, and from 1,000 to about 1,600 feet below is the Lloyd aquifer. As designated by the U.S. Environmental Protection Agency (EPA), Long Island's aquifer system is one

of 78 "sole source" aquifers in the nation recognized under the aquifer-protection program authorized by the U.S. Safe Drinking Water Act (SDWA).

The Lab's five in-service drinking-water wells draw up to 1,000 gallons per minute, or about 1.34 million gallons of water per day from the Upper Glacial aquifer to supply drinking
