PROTECTION OF CONCRETE IN COOLING TOWERS FROM MICROBIOLOGICALLY INFLUENCED CORROSION

M.L. Berndt
Department of Energy Sciences and Technology
Brookhaven National Laboratory

Geothermal Resources Council Transactions, Vol. 25, 3-7, San Diego, 2001

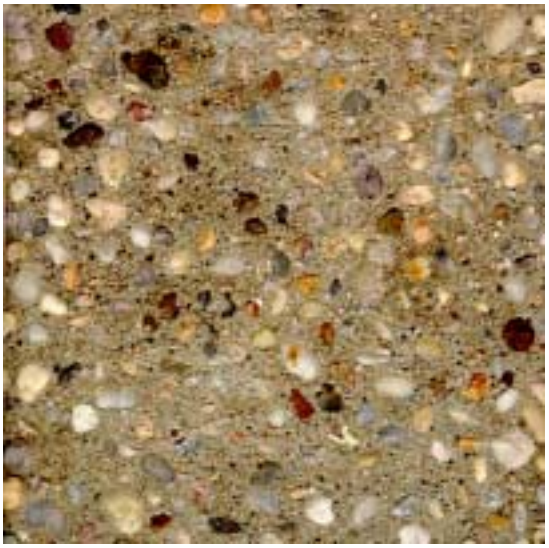
The uncoated concretes all experienced deterioration from exposure in the cooling tower basins. The most severe attack was observed on the plain Type I cement concrete. Extensive etching occurred to reveal coarse and fine aggregate. Partial replacement of cement with silica fume improved the durability. Attack of the silica fume-modified concretes also occurred but was not as advanced as that for the plain concrete. Fine aggregate and small amounts of coarse aggregate were exposed on the silica fume-modified concretes. The 10% silica fume mix had the best performance of the tested concretes. Figures 1 and 2 compare the surfaces of the plain and 10% silica fume concretes after the field tests. The degree of attack on all of the field tested uncoated concrete specimens was greater than that in the laboratory tests. This is probably due to the longer exposure period plus the possibility of other bacteria involved in the MIC process. The field rankings of the materials were similar to those obtained from exposure to sulphur oxidizing bacteria in the Atlas cell arrangement. *(Insert Figures 1 and 2)*

Figure 1. Surface of plain concrete after field exposure.

Figure 2. Surface of 10% silica fume concrete after field exposure.
