Type B Accident Investigation Board Report

Arc Flash at Brookhaven National Laboratory April 14, 2006

August 2006

Brookhaven Site Office
U.S. Department of Energy
Upton, New York

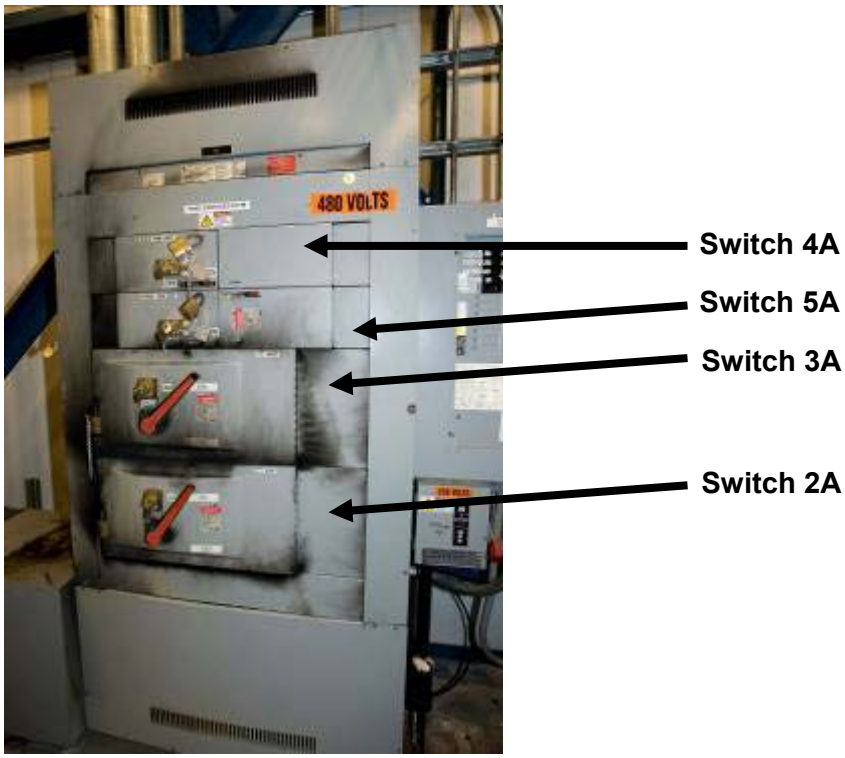
Figure 1-3. Electrical panel PB-1

Possible sources of foreign objects entering into the switches were found in panel PB-1. These consisted of conduits openings that entered panel PB-1. The conduits that had cables installed in them did not have the void spaces filled, and an empty conduit was not capped. No foreign objects were found during the inspection and removal of the failed switches. The switch cabinets covers were in place and locked closed before the arc flash occurred (see Figures 1-3 and 1-4).

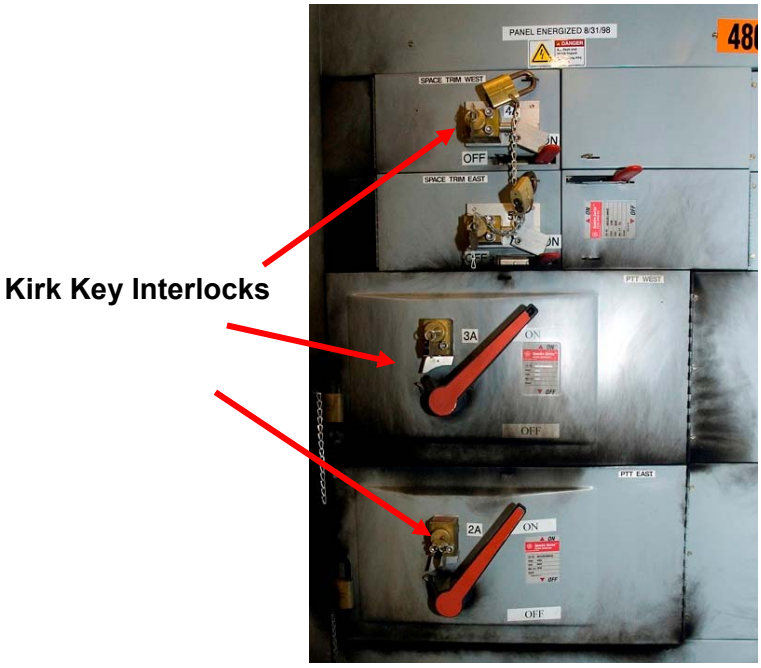
Figure 1-4. Kirk Key interlocks on switches 2A, 3A, 4A, and 5A

The inside of the two 400-amp switches 2A and 3A was coated with a thick layer of black soot. The switch components appeared from the front to be intact, except for thin plastic insulating sheets at the left end of the switches, opposite the load terminals. The left ends of the 400-amp switches were partially blown out, and the adjacent wiring insulation was melted from the heat of the arc flash. The vent panels on the ends of the switches were completely seared by the heat and blown off. The front covers were deformed and would have failed eventually if the fault persisted beyond the 0.2-second clearing time (see Figure 2-5 and Figure 1-4).

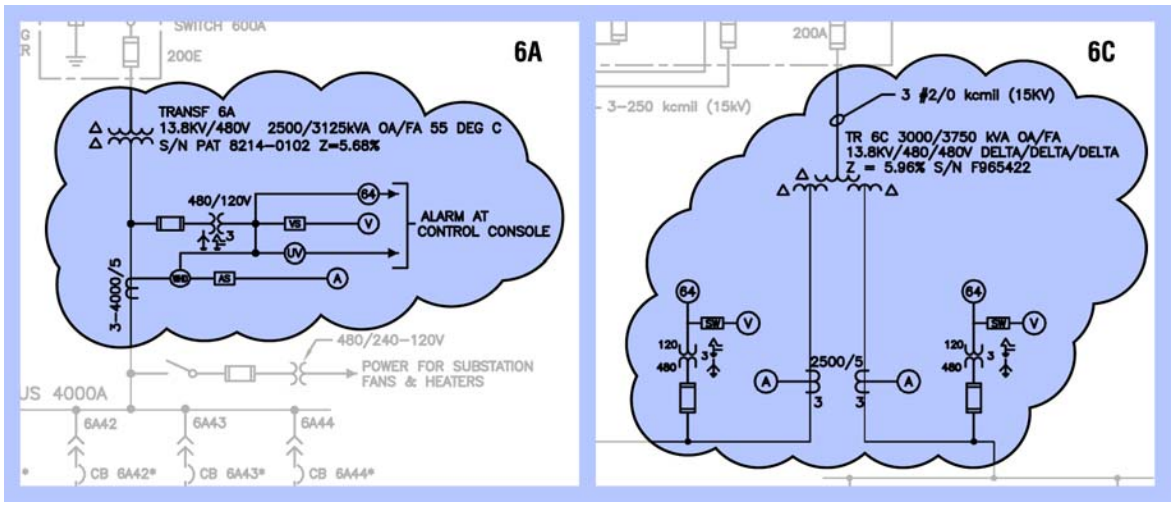
Figure 2-1. Circuit 64 designs for the 6A transformer (with alarm to control console) and 6C (without alarm to control console).

Substation 6C provides power to the electrical panel involved in the arc flash. This substation had a ground-fault detection relay installed, but it was inoperable because it did not have the required power source. The STAR control room and RHIC Main Control Room staff and the Chief Electrical Engineer were unaware that substation 6C did not have the capability to monitor ground-fault conditions. A surveillance of the voltages of substation 6C was performed 3 days before the accident; and, although a slight ground fault was recorded on the inspection form, no corrective action was taken. A ground fault on one of these cables resulted from a cut in the insulation and from the cable being submerged in a flooded manhole.

JON 2	BNL needs to immediately verify that all ground-fault monitoring devices are connected to remote alarms in the RHIC Main Control Room.	BNL failed to ensure that ground-fault detector relays, as well as monitoring and alarm systems, were properly designed, installed, tested, and maintained.
JON 3	BNL needs to determine and review the specific factors by which RHIC and Plant Engineering design reviews and approval processes failed to ensure installation of a functional ground-fault monitoring and alarm system as specified in BNL standards and DOE requirements. Additionally, BNL needs to implement the corrective actions identified by this review to prevent recurrence.	BNL failed to ensure that a ground-fault monitoring system provided prompt notification to the Main Control Room for safe and reliable operation.
JON 4	BNL needs to improve the rigor and formality of the engineering design and design review processes to ensure that the functional specifications identified in DOE Directives and BNL standards are addressed.

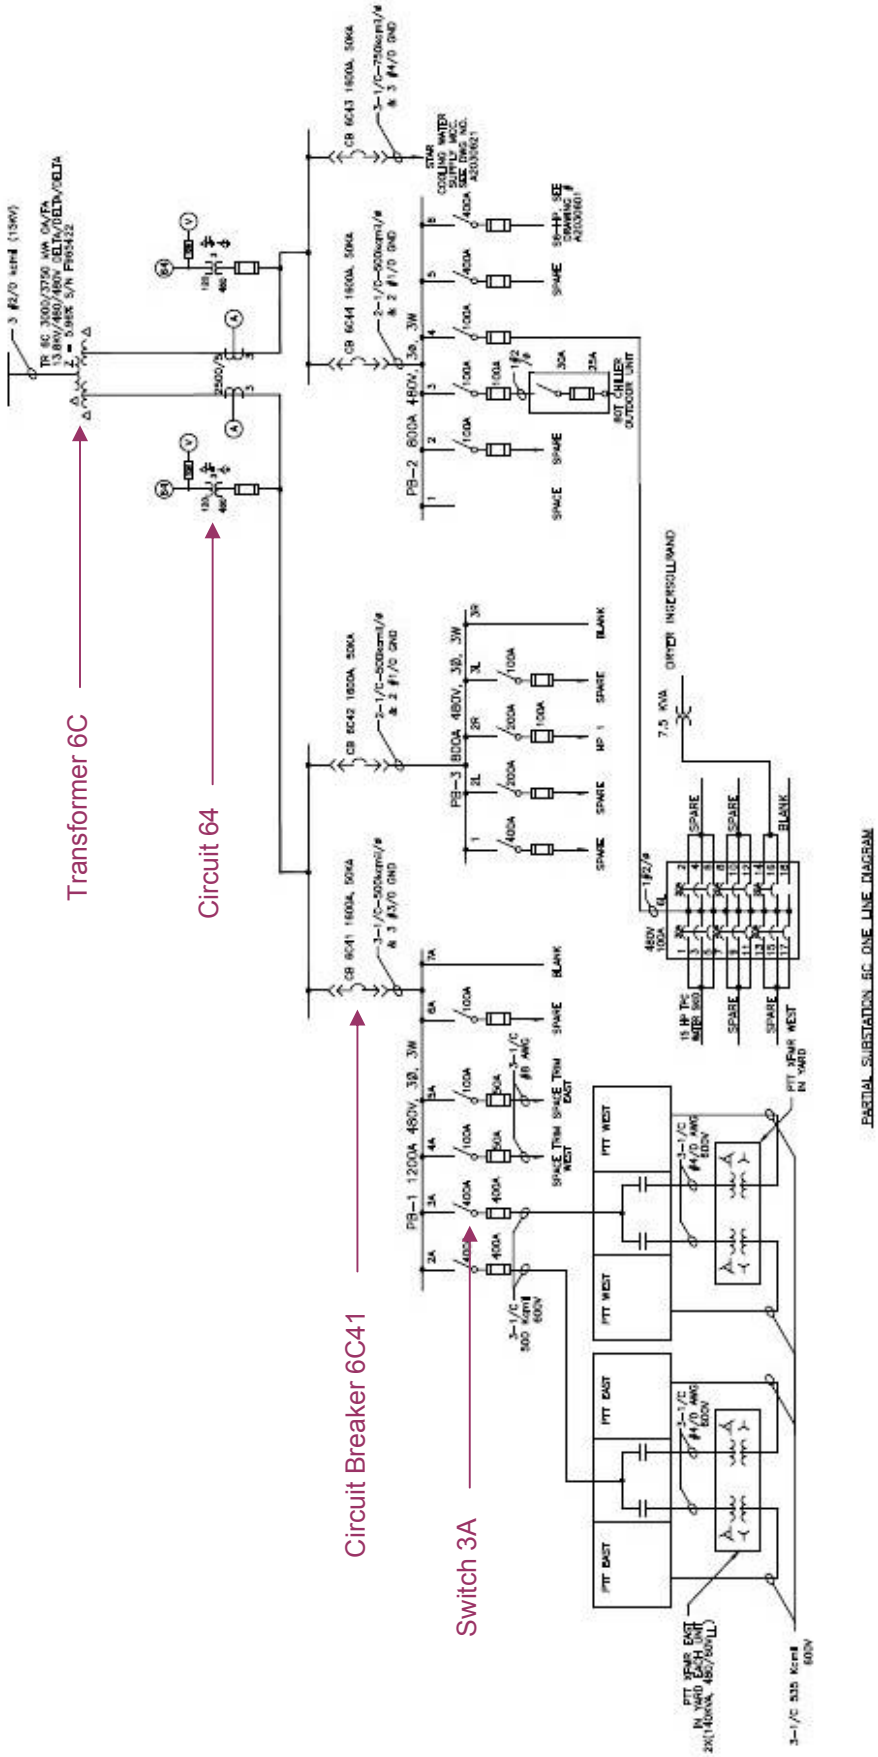
Figure 2-4. Partial one-line diagram substation 6C

Following the accident, BNL calculated the phase-to-ground fault current available at panel PB-1 as 36 kA for bolted faults and 16.7 kA for arcing faults. A bolted fault is caused when either a phase-to-phase or a phase-to-ground is directly connected together (bolted). Arcing faults occur when electrical clearances are reduced or compromised by deteriorating insulation or human error, causing an arc to form phase-to-phase or phase-to-ground. The arc burns in open air, releasing a large amount of energy until an upstream overcurrent protection device opens to clear the fault. Since this was an arcing fault, the current was limited to a maximum of 16.7 kA, which is below the 24-kA instantaneous trip setting of

the upstream circuit breaker (6C41). The short time-setting for circuit breaker 6C41 was 5,760 A, with an intentional 0.15-second time delay. This circuit breaker requires an additional 0.05 seconds to clear a fault, making the total clearing time about 0.2 seconds. Clearing time is the period of time required for the circuit breaker to open, thus "clearing" the fault.

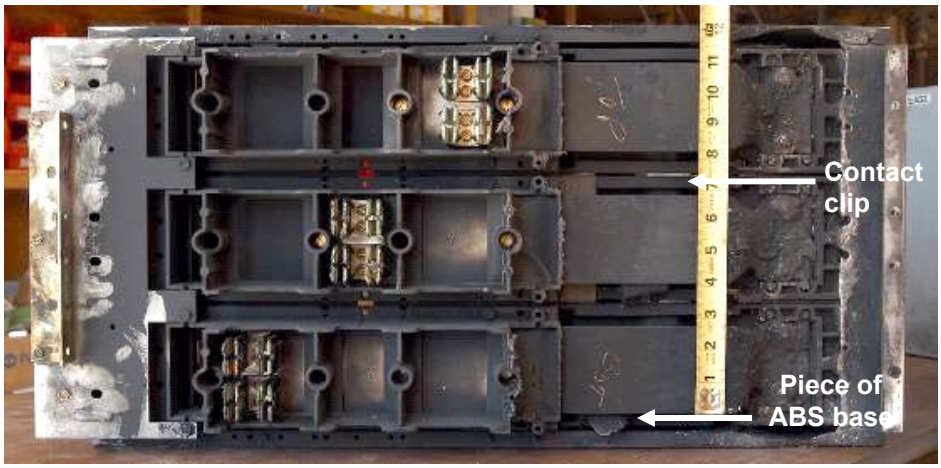
Figure 2-8. Damaged Switch 3A
(Note location of contact clip and piece of ABS base)

The removal of the bus bars disclosed that an arc had occurred between the aluminum bus and the adjacent steel switch frame. This was observed on the B-phase of switch 3A. (See small yellow arrow on Figure 2-9.) The bus bar is held about ¾ inch from the steel frame by its plastic support with two opposing screws (see yellow arrows on Figure 2-9), which are approximately ½ inch apart (Figure 2-10). The screw end on the right (Figure 2-9) connects the bus bar to its plastic support and is in full contact with the 480-volt bus. The screw on the left (screw removed in Figure 2-9) holds a switch assembly on the front onto the steel support piece, and is at ground potential.

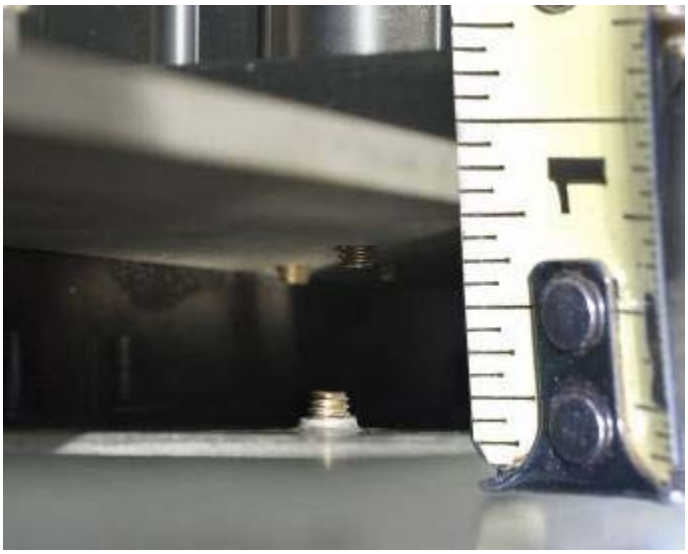
Figure 2-10. Space between screw ends on undamaged switch

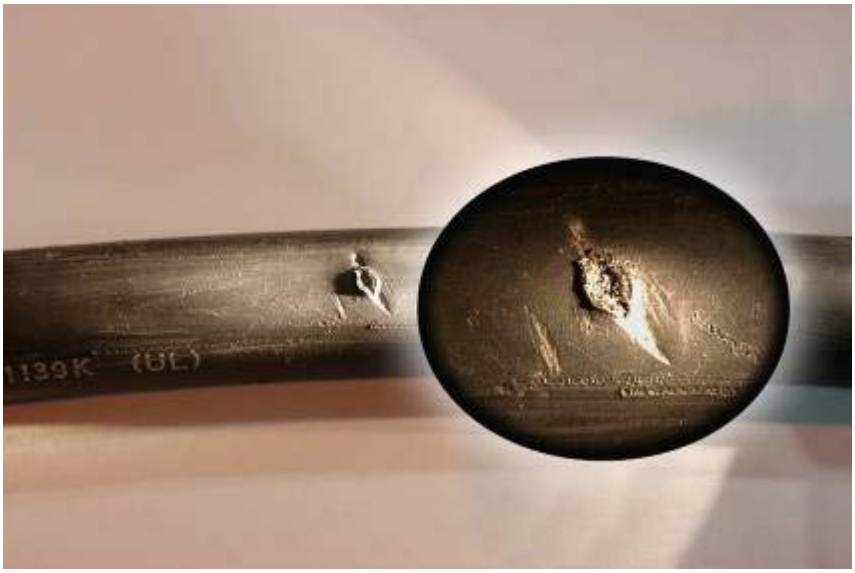
Figure 2-15. Damaged cable with oxidized copper

Figure 2-14. Damaged cable which was underwater in manhole from substation 6C to panel PB-1

The pinhole was surrounded by a small, volcano-shaped mound of carbonized insulation. When the insulation was removed, the copper wire in the area of the nick was found to be oxidized and discolored (Figure 2-15), an indication that this condition had been present for an extended period of time. When the manhole was drained, the ground fault cleared. A new cable was installed and no ground faults were detected.

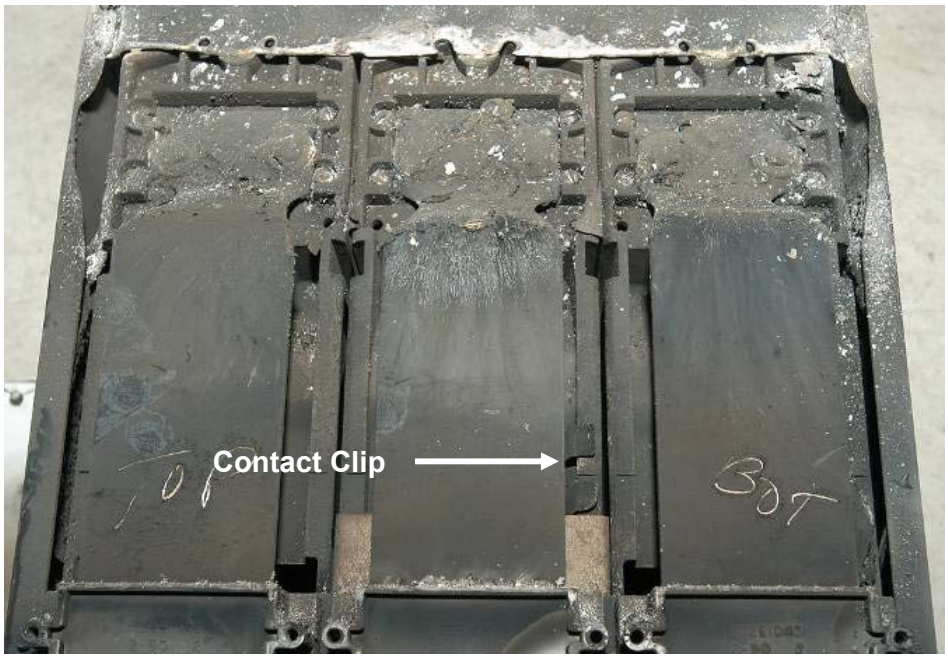
Figure 2-16. Loose arc chute from 600-amp Spectra-fused disconnect switch

observed damage to the switches by the failure of the ABS Base led to the inspection of other Spectra 400-amp fused-disconnect switches at BNL. These inspections identified cracking of the ABS Bases of the switches that were installed at the same time as those in panel PB-1. BNL has subsequently removed a switch from service and cycled the switch. The ABS Bases cracked, but failed to release the contact clips, after more than 4,000 switch operations. BNL inspected all of the GE Spectra-type switches in use and found that the arc chutes were broken on a 600-amp switch and the arch chute had been displaced on one switch. (See Figure 2-16)

JON 10	BNL needs to inspect all GE Spectra Series switches to ensure their mechanical integrity.	BNL failed to establish a preventive maintenance inspection program for fused-disconnect switches and ground-fault relays.
JON 11	BNL needs to establish a preventive maintenance inspection program for electrical distribution system equipment to include fused-disconnect switches and ground-fault relays.	
JON 12	BNL needs to establish a formalized project management process for arc flash calculations that establishes priorities, resources, and accountabilities.	BNL failed to implement NFPA 70E.
JON 13	BNL needs to conduct an independent effectiveness review of the implementation of the personal protective equipment and training requirements of NFPA 70E.	
JON 14	BHSO needs to monitor the status of the corrective actions for the following: • SC Energized Electrical Work Review; • BNL self-assessment of energized electrical work; and • Performance of BNL's effectiveness review.	BNL failed to adequately monitor the progress of its implementation of NFPA 70E requirements. BHSO failed to adequately validate BNL's implementation of corrective actions from BNL's self-assessment and the SC Energized Electrical Work Review.

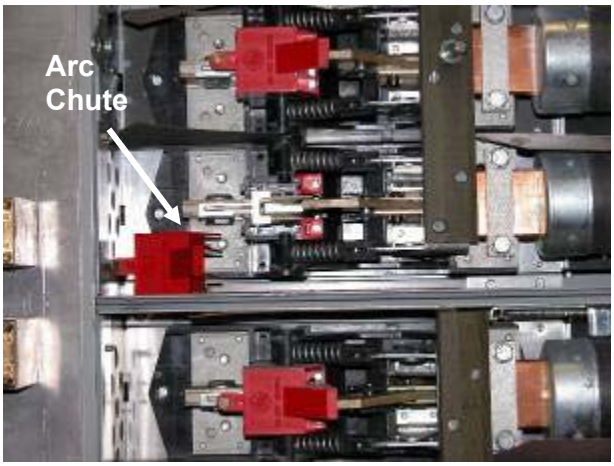
Figure 2-18. Location of contact clip on Switch 3A after backing plate removed

A single contact clip of switch 3A was found on the side of the phase B bus after the switch was removed from panel PB-1(Figures 2-17 and 2-18). The contact clip from switch 3A was partially damaged by arcing, as show in Figure 2-19. On switch 2A, which had two pieces of the ABS base displaced (Figure 2-20), only one of the contact clips could be found. There was no evidence that the contact clips from either switch 2A or 3A had contacted the buses; however, this could not be proven with any certainty. Had the contact clip from switch 3A caused the arc flash, it might have been completely destroyed in the ensuing arc, but evidence of arcing would have been left on the aluminum bus at the point of contact. No such evidence was seen, and the bus bar would have been damaged where grounding occurred.
